# SOUTH FORK HOPPERS CREEK STREAM AND WETLAND RESTORATION PROJECT

## ANNUAL MONITORING REPORT FOR 2008 (YEAR 3)

Project Number: D04006-4

November 2008

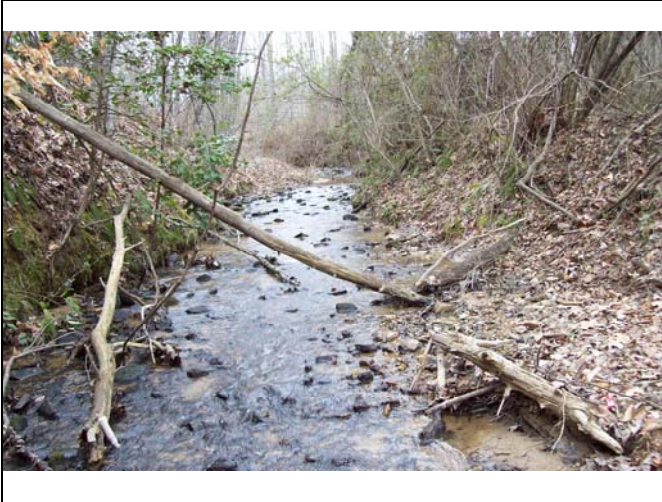
P-1 Site 1 – reference site - looking upstream

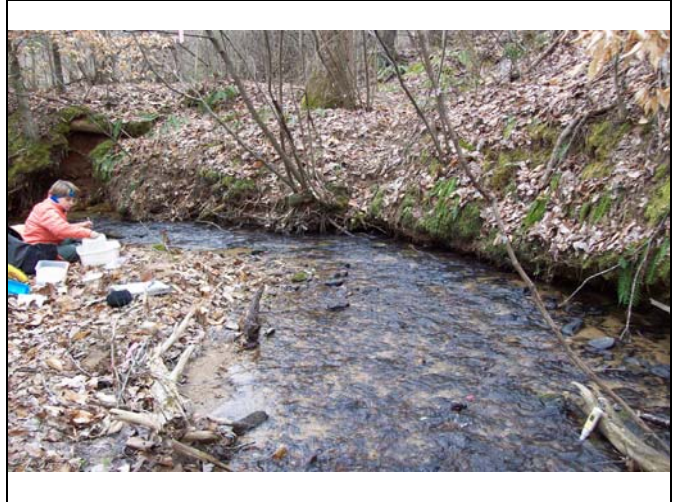
P-2 Site 1 – reference site - looking downstream

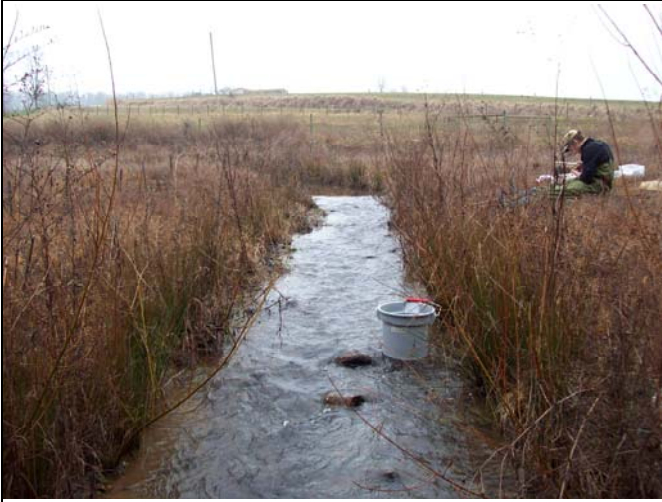
P-3 Site 2 – looking upstream

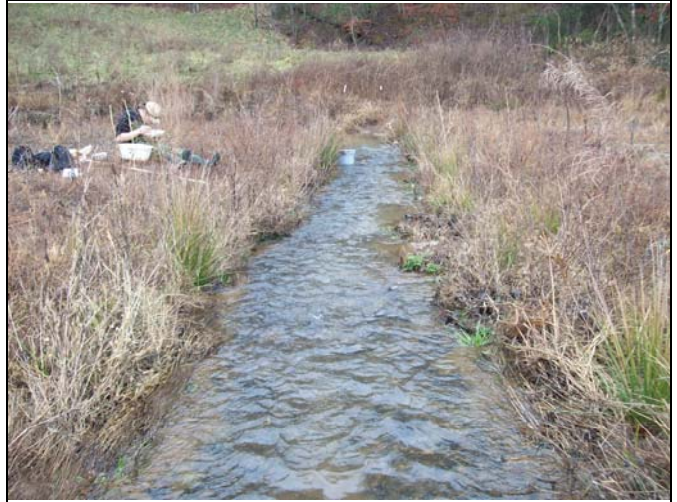
P-4 Site 2 – looking downstream

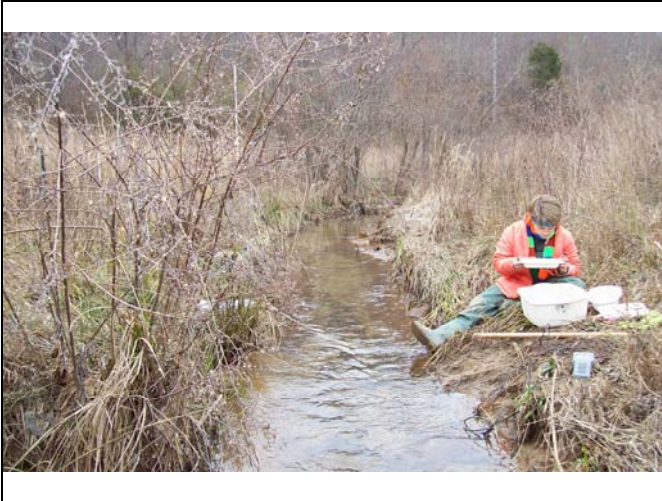
P-5 Site 3 – looking upstream

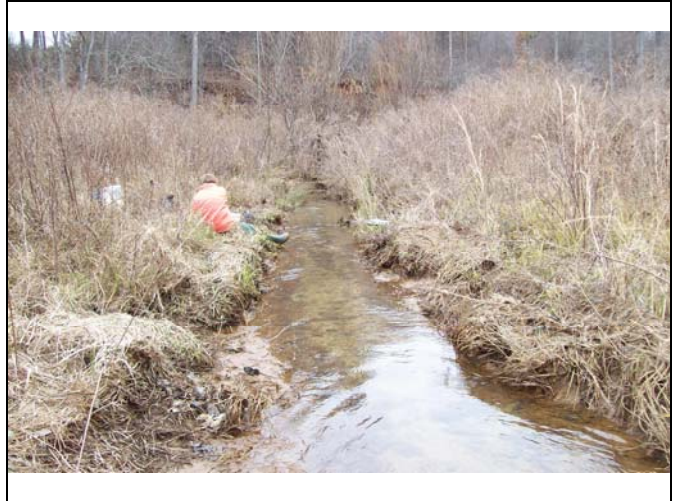
P-6 Site 3 – looking downstream
