**Year 1 Monitoring Report for Stream Mitigation of South Muddy Creek
Tributaries
(Queen Property)**

South Muddy Creek Tributaries
McDowell County, NC
SCO # D04006-01

Submitted: September 2007

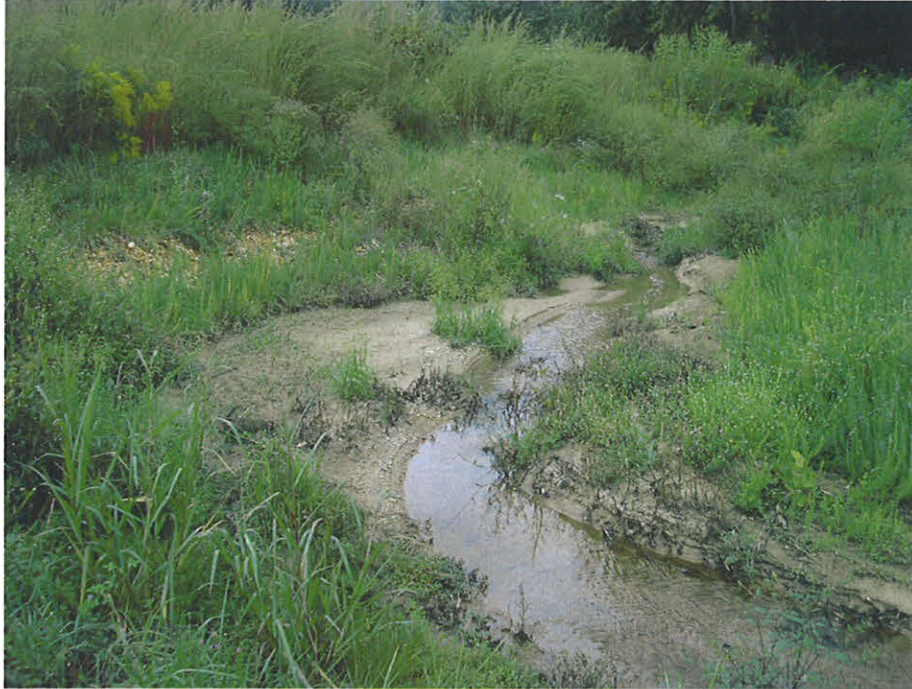
Feature Issue	Station Numbers	Suspected Cause	Photo Number
Aggradation	4+50 (A2)	Large bar, 25 feet aggraded	SPA 1
	3+00 (A2)	Overwide channel, 40 feet aggraded	
Bank failure	79+50 (A Middle)	Mat failed; scour hole, 5'	SPA 2, SPA 3
	12+10 (B)	Complete loss of riffle, bank failure.	
Bank scour	103+00 (A Upper)	Large hole, scour (15 feet)	SPA 4, SPA 5, SPA 6
	83+30 (A Middle)	Sloughing, coir log undercut and fallen into pool (15 feet)	
	82+70 (A Middle)	Sloughing, coir log undercut and fallen into pool (15 feet)	
	3+00 (A Lower)	Sloughing	
	19+70 (B)	Channel scouring around log sill	
	18+50 (B)	Scour at outside meander bend; significant aggradation	
	16+00 (B)	Scour, matting loose and failing, bank slough	
	15+70 (C)	Bank scour/ sloughing	
	4+50 (C)	Bank scour/ sloughing

SPA 1
Aggradation in Tributary A2 at station 3+00.
(EMH&T, Inc. 9/19/06)

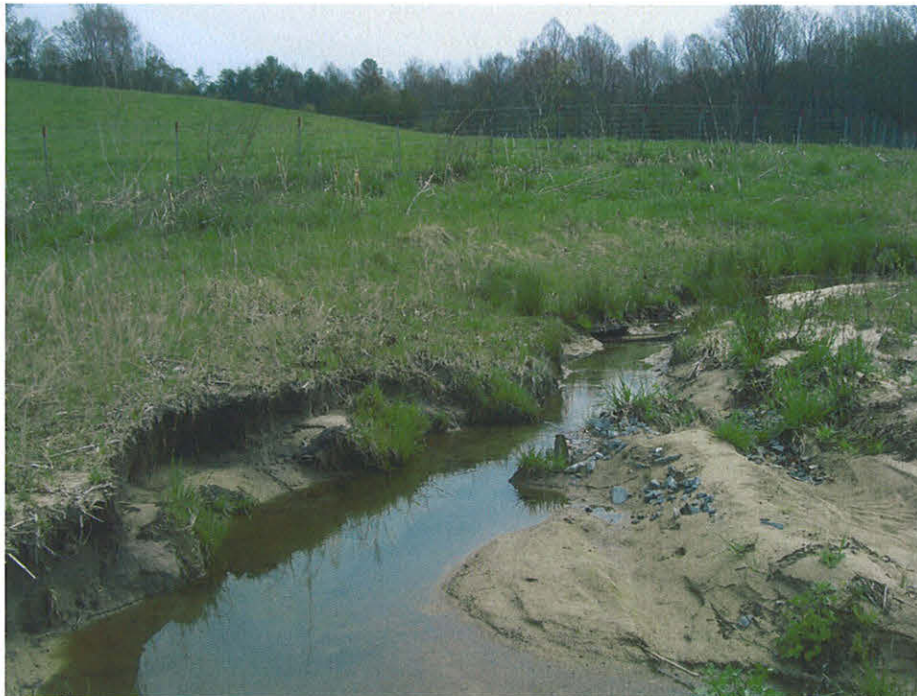
SPA 2
Bank failure along Tributary B at station 12+10.
(EMH&T, Inc. 4/14/07)

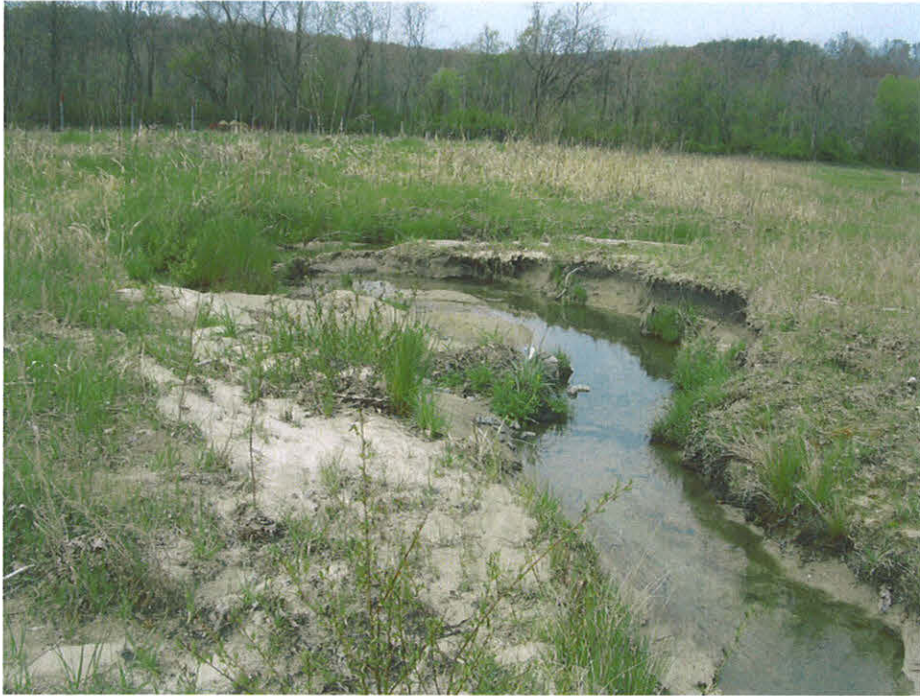
SPA 3
Bank failure along Tributary B at station 12+10.
(EMH&T, Inc. 4/14/07)

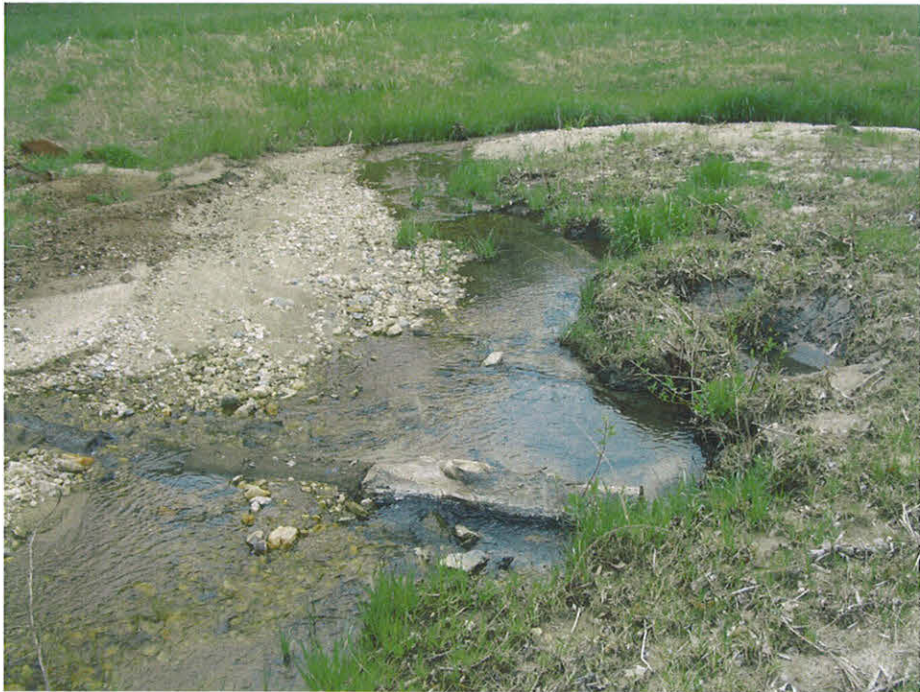
SPA 4
Bank scour along Tributary B at station 19+70.
(EMH&T, Inc. 4/14/07)

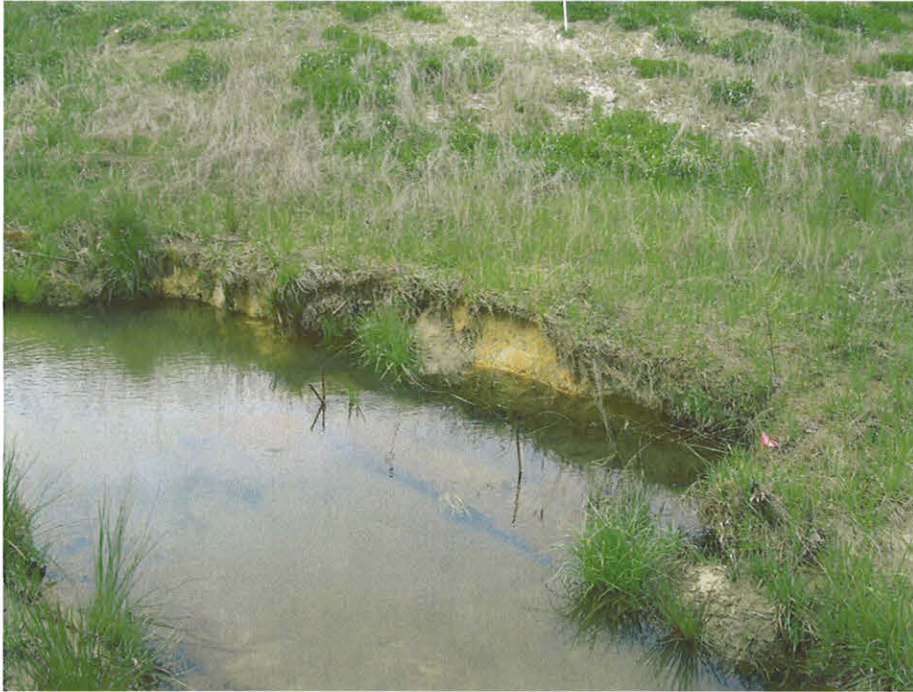
SPA 5
Bank scour along Tributary A (middle) at station 83+30.
(EMH&T, Inc. 4/14/07)

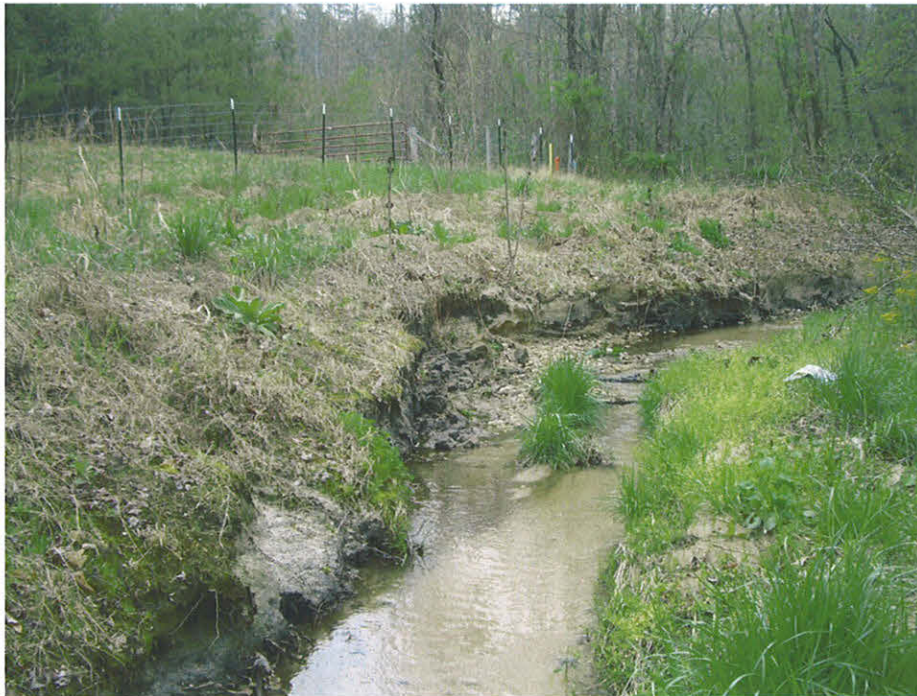
SPA 6
Bank scour along Tributary C at station 15+70.
(EMH&T, Inc. 4/14/07)
