# **Year 3 Monitoring Report for South Muddy Creek Tributaries (Queen Properties)**

South Muddy Creek Tributaries  
McDowell County, NC  
SCO # D04006-01

**Submitted:** December 2008

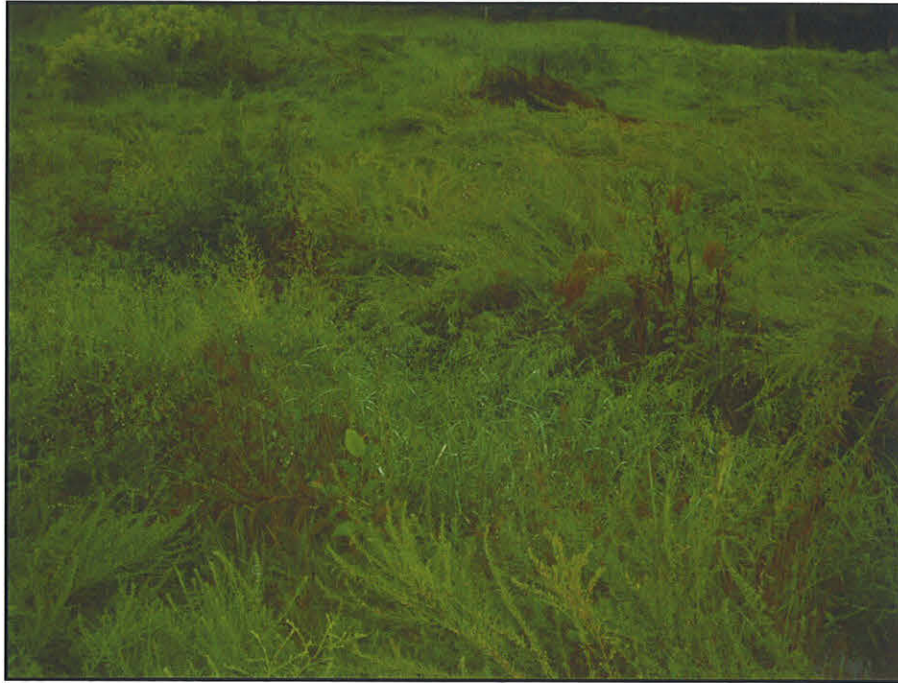
**VPA 1**

**View of *Sericea lespedeza* growing along bank of Tributary A (lower), across the stream valley at station 64+13.  
(EMH&T, Inc. 9/11/08)**

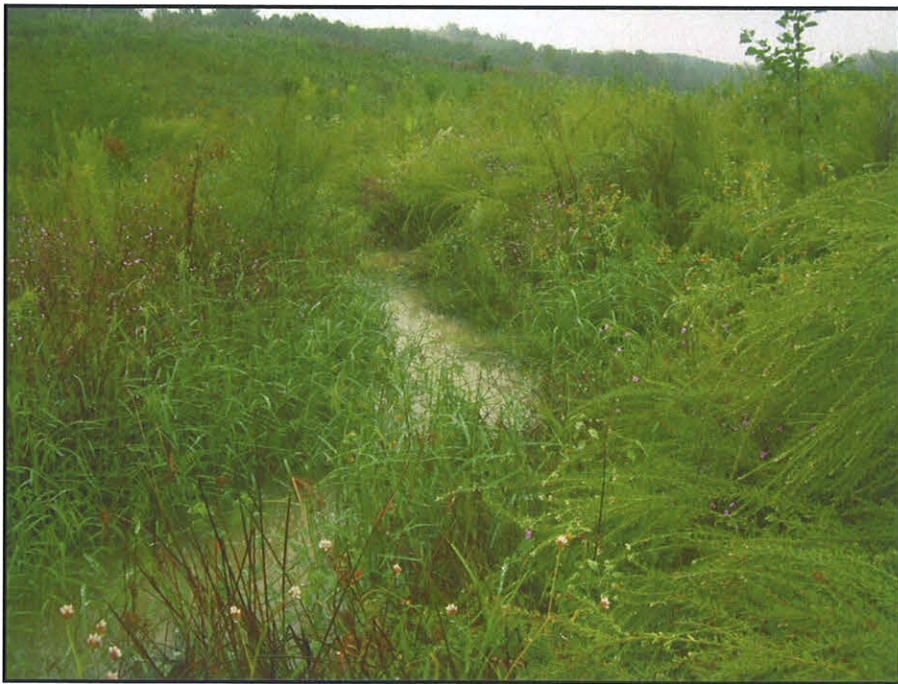
**VPA 2**

**View of *Sericea lespedeza* growing along bank of Tributary A (lower), looking upstream from station 28+23.  
(EMH&T, Inc. 9/11/08)**

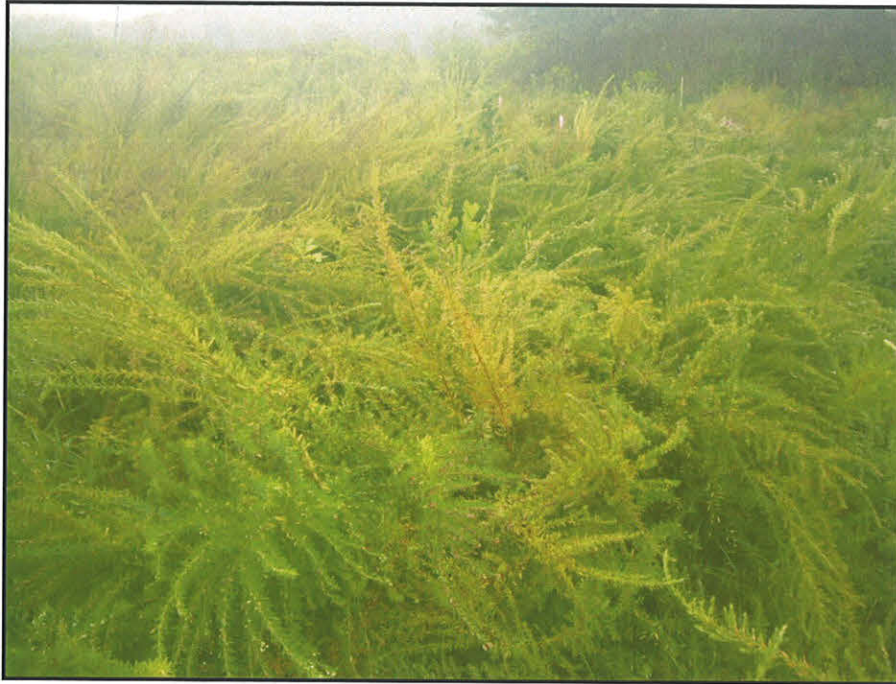
**VPA 3**

**View of *Sericea lespedeza* growing in Vegetation Plot 2 along Tributary A (upper).**  
(EMH&T, Inc. 9/10/08)

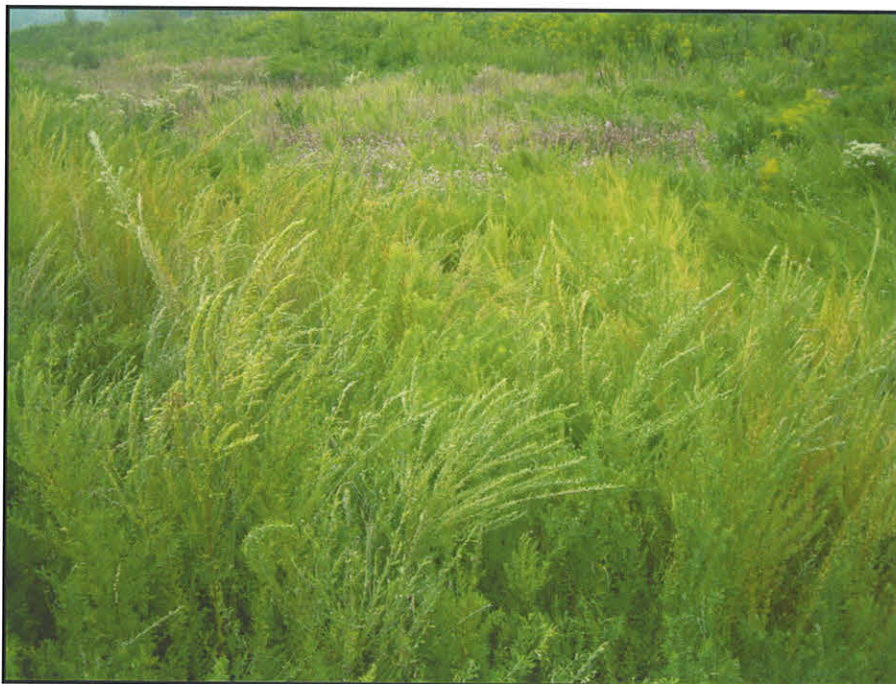
**VPA 4**

**View of *Sericea lespedeza* growing in Vegetation Plot 5 along Tributary A (middle).**  
(EMH&T, Inc. 9/10/08)
