Year 4 Monitoring Report for South Muddy Creek Tributaries (Queen Properties)

South Muddy Creek Tributaries
McDowell County, NC
SCO # D04006-01

Submitted: December 2009

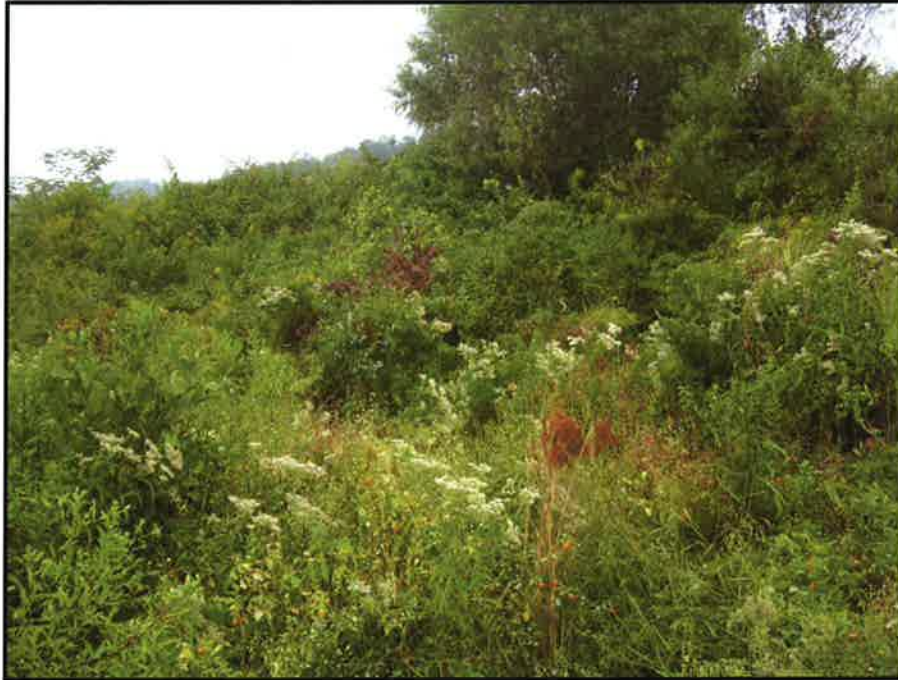
SPA 1

Aggradation along Tributary A2 near the top of the reach. The stream channel in this area is moving toward wetland conditions.

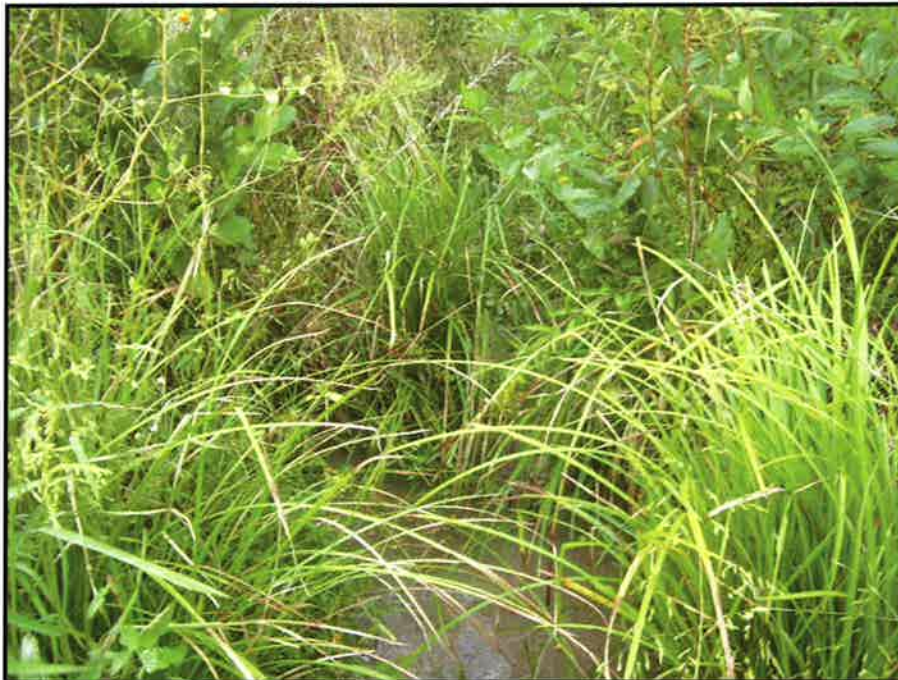
SPA 2

Bank failure along Tributary B at station 12+10; riffle has been lost. Buffer vegetation is so dense that erosion is no longer apparent; channel is also becoming vegetated and appears to be stable.

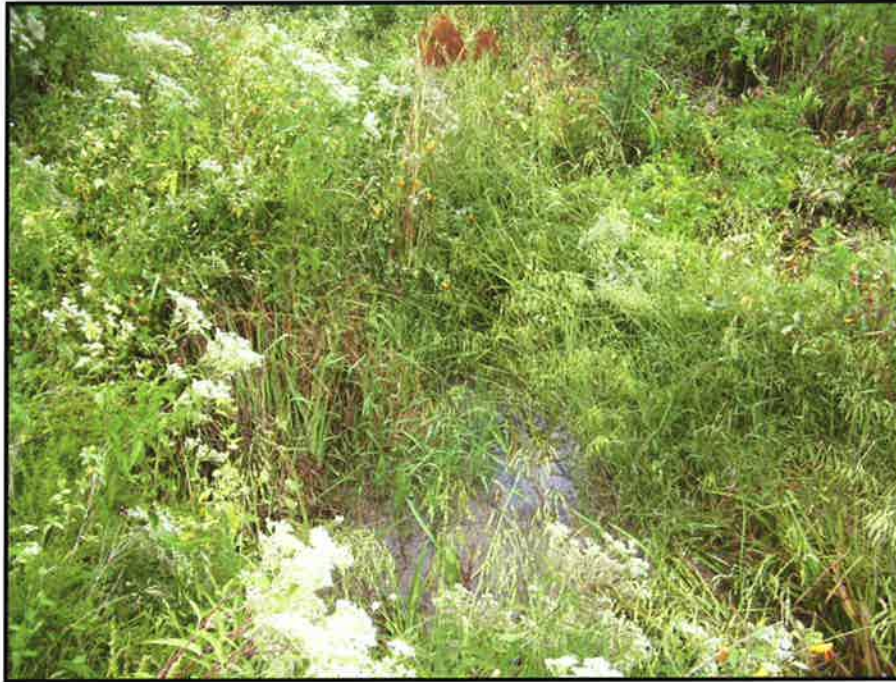
SPA 3
Slumping of the left bank on Tributary A (middle) near station 84+75.
(EMH&T, Inc. 9/16/09)

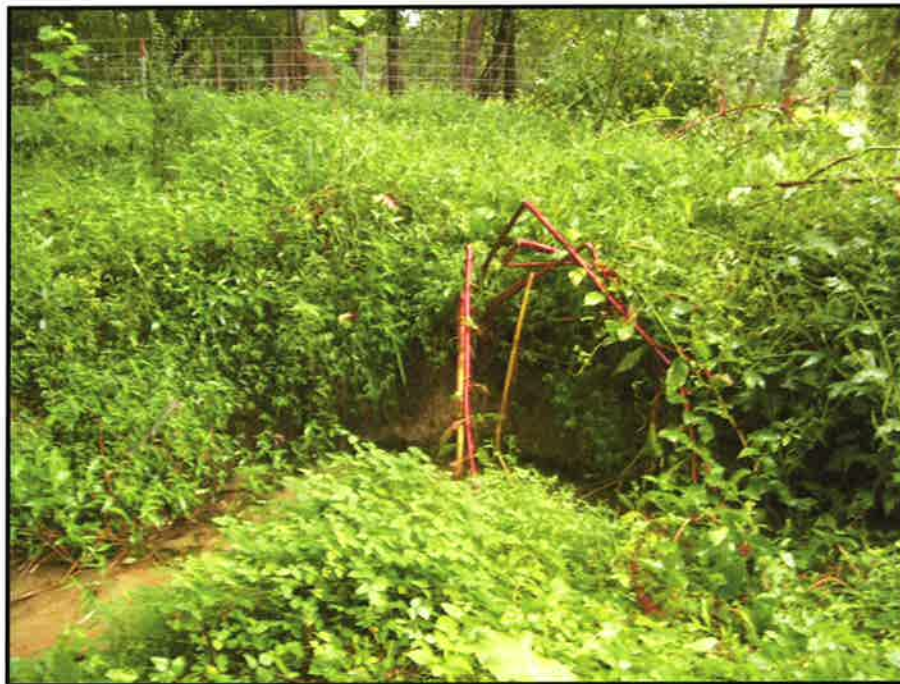
SPA 4
Close-up of bank scour along the right bank of Tributary C near station 4+11.
(EMH&T, Inc. 9/16/09)

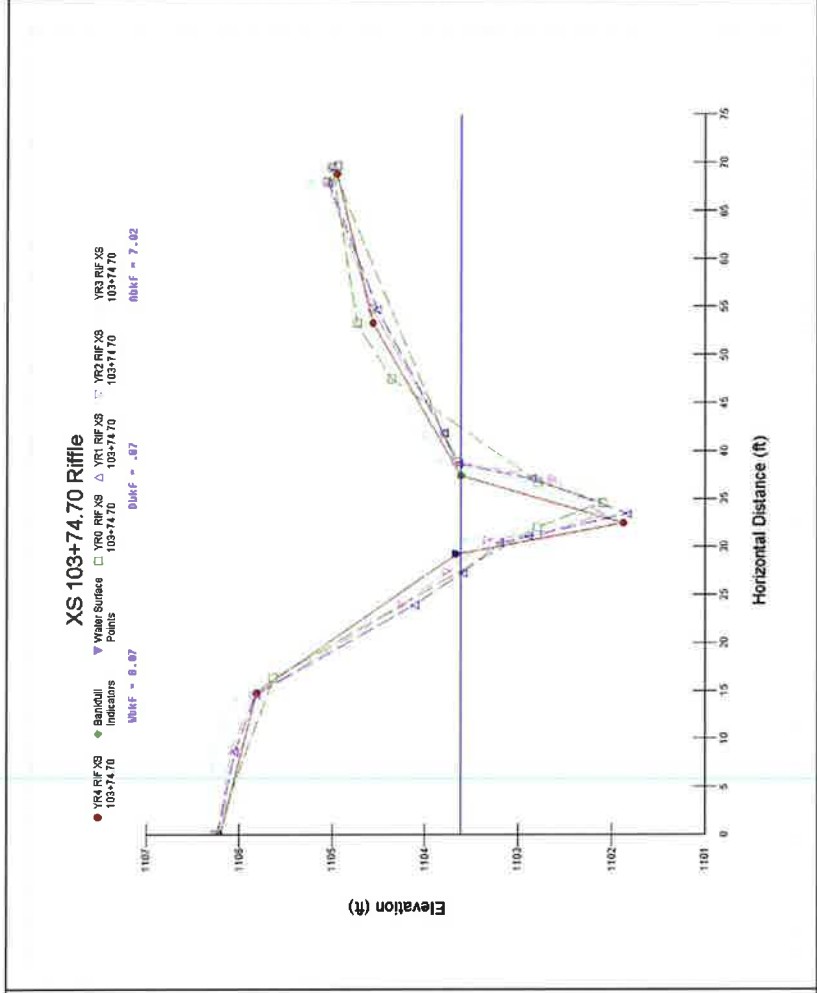
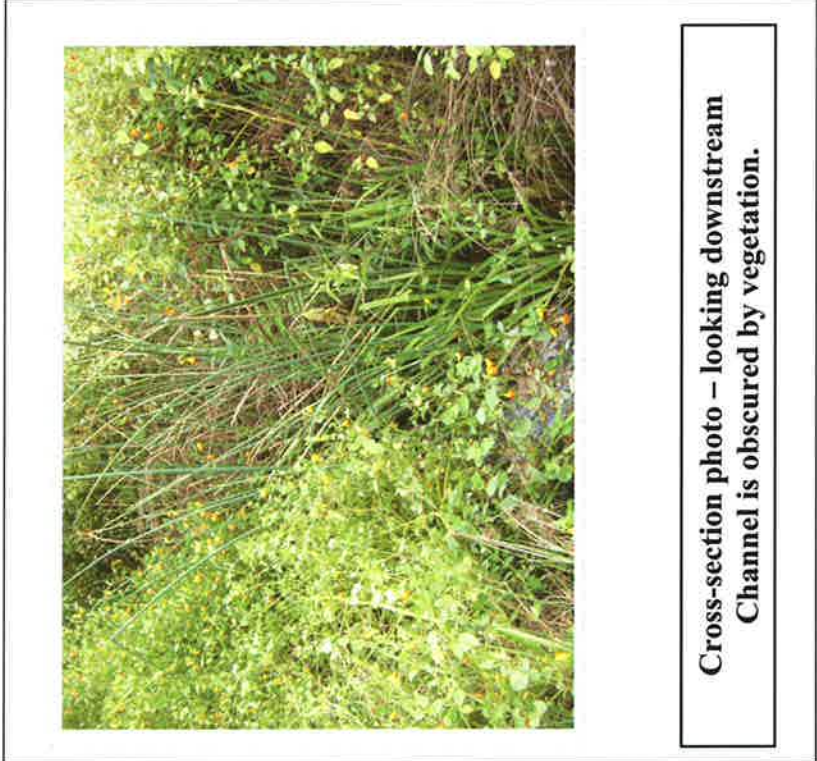
**Cross-section photo – looking downstream
Channel is obscured by vegetation.**

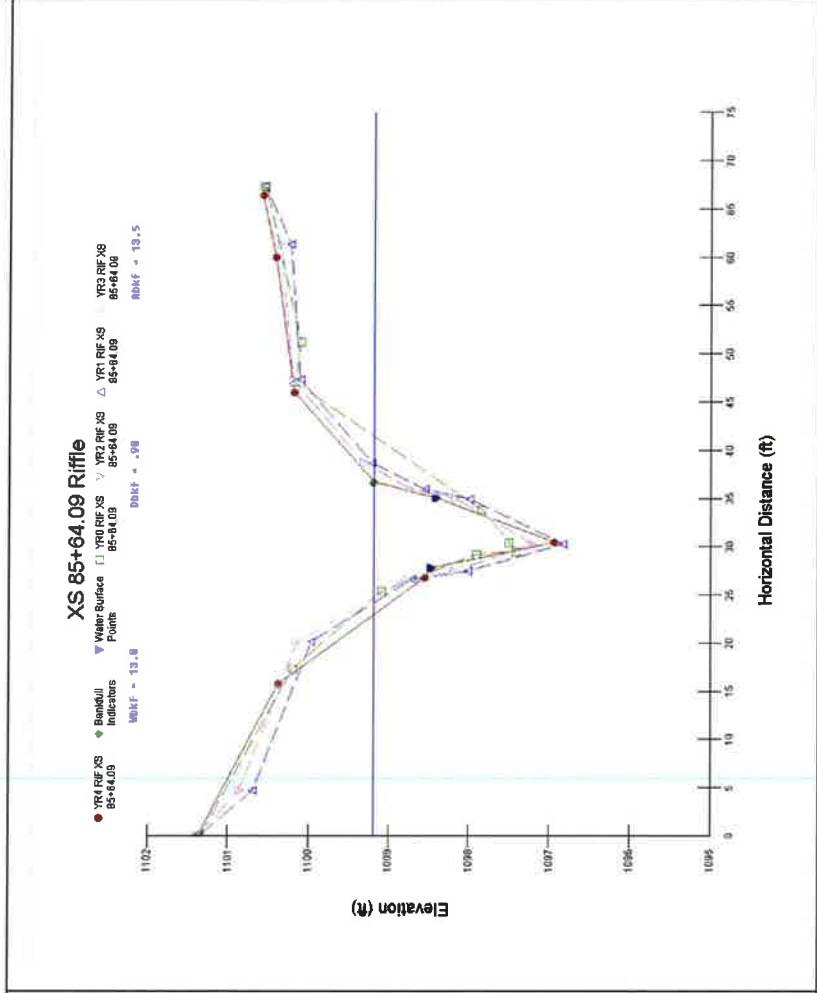
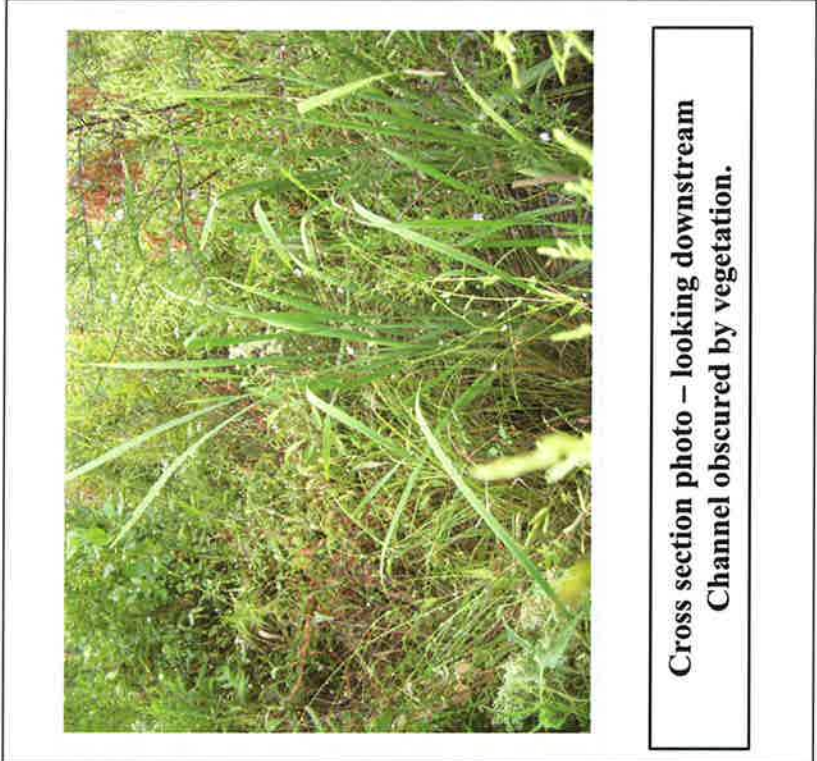
**Cross section photo – looking downstream
Channel obscured by vegetation.**
