Subject: Year 5 Monitoring Report for Stream Mitigation of South Muddy Creek Tributaries
SCO# D04006-01

Year 5 Monitoring Report for South Muddy Creek Tributaries (Queen Properties)

South Muddy Creek Tributaries
McDowell County, NC
SCO # D04006-01

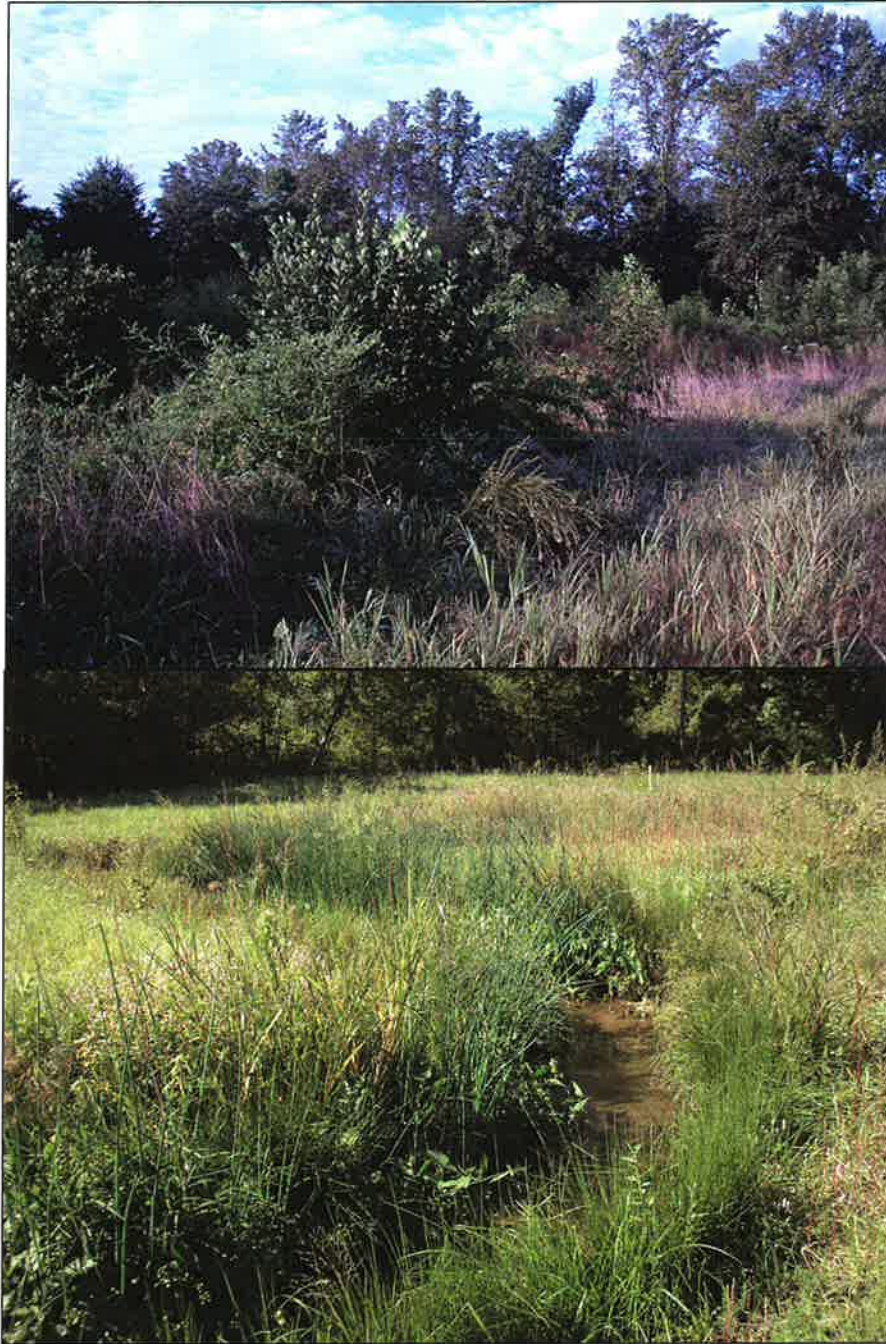
Fixed Station 1

Overview of Tributary A (upper), facing upstream.

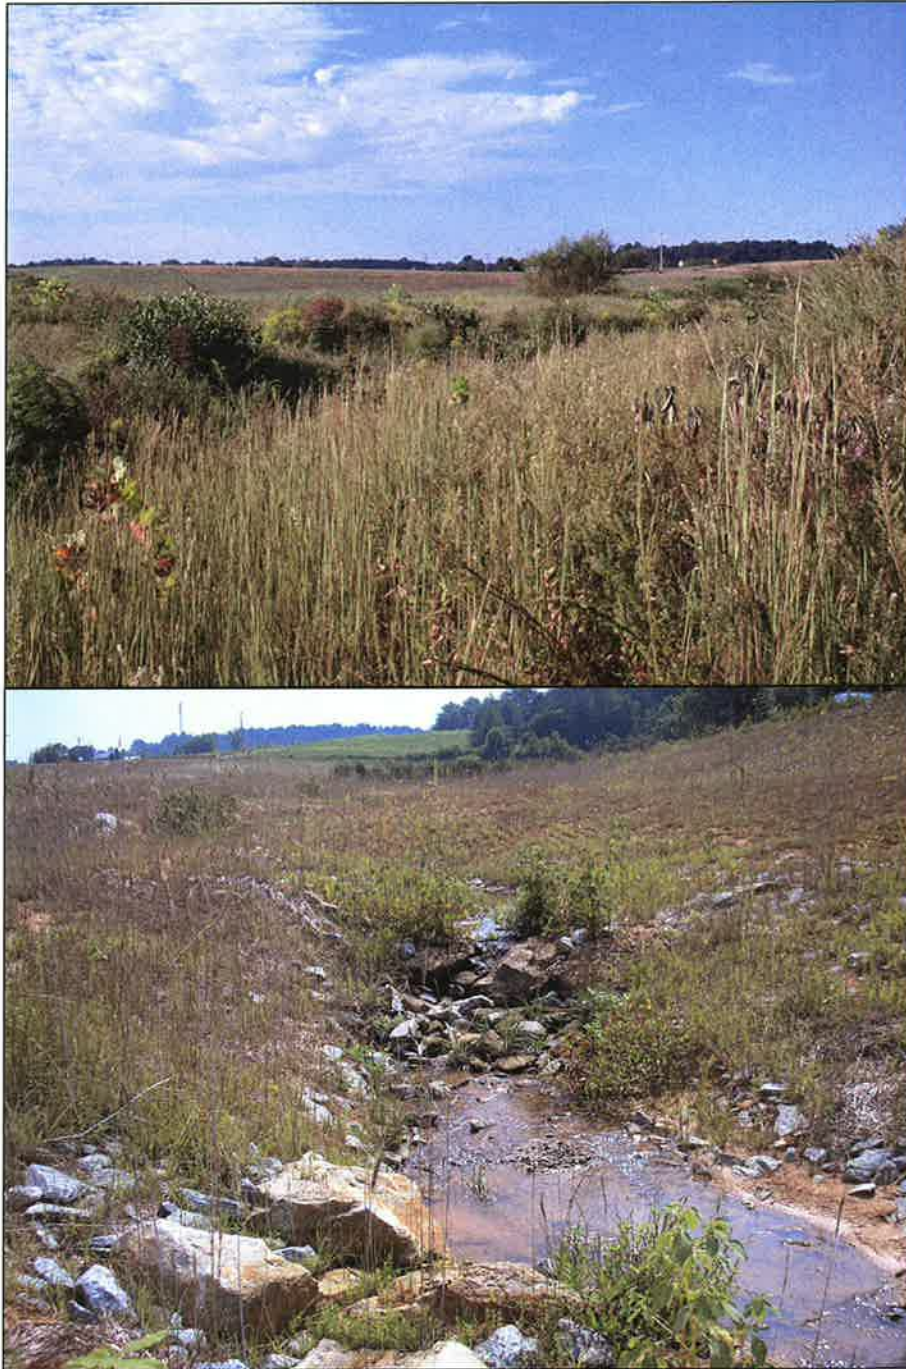
Fixed Station 2

Overview of valley along confluence of Tributary A2 with Tributary A, facing upstream.

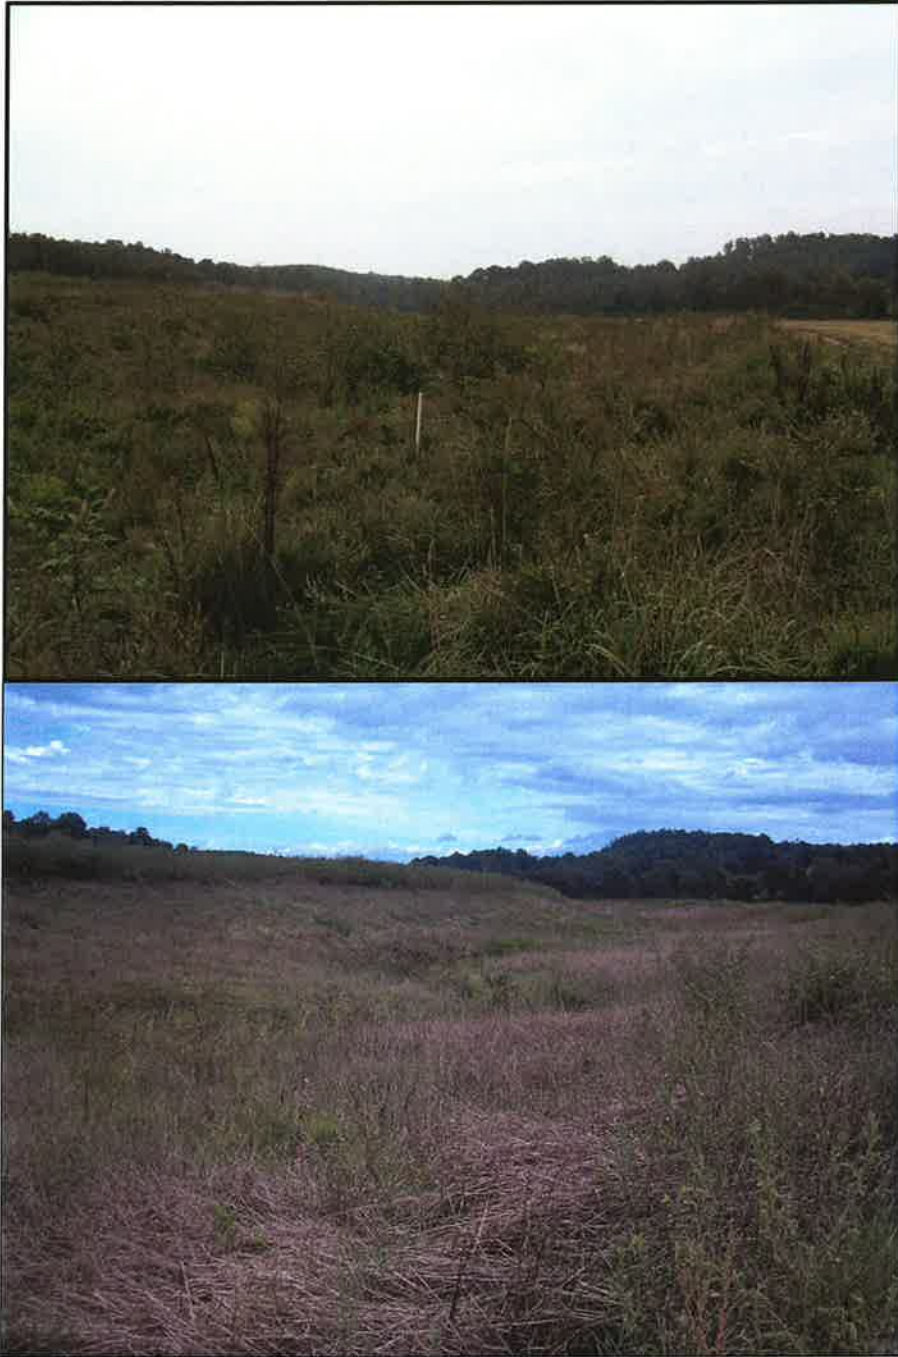
Fixed Station 3

Overview of valley along Tributary A (lower) near station 31+50, facing downstream.

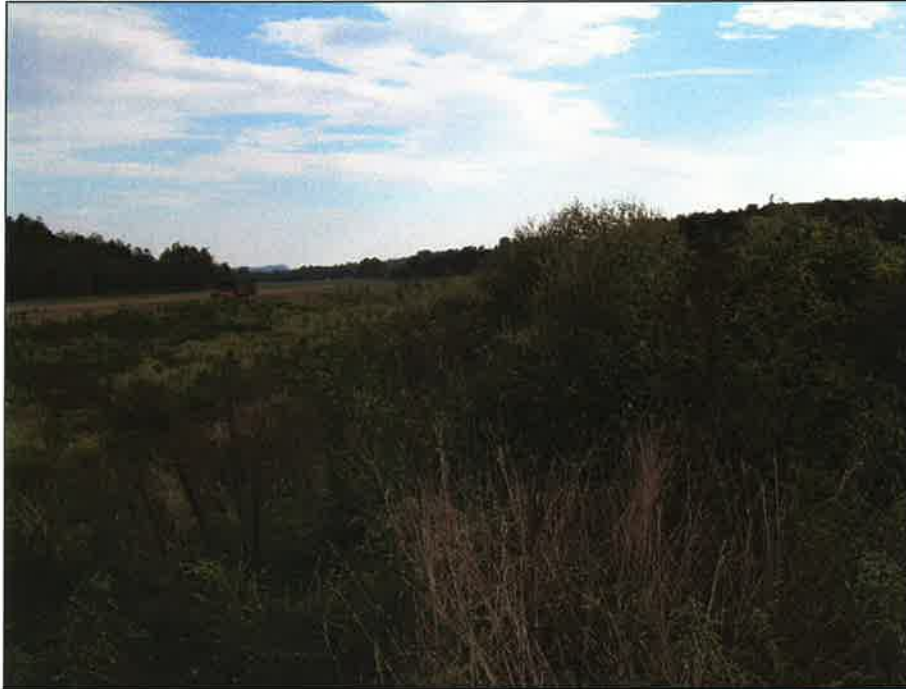
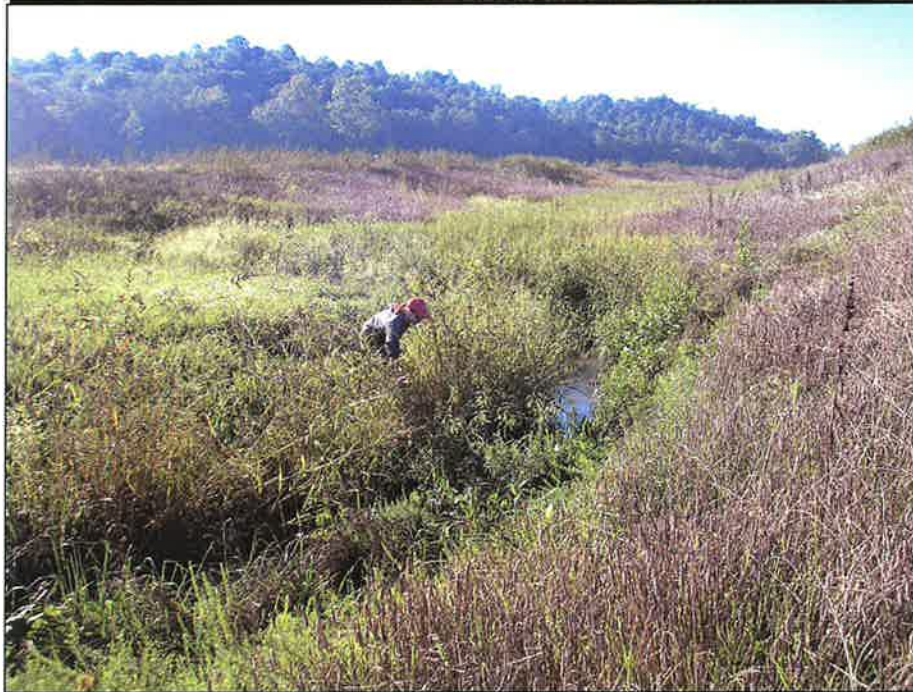
Fixed Station 4

Overview of valley along Tributary A (lower) near station 31+50, facing upstream.

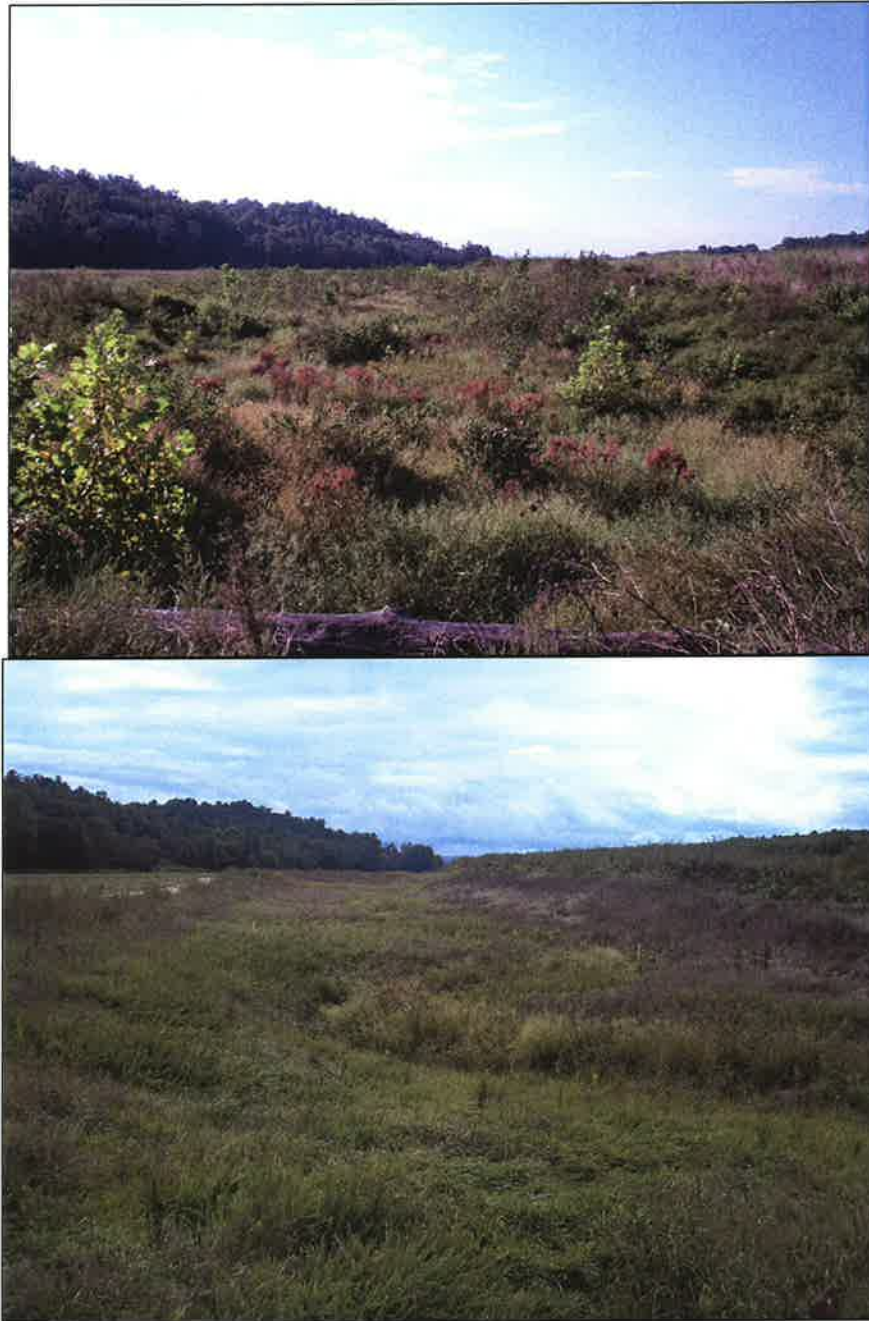
Fixed Station 5

Overview of valley on Tributary A (lower) at large culvert, facing upstream.

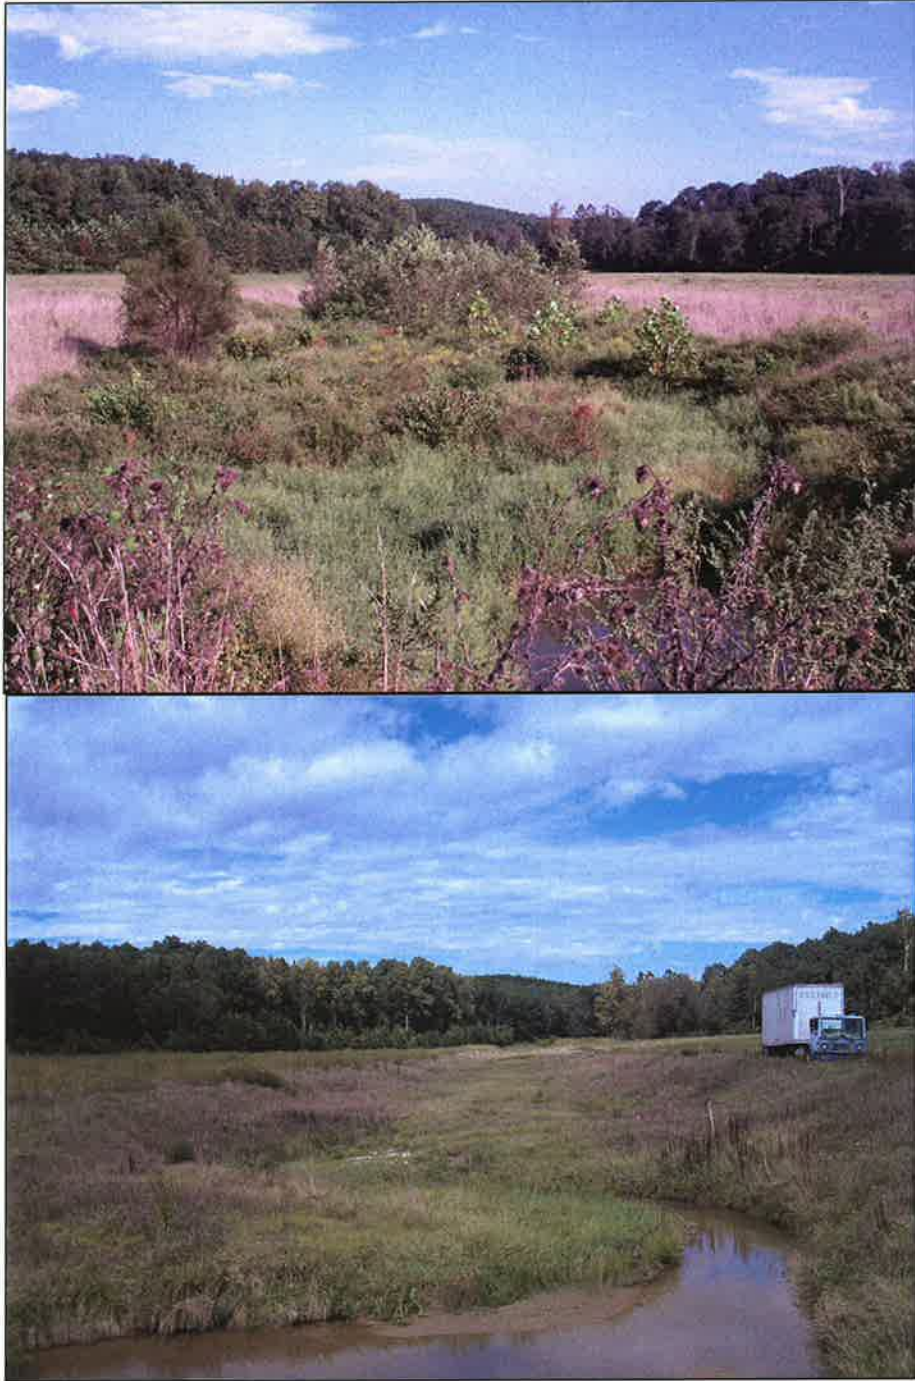
Fixed Station 6

Overview of valley on Tributary A (lower) at large culvert, facing downstream.

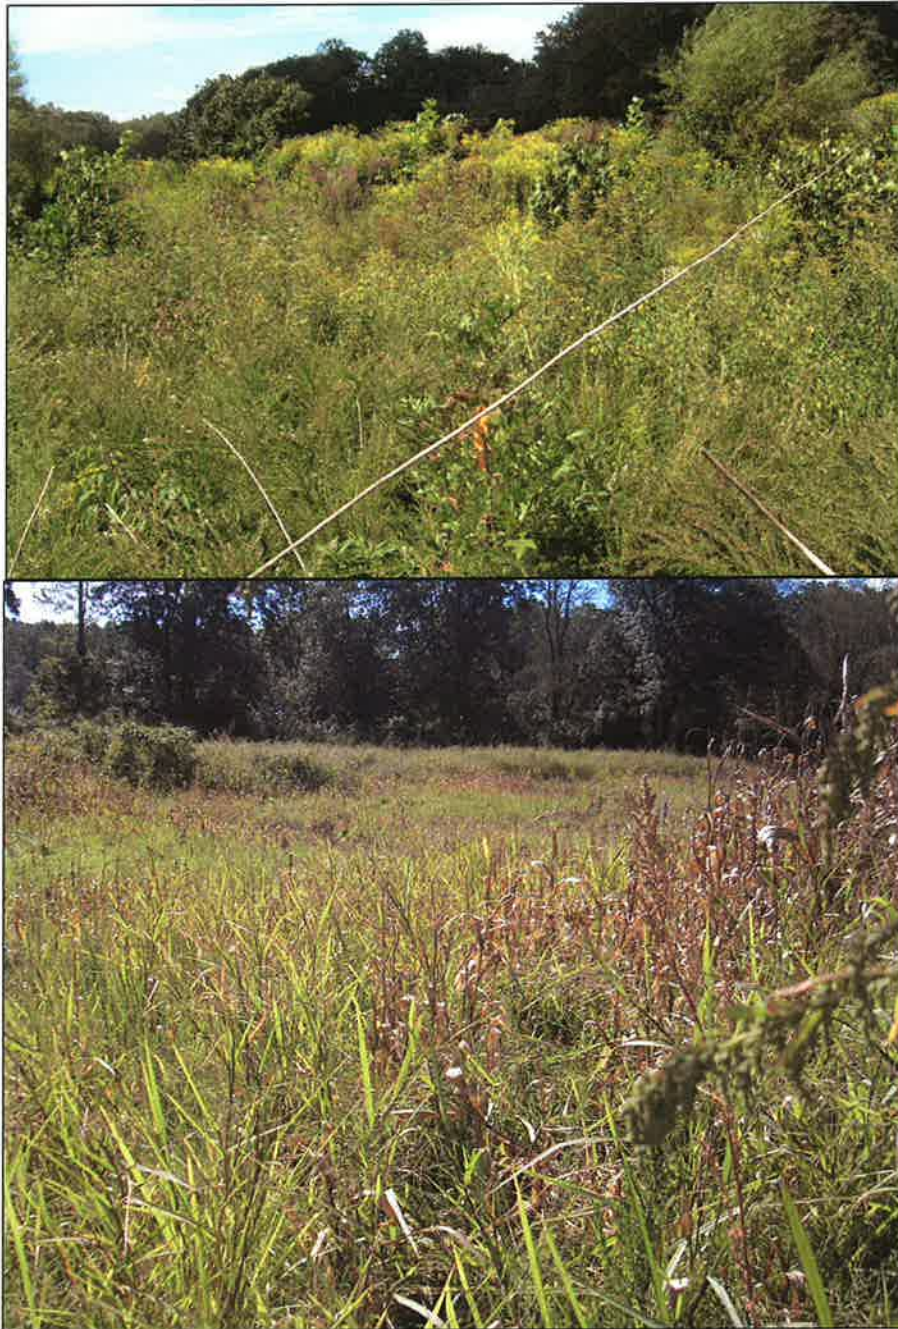
Fixed Station 7

Overview of valley along Tributary B, facing upstream.

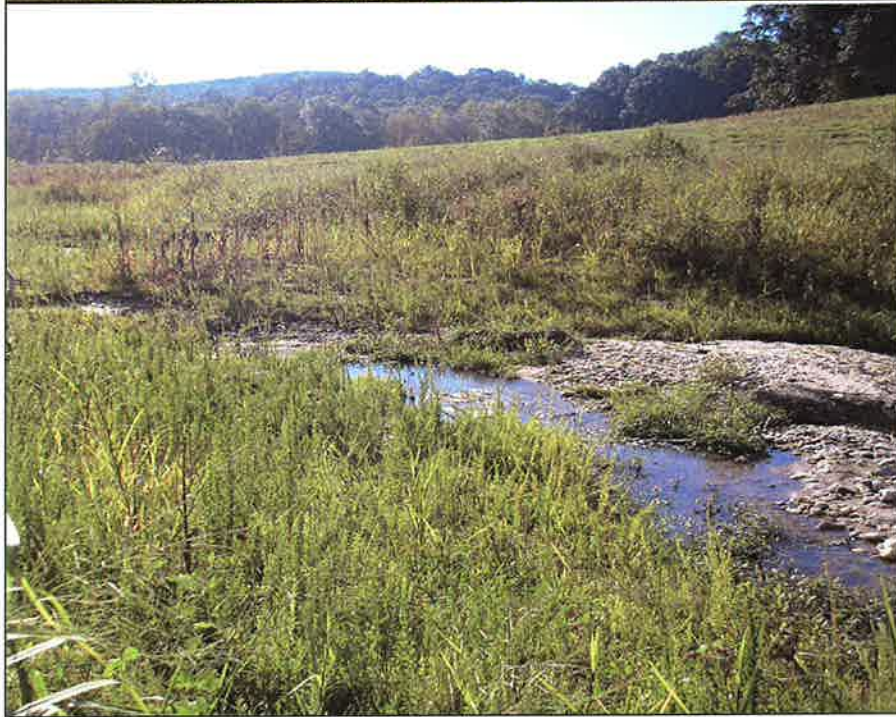
Fixed Station 8
Overview of valley along Tributary B, facing downstream.
Year 5 – top photo (EMH&T, Inc. 9/16/10)
Year 1- bottom photo (EMH&T, Inc. 9/19/06)

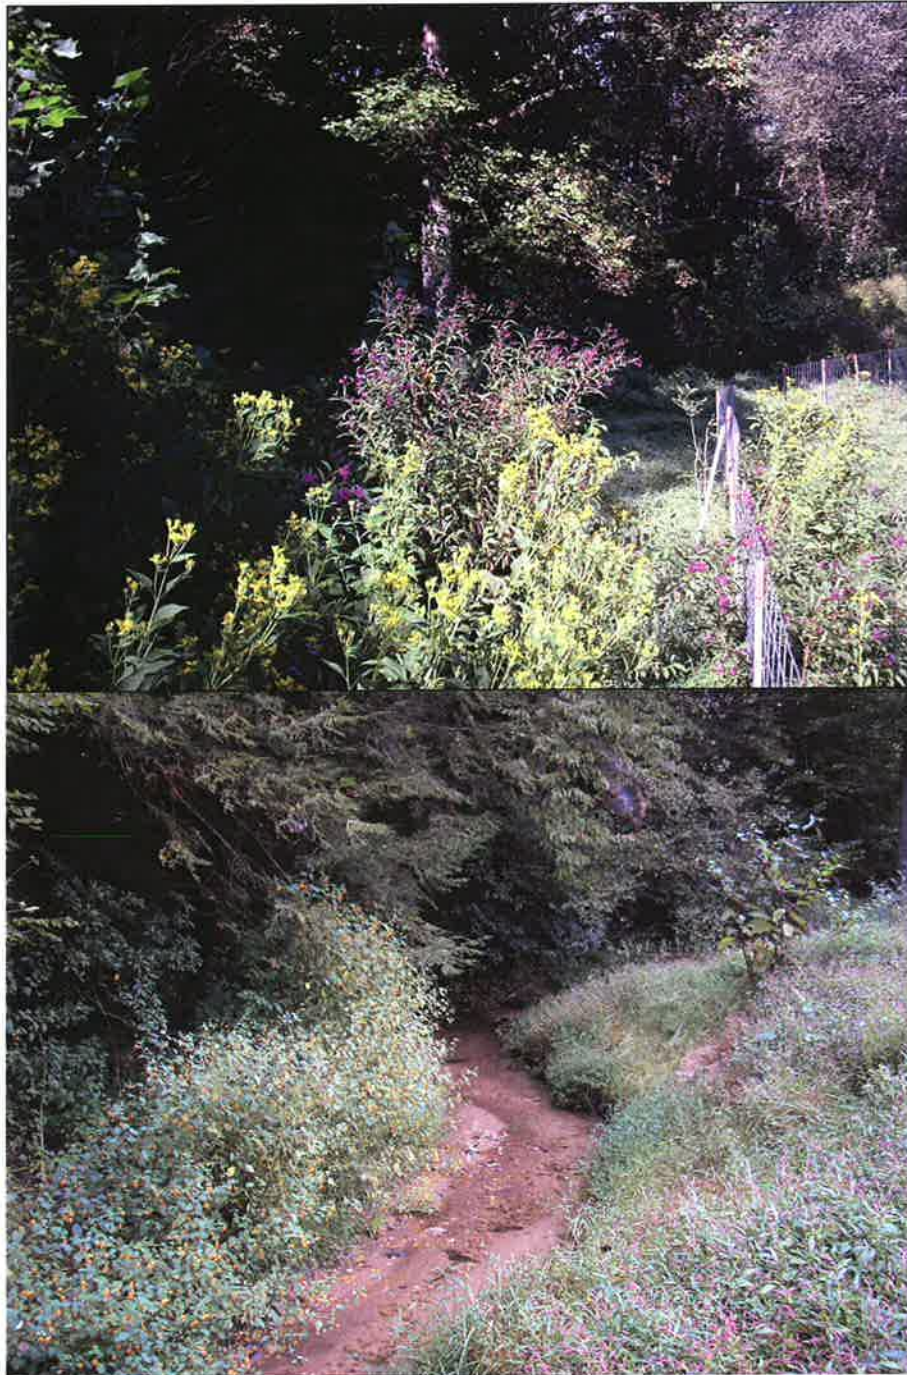
Fixed Station 9

Overview of valley along Tributary C near station 6+50, facing downstream.

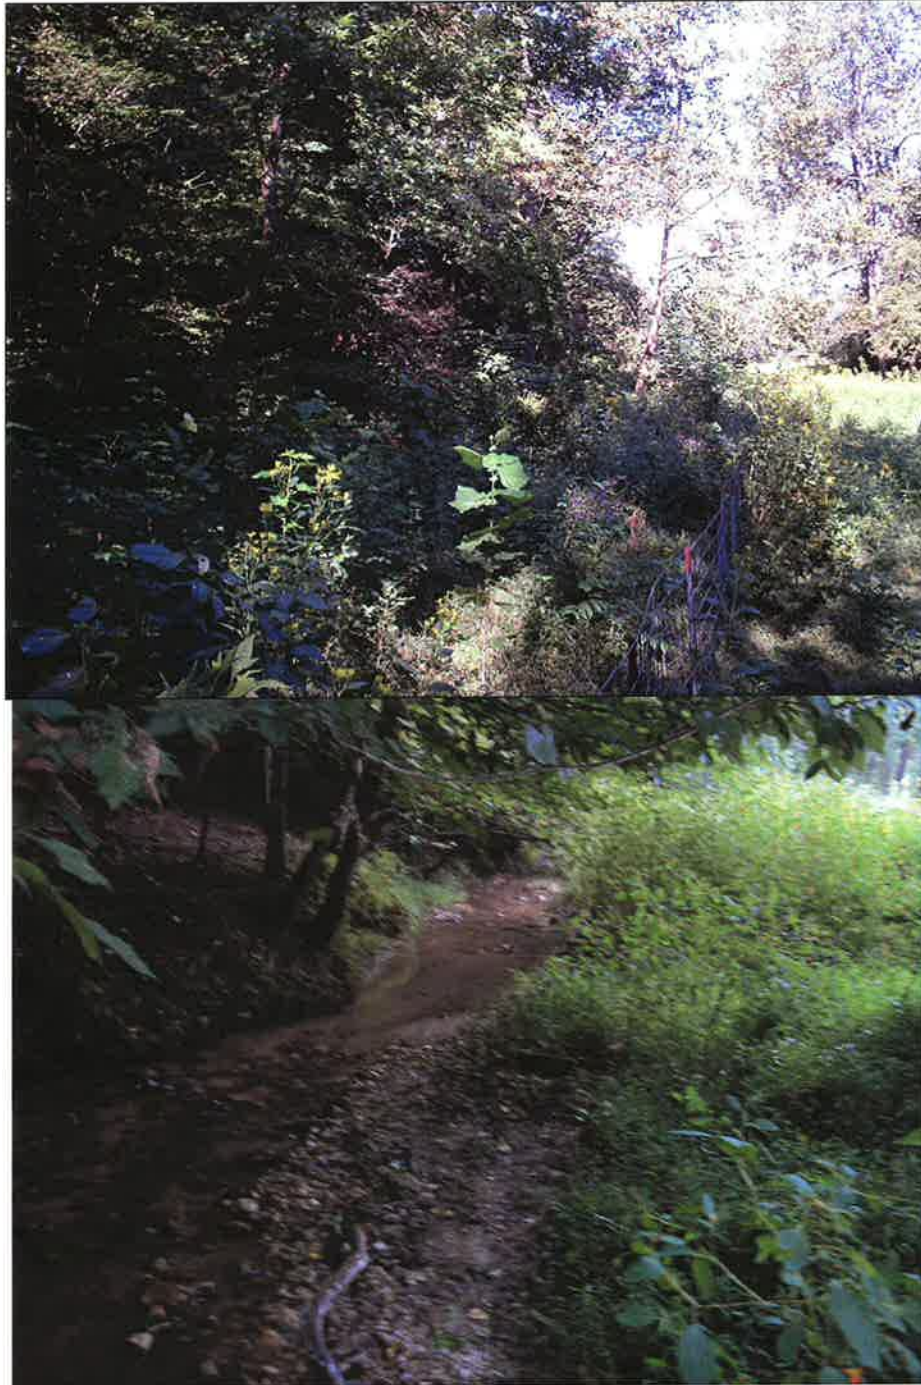
Fixed Station 10

Overview of valley along Tributary C near station 8+50, facing downstream.
