ANNUAL REPORT FOR 2006 (Year 3)

Spring Valley Park Stream Restoration Site
Greensboro, North Carolina
EEP Project No. 354

FINAL *Spring Valley Stream Mitigation Site*
Annual Monitoring Report for 2006 (Year 3)

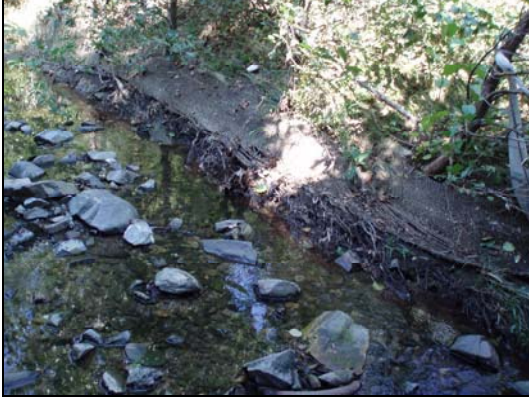
Spring Valley 2006 - Problem Area 1

Station Numbers	Suspected Cause	Photo Number
Coir matting failure	11+00-12+00	Improper installation, unstable banks due to lack of rooted vegetation (50-100 foot sections in all cases)	PA #1
	13+20		PA #2
	14+40		
Headers on cross vanes are set too high	15+40	Improper installation, the header rock is set too high and water is flowing underneath	PA #4
	15+71		
Headers on cross vanes are set too high	16+80	Improper installation, the header rock is set too high and water is flowing underneath	PA #5
Left bank erosion	17+10	Unstable banks due to lack of rooted vegetation	PA #6
Header rock moved downstream from cross vane	17+15	Improper installation, header rock not set during construction	PA #7
Bank washed out behind root wad	17+40	Unstable banks due to lack of rooted vegetation	PA #8
Coir matting failure	17+50	Improper installation, unstable banks due to lack of rooted vegetation, erosion occurring from rootwad to cross vane	PA #9

Table B Spring Valley Problem Areas			
Feature Issue	Station Numbers	Suspected Cause	Photo Number
Coir matting failure	11+00-12+00	Improper installation, unstable banks due to lack of rooted vegetation (50-100 foot sections in all cases)	PA #1
	13+20		
	14+40		
Exposed sewer line	15+15	Down cutting due to downstream structure failure	PA #3
Headers on cross vanes are set too high	15+40	Improper installation, the header rock is set too high and water is flowing underneath	PA #4
	15+71		
Headers on cross vanes are set too high	16+80	Improper installation, the header rock is set too high and water is flowing underneath	PA #5
Left bank erosion	17+10	Unstable banks due to lack of rooted vegetation	PA #6
Header rock moved downstream from cross vane	17+15	Improper installation, header rock not set during construction	PA #7
Bank washed out behind root wad	17+40	Unstable banks due to lack of rooted vegetation	PA #8

- At this time, no repairs are recommended. The aforementioned problem areas discussed in Table V need to be monitored and if the problems worsen over time, then a remedial plan needs to be developed.

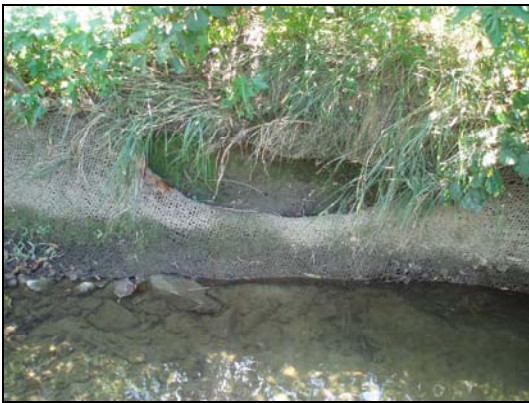
Spring Valley 2006 - Problem Area 9

Coir matting failure	17+50	Improper installation, unstable banks due to lack of rooted vegetation, erosion occurring from rootwad to cross vane	PA #9
Undercutting bank	17+80	High flow events, unstable banks due to lack of rooted vegetation	PA #10
Left bank erosion	18+40	Unstable banks due to lack of rooted vegetation, eroding downstream of cross vane	PA #11
Right bank erosion	18+60	Unstable banks due to lack of rooted vegetation, bank washed out behind rootwad (STA 19+50)	PA #12
	19+20		PA #13
	20+50		PA #14
Left bank erosion	20+70	Unstable banks due to lack of rooted vegetation, mid-channel bars forming	PA #15
Scour behind vane arm	20+80	Improper installation, bank washing out behind vane arm, piping occurring around structure	PA #16
Scour at end of vane arm		Improper installation, vane arm set at too high an elevation	PA #17

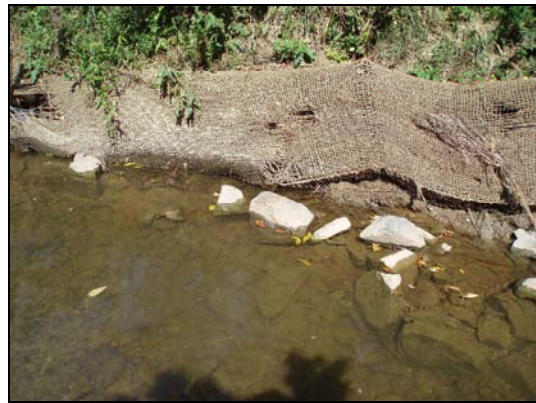
Spring Valley 2006 - Problem Area 10

Undercutting bank	17+80	High flow events, unstable banks due to lack of rooted vegetation	PA #10
Left bank erosion	18+40	Unstable banks due to lack of rooted vegetation, eroding downstream of cross vane	PA #11
Right bank erosion	18+60	Unstable banks due to lack of rooted vegetation, bank washed out behind rootwad (STA 19+50)	PA #12
	19+20		PA #13
	20+50		PA #14
Left bank erosion	20+70	Unstable banks due to lack of rooted vegetation, mid-channel bars forming	PA #15
Scour behind vane arm	20+80	Improper installation, bank washing out behind vane arm, piping occurring around structure	PA #16
Scour at end of vane arm		Improper installation, vane arm set at too high an elevation	PA #17
