**Spring Valley Park Stream Restoration Site
Greensboro, North Carolina
EEP Project No. 354**

**2007 Annual Monitoring Report
Monitoring Year 4**

**Monitoring Year: 2007
Measurement Year 4
As-Built Date: 2004
NCEEP Project Number 354**

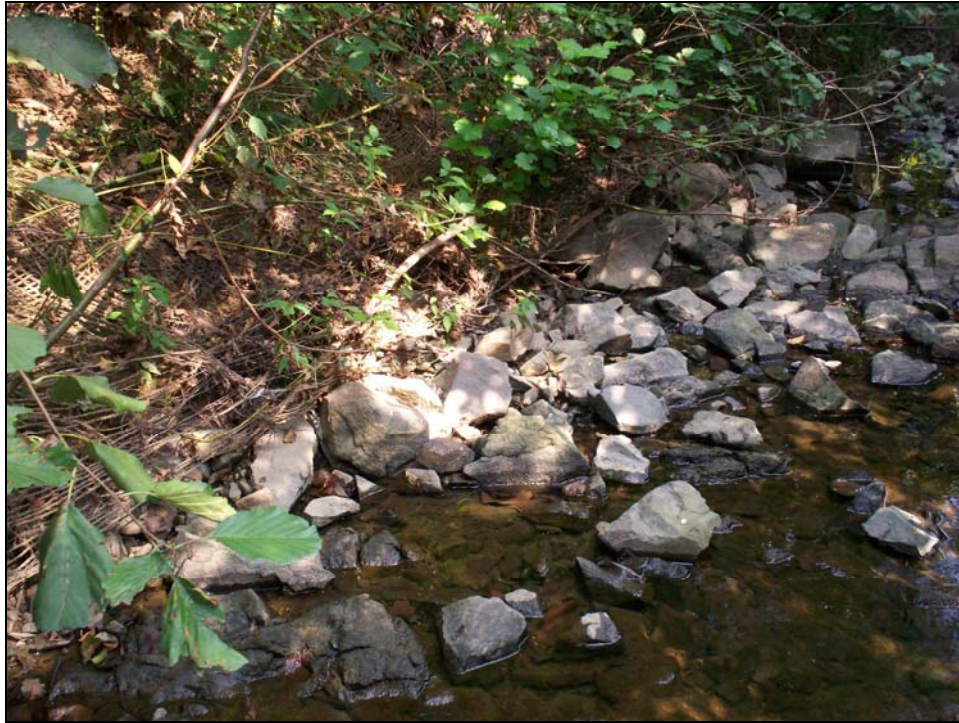
Table VI. Vegetative Problem Areas Spring Valley Park Stream Restoration Site			
Feature/Issue	Station #/Range	Probable Cause	Photo #
Coir matting failure	11+00 to 11+50	Unstable banks due to lack of rooted vegetation	PA #1

Problem Area # 1. Coir matting failure. Station 11+50 Left bank.

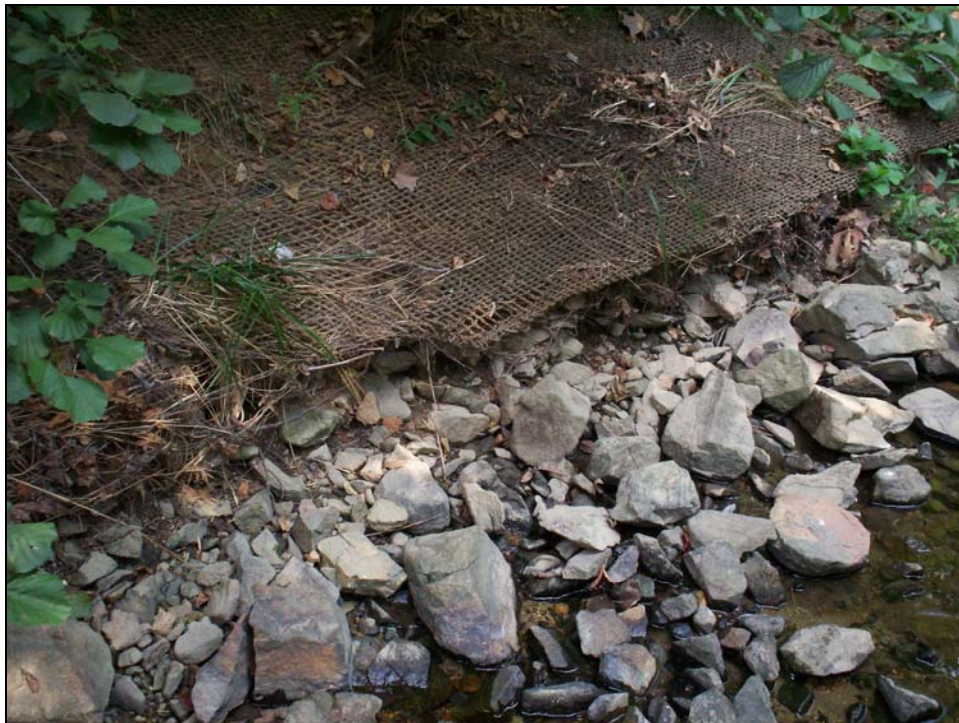
Problem Area # 2. Coir matting failure. Station 13+20 Left bank.

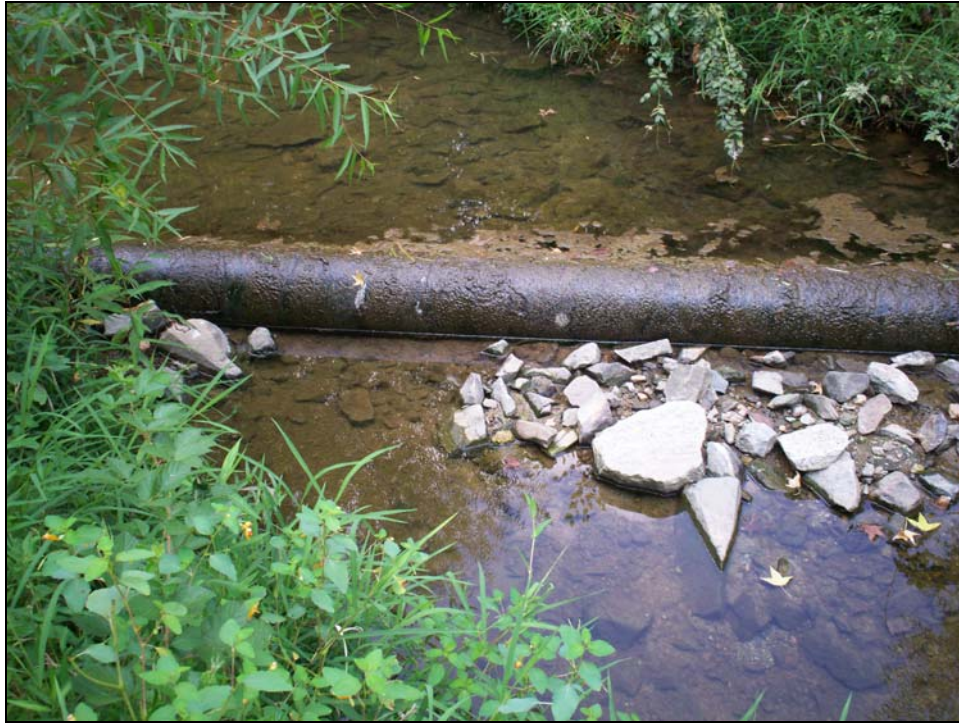
Problem Area # 3. Sewer line exposed. Station 14+40 Upstream.

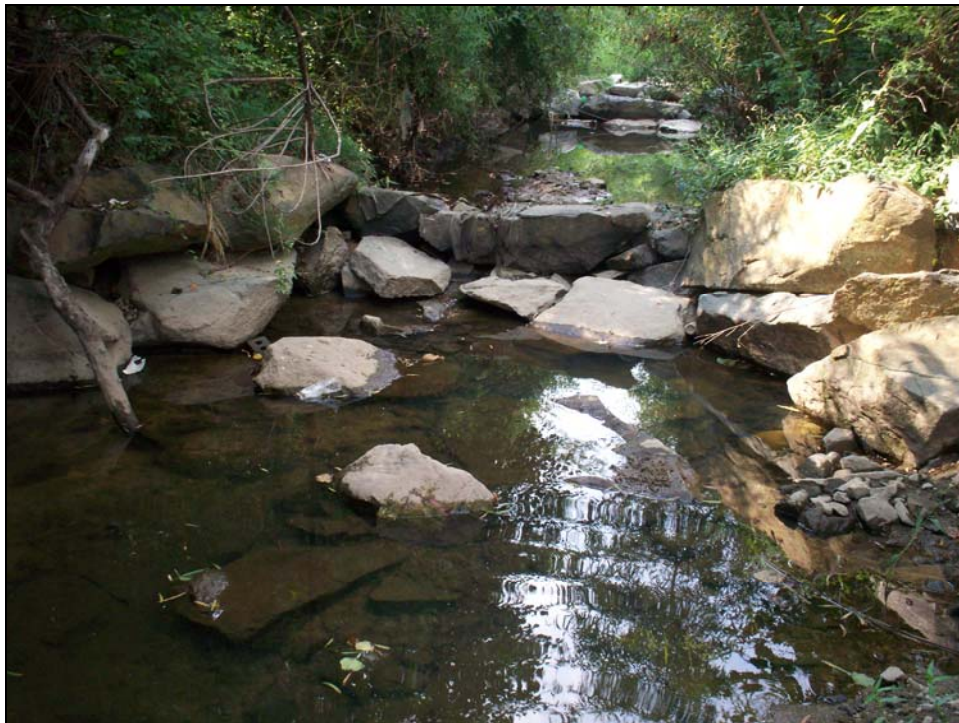
Problem Area # 4. Header on rock vane too high. Station 15+15 Upstream.

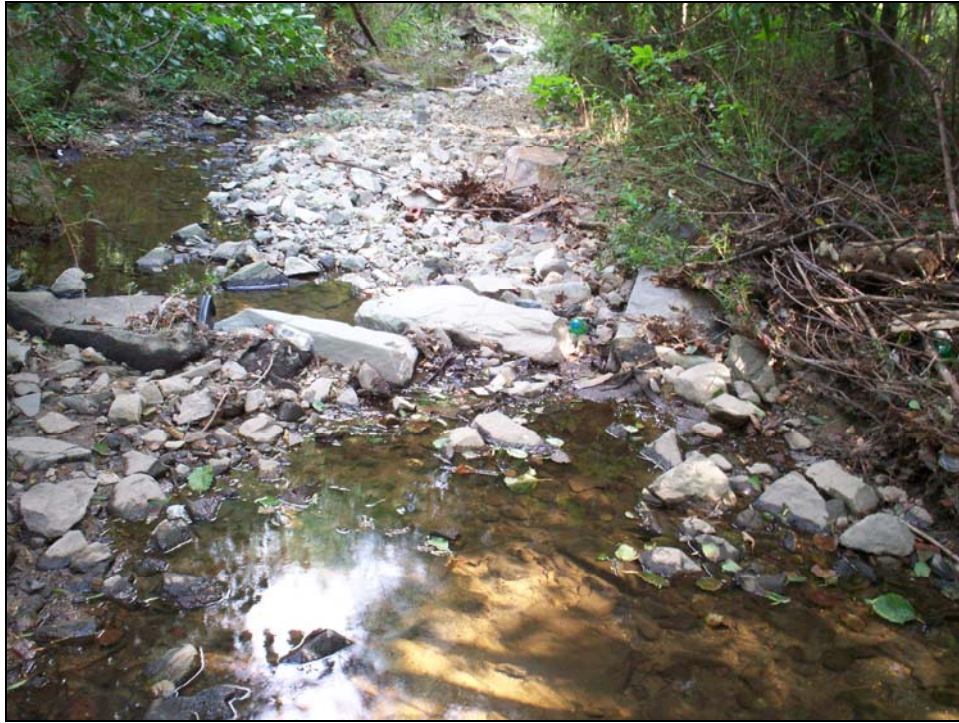
- A number of rock structures (approximately 75%) appear to be functioning properly, but in some cases noted in plan view, header rocks were improperly placed causing scouring or water to flow beneath the header rock. Where these structures are improperly installed (STA 15+75 and 16+50), there are still pool features present and the bed above and below the structures appear to be holding grade.

Problem Area # 5. Header on rock vane too high. Station 15+75 Downstream.

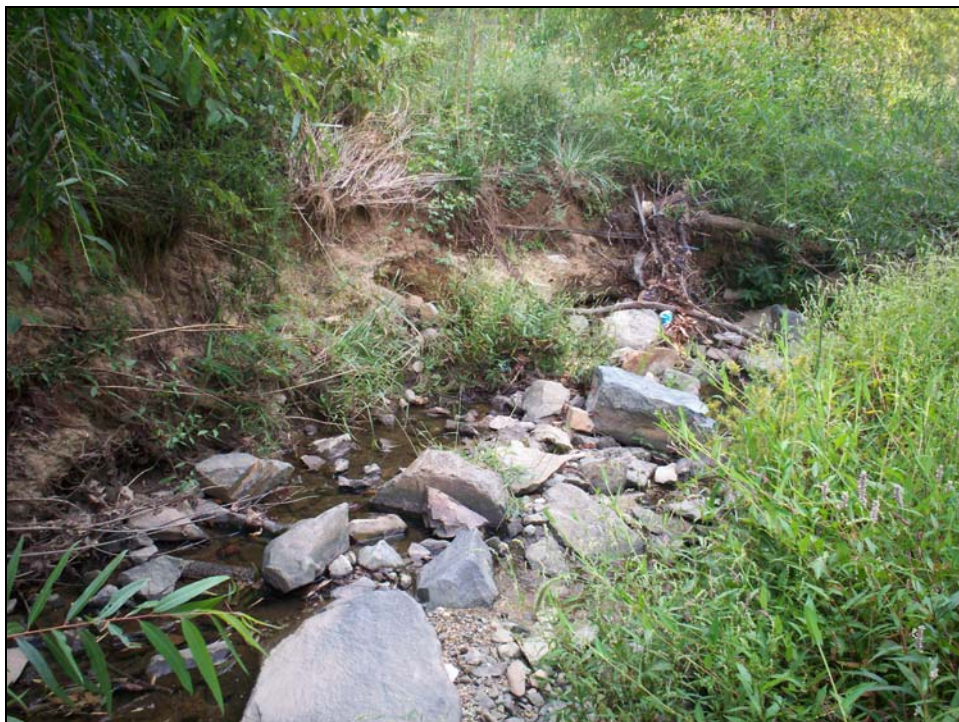
Problem Area #6. Left bank erosion. Station 16+80 Left bank.

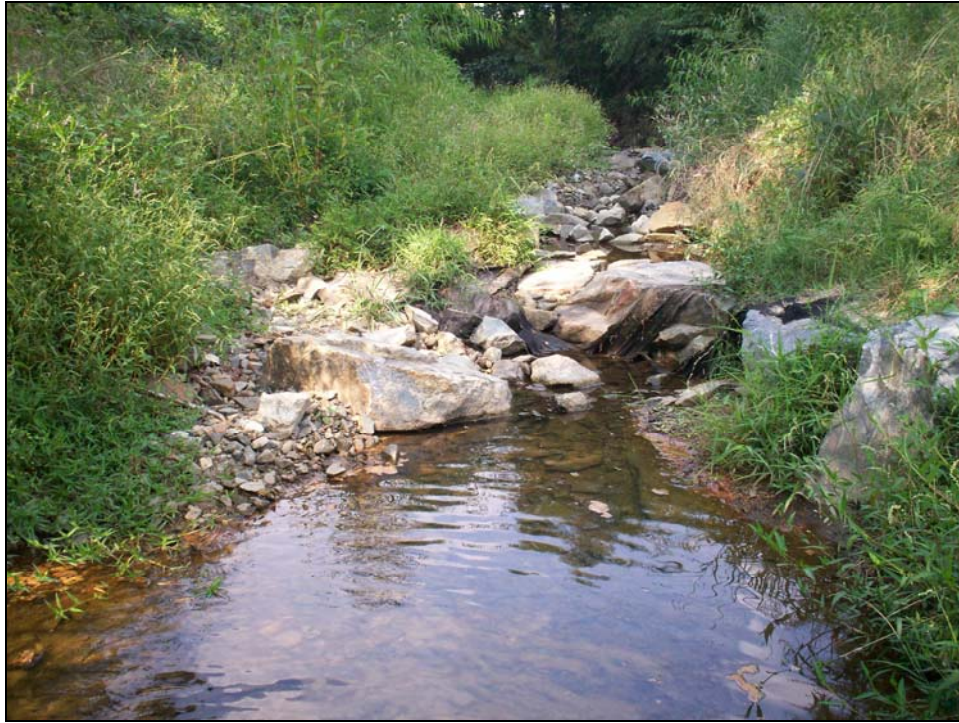
Problem Area #7. Cross vane header moved downstream. Station 17+10 Upstream.

It is recommended that PA #7 be investigated for effect on stream stability and possible repair of vane. No Remedial actions are recommended at this time.

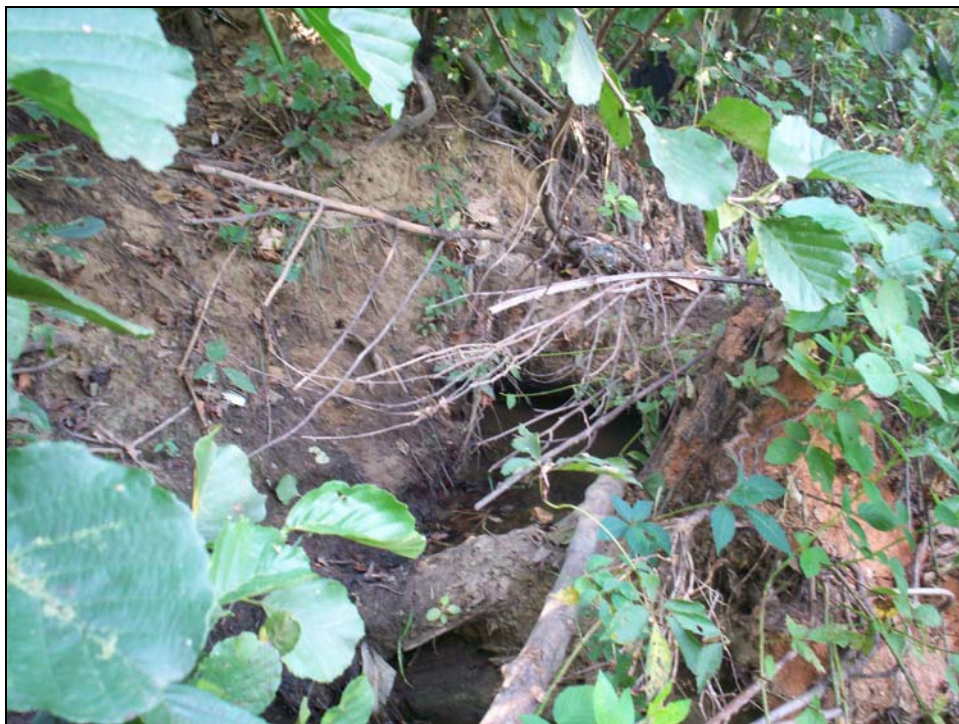
Problem Area #8. Erosion behind root wad. Station 17+15 Right bank.

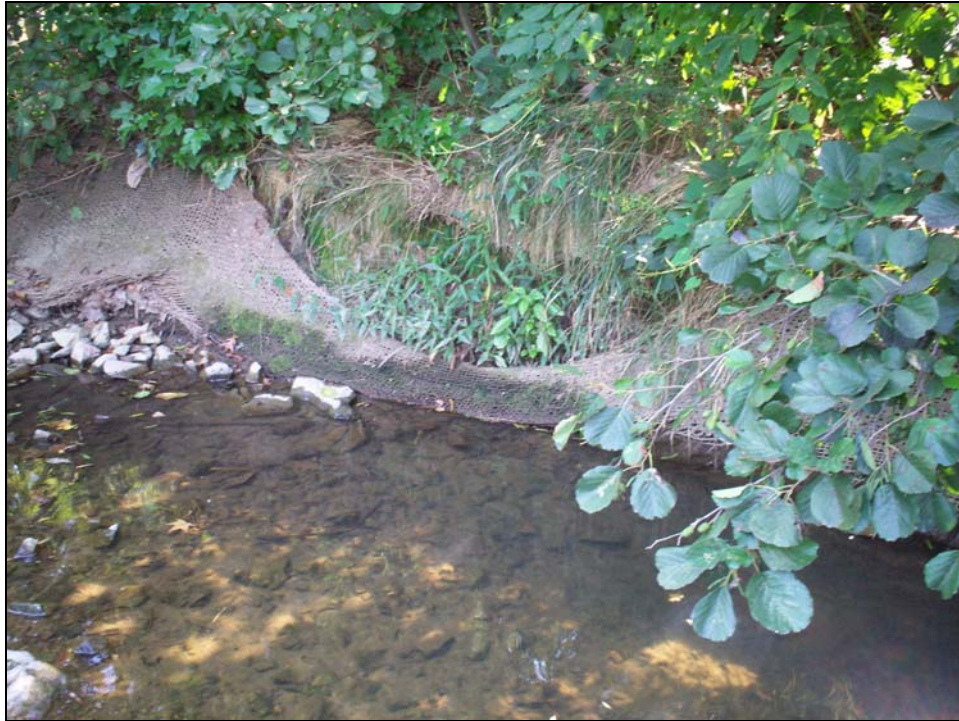
Problem Area #9. Coir matting failure. Station 17+50 Right bank.

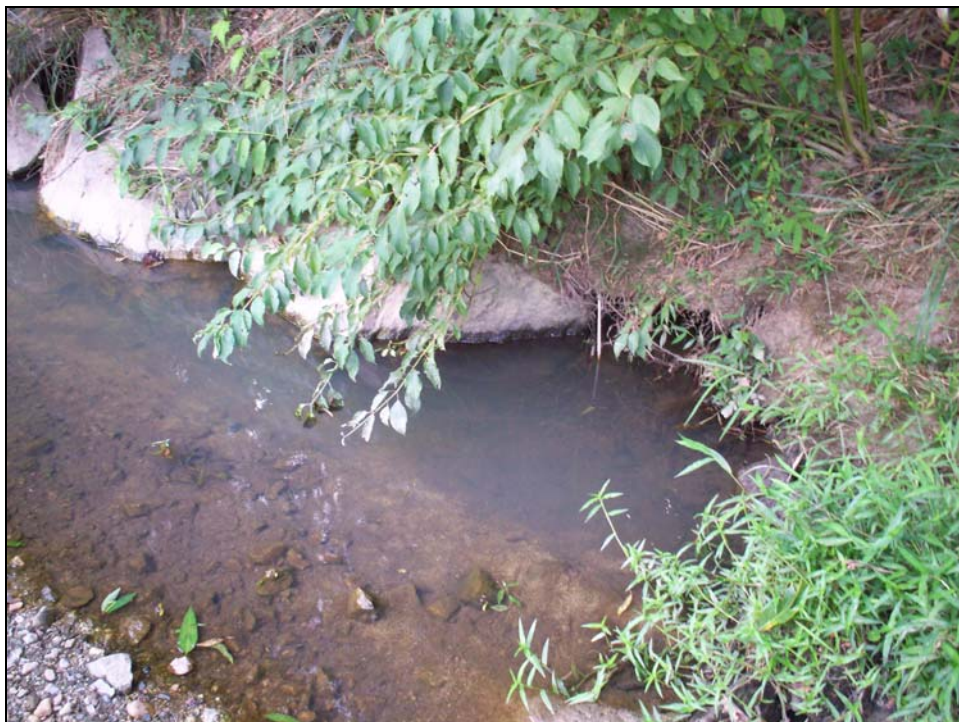
Problem Area # 14. Minor erosion behind gabion wall. Station 19+20 Right bank.

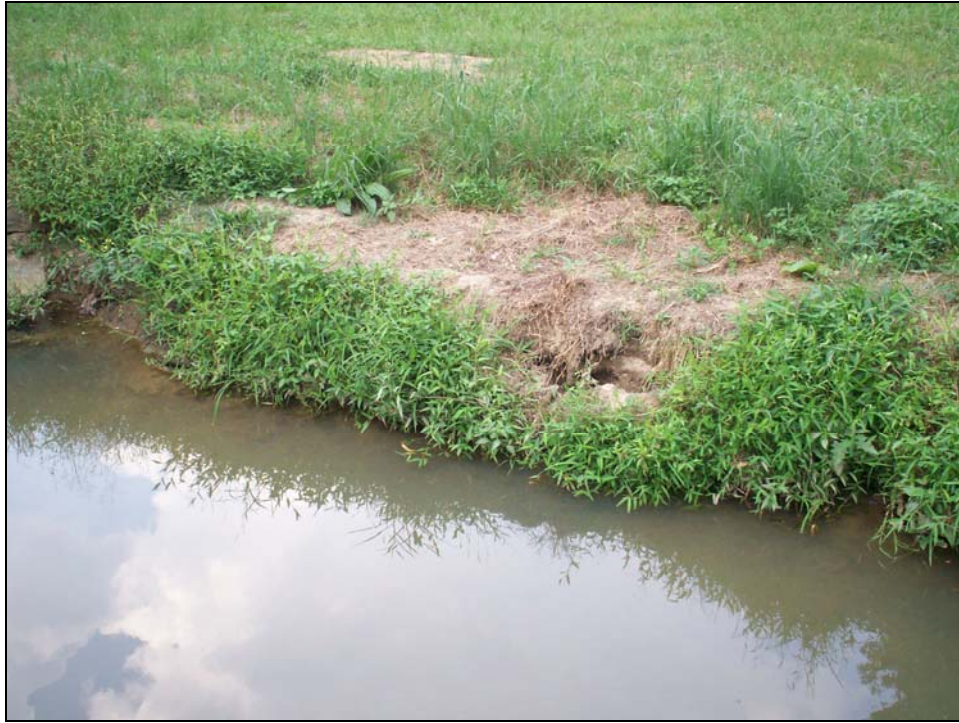
Problem Area # 15. Erosion and mass wasting along left bank due to lack of adequate buffer. Station 18+75 Left bank.

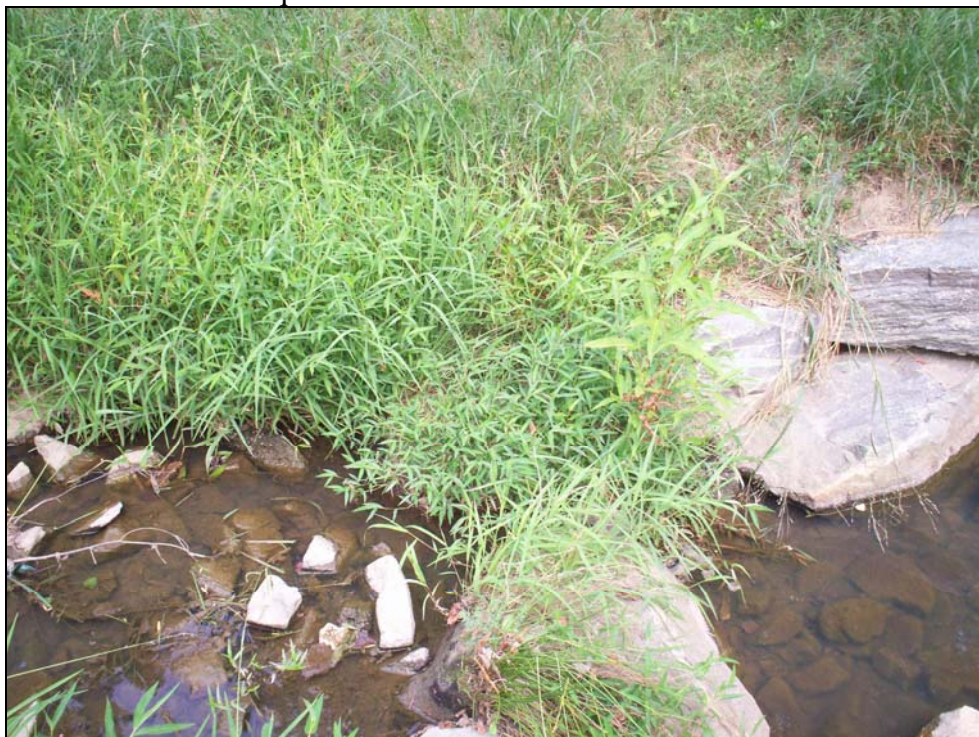
Problem Area # 16. Erosion behind rock vane arm. Station 20+20 Left bank.

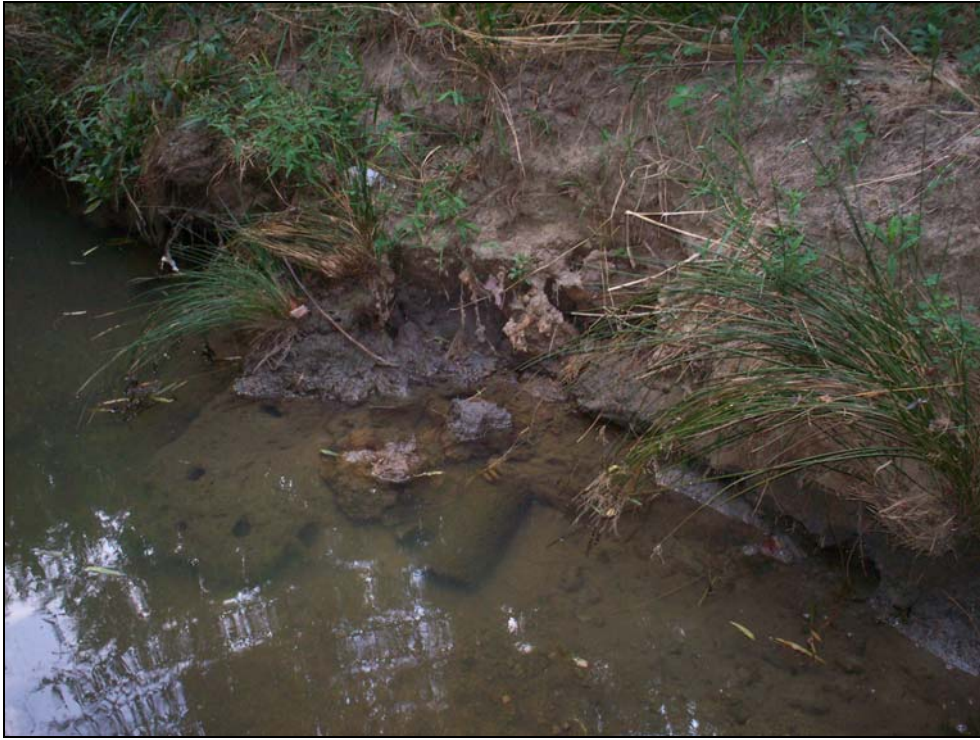
Problem Area # 17. Unstable banks due to erosion. Station 20+30 Right bank.

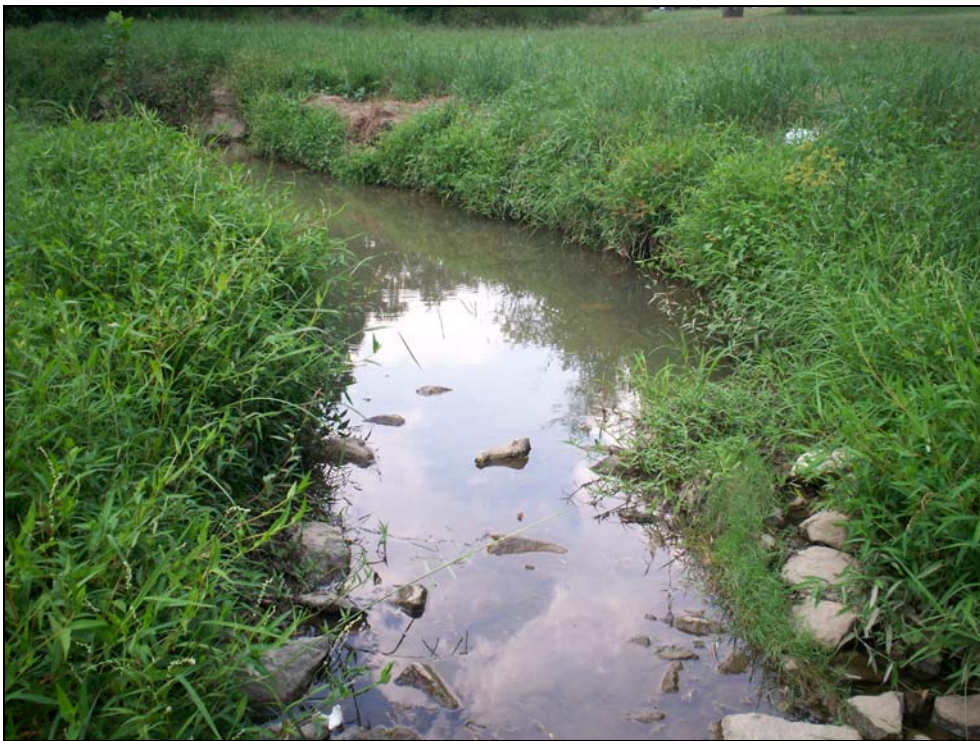
Problem Area # 18. Lower portion of project lacks of woody vegetated buffer. Station 21+00 Upstream.

- Areas lacking woody vegetative buffer should be stabilized by planting woody vegetation or using other means to stabilize the banks.
- At this time, no repairs are recommended. The aforementioned problem areas discussed in Table B.1 need to be monitored and if the problems worsen over time, then a remedial plan needs to be developed.
