**Spring Valley Park Stream Restoration Site
Greensboro, North Carolina
EEP Project No. 354**

**FINAL 2008 Annual Monitoring Report
Monitoring Year 5**

**SPRING VALLEY STREAM RESTORATION
2008 FINAL MONITORING REPORT**

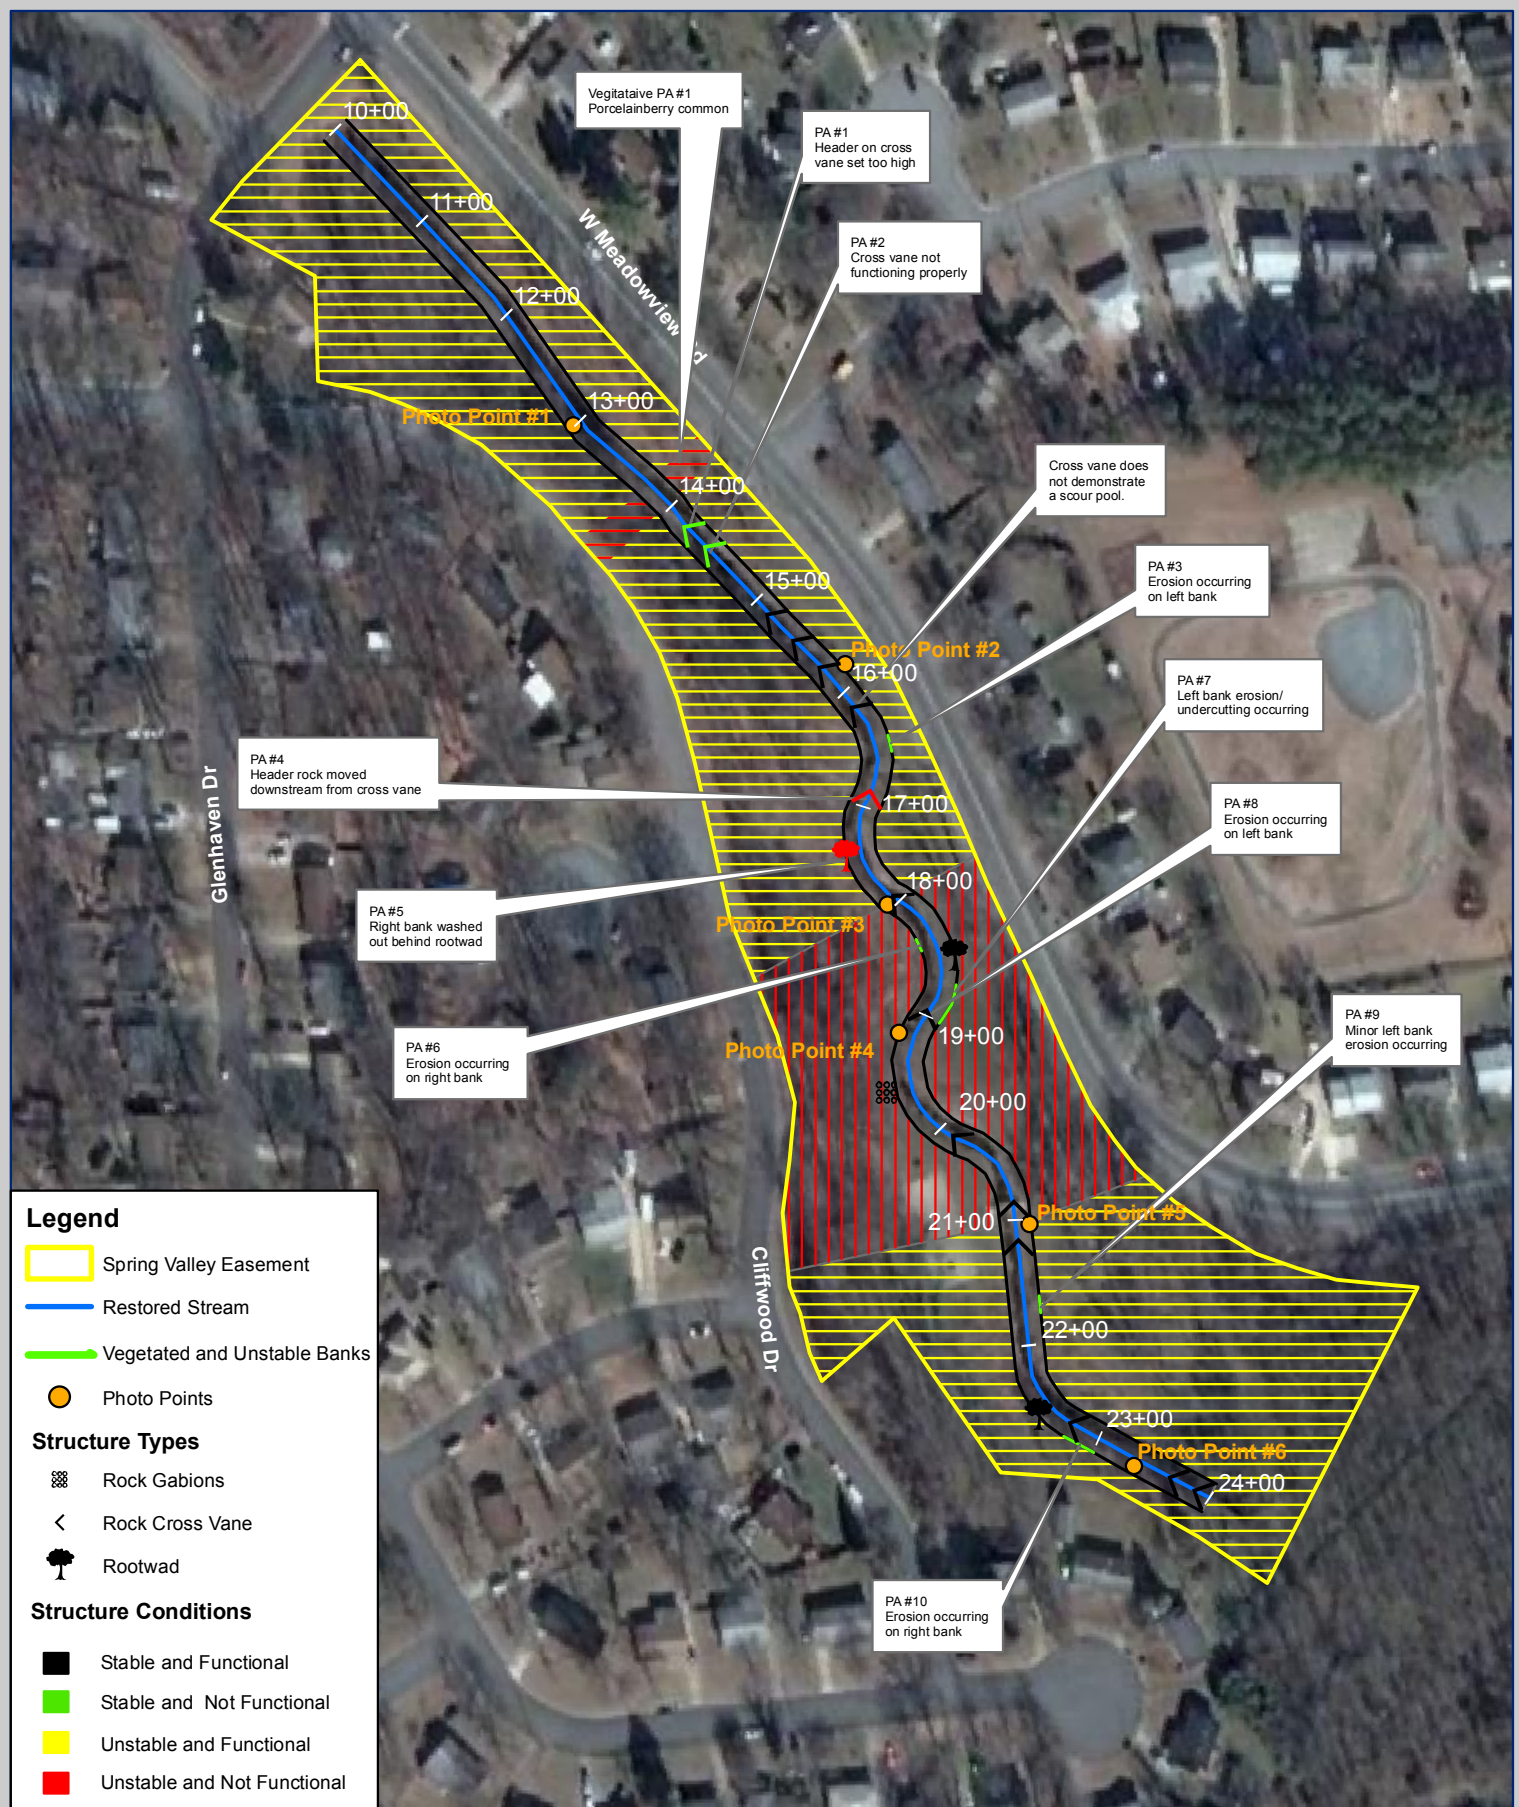
Appendix B, Section B-1
Spring Valley Current Conditions Plan View
Year 5 Monitoring
October 2008

Several minor areas of concern were observed and documented, including localized bank scour, and minor issues with a few of the engineered structures. The locations of these problem areas are shown in **Appendix B, Section B-1**.

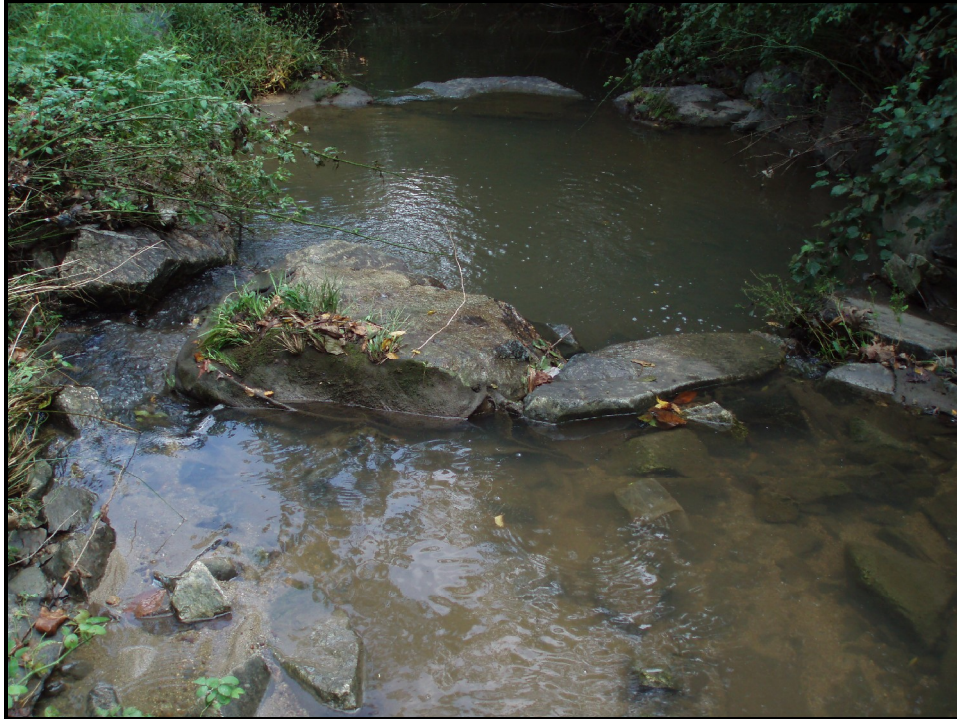
Table B.1. Stream Problem Areas Spring Valley Park Stream Mitigation/Project No. 354				
Feature Issue	Station Numbers	Suspected Cause	Photo Number	Structure Status
Header on cross vane set too high	14+15	Water flowing around due to improper installation	PA #1	SF
Cross vane issue	14+40	Cross vane not functioning as intended	PA #2	SF
Left bank erosion	16+50	Lack of rooted vegetation	PA #3	--
Header rock moved downstream from cross vane	16+90	Improper installation	PA #4	UF
Right bank washed out behind root wad	17+40	Improper installation; lack of rooted vegetation	PA #5	UF
Right bank erosion	18+40	Lack of rooted vegetation	PA #6	--
Left bank erosion/undercut	18+80	Lack of rooted vegetation	PA #7	--
Left bank erosion	19+00	Lack of rooted vegetation	PA #8	--
Minor left bank erosion	21+80	Lack of rooted vegetation	PA #9	--
Right bank erosion	22+80 to 23+00	Lack of rooted vegetation	PA #10	--

PA #1 – Header on cross vane set too high, water flowing around due to improper installation. Sta. 14+15

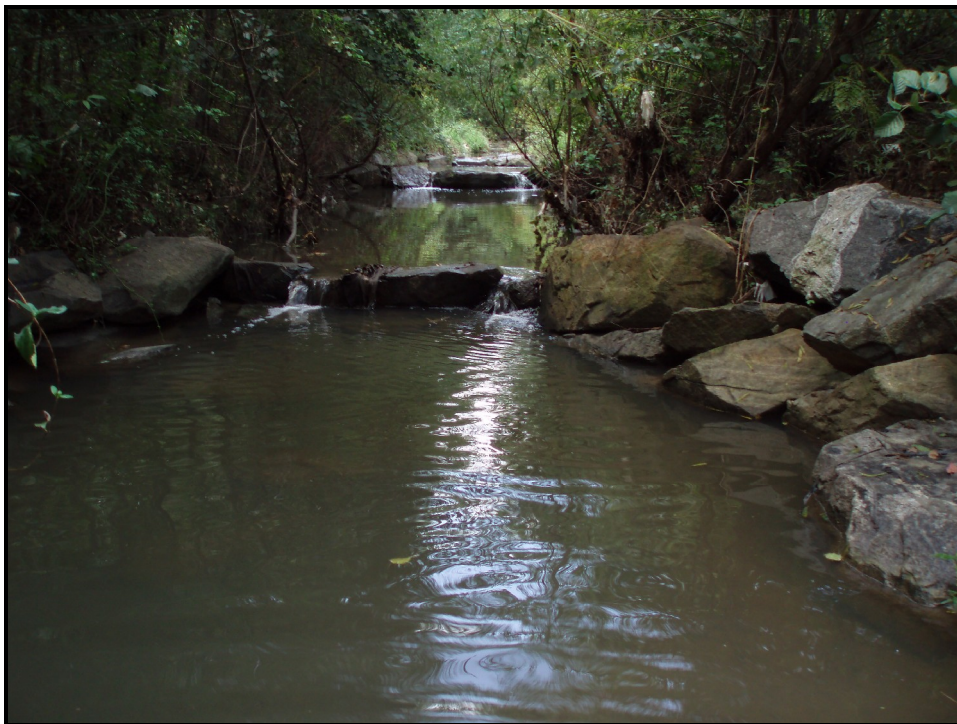
PA# 2 – Cross vane not functioning as intended. Sta. 14+40

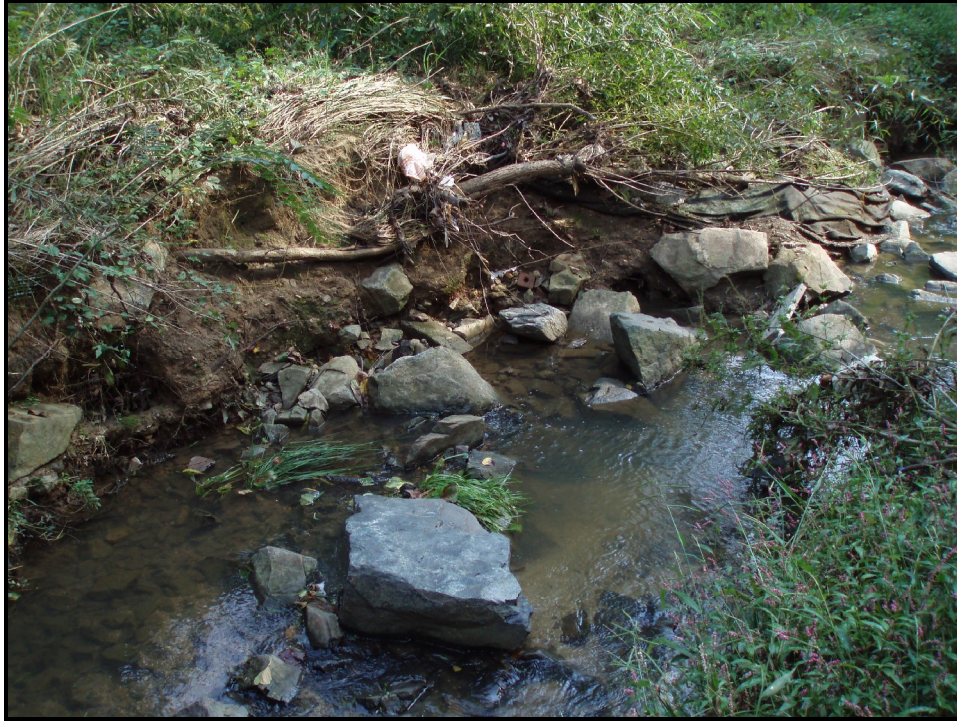
PA #3 – Left bank erosion; lack of rooted vegetation. Sta. 16+50

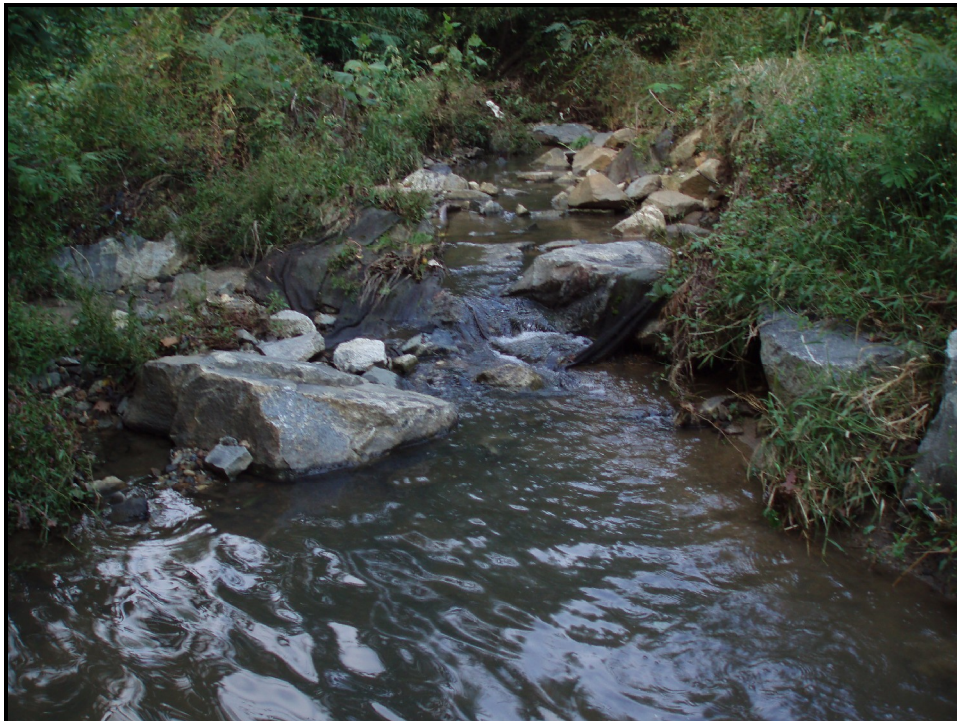
PA #4 – Header rock moved downstream from cross vane; improper installation. Sta. 16+90

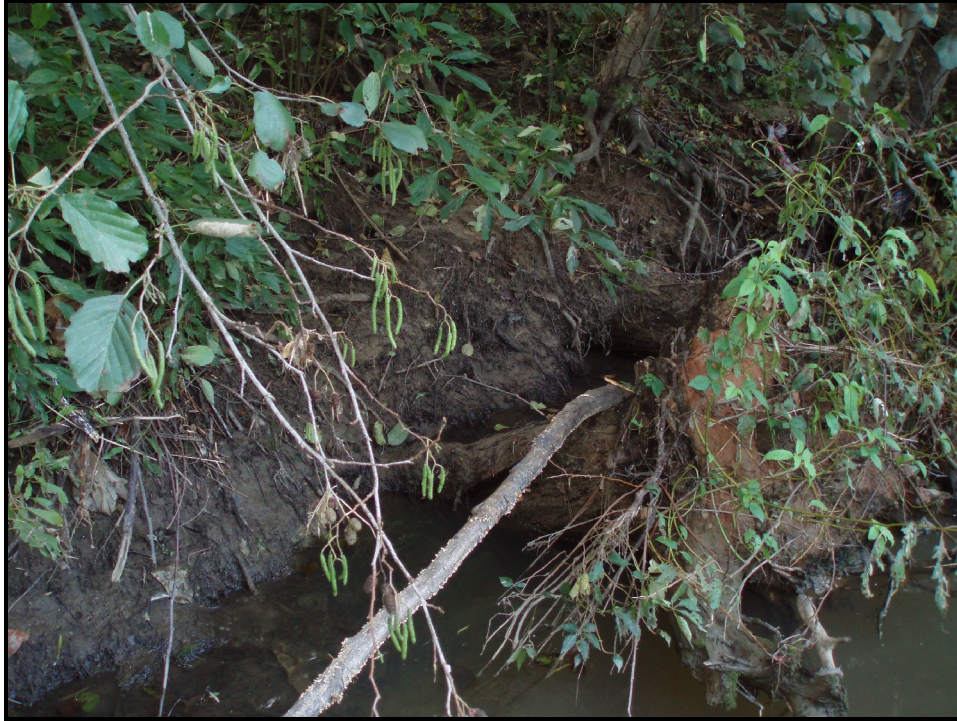
**PA #5 – Right bank washed out behind root wad; improper installation.
Sta. 17+40**

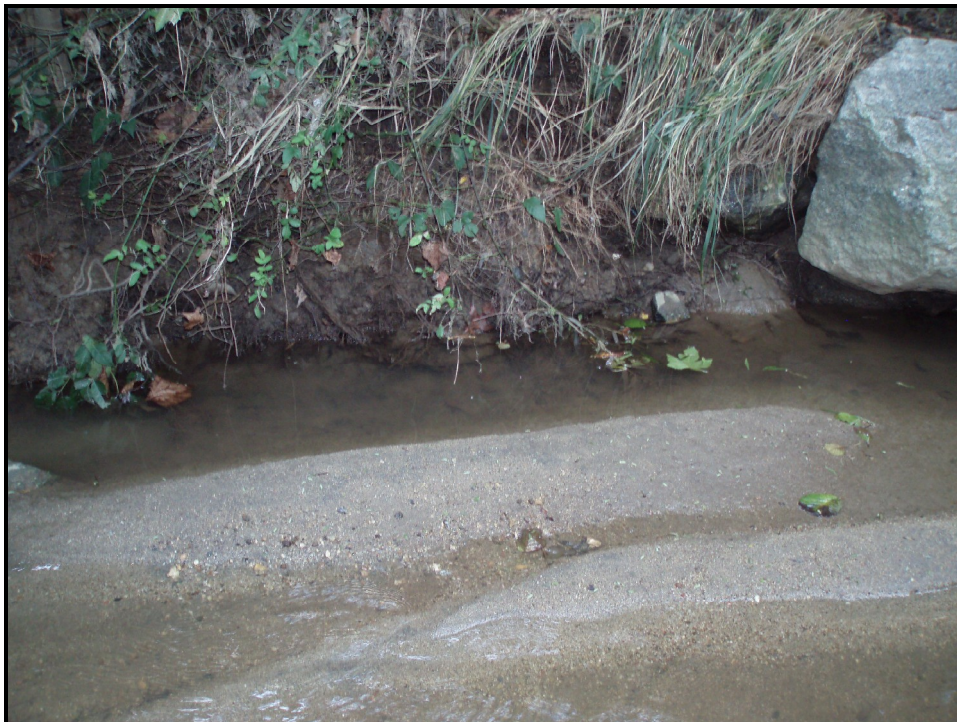
PA #6 – Right bank erosion; lack of rooted vegetation. Sta. 18+40

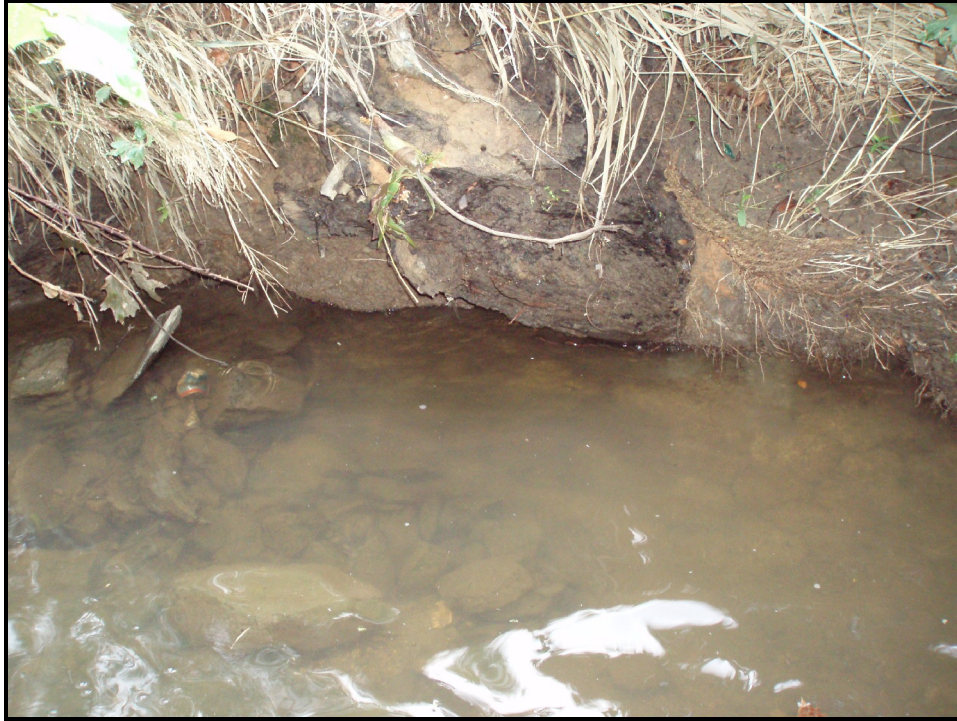
PA #7 – Left bank erosion/undercut; lack of rooted vegetation. Sta. 18+80

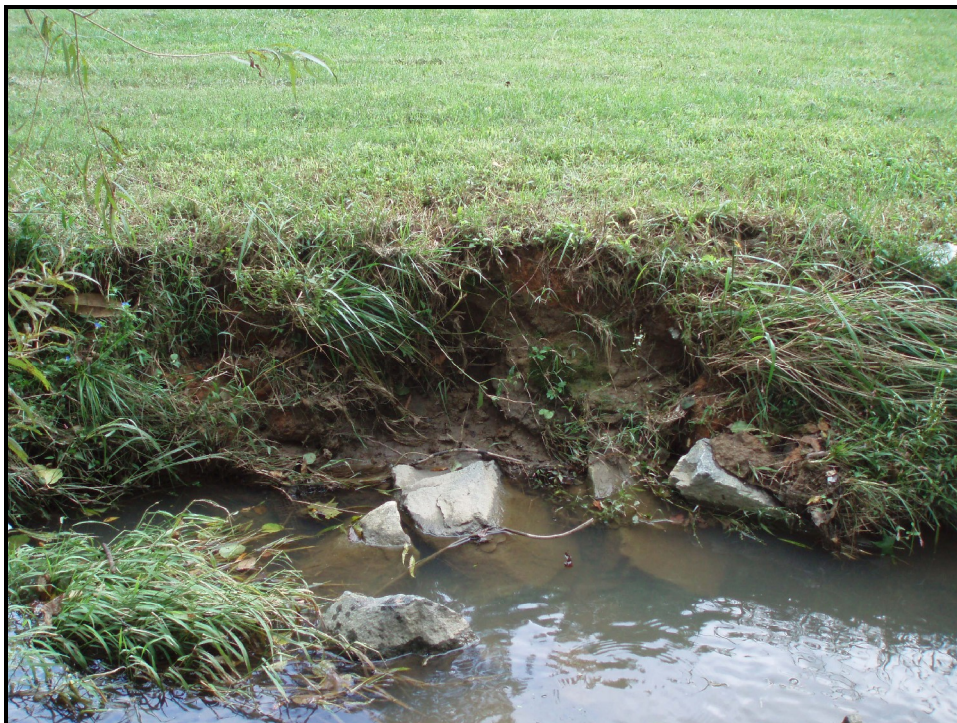
PA #8 – Left bank erosion; lack of rooted vegetation. Sta. 19+00

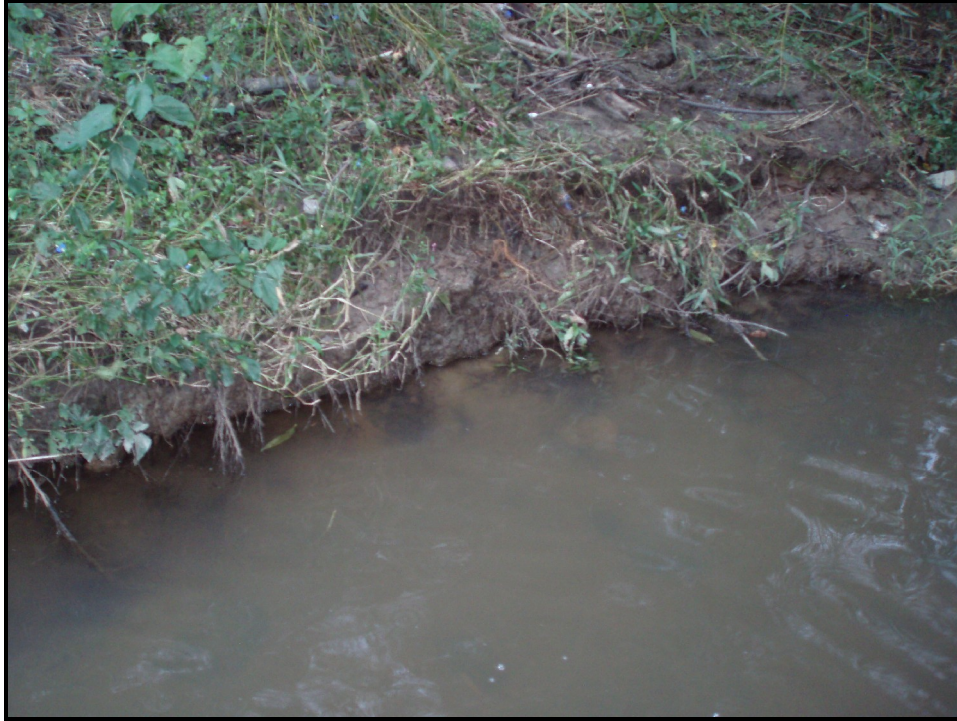
PA #9 – Minor left bank erosion; lack of rooted vegetation. Sta. 21+80

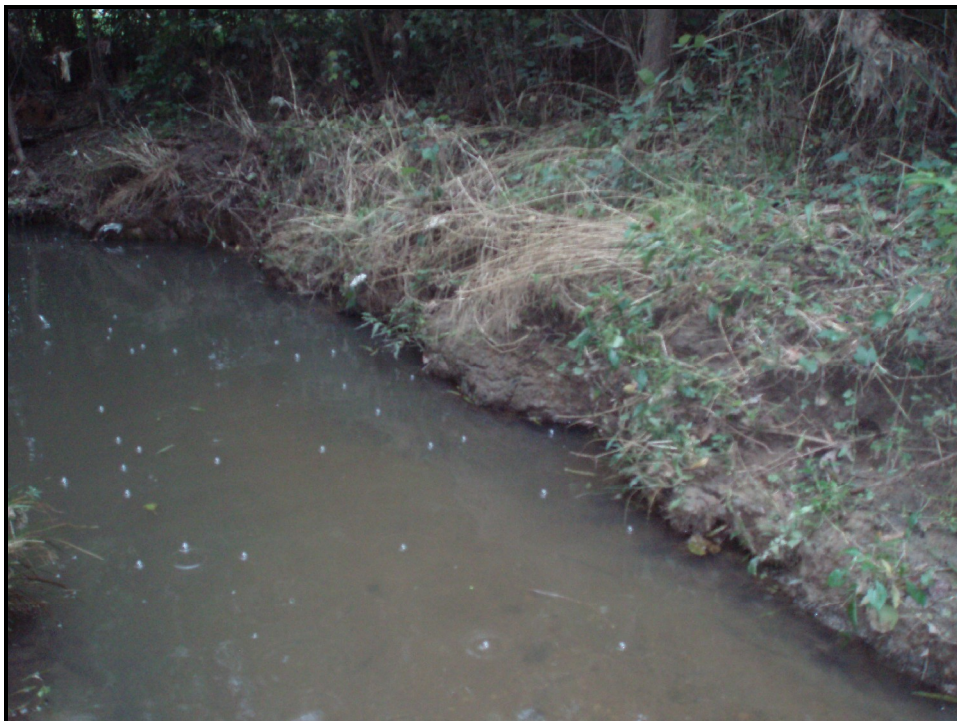
PA #10 – Right bank erosion; lack of rooted vegetation. Sta. 22+80 to 23+00
