ANNUAL REPORT FOR 2006 (Year 6)

Starmount Forest Country Club Mitigation Site
Greensboro
Guilford County
EEP Project No. 360

January 2007

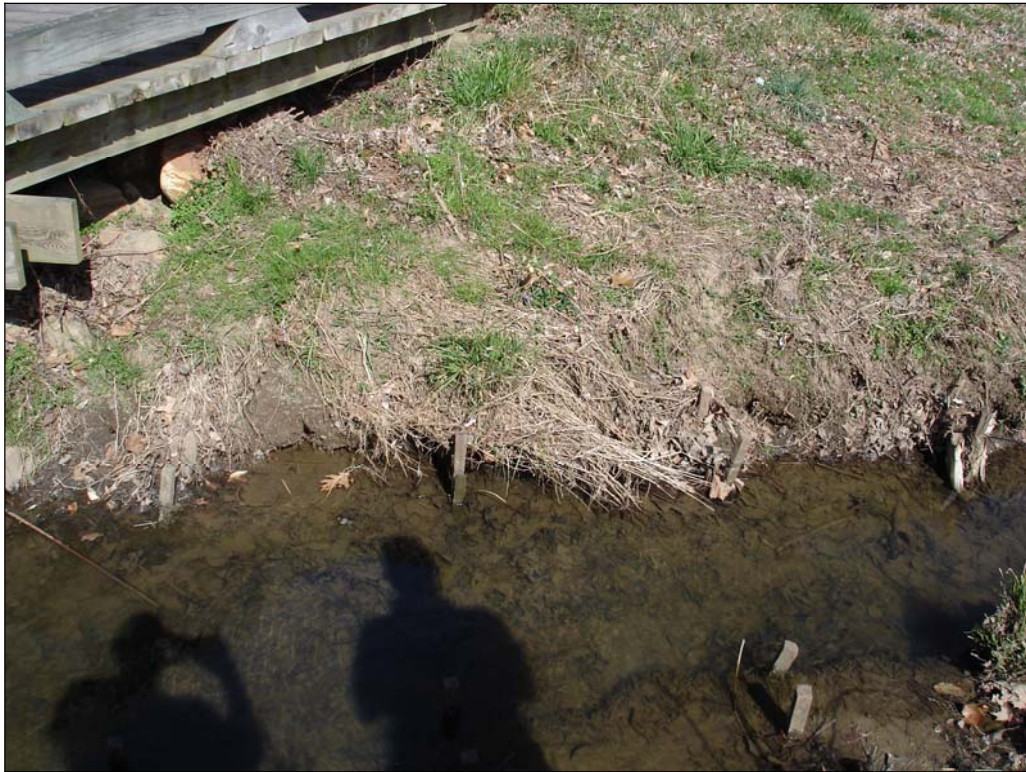
Starmount Forest 2006, Thread D, minor bank erosion at STA 4+80.

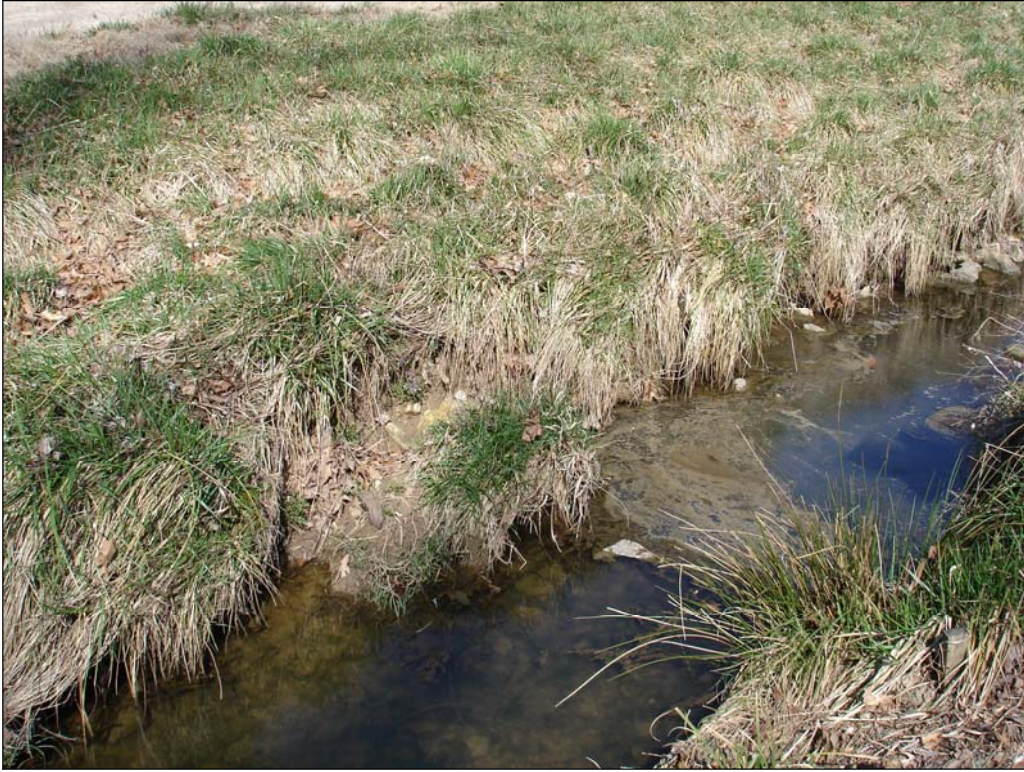
Starmount Forest 2006, Thread D, minor bank erosion at STA 7+10.

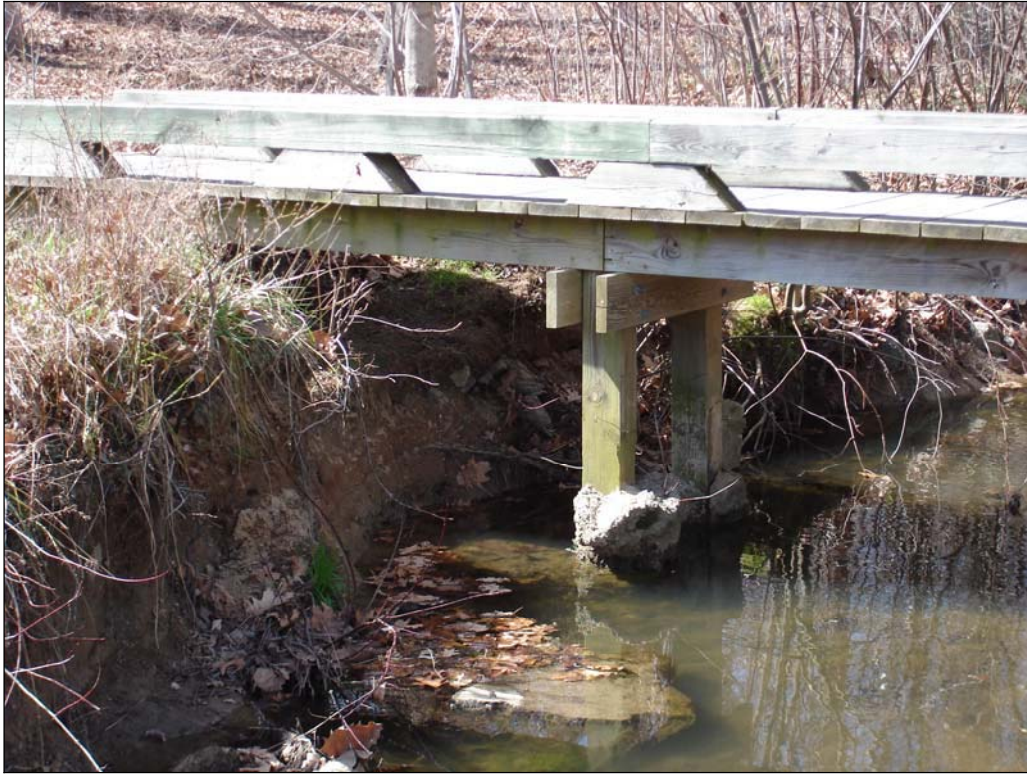
Feature Issue	Station Numbers	Suspected Cause	Photo Number
Erosion on right bank beneath cart path bridge	Thread B STA 2+30	Insufficient vegetative cover and/or bank protection	PA #1
Aggradation, central bar formation	Thread B STA 4+50	Excess sediment input from upstream sources, insufficient water velocity to move sediment	PA #2
Erosion on left bank	Thread D 5+50 to 6+00	Insufficient bank protection and potential improper design	PA #3

Starmount Forest 2006, PA #1.

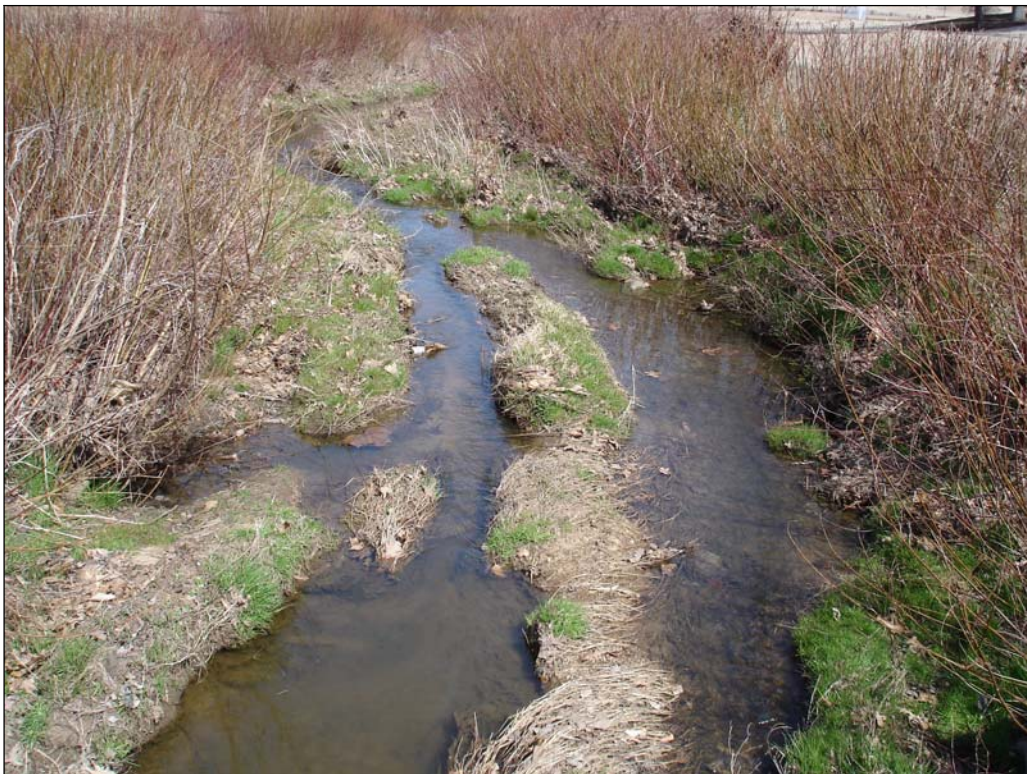
Starmount Forest 2006, PA #2.

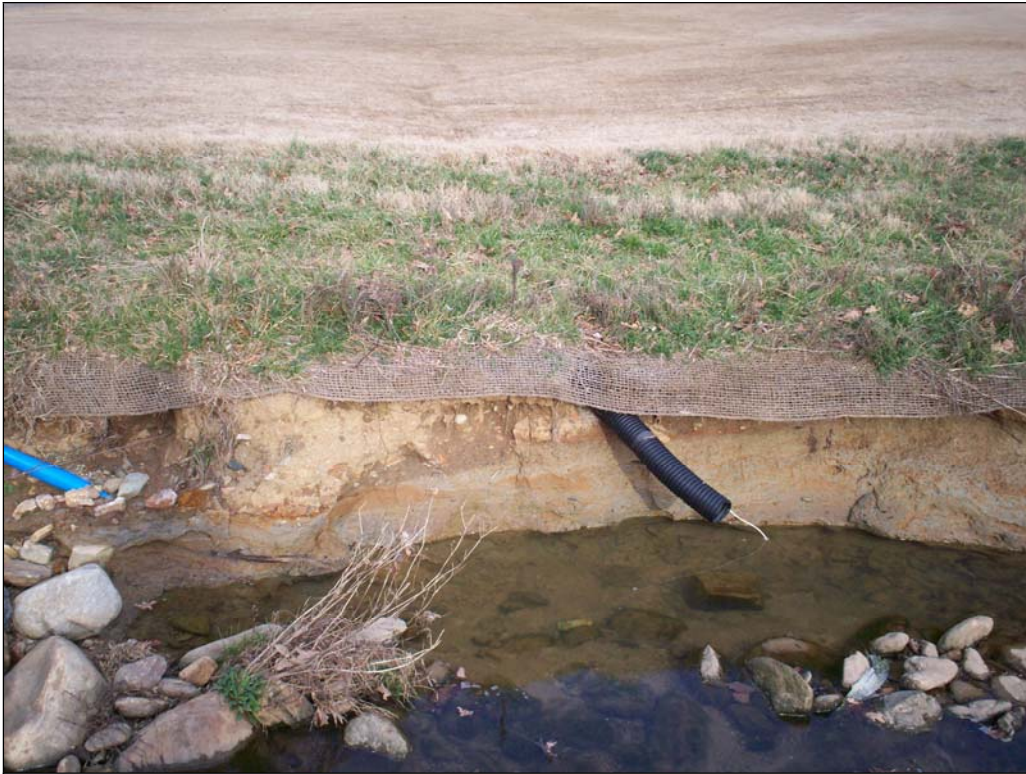
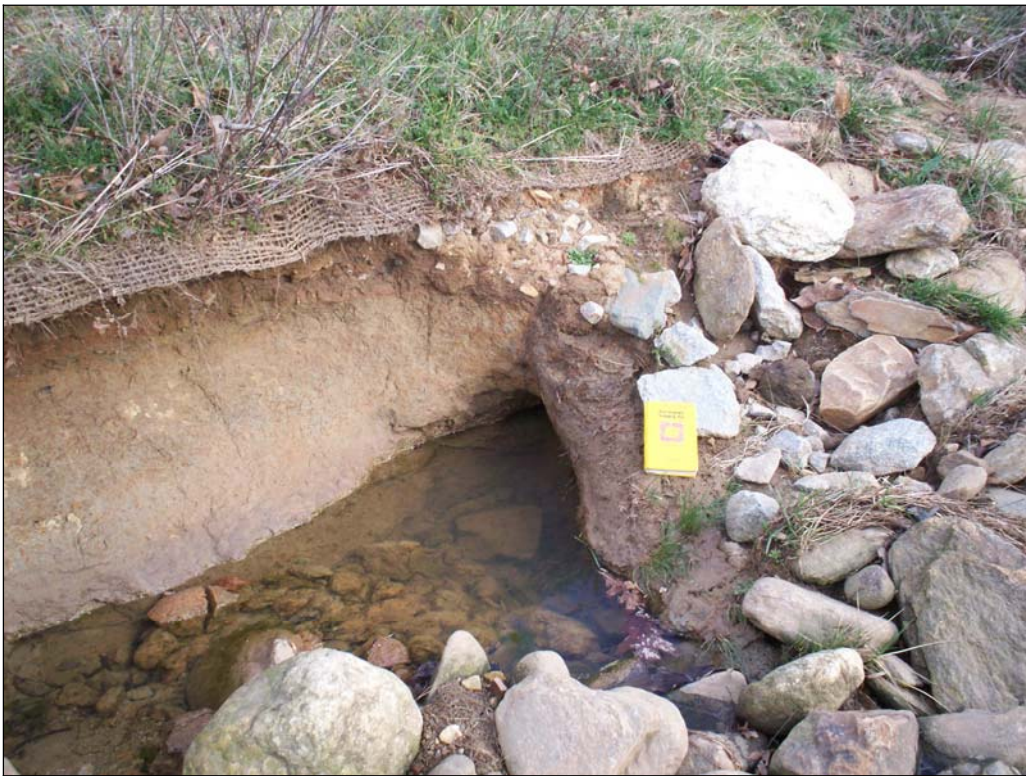
Particular attention was paid to the repair areas on Thread B (169 linear feet) and Thread D (314 linear feet). Thread B is stable and well vegetated. The repairs appear successful and no further remedial actions are needed. Thread D contains one area of bank erosion that will need repair in the future. This problem area is discussed in more detail in Appendix B.

Starmount Forest 2006, PA #3.
