# **St. Clair Creek Restoration Project Year 8 Monitoring Report FINAL**

Beaufort County, North Carolina

DMS Project ID No. 95015

Report Prepared and Submitted by Michael Baker International

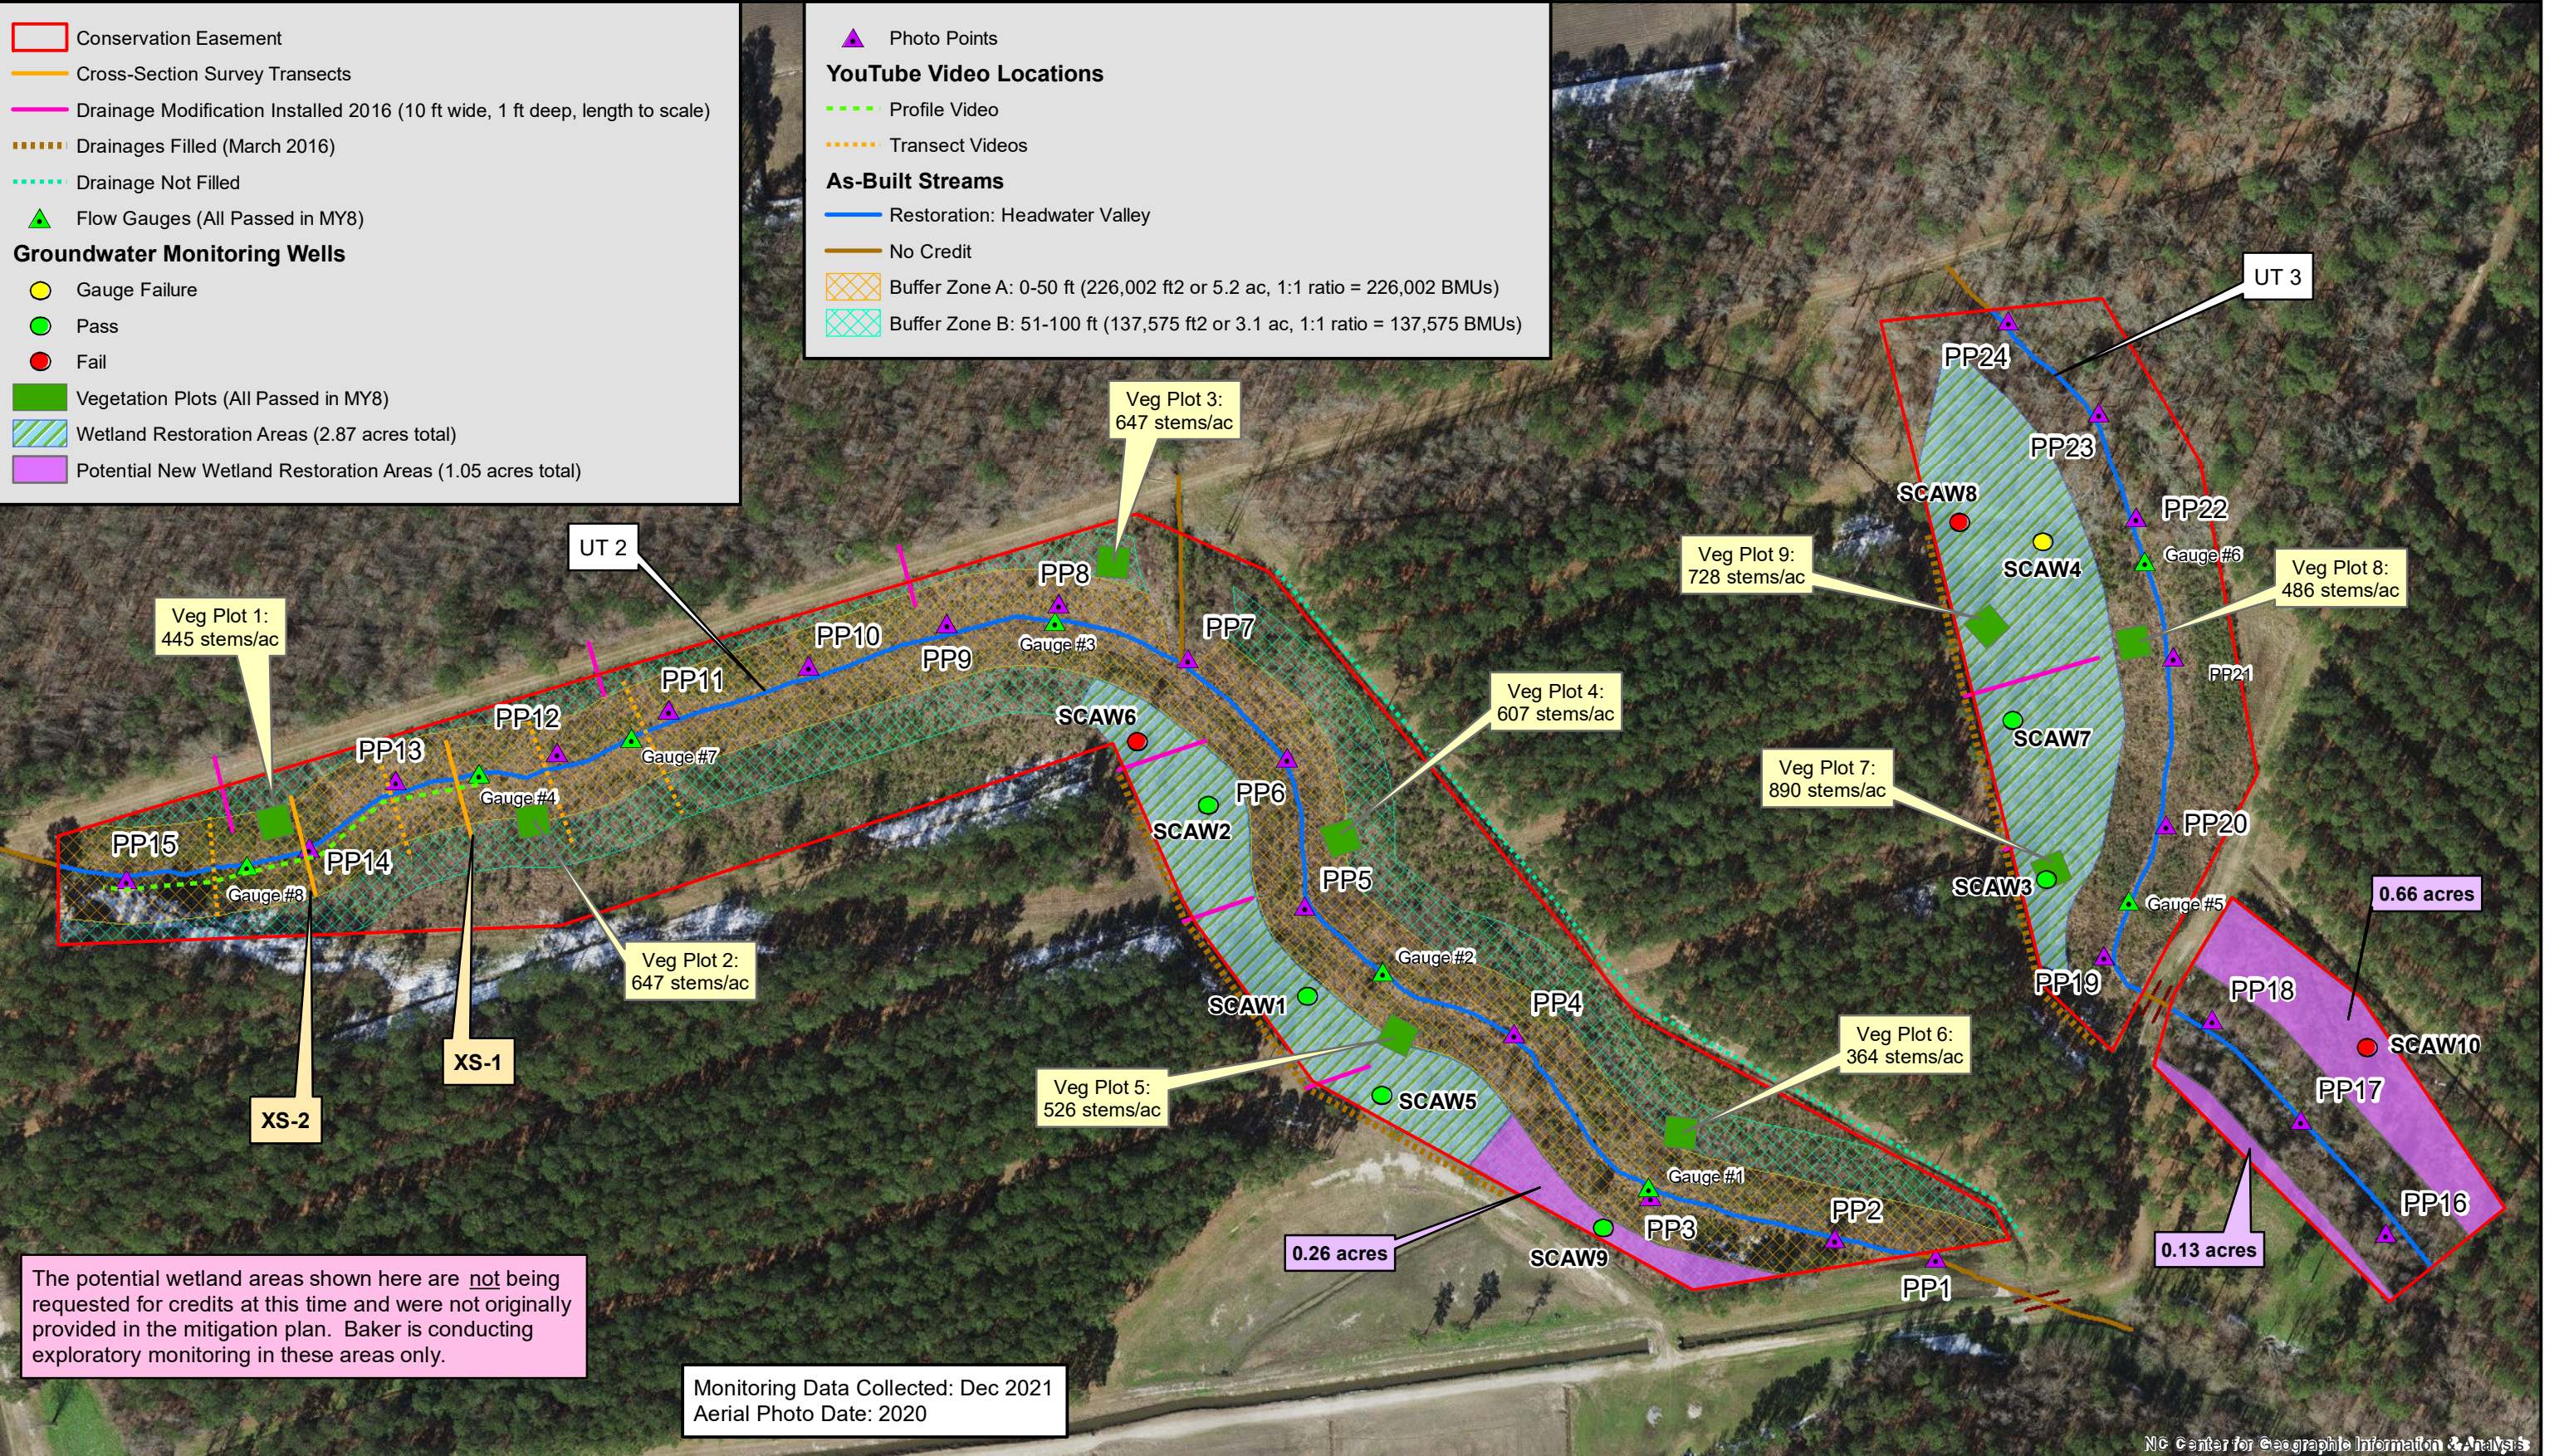
**Figure 2**  
Current Conditions Plan View: MY8  
St. Clair Creek Site  
Beaufort County, NC

It was observed during the Year 8 monitoring that diffuse flow does move through all of the installed swales, and all remain stable and vegetated. Additional groundwater monitoring wells 5-8 were installed in April of 2016 specifically to observe the wetland restoration areas potentially affected by these modifications. The locations of this work are provided in Figure 2 in Appendix B.

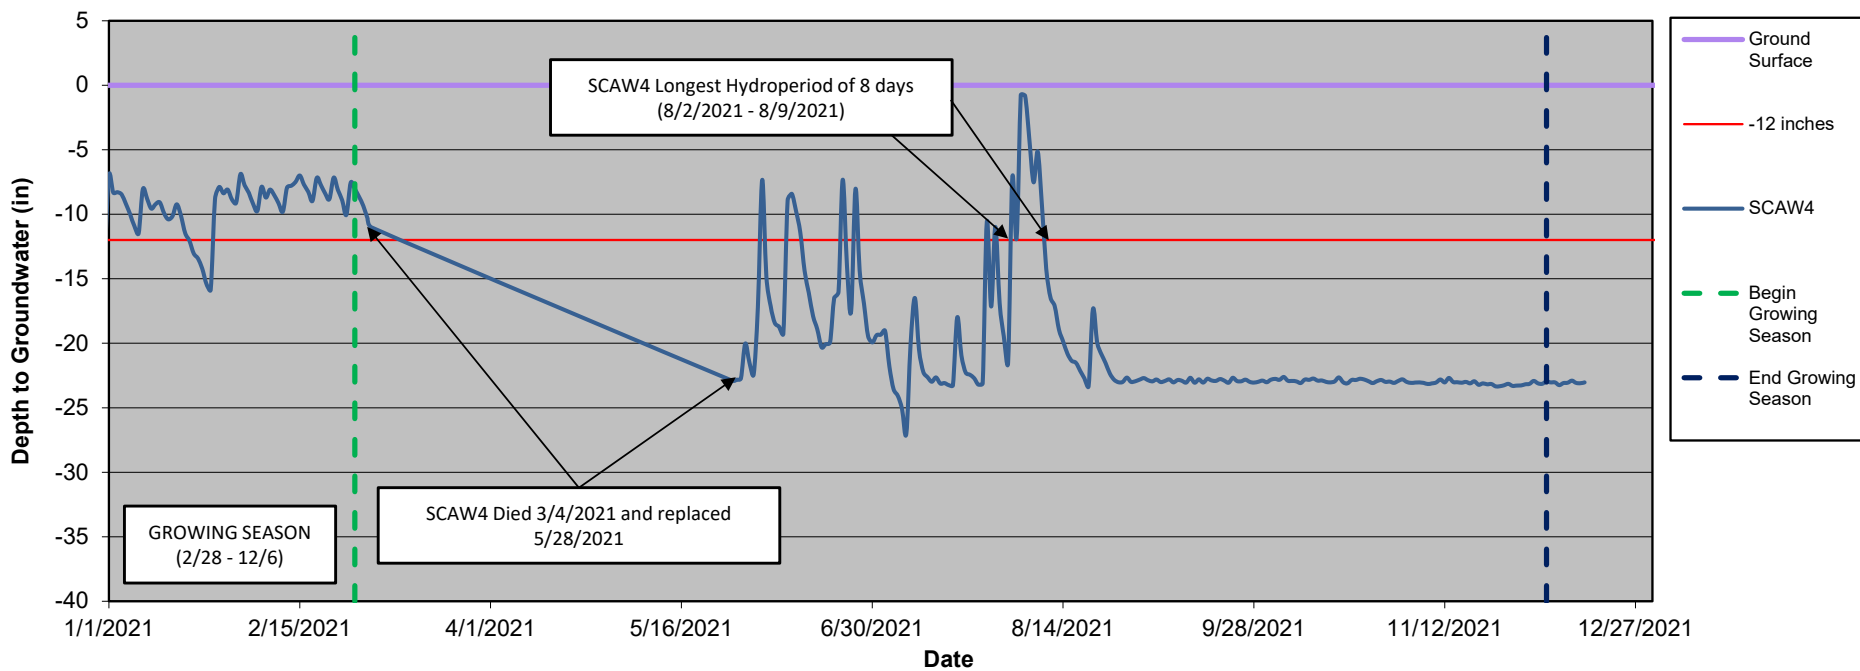
### St. Clair Creek Wetland Restoration Well (UT3) (As-Built Well - SCAW4)

Additionally, during Year 8 monitoring the gauge in wetland well SCAW4 failed very near the start of the growing season and thus was unable to provide any meaningful data during the critical success timeframe. It was sent to the manufacturer (In-Situ) for additional evaluation though they were unable to retrieve any additional data. However, in the past it had been one of the better performing wells and given how its performance tracked with the other successful wells, it seems likely it would have passed given the data recorded up until gauge failure.

\*\*SCAW4 gauge died at the very beginning of the MY8 growing season and thus missed the crucial success period timeframe.

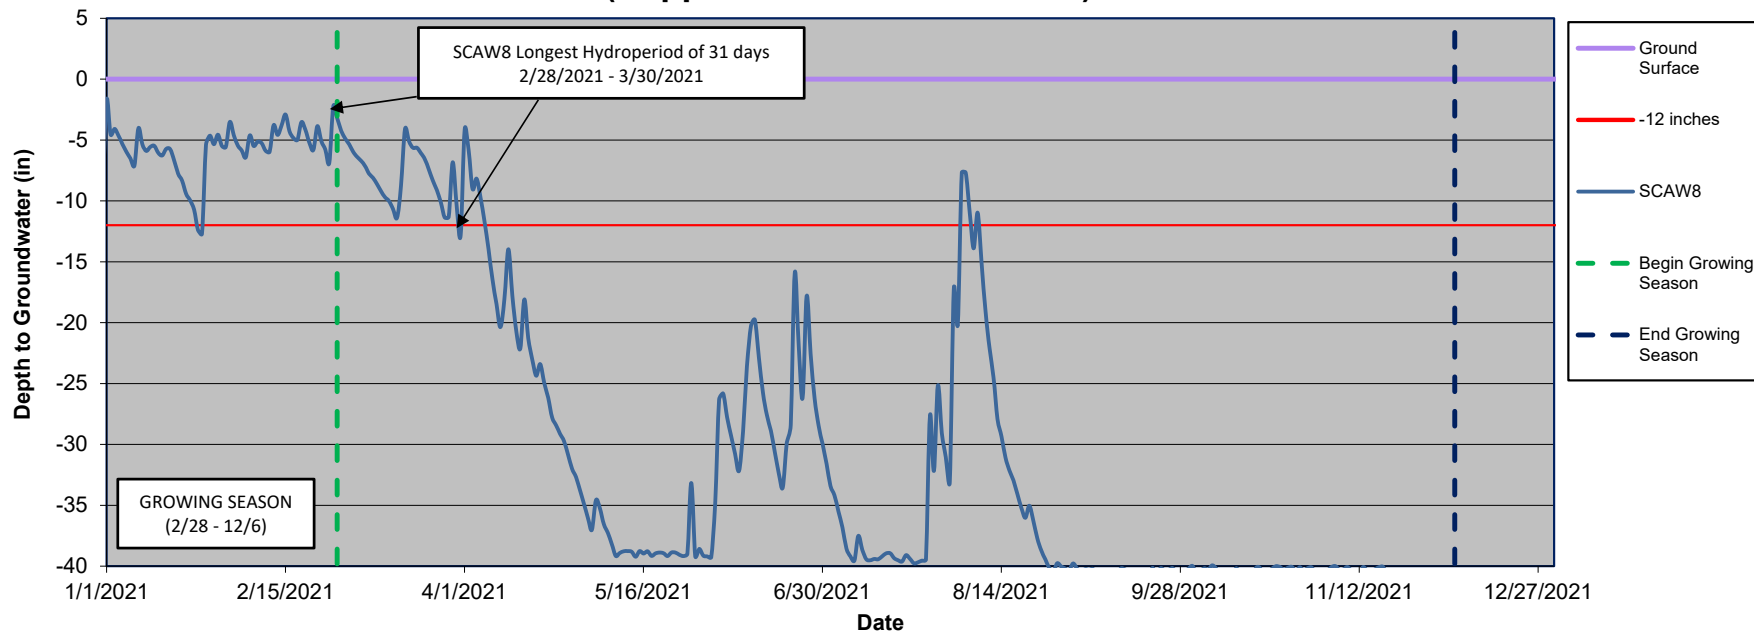
### St. Clair Creek Wetland Restoration Well (UT3) (Supplemental Well - SCAW8)

**HIGHLIGHTED** indicates wells that *did not* meet the success criteria for the most consecutive number of days within the monitored Year 8 growing season with a water 12 inches or less from the soil surface. For Year 8 wetland monitoring, five of the eight wells located in currently credited wetland areas exhibited hydroperiods greater than 12% during the 2021 growing season. Well SCAW4 had gauge failure at the start of the growing season, and SCAW8 missed by 2 days.

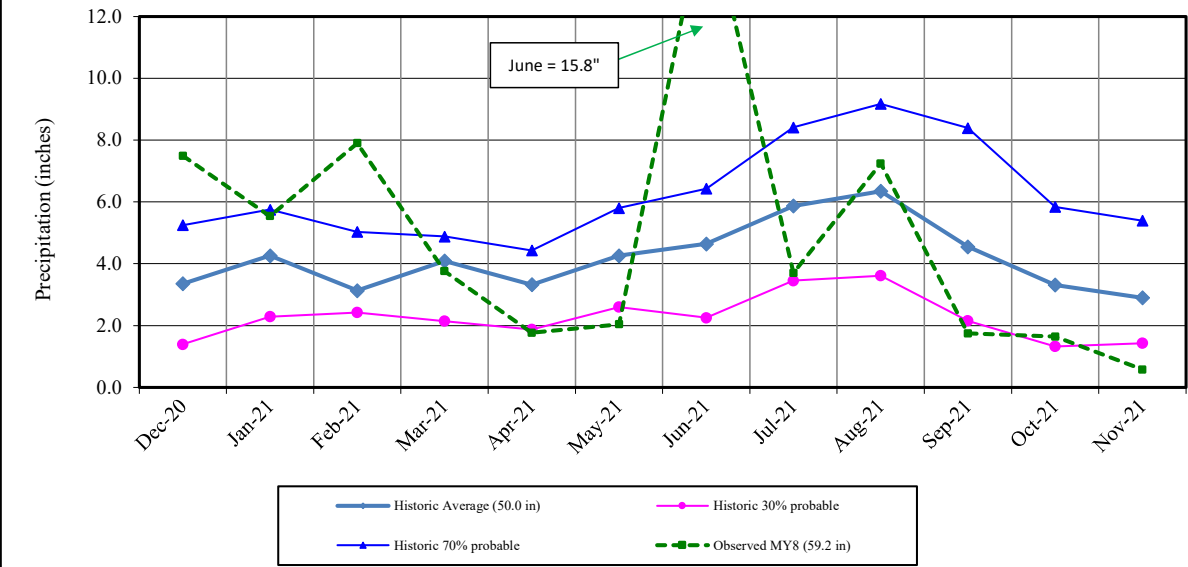
**Figure 5. Observed Rainfall versus Historic Average  
St. Clair Restoration Project (DMS No. 95015) MY8 2021**

Total observed area rainfall for the previous 12-month period from December 2020 through November 2021 was 59.2 inches, as compared to the Beaufort County WETS table for the same period of 50.0 inches annually (see Figure 5 in Appendix D). However, to simply conclude that the annual rainfall was above average would be misleading. In fact, the distribution of that rainfall was heavily weighted over the winter of 2020-2021 and then within the single month of June 2021, all of which were above the historic 70% probable (June was over twice that value). The remainder of the year was quite dry. Six of remaining months were at or below the historic 30% probable. The fall of 2021 was so dry that the site is currently under a Level D2: Severe Drought. This will almost certainly impact the stream flow and wetland hydrology in the winter and spring of 2021-2022, unless significant and consistent rainfall returns.

Note: Beaufort County historic average rainfall is 50.0 in, while observed previous 12 months rainfall total recorded onsite was 59.2 in.

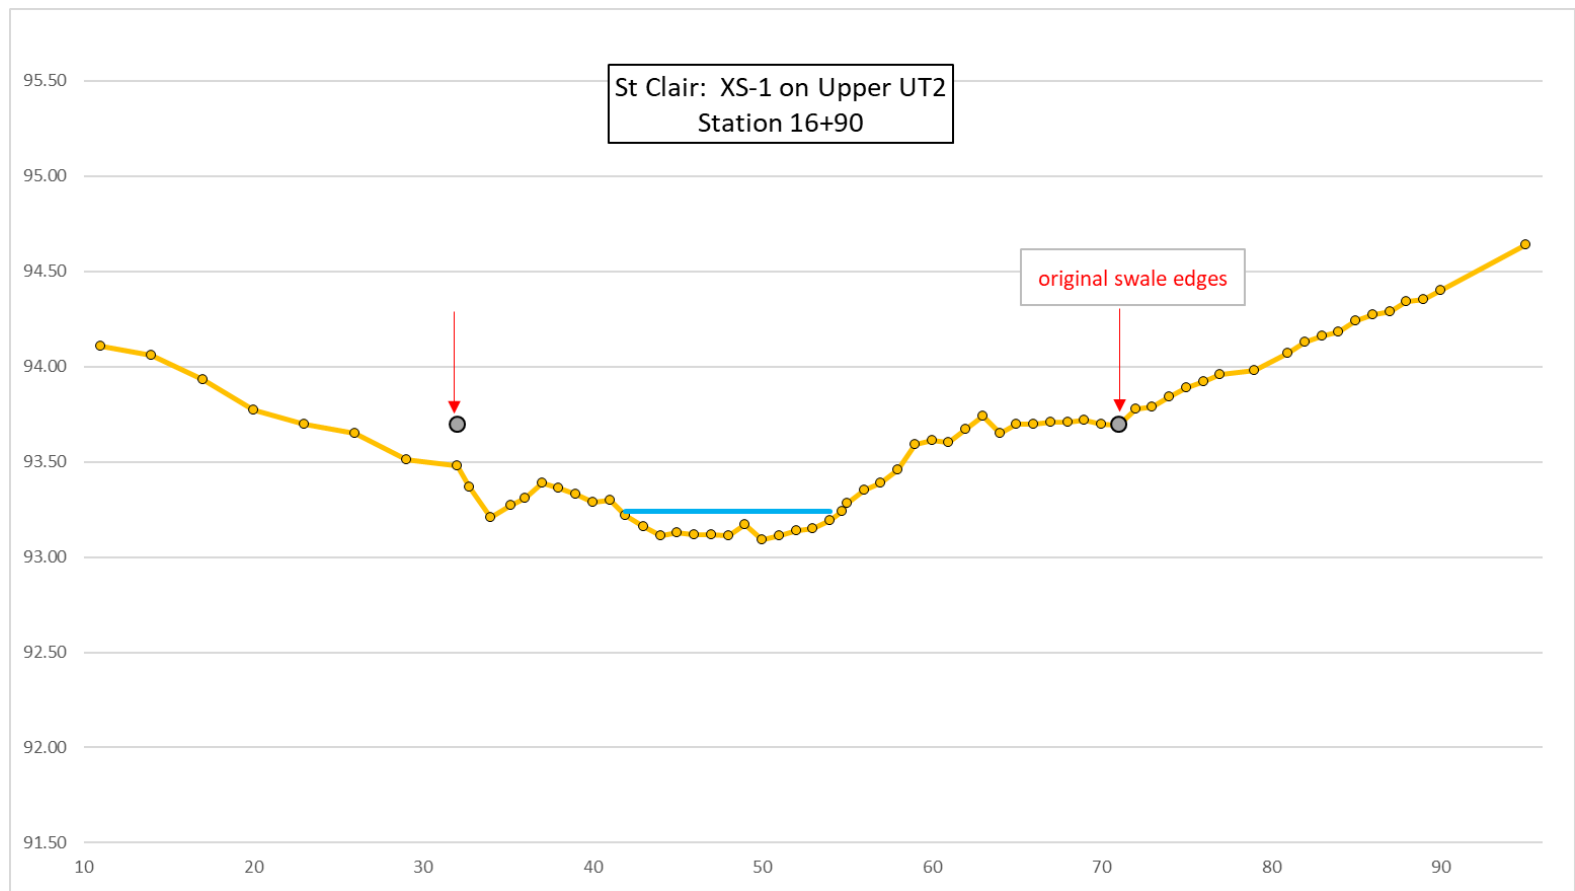
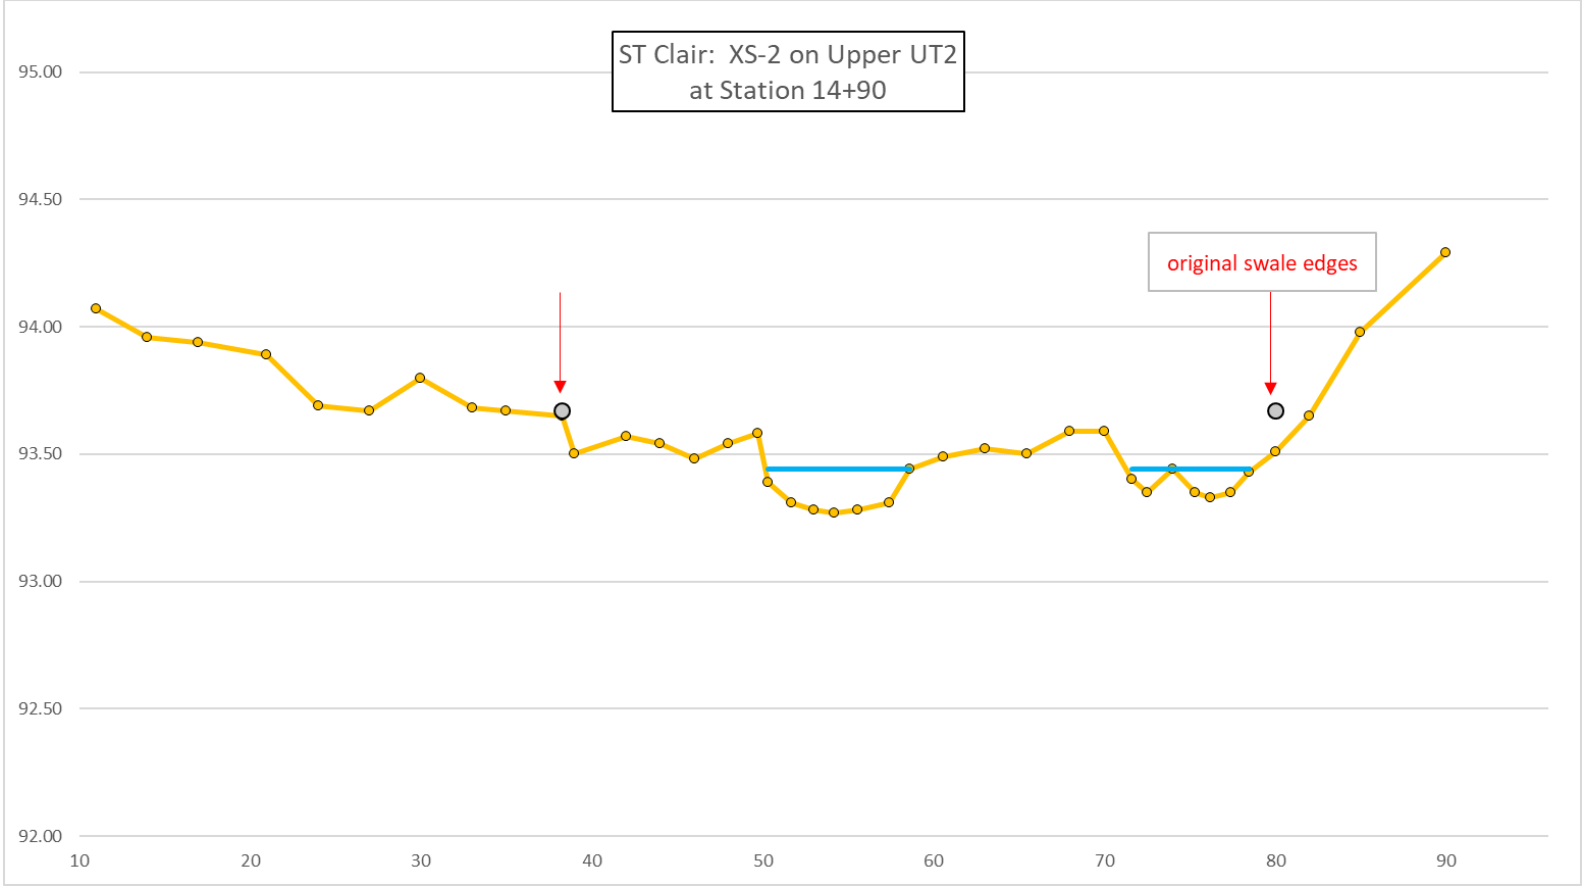
### St Clair Cross Sections (collected 5/1/20):

Please find attached the results of these cross-sections. They reveal the presence of a distinct multi-thread channel with shallow water present in the two primary threads at the time of the survey in the upper transect, and larger channel development with shallow water present in the lower transect. Both transects show signs of channel scour and evolution, with rough, irregular rutting and scour found all across the transects, even along the relatively gentle adjacent side slopes draining into the channel.
