# **St. Clair Creek Restoration Project Year 2 Final Monitoring Report**

Beaufort County, North Carolina

DMS Project ID No. 95015

Report Prepared and Submitted by Michael Baker International

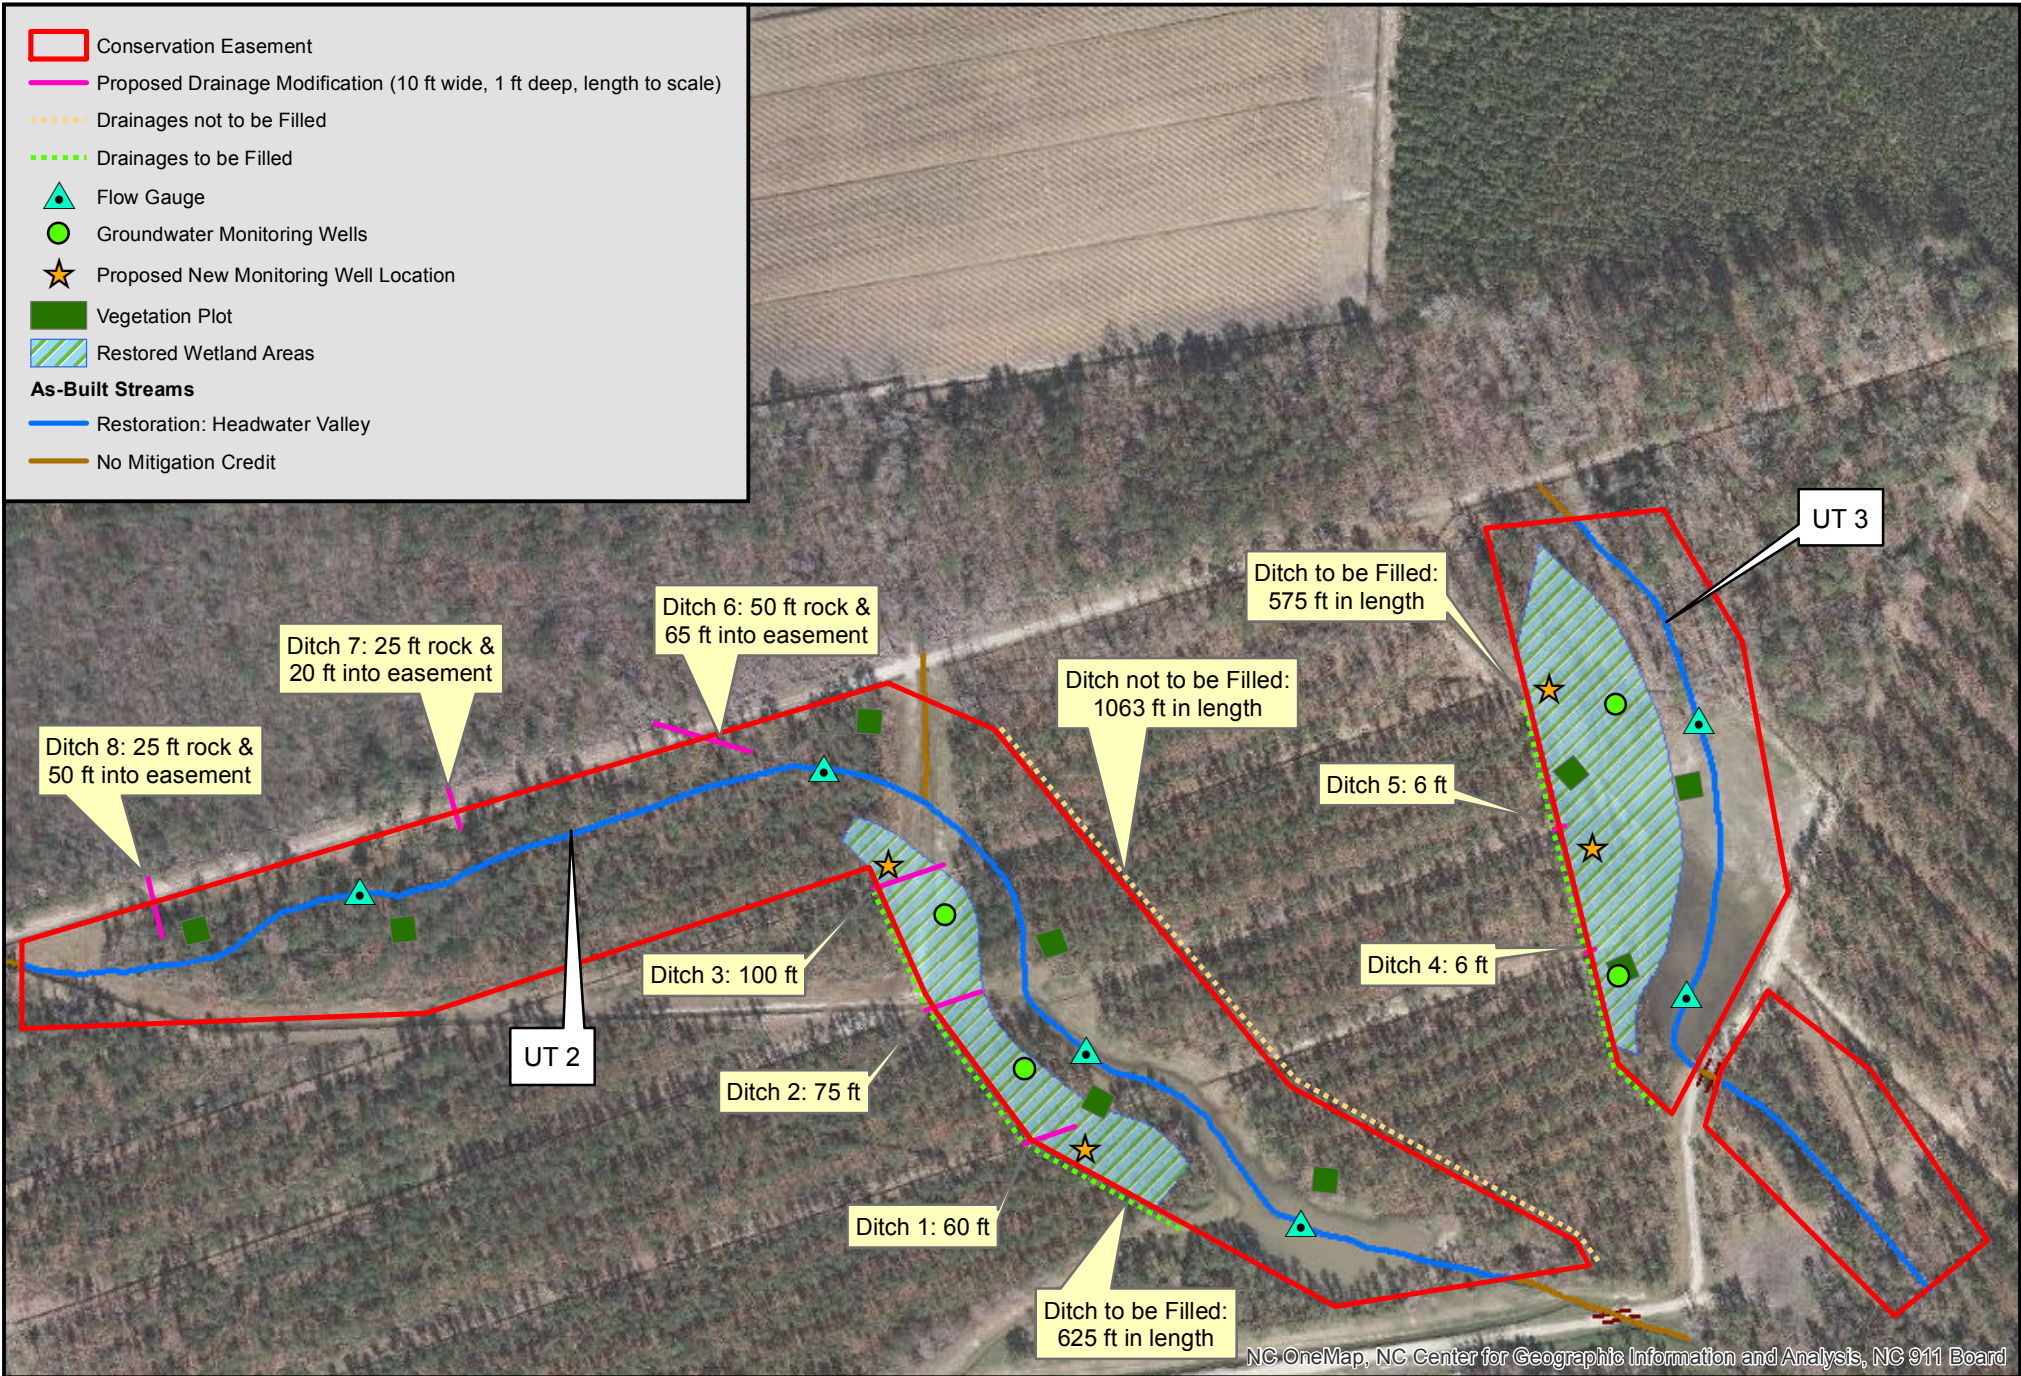
**Figure 2**  
 Current Condition Plan View - MY2  
 St. Clair Creek Site  
 Beaufort County, NC

In the fall of 2015, the restoration site landowner cut a network of drainage ditches adjacent to the easement boundaries of both UT2 and UT3 (See Figure 3). The landowner implemented a plan to re-cut pre-existing ditches that joined a new deeper ditch that directly abuts the Site's conservation easements. These new ditches were cut on the eastern and western boundary of UT2 as well as the western boundary of UT3. The landowner cut the ditches with the intent to drain water away from his pine plantation that abuts both easement boundaries on the west and east. Additionally, the property and farm access road that lies to the north of the Site is also retaining water and needs to drain across the northern road into the conservation easement to prevent hydrologic trespass.

The work described above was designed and implemented without first consulting Baker. The ditches were first discovered during fall monitoring in late 2015.

To remedy the potential impacts of the new ditch network on restored wetland functions, Baker is implementing a work plan to alleviate the hydrologic trespass outside of the conservation easement and to fill the new ditches so wetland hydrology will be unimpaired. The proposed work will take place in three different locations (Figure 3). (1) The northern conservation easement boundary of UT 2 along the existing farm road, (2) the western conservation easement boundary of UT2 along the wetland restoration area, and (3) along the western conservation easement boundary of UT3 along the wetland restoration area.

Location (1): Work in this area will consist of connecting existing shallow drainage ditches from an adjacent property across the farm road into the conservation easement on UT2. A shallow ditch (1' deep by 2' wide) will be cut through the farm road and then filled with rip rap outside of the easement to allow water to filter through the rock (French drain) and move across the road, but will also allow the landowner to cross easily. Once the rock-filled ditch reaches the conservation easement boundary, a shallow, wide, flat depression (10' wide by 1' deep with a 0% slope) will be excavated to tie these depressions into the existing ground elevations within the conservation easement. The locations shown as pink lines on Figure 3 are to scale (length) and are aligned as such to utilize the existing drainage paths as discovered during a field visit for storm event. Flow will be diffuse through these depressions. These areas within the conservation easement will be seeded and re-planted with bare-root trees.

Location (2): Work in this area will consist of excavating shallow and wide depressions through the wetland restoration polygon along UT 2 to connect and help drain the existing lateral ditches outside the conservation easement that were plugged during construction. The depressions will be approximately 10' wide and 1' deep. The depression depth of 1' will be measured down from the existing ground surface inside the wetland area at the conservation easement boundary with the intent to prevent hydrologic trespass within the landowner's existing pine timber. The depression bottoms will be significantly higher than the existing lateral ditch bottoms within the timber. The depressions will essentially be a zero slope and will rely on the hydraulic head from the groundwater within the timber to promote flow. It is anticipated that flow will be diffuse and very low. The depressions will be excavated inside the conservation easement only as far as needed to tie into the existing ground elevations. The lengths of these depressions are shown to scale on the attached figure and are based upon survey data collected in early February 2016. The required excavations will be decrease as the

depressions get closer to the stream. In addition, the recently excavated ditch adjacent to the conservation easement will be filled. This is shown as a green dashed line on the attached figure. The disturbed areas within the conservation easement will be seeded and re-planted with bare-root trees.

Location (3): Work in this area will consist of only removing a small (~5' wide) plug that separates the newly excavated ditch along UT3 (dashed green line in Figure 3) and existing small depressions within the conservation easement. These depressions are likely old remnant ditches excavated many years before the current conditions. These depressions are vegetated and shallow which will serve to prevent hydrologic trespass in the timber areas outside the conservation easement between UT 2 and UT 3. Little to no grading will be required inside the conservation easement along UT 3. In addition, the recently excavated ditch adjacent to the conservation easement will be filled.

Four new monitoring wells will be installed at the beginning of the growing season in Year 3/2016. These additional wells will provide additional wetland success data, as well as collect groundwater levels in the areas adjacent to where the additional ditching repairs will take place. These four new wells are to be installed as shown in Figure 3.

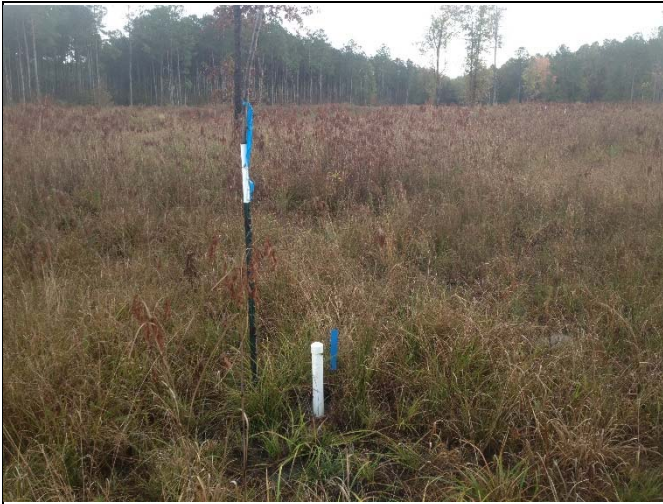
Auto Well – SCAW1, November 18, 2015

It is noted that in the spring of 2015 three wetland restoration wells (SCAW1, SCAW2 and SCAW4) had accumulated bentonite/mud in the bottom of the well casings. A thick, gooey material was found to be clogging the water pressure sensors located in the bottom of the pressure transducers. This accumulation of material was suspected to be the likely cause for the observed erroneous water levels recorded in the well casings. To verify groundwater depths and check for logger accuracy, manual groundwater measurements were recorded during three site visits and compared to datalogger readings in the appropriate date/time windows. The manual measurements were then used to determine if there were any significant differences in the recorded groundwater levels. After comparing the data, it was found that three wetland restoration loggers had errors in depth than was recorded manually. To correct this issue, all well casings, including SCAW3 were pumped to clear excess bentonite/mud that had built up and to prevent further buildup on the pressure sensors. The on-site reference wells were not pumped during this time. Additionally, links in the suspension chains from which the loggers hang in the well casings were also removed so the chain would be shorter. This was an effort to raise the loggers off the bottom of the well casings as to be above the bentonite/mud buildup. Subsequent to these adjustments, all on-site well data loggers now are free of bentonite and the atmospheric pressure hole is clear of any obstructions.

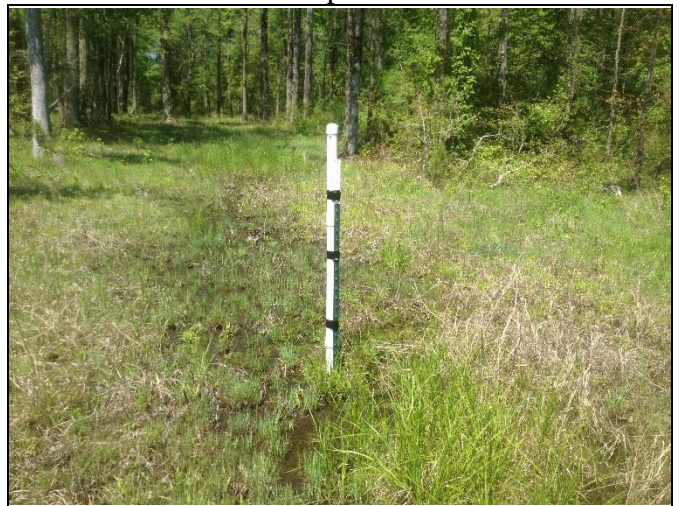
Flow Logger (UT3) – SCFL6, April 21, 2015  
no flow present, but water is present around gauge
