St. Clair Creek Restoration Project Year 3 Final Monitoring Report

DMS Project ID No. 95015

Submission Date: January 2017

Report Prepared and Submitted by Michael Baker International

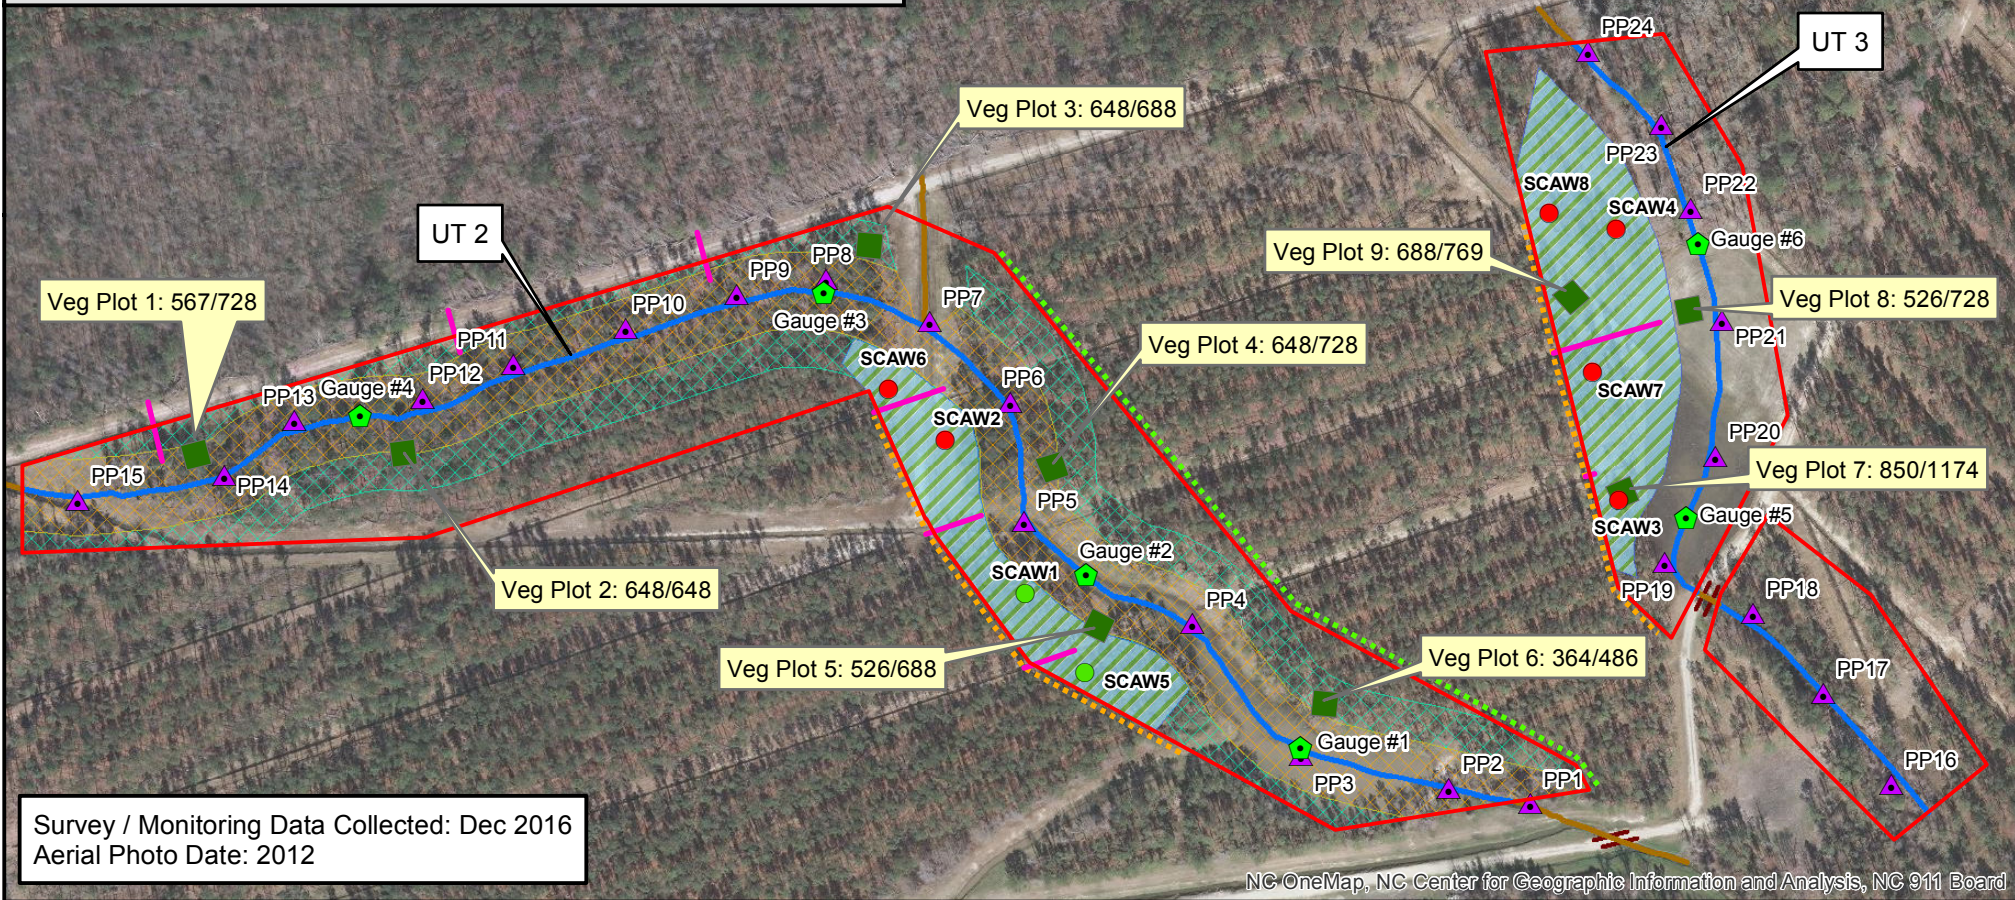
Figure 2
Current Condition Plan View - MY3
St. Clair Creek Site
Beaufort County, NC

In the fall of 2015, the restoration site landowner cut a network of drainage ditches adjacent to the easement boundaries of both UT2 and UT3 (shown as dashed green lines on Figure 3). The landowner implemented a plan to re-cut pre-existing lateral drainage ditches that joined a new deeper ditch that directly abuts the Site's conservation easements. These new ditches were cut on the eastern and western boundary of UT2 as well as the western boundary of UT3. The landowner cut the ditches with the intent to drain water away from his pine plantation that abuts both easement boundaries on the west and east. Additionally, the property and farm access road that lies to the north of the Site was also retaining water and needed to drain across the northern road into the conservation easement to prevent hydrologic trespass.

In the fall of 2015, the restoration site landowner cut a network of drainage ditches adjacent to the easement boundaries of both UT2 and UT3 (See Figure 3). The landowner implemented a plan to re-cut pre-existing ditches that joined a new deeper ditch that directly abuts the Site's conservation easements. These new ditches were cut on the eastern and western boundary of UT2 as well as the western boundary of UT3. The landowner cut the ditches with the intent to drain water away from his pine plantation that abuts both easement boundaries on the west and east. Additionally, the property and farm access road that lies to the north of the Site is also retaining water and needs to drain across the northern road into the conservation easement to prevent hydrologic trespass.

filled the new ditches so wetland hydrology would be unimpaired. The proposed work took place in March 2016 in three different locations (Figure 3). (1) The northern conservation easement boundary of UT 2 along the existing farm road, (2) the western conservation easement boundary of UT2 along the wetland restoration area, and (3) along the western conservation easement boundary of UT3 along the wetland restoration area.

Location (1): Work in this area consisted of connecting existing shallow drainage ditches from an adjacent property across the farm road into the conservation easement of UT2. A shallow ditch (1' deep by 2' wide) was cut through the farm road and then filled with rip rap outside of the easement to allow water to filter through the rock (French drain) and move across the road, but also allows the landowner to cross easily. Once the rock-filled ditch reaches the conservation easement boundary, a shallow, wide, flat depression (10' wide by 1' deep with a 0% slope) was excavated to tie these depressions into the existing ground elevations within the conservation easement. The locations shown as pink lines on Figure 3 are to scale (length) and are aligned as such to utilize the existing drainage paths as discovered during a field visit for storm event. It was observed during Year 3 monitoring that flow now diffuses through these depressions. These areas within the conservation easement were seeded and re-planted with bare-root trees.

Location (2): Work in this area consisted of excavating shallow and wide depressions through the wetland restoration polygon along UT 2 to connect and help drain the existing lateral ditches outside the conservation easement that were plugged during construction. The depressions constructed are approximately 10' wide and 1' deep. The depression depth of 1' was measured down from the existing ground surface inside the wetland area at the conservation easement boundary with the intent to prevent hydrologic trespass within the landowner's existing pine timber. The depression bottoms are significantly higher than the existing lateral ditch bottoms within the timber. The depressions are essentially a zero slope and rely on the hydraulic head from the groundwater within the timber to promote flow. The depressions were excavated inside the conservation easement only as far as needed to tie into the existing ground elevations. The constructed lengths of these depressions are shown to scale in Figure 3. The required excavations are shallower as the depressions get closer to the stream valley. In addition, the excavated ditch adjacent to the conservation easement was filled. This is shown as a green dashed line on the attached figure. The small amount of flow that this depression receives flows diffusely as observed during Year 3 monitoring. The disturbed areas within the conservation easement were seeded and re-planted with bare-root trees.

Location (3): Work in this area will consisted of removing a small (~5' wide) plug that separated the newly excavated ditch along UT3 (dashed green line in Figure 3) and existing small depressions within the conservation easement. These depressions were likely old remnant ditches excavated many years before the current conditions. These depressions are vegetated and shallow which serves to prevent hydrologic trespass in the timber areas outside the conservation easement between UT 2 and UT 3.

Additionally, at the time of construction it was determined based on field observations that an additional shallow ditch would need to be excavated to 151 feet through the wetland restoration polygon (Ditch 5) along UT 3 to connect and help drain the existing lateral ditches outside the conservation easement that were plugged during construction. The depressions constructed are approximately 10' wide and 1' deep. Little to no grading will be required inside the conservation easement along UT 3 except Ditch 5.

In addition, the excavated ditch adjacent to the conservation easement was filled. Construction of the proposed activities as described above was implemented in Year 3 (March 2016).

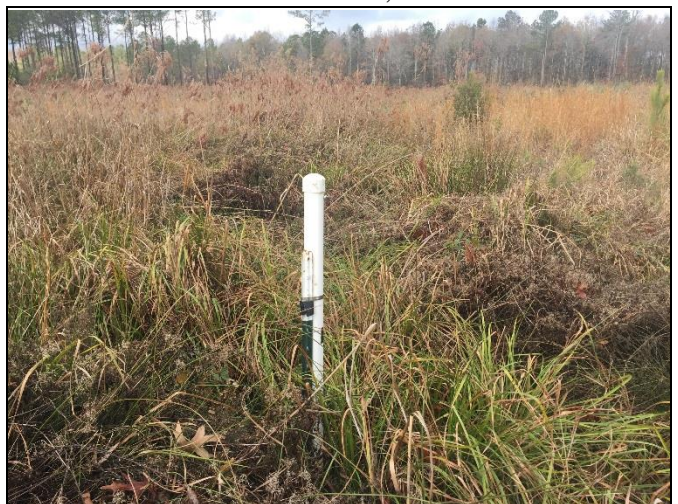
Flow Logger (UT2) – SCFL2, December 13, 2016
flow present

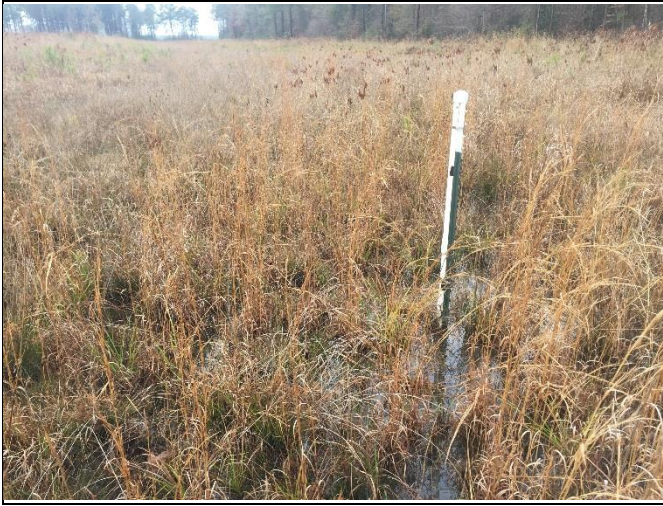
Flow Logger (UT2) – SCFL3, December 13, 2016
flow present

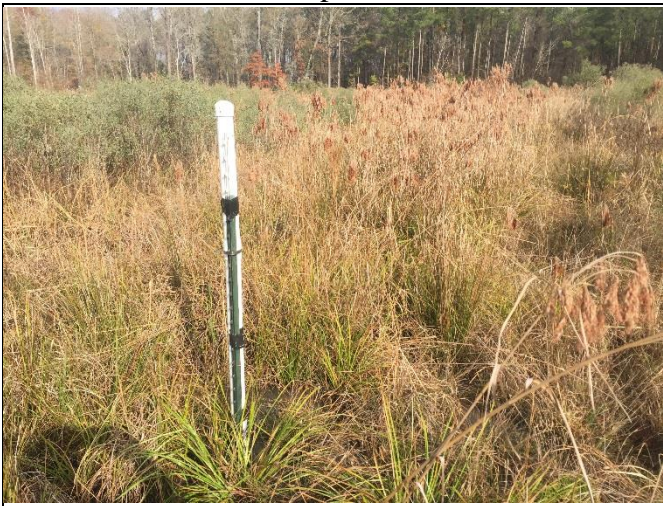
Flow Logger (UT3) – SCFL5, December 13, 2016
slight flow present

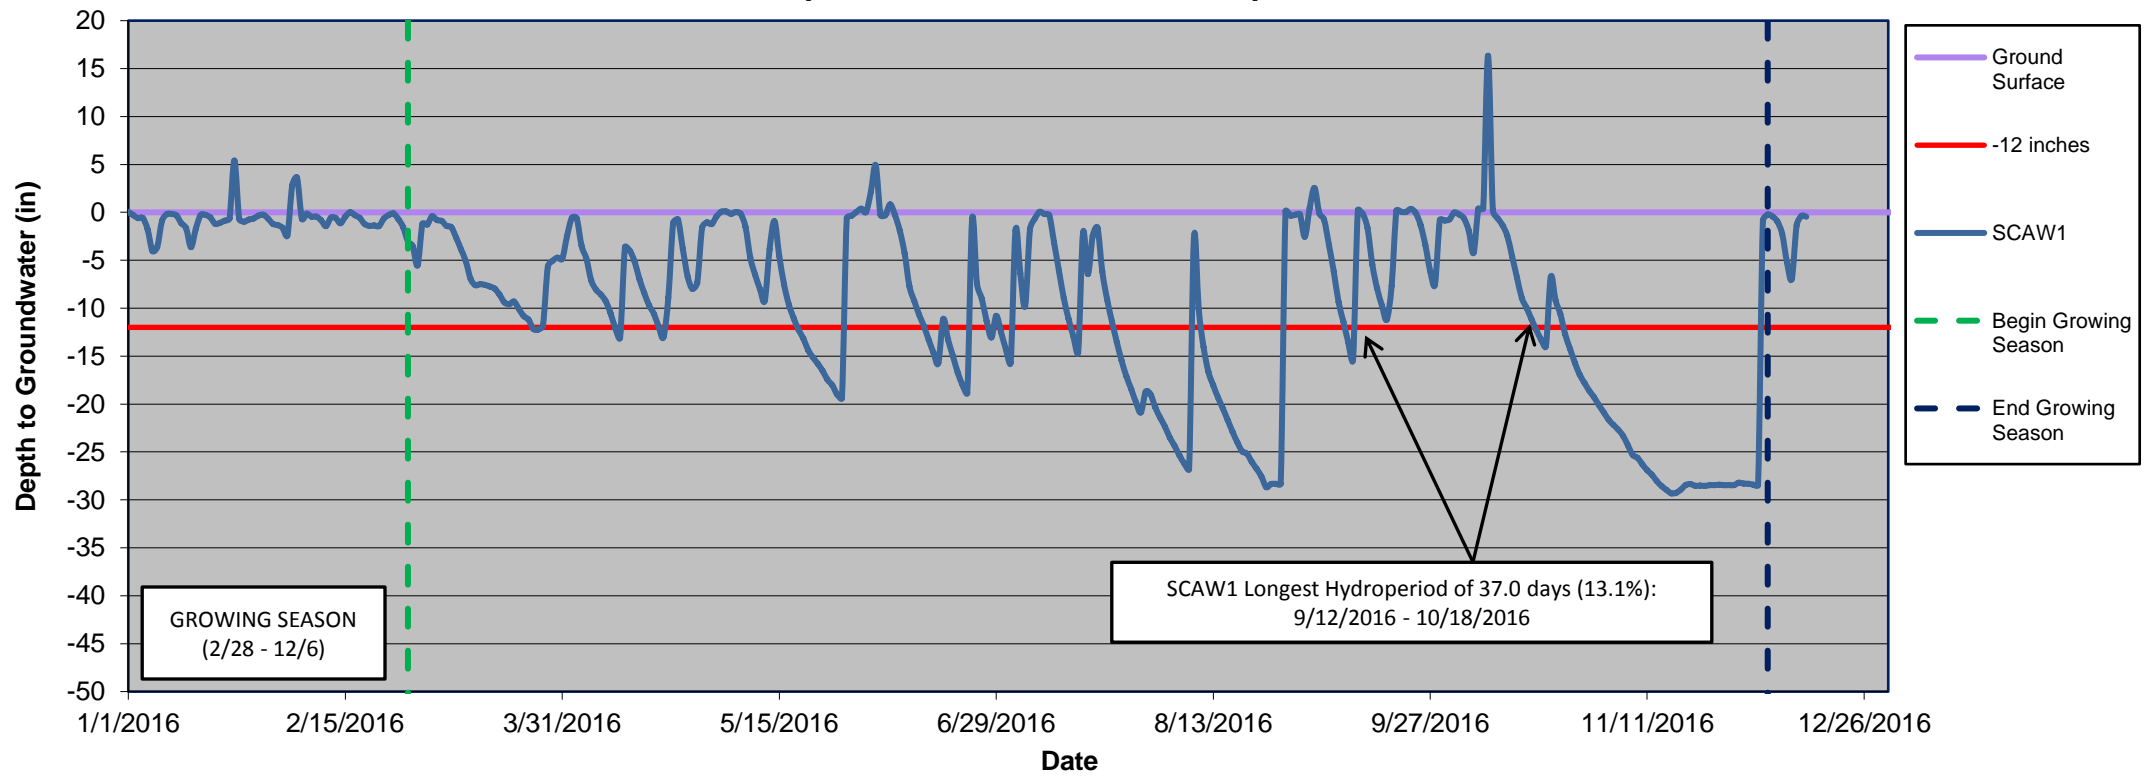
St. Clair Creek Wetland Restoration Well (UT2) (As-built well - SCAW1)

It is noted that in the spring of 2015 three wetland restoration wells (SCAW1, SCAW2 and SCAW4) had accumulated bentonite/mud in the bottom of the well casings. A thick, goeey material was found to be clogging the water pressure sensors located in the bottom of the pressure transducers. This accumulation of material was suspected to be the likely the cause for the observed erroneous water levels recorded in the well casings. To verify groundwater depths and check for logger accuracy, manual groundwater measurements were recorded during three site visits and compared to datalogger readings in the appropriate date/time windows. The manual measurements were then used to determine if there were any significant differences in the recorded groundwater levels. After comparing the data, it was found that three wetland restoration loggers had errors in depth other than what was recorded manually. To correct this issue, all well casings, including SCAW3 were pumped to clear excess bentonite/mud that had built up and to prevent further buildup on the pressure sensors. The on-site reference wells were not pumped during this time. Additionally, links in the suspension chains from which the loggers hang in the well casings were also removed so the chain would be shorter. This was an effort to raise the loggers off the bottom of the well casings as to be above the bentonite/mud buildup. Subsequent to these adjustments, all on-site well data loggers now are free of bentonite and the atmospheric pressure hole is clear of any obstructions.
