# St. Clair Creek Restoration Project Year 4 Final Monitoring Report

DMS Project ID No. 95015

Monitoring Year: 4 of 7

Report Prepared and Submitted by Michael Baker International

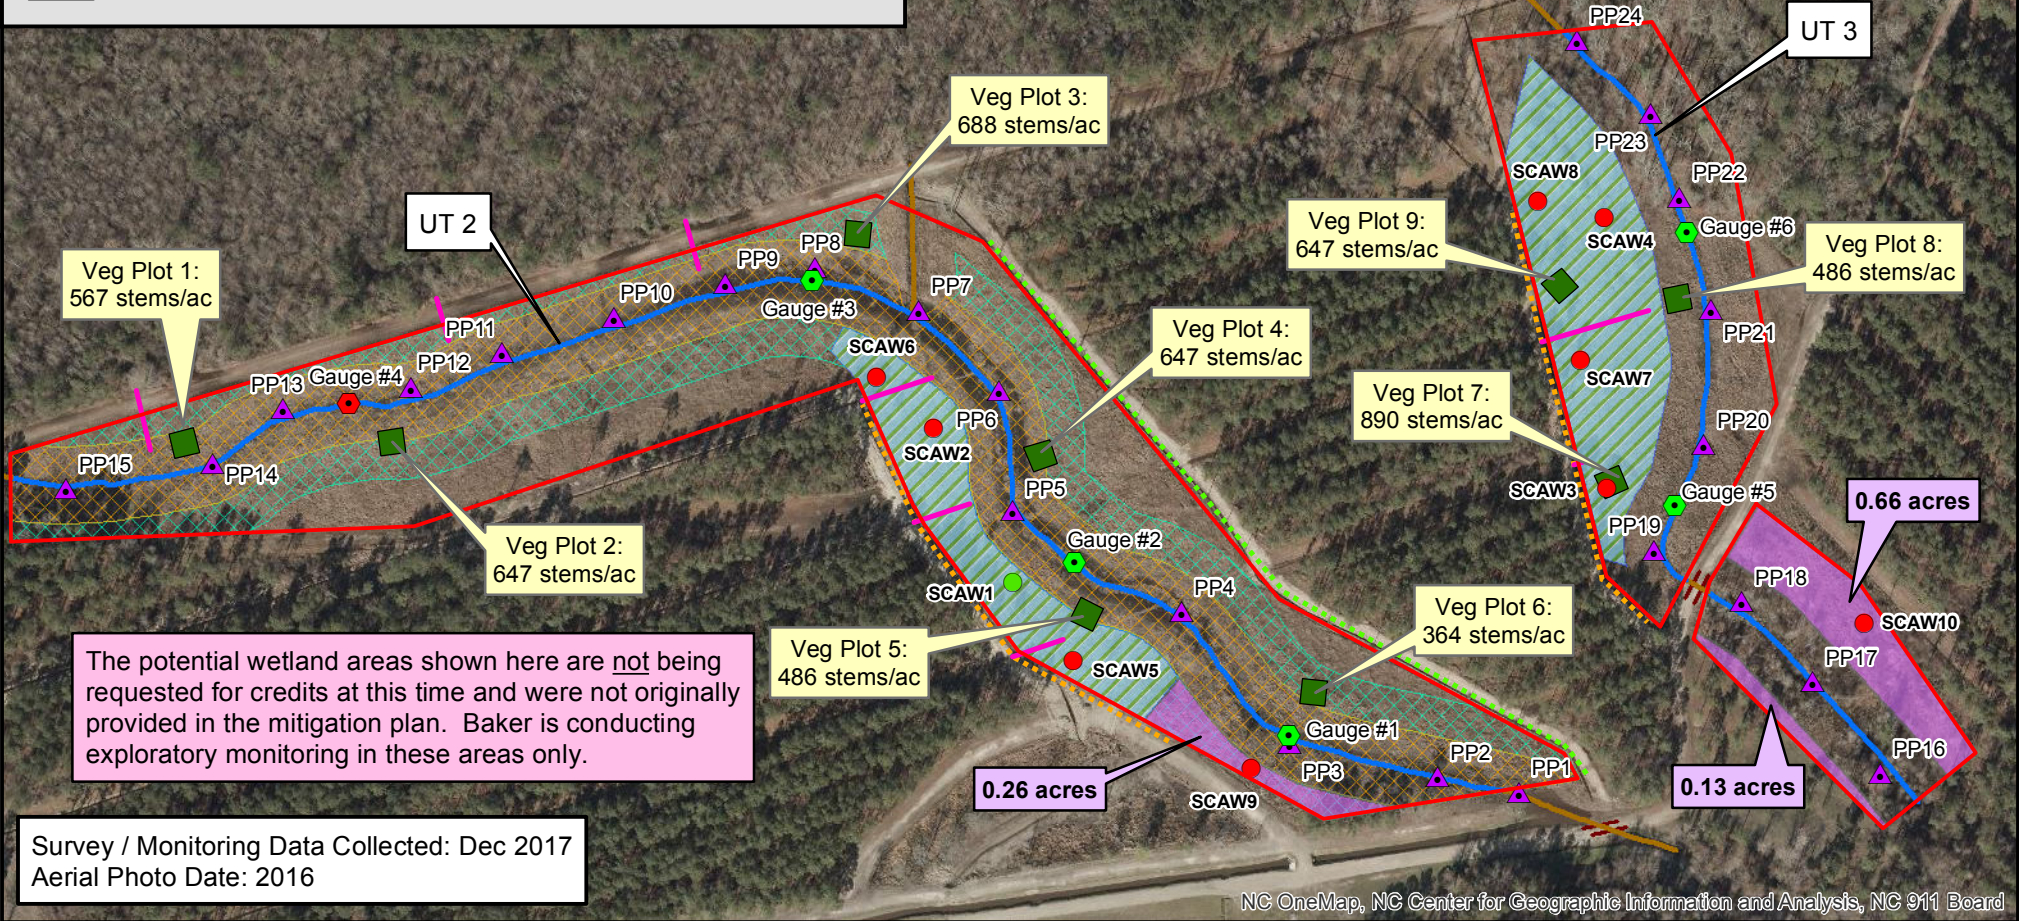
**Figure 2**  
Current Conditions Plan View: MY4  
St. Clair Creek Site  
Beaufort County, NC

It was observed during the Year 4 monitoring that diffuse flow does now move through all of the installed swales, and all remain stable and vegetated. Additional groundwater monitoring wells 5-8 were installed in April of 2016 specifically to observe the wetland restoration areas potentially affected by these modifications. The locations of this previous work are provided in Figure 2 located in Appendix B.

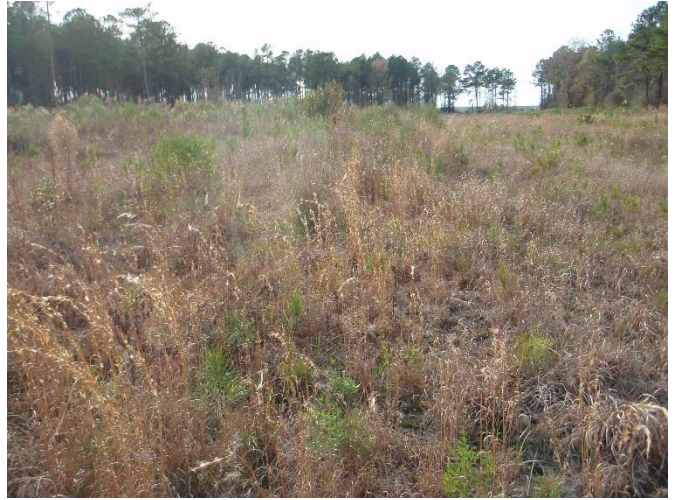
Loblolly Pines on UT2 (Dec. 2017)

Following Year 3 monitoring, loblolly pine (*Pinus taeda*) seedlings were discovered scattered throughout the buffer of Reach UT-2 and a portion of UT-3. To prevent this nuisance species from affecting the planted stems, a thinning and removal effort took place in May of 2017 targeting the loblolly pines. The methods used were hand/power tools and some chemical application. A previous thinning effort had been conducted on UT-2 in March of 2016. During project monitoring work in October 2017, some small pines were still found scattered throughout the Site, but in clearly reduced numbers and sizes. The Site will be closely observed for pine growth throughout the remaining monitoring period. Additionally, a small area of Chinese privet (*Ligustrum sinense*) was treated on the upstream portion of UT-2 in May 2017 as well. The Vegetation Problem Area photolog found in Appendix B provides several before/after photographs of some of the treated areas.

Table 6b. Vegetation Problem Areas St. Clair Creek Restoration Project: DMS Project ID No. 95015				
Feature Issue	Station Number	Suspected Cause	Resolution	Photo Number
Loblolly Pine ( <i>Pinus taeda</i> )	Scattered throughout buffer on UT-2	Post-restoration seed source	Treated in March 2016 - hand/power tools and chemical application	Photos 1-4 in VPA Photolog
			Treated again in May 2017- hand/power tools and chemical application	
Chinese Privet ( <i>Ligustrum sinense</i> )	UT-2: 12+00 to 13+00	Post-restoration seed source	Treated in May 2017- hand/power tools and chemical application	Photos 5-6 in VPA Photolog

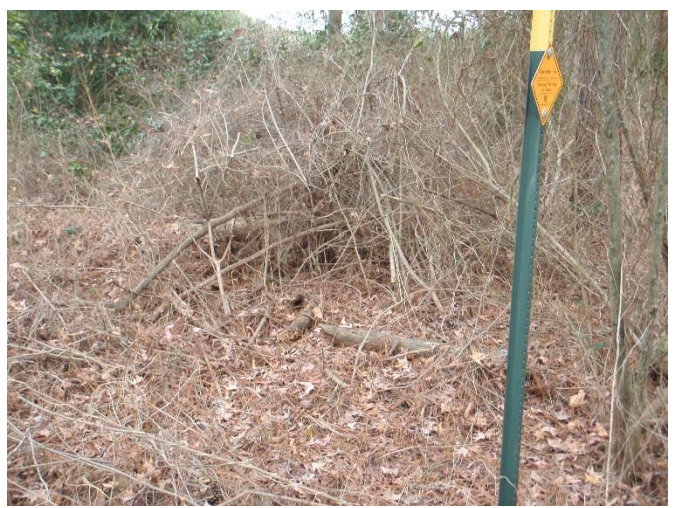
Chinese Privet on UT2 (Dec. 2017)

2 and UT-3, as well as one small portion of Chinese privet on the upstream portion of UT-2. The methods used were hand/power tools and some chemical applications.

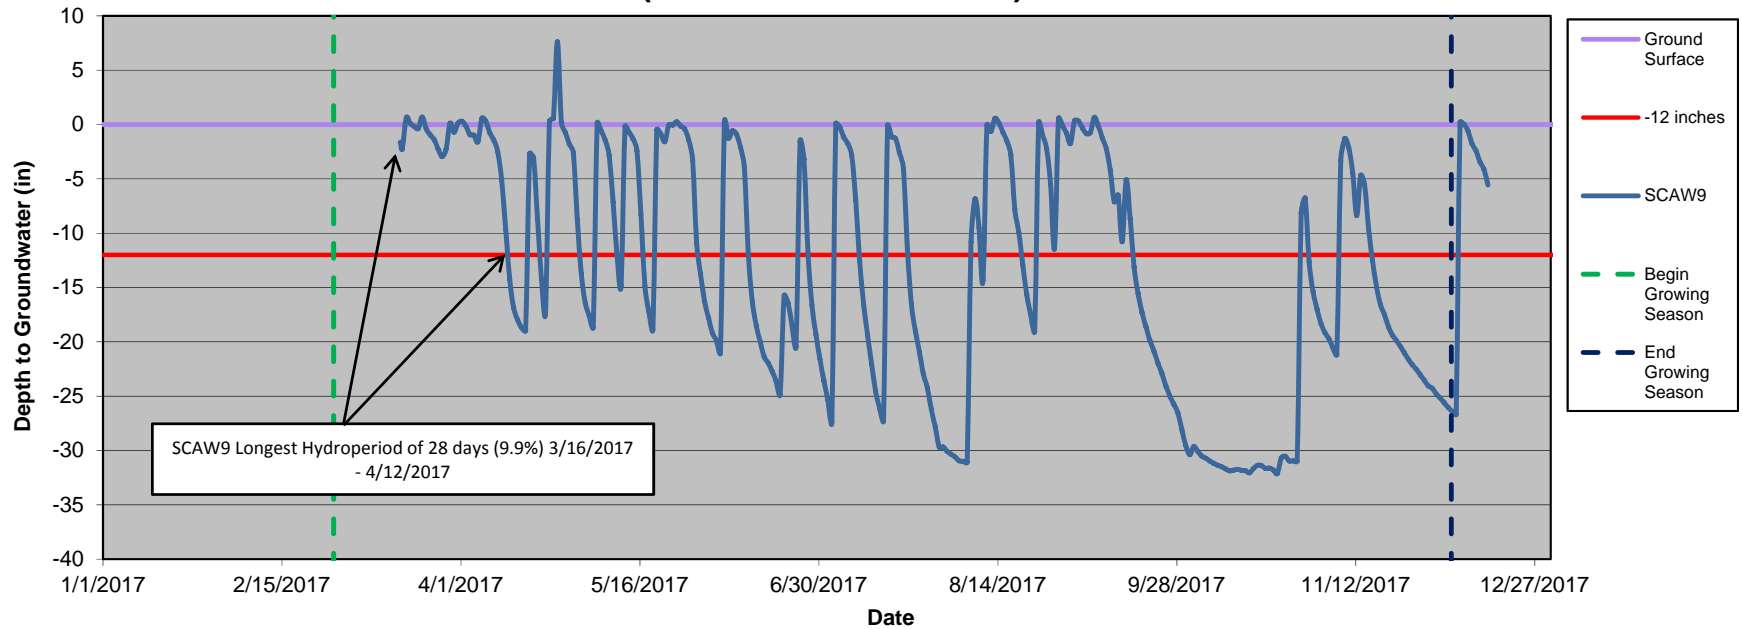
### St. Clair Creek Wetland Restoration Well (UT2) (As-built well - SCAW9)

after the start of the growing season in 2017 but both still achieved 28 days of consecutive groundwater levels within 12 inches of ground surface (for 9.9% of the growing season). It is anticipated they will meet the success criteria in the future.

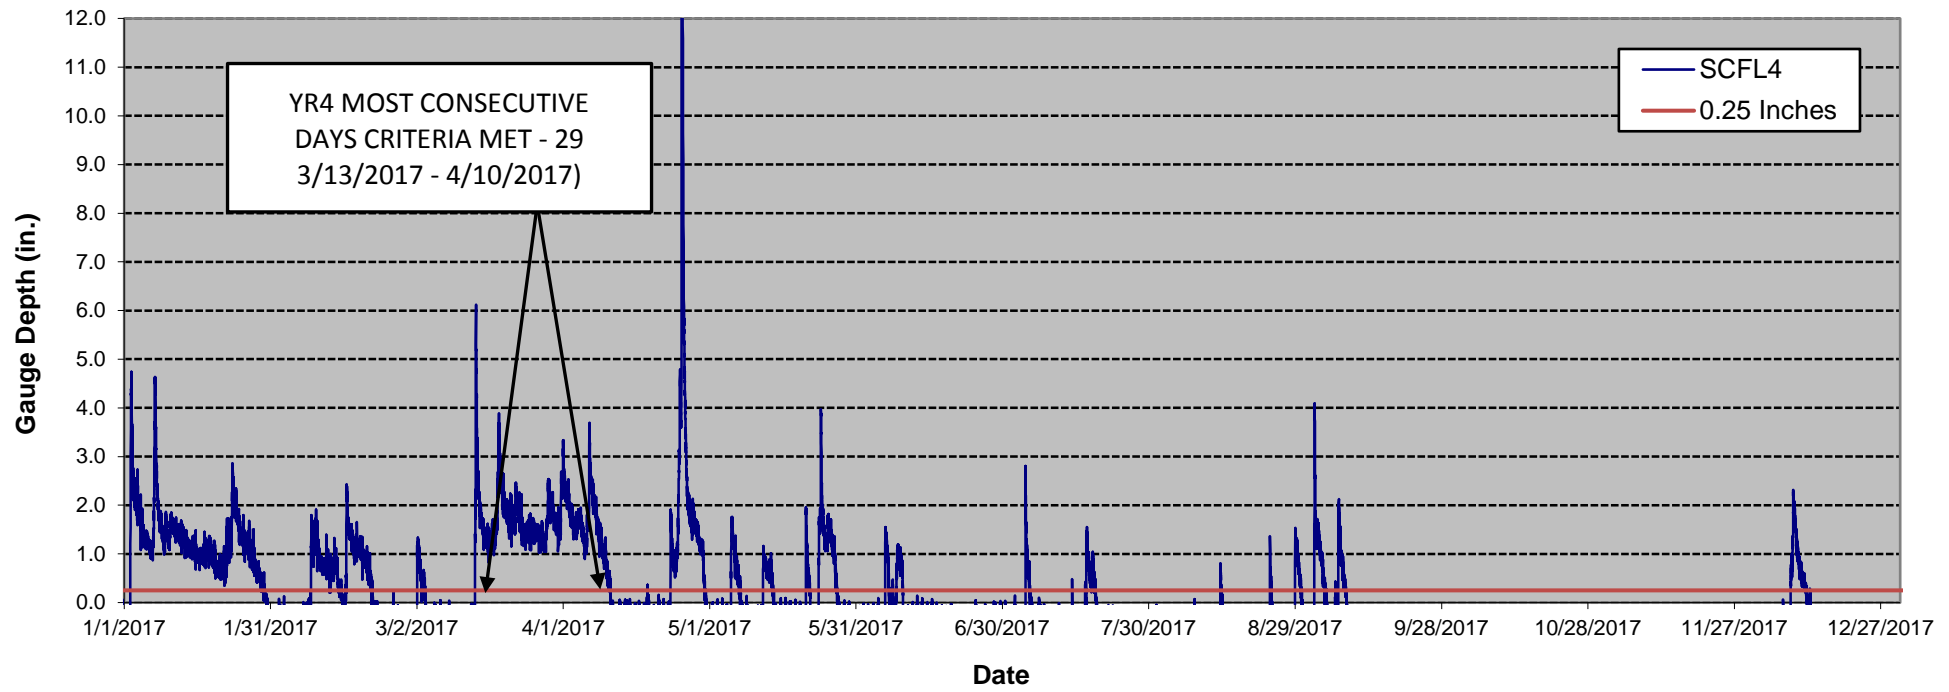
### St. Clair Creek Flow Gauge SCFL4 (Upstream UT2)

**Response: Flow gauge SCFL#4 recorded separate 29-day and 28-day flow events, but did not meet success criteria of 30-days during the year. The overall rainfall for the site was below the Beaufort County historic average with a 1.7" deficit, and all of the flow gauges experienced reduced duration consecutive-day flow events this monitoring year as compared to last year. However, as**

*SCFL4 also recorded a 28-day consecutive flow event in 2017, in addition to the 29-day flow event listed above.														
<b>Success Criteria per St. Clair Creek Mitigation Plan:</b> "A surface water flow event will be considered perennial when the flow duration occurs for a minimum of 30 days. Two surface water flow events must be documented within a five-year monitoring period; otherwise, monitoring will continue for seven years or until two flow events have been documented in separate years. The automated gauges should document the occurrence of extended periods of shallow surface ponding, indicative of flow.."														
Surface water flow is estimated to have occurred when the pressure transducer reading is equal to or above 0.25 inches.

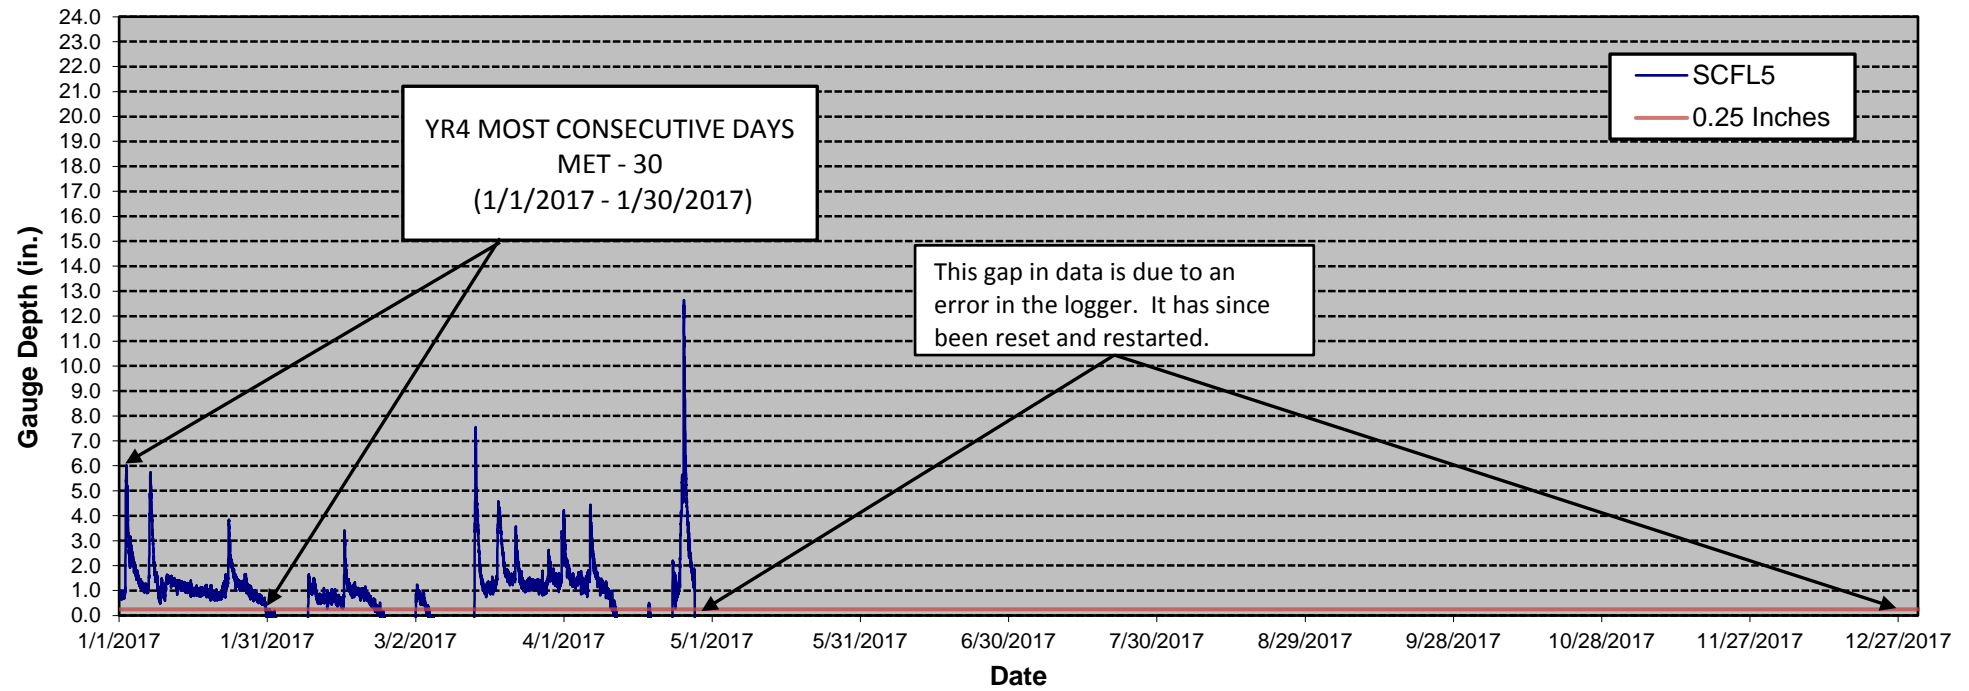
### St. Clair Creek Flow Gauge SCFL5 (Downstream UT3)

Note that flow gauge SCFL#5 located on the bottom of UT-3 did meet the success criteria early in 2017, but experienced a malfunction in early May and did not record data from that point forward. It has since been reprogrammed and reset and is now operating correctly. It will be very closely observed in the coming monitoring year. The complete flow data and observed rainfall graphs for each flow gauge, along with the flow gauge success summary Table 11 are all located in Appendix D.

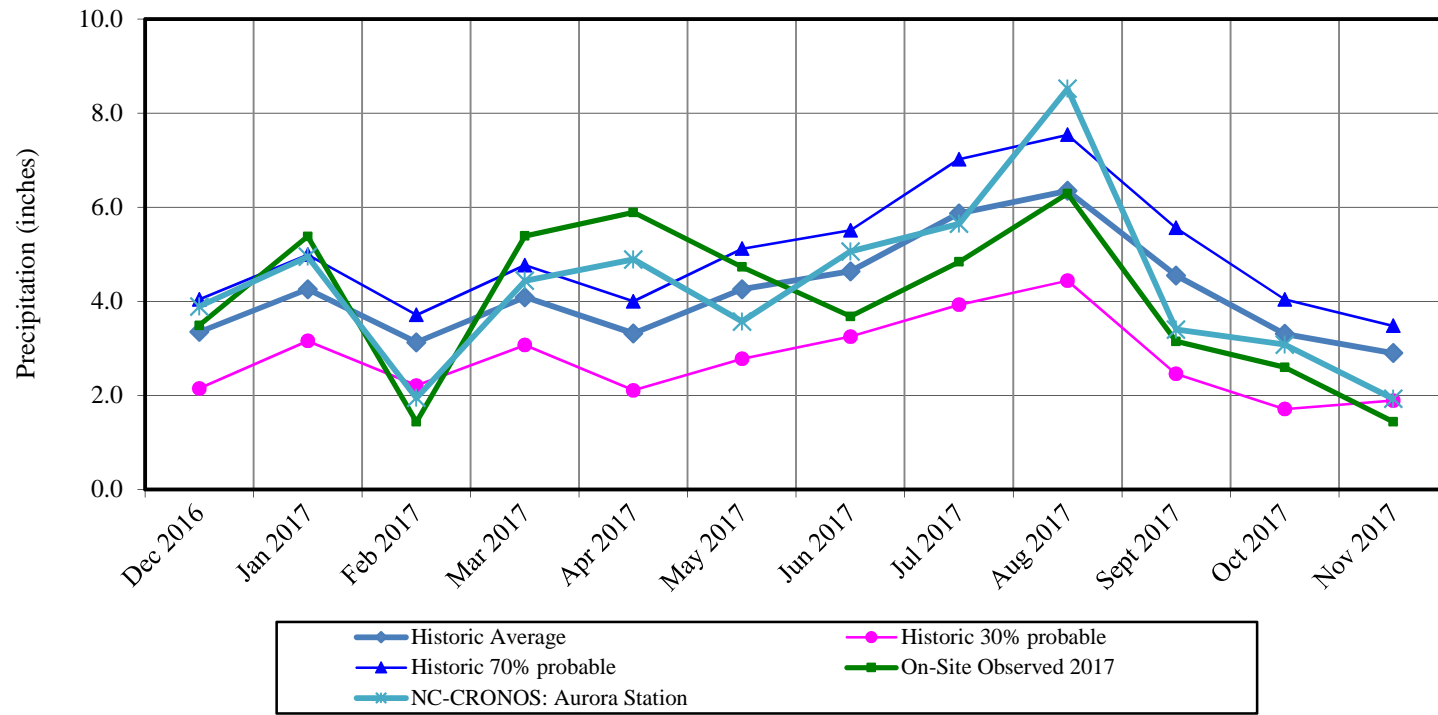
**Figure 5. St. Clair Restoration Project  
DMS Project No. 95015  
Year 4 (2017) Observed Rainfall versus Historic Average**

Note: Beaufort County historic average rainfall is 50.03 in, while observed previous 12 months rainfall total recorded onsite was 48.32 in, a deficit of 1.71 in.
