Mitigation Project Name St. Clair Creek  
 DMS ID 95015  
 River Basin Tar-Pamlico  
 Cataloging Unit 03020104

Subject: Task 11: Response Letter to DMS review comments regarding the Draft Year 5 Monitoring Report for the St. Clair Creek Restoration Project (#95015)  
Beaufort County, North Carolina, Cape Fear Basin – CU#03020104  
DMS No. 95015, Baker No. 125116

# **St. Clair Creek Restoration Project Year 5 FINAL Monitoring Report**

Beaufort County, North Carolina

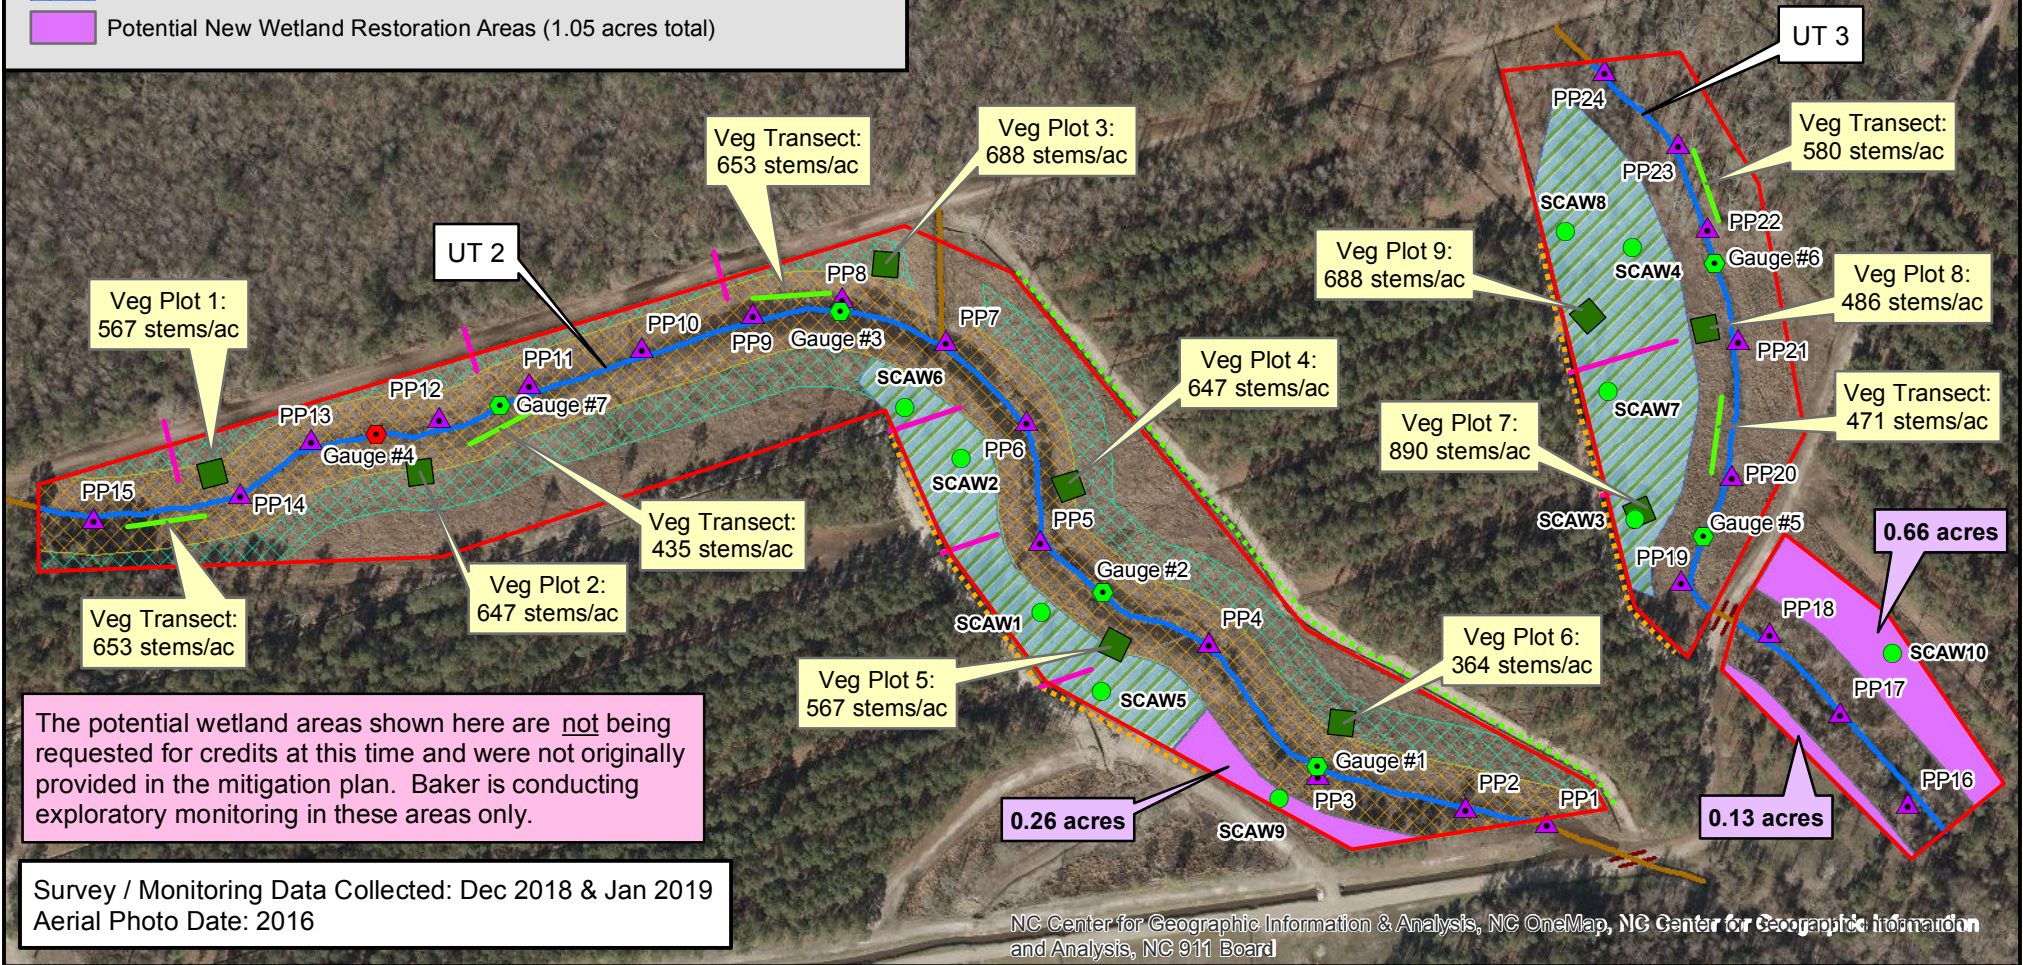
**Figure 2**  
**Current Conditions Plan View: MY5**  
**St. Clair Creek Site**  
**Beaufort County, NC**

5. Appendix B, Figure 2: In the figure included in the hardcopy of the report, the colors denoting Flow Gauge Meeting Criteria and Not Meeting Criteria are the same in both the legend and on the map. Please make sure they are different when the final is submitted. Note: the pdf copy submitted electronically does not have this problem.

The potential wetland areas shown here are **not** being requested for credits at this time and were not originally provided in the mitigation plan. Baker is conducting exploratory monitoring in these areas only.

**Response: We apologize for the misleading and confusing printed color error. This does not appear in our GIS files nor in our pdf copies either and we will make sure that it does not print incorrectly again for the final hardcopies.**

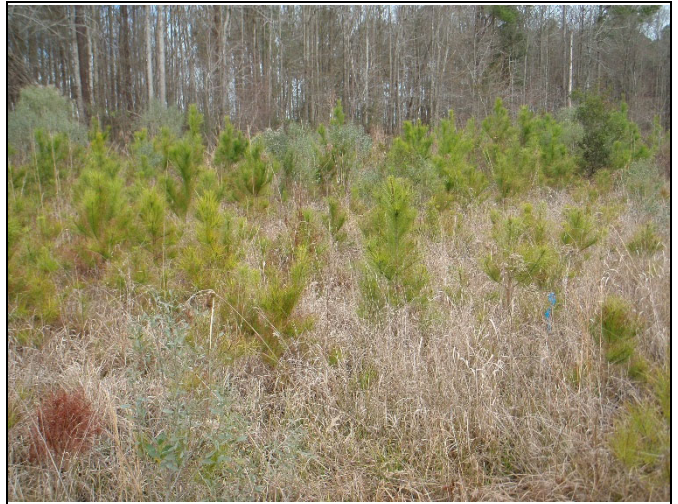
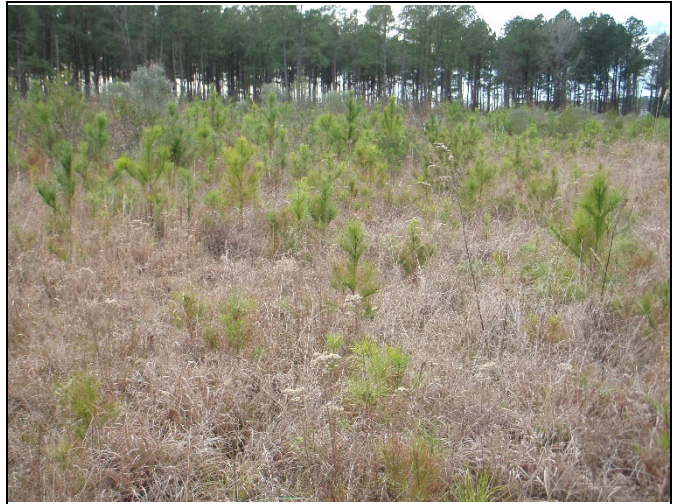
Following Year 5 monitoring, *Pinus taeda* (loblolly pine) seedlings and short saplings were found scattered throughout the riparian buffer of the UT2 restoration area as well as in smaller portions of UT3. It should be noted that the pines do not appear to be suppressing planted species survival or growth as vegetation density appears strong throughout the project, even in areas with pine presence. However, due to IRT concerns, these pines will be treated and heavily thinned during 2019 using hand/power tools and/or chemical applications. The Site will continue to be closely observed for pine growth throughout the remaining monitoring period. Several photographs of the scattered pines can be found in the Vegetation Problem Area Photolog in Appendix B.

Table 6b. Vegetation Problem Areas				
St. Clair Creek Restoration Project: DMS Project ID No. 95015				
Feature Issue	Station Number	Suspected Cause	Resolution	Photo Number
Loblolly Pine ( <i>Pinus taeda</i> )	Scattered throughout buffer on UT-2	Post-restoraton seed source	Will be treated in 2019 with power tools and/or chemical application.	Photos 1-4 in VPA Photolog

Loblolly Pines on UT2

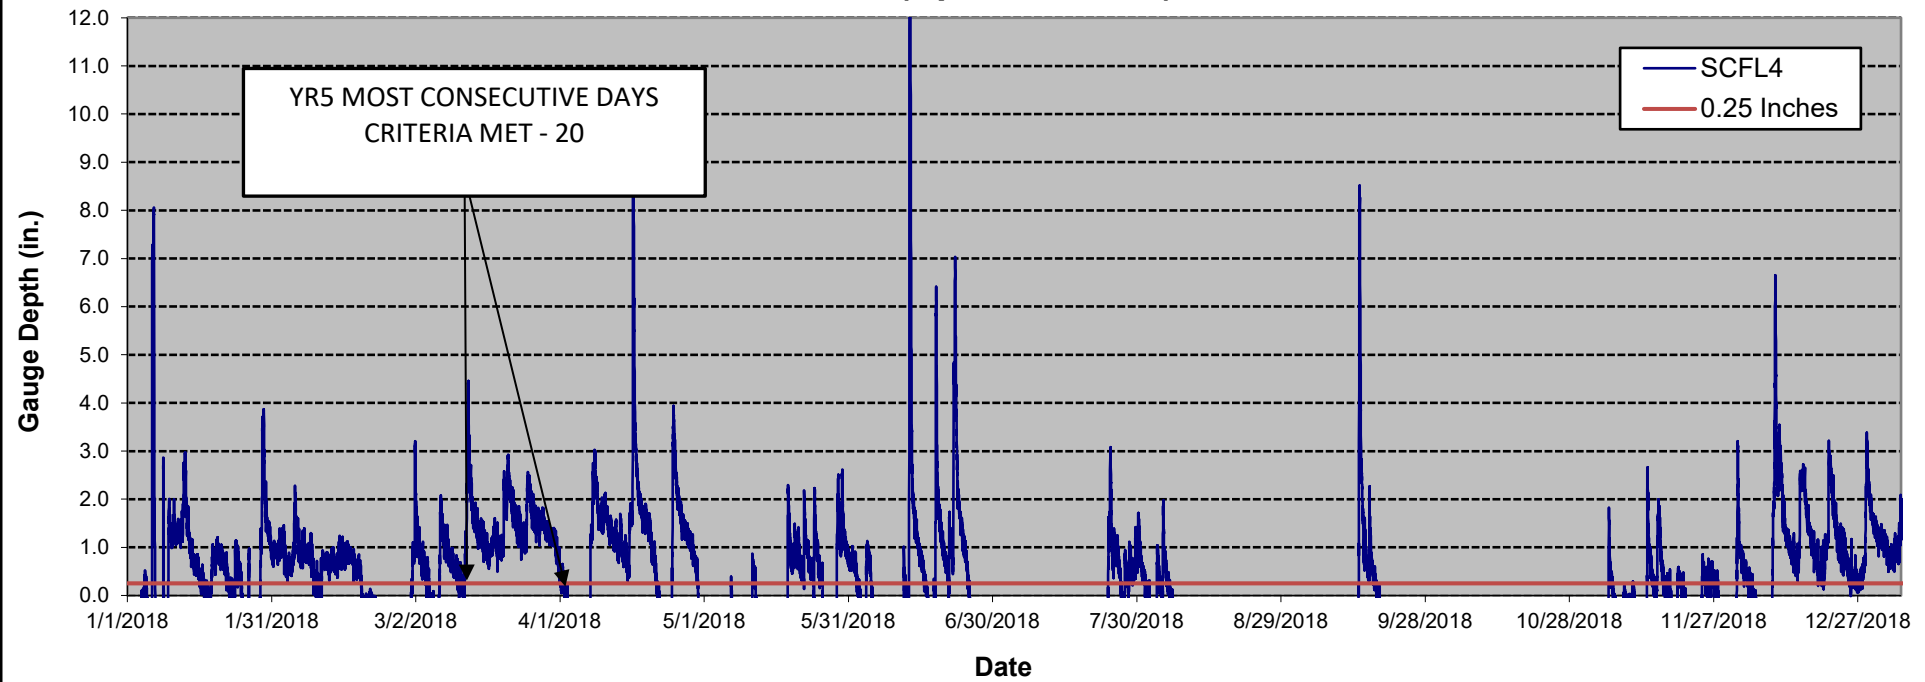
### St. Clair Creek Flow Gauge SCFL4 (Upstream UT2)

3. Section 1.0, page 2 and Section 2.1.1, page 3: The report discusses the failure of flow gauge SCFL#4. This gauge has failed 4 out of 5 monitoring years, though barely missing the 30 consecutive days of flow requirement in Year 4 (29 days). Based on this, DMS has the following comments/concerns:

- a. Clarify reason/potential reason for flow gauge SCFL#4 not meeting 30 consecutive days of flow requirements, especially given that this area was impacted by two hurricanes and a wetter than normal summer and fall. Baker needs to be prepared to discuss at the upcoming credit release meeting.

**Response: Baker certainly understands the concern from not meeting the success criteria during such an overall wet year, but the flow gauges on site have always met the criteria in the late winter to early spring when the water table is highest and is contributing some base flow that is supplemented with the rain. In the summer and through the fall, the evapotranspiration rates are very high, the water table plummets, and there is no base flow present – it’s all rainfall driven. And it is difficult to achieve 30-days continuous flow on just rainfall alone. So all of the rain from this past fall and winter did not actually contribute much to the continuous flow requirement. Because of that rain we did observe more *total* days of flow on site, just not continuous and unbroken flow. Hurricane Matthew also dropped an extreme amount of rain on site in 2016 without triggering 30-days of continuous flow. Yet all flow gauges on site did meet the criteria earlier that same year in the winter/spring with a high water table and modest rainfall.**

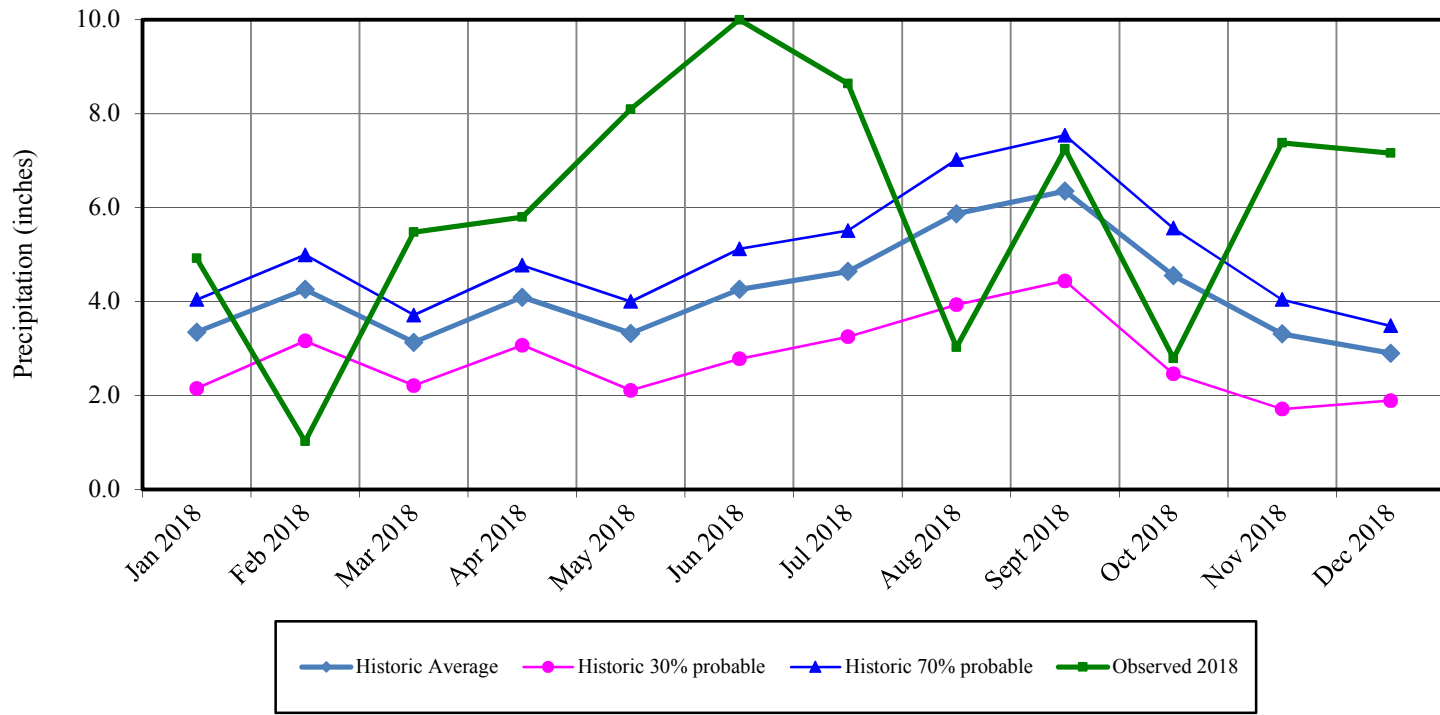
**Figure 5. Observed Rainfall versus Historic Average  
St. Clair Restoration Project (DMS No. 95015) MY5 2018**

Total observed area rainfall for the previous 12-month period from January 2018 to December 2018 was 70.57 inches, as compared to the Beaufort County WETS table for the same period of 50.03 inches annually, an annual excess of 20.54 inches (see Figure 5 in Appendix D).

Note: Beaufort County historic average rainfall is 50.03 in, while observed previous 12 months rainfall total recorded onsite was 70.57 in, an excess of 20.54 in.
