| Mitigation Project Name | St Clair Creek Restoration Project | USACE Action ID | 2008-02655 |

Figure 2
Current Conditions Plan View: MY7
St. Clair Creek Site
Beaufort County, NC

**Figure 5. Observed Rainfall versus Historic Average
St. Clair Restoration Project (DMS No. 95015) MY7 2020**

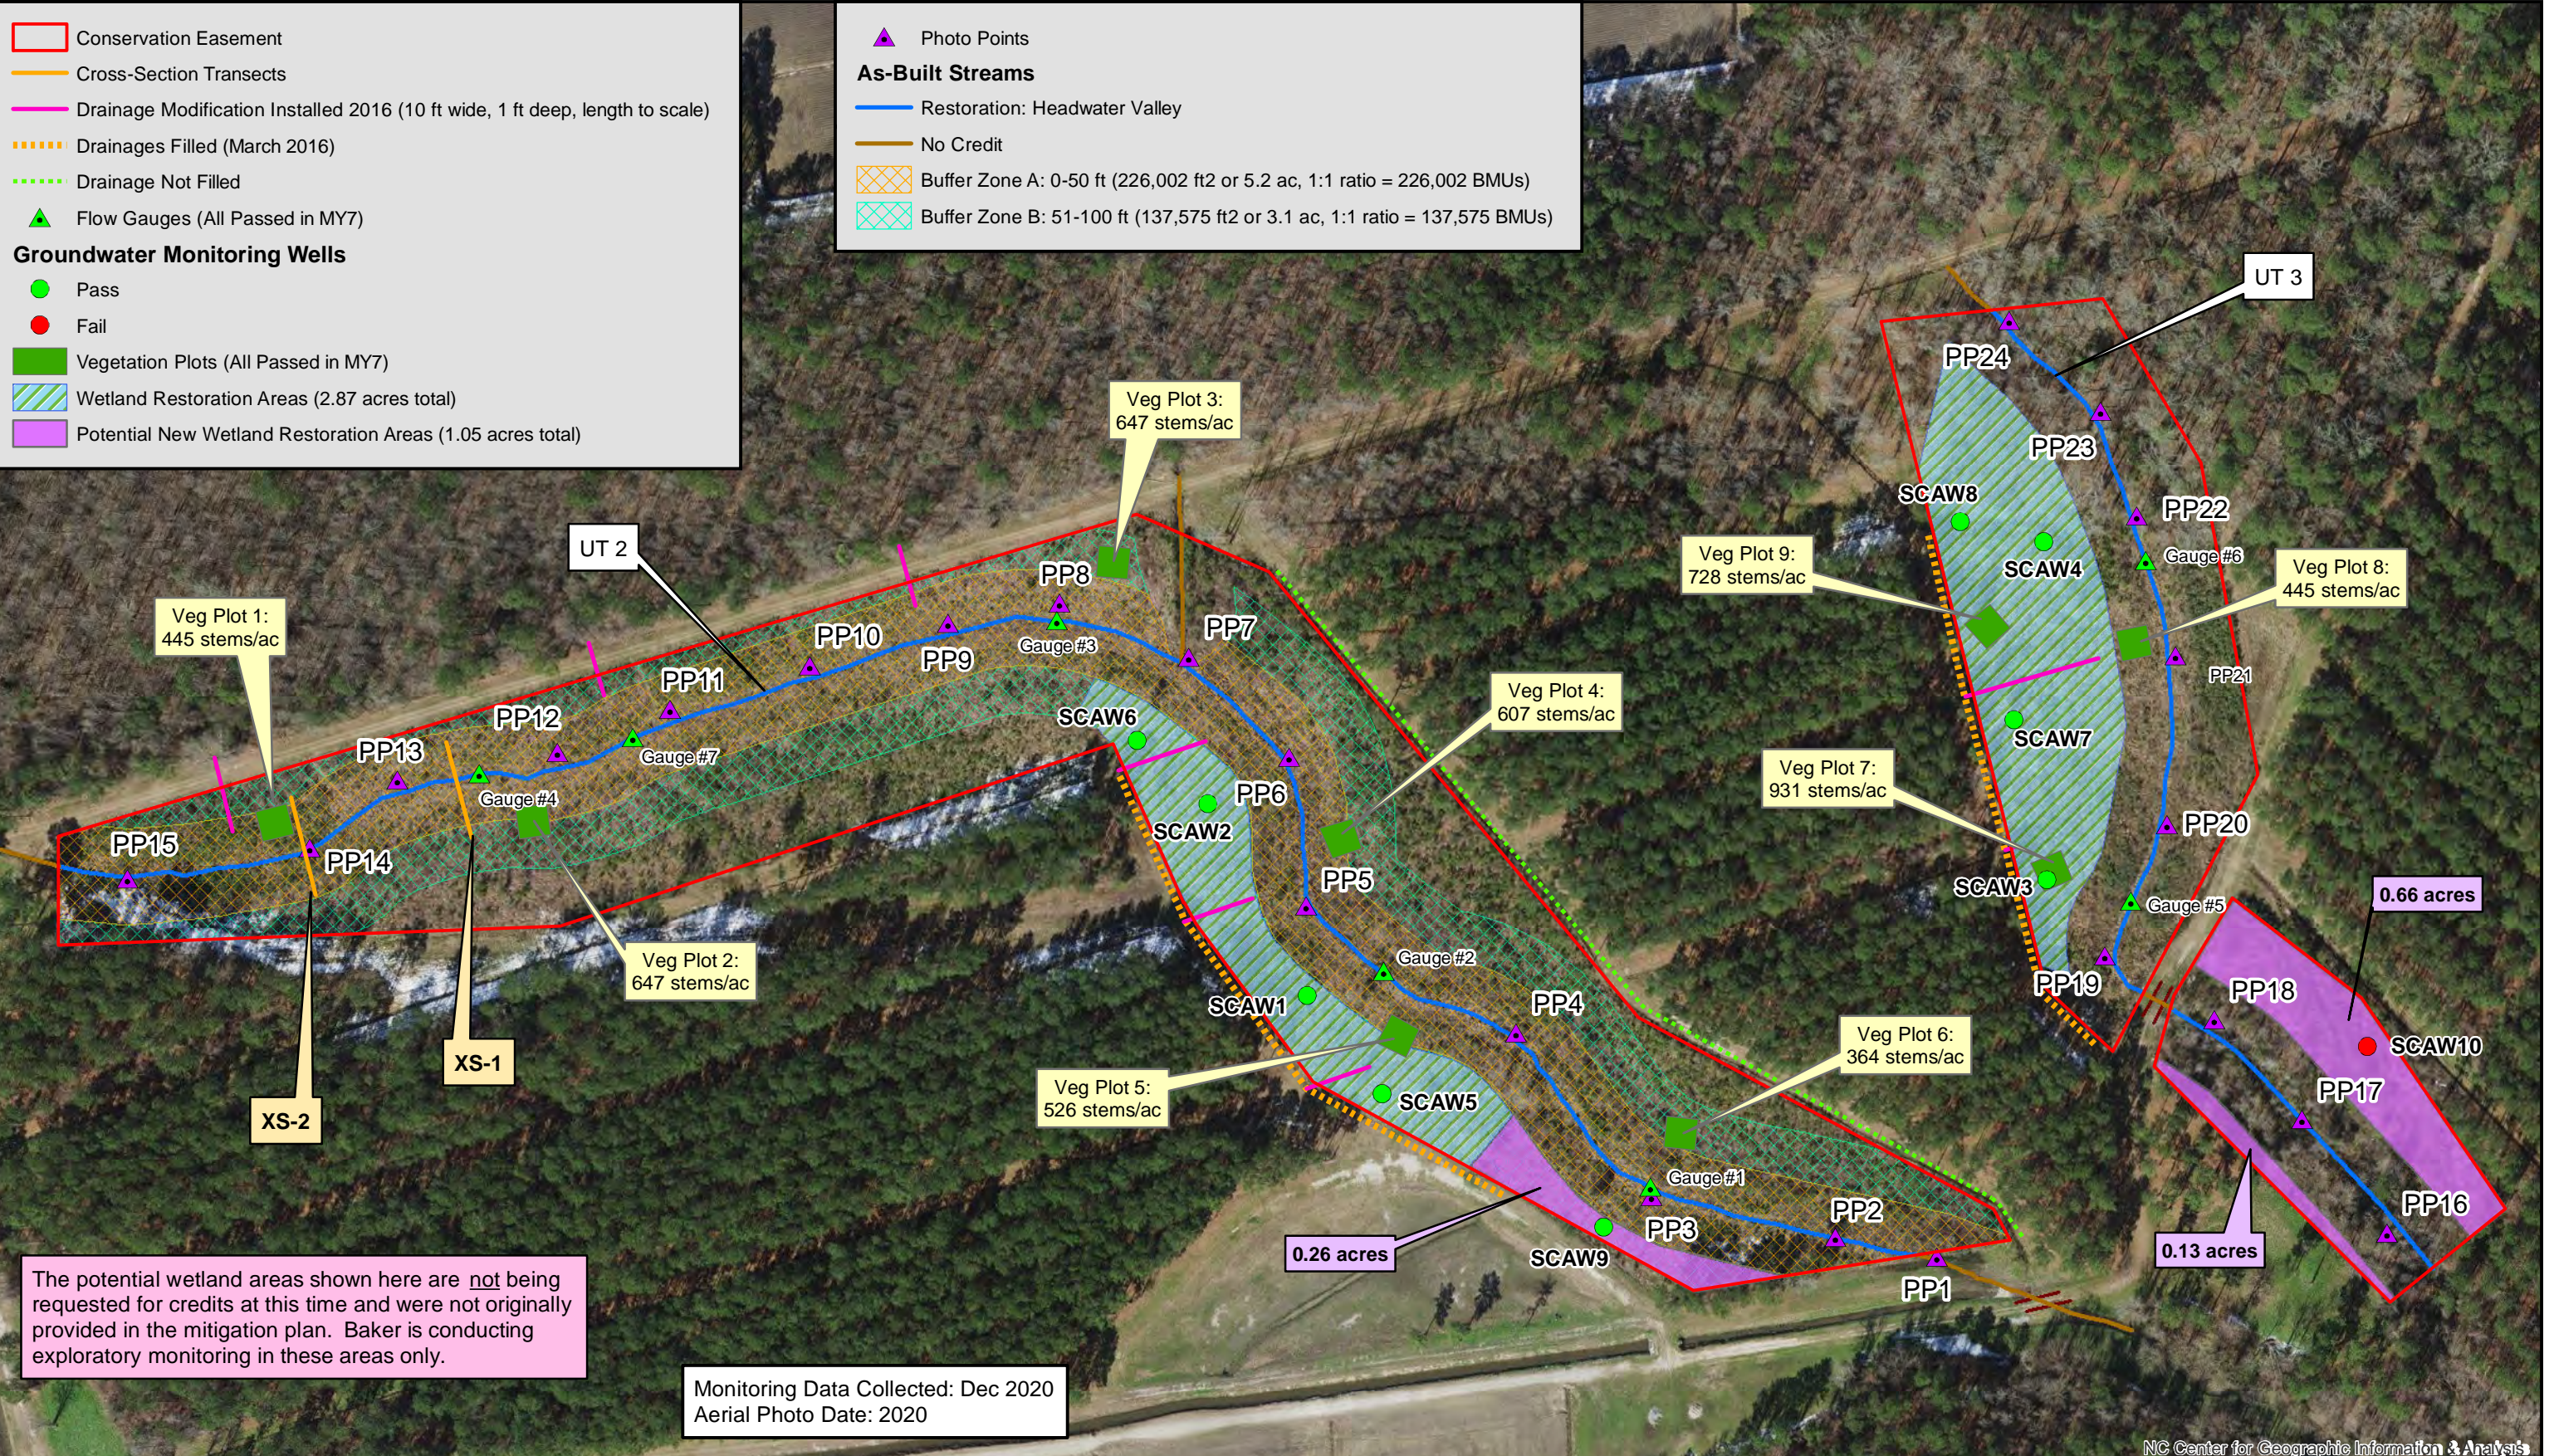
It was observed during the Year 7 monitoring that diffuse flow does move through all of the installed swales, and all remain stable and vegetated. Additional groundwater monitoring wells 5-8 were installed in April of 2016 specifically to observe the wetland restoration areas potentially affected by these modifications. The locations of this previous work are provided in Figure 2 in Appendix B.

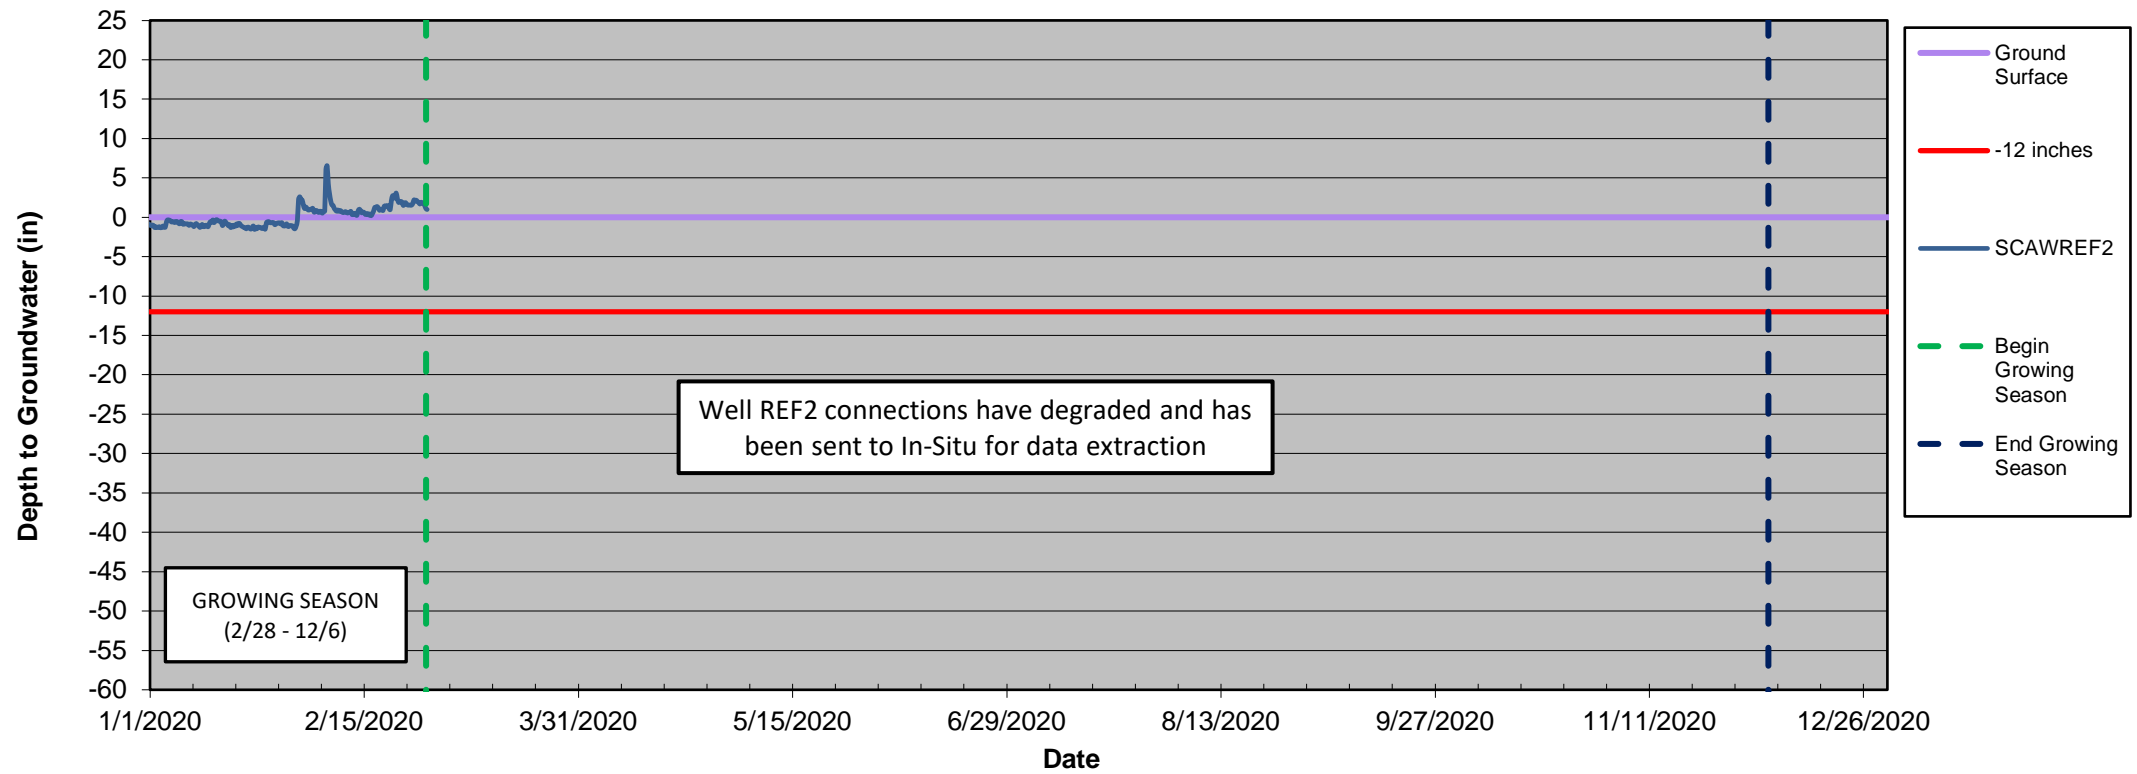
St. Clair Creek Wetland Reference Well (UT3) (REF2)

Additionally, during Year 7 monitoring, the connection pins on the wetland reference well SCAWREF2 degraded to the point where Baker was unable to connect and download the device. It has been sent to the manufacturer (In-Situ) for their processing.

**REF2 well gauge connections have degraded and it has been sent to In-Situ for additional MY7 data retrieval. A new gauge will be installed in the winter of 2021.

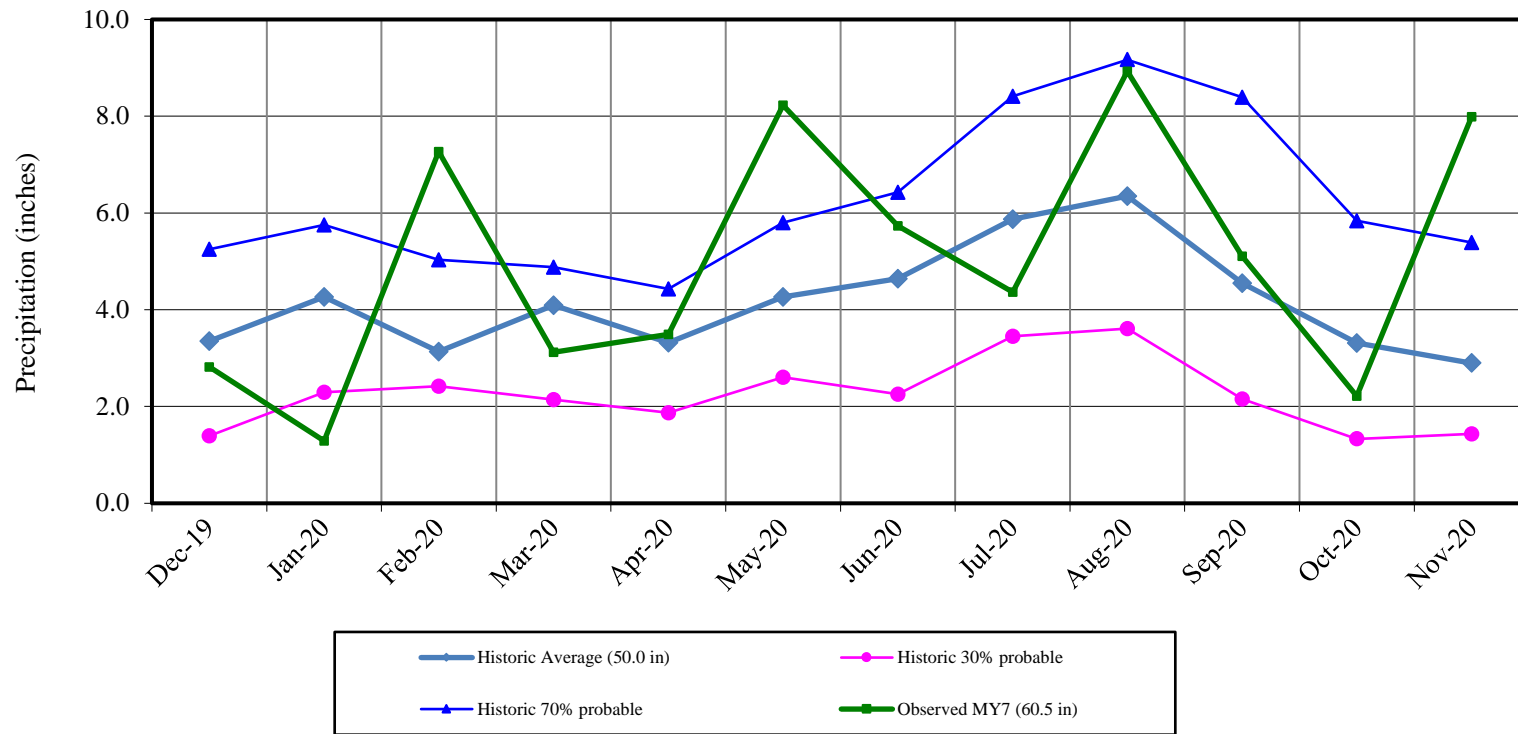
Total observed area rainfall for the previous 12-month period from December 2019 through November 2020 was 60.5 inches, as compared to the Beaufort County WETS table for the same period of 50.0 inches annually (see Figure 5 in Appendix D).

Note: Beaufort County historic average rainfall is 50.0 in, while observed previous 12 months rainfall total recorded onsite was 60.5 in.

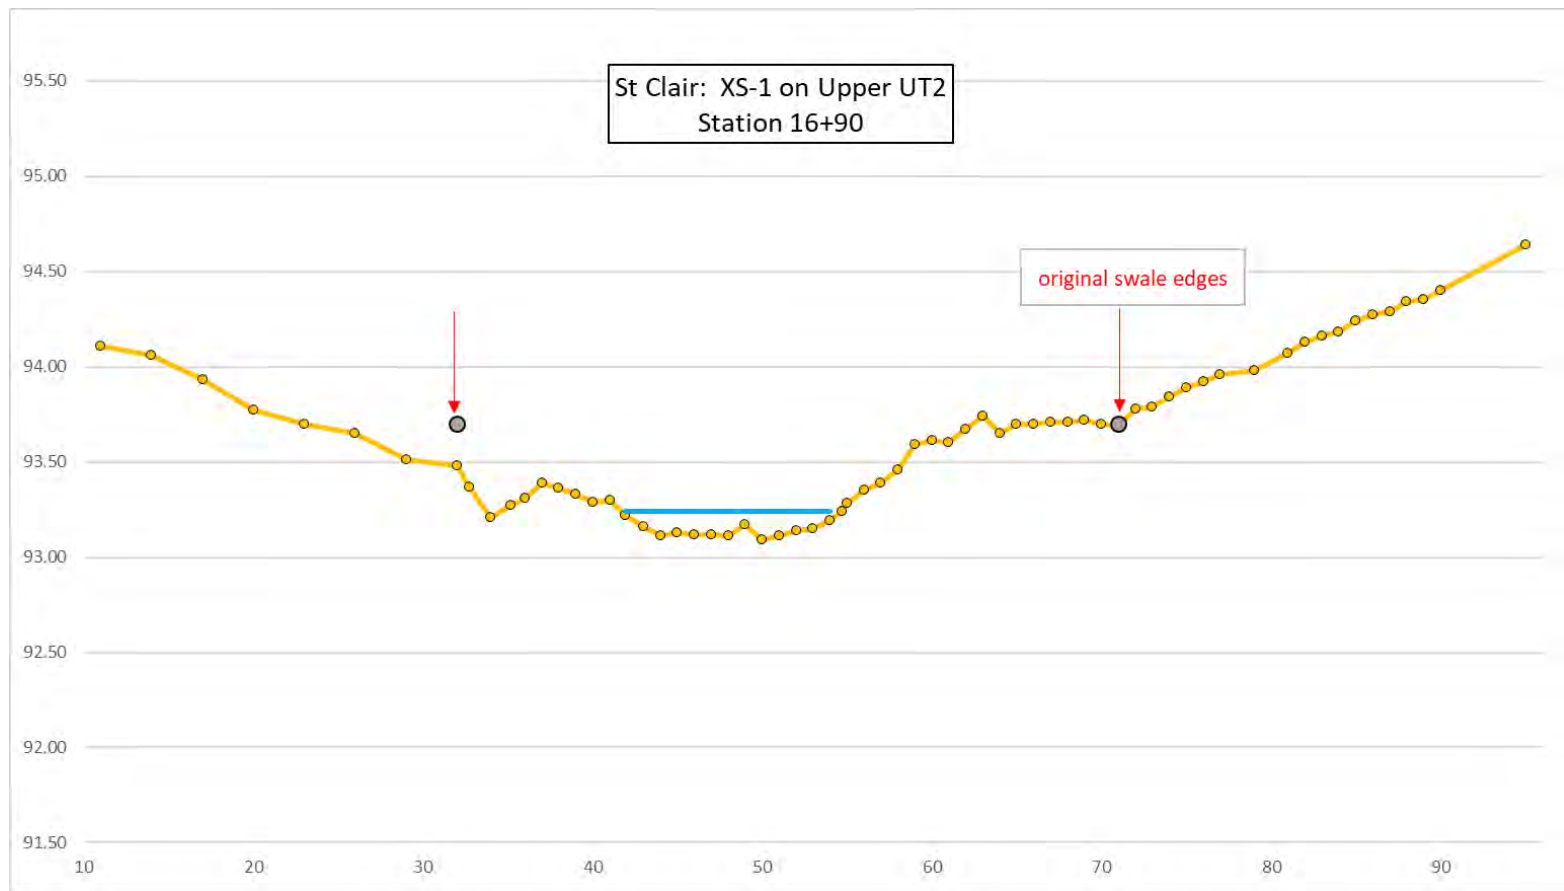
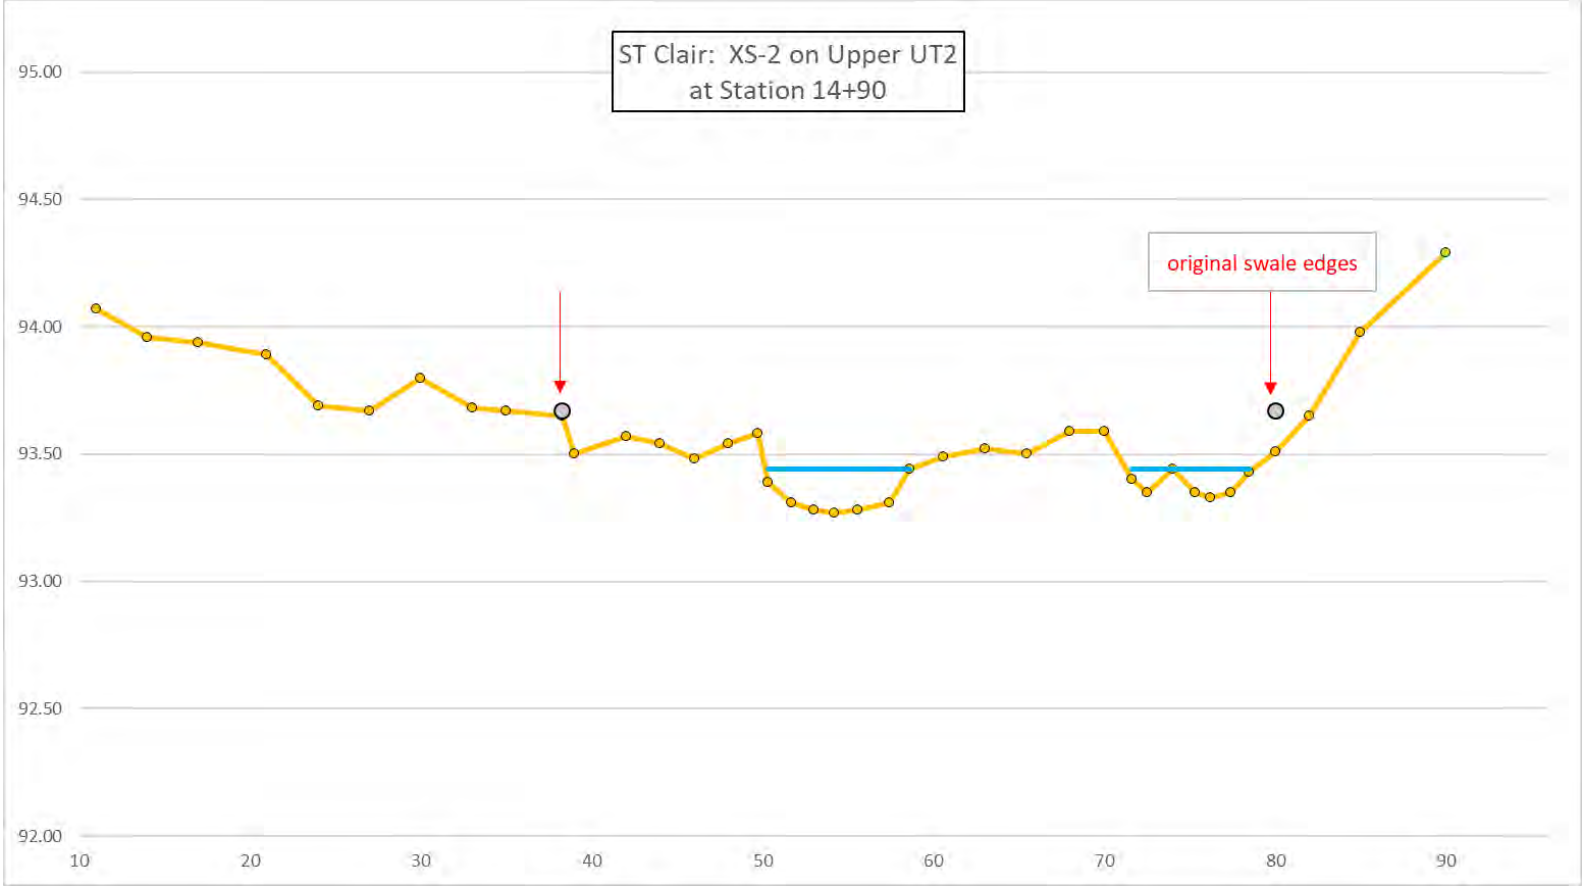
St Clair Cross Sections (collected 5/1/20):

The entire reach is seasonally thick with herbaceous vegetation, which serves to mask both the presence of water in the reach in photographs as well as the development of a threaded channel system. Even during field inspections it can be difficult to discern the level of scour and channel formation present in the reach. As such, Baker took two cross-section transects in the upper portion of UT2 on May 1, 2020 to better illustrate the current conditions in these locations.

Please find attached the results of these cross-sections. They reveal the presence of a distinct multi-thread channel with shallow water present in the two primary threads at the time of the survey in the upper transect, and larger channel development with shallow water present in the lower transect. Both transects show signs of channel scour and evolution, with rough, irregular rutting and scour found all across the transects, even along the relatively gentle adjacent side slopes draining into the channel.
