Monitoring Year 4 FINAL Monitoring Report
Stewarts Creek Tributaries Stream Restoration Project
Surry County, North Carolina
Yadkin River Basin, Hydrologic Unit Code (HUC) 03040101

May, September 2023 – November 2023

December 2023

NCDEQ Contract No. 7183
DMS ID No. 100023
RFP#16-006993 (Issued 9/16/2016)
USACE Action ID No. SAW-2017-01508
DWR ID No. 20171043

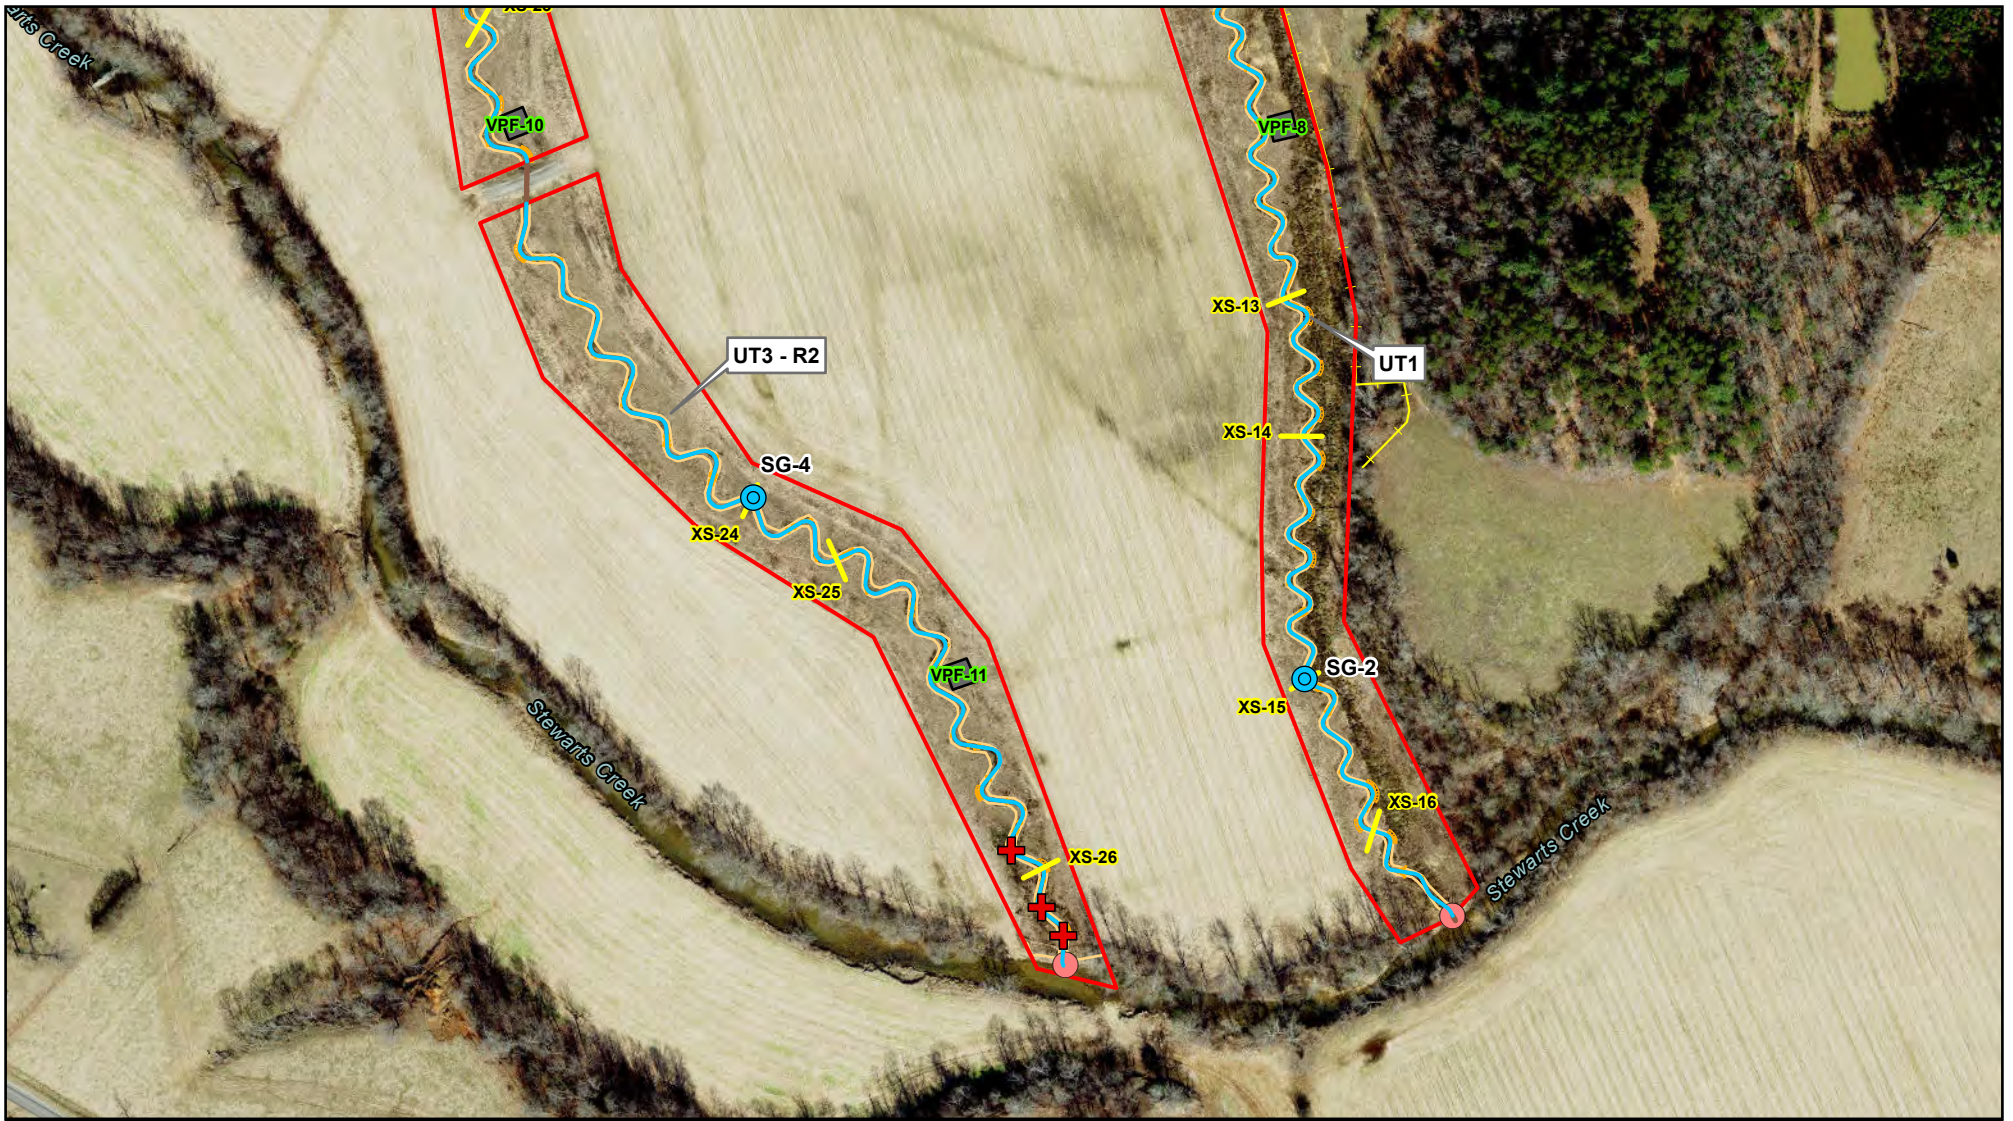
**STEWARTS CREEK TRIBUTARIES
 STREAM RESTORATION PROJECT**
 CURRENT CONDITION PLAN VIEW: ASSET MAP
 MY4: 2023

While visually assessing the site during MY4, 3 beaver dams were found on the lower end of UT3 Reach 2, as shown in the CCPV (Figure 1C). They were removed and the channel was cleared. No damage was done to the stream bed or banks. A trapping specialist from the USDA APHIS program was contacted and inspected the site. After revisiting the site in the following weeks, the specialist confirmed that these beaver dams were inactive and he suspected the animals were no longer in the area. EPR will continue to visually inspect these areas and take further action if more beaver dams are found in MY5.

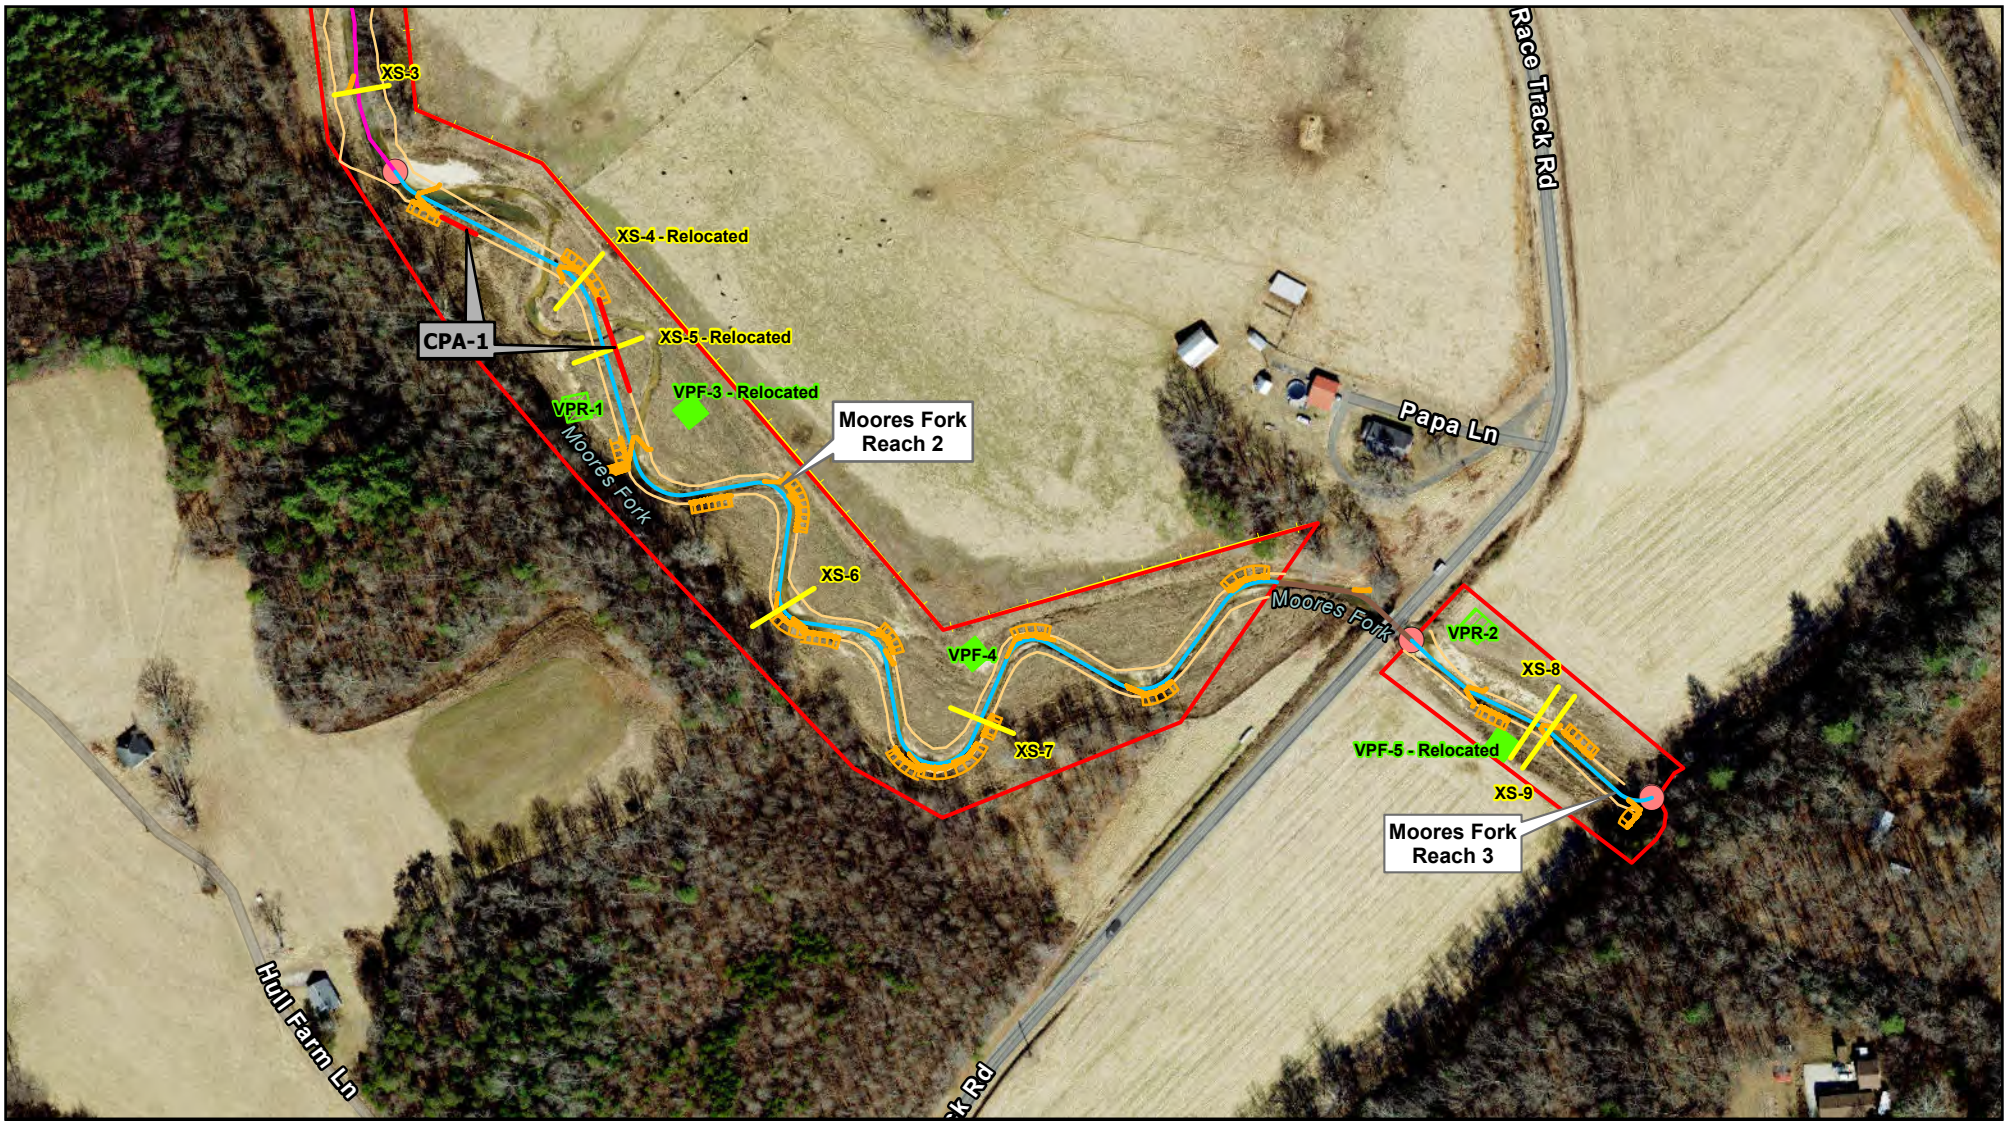
**STEWARTS CREEK TRIBUTARIES
 STREAM RESTORATION PROJECT**
 CURRENT CONDITION PLAN VIEW: ASSET MAP
 MY4: 2023

2023-2024. The Channel Problem Area (CPA1) is shown in the CCPV (Figure 1E). The stream bed and banks shown in cross section 7 have remained stable since the MY3 repairs. Cross section 6 follows a similar pattern to XS 7. It has remained stable and only had minor adjustments. Cross section 8 has had no adjustment since construction with similar dimensions to the as-built design. Cross section 9 has remained stable since MY1. It is directly below a rock vane structure that acts as grade control and bank stability. Over the course of the monitoring year, EPR will continue to monitor the cross sections to ensure that they are stable and functioning. No other cross sections were surveyed in MY4, and cross section monitoring will resume in MY5. The cross-section plots, photos, and data summary are included in Appendix C.

The only area of channel instability noted in MY4 is the previously mentioned CPA-1, located within the upstream repaired section of Moores Fork Reach 2. The problem area is two separate sections of bank toe erosion, an upstream section on the right bank (50') and a downstream section on the left bank (125'). In both sections, where toe wood was installed as part of the 2022 AMP, the section of streambank immediately downstream of the toe wood eroded immediately after construction was complete but before vegetation had a chance to establish. These areas have been monitored throughout 2023 and have not worsened since the initial event. EPR is planning to reshape the stream channel and install additional toe wood through both of these sections in winter 2023-2024 to match the intended design from the 2022 AMP. No cross sections or vegetation plots will be relocated by these repairs, and as little vegetation will be disturbed as possible. Any disturbed areas will be reseeded and planted with bare root trees from the approved AMP planting list.
