**Monitoring Year 1 FINAL Monitoring Report**  
**Stewarts Creek Tributaries Stream Restoration Project**  
**Surry County, North Carolina**  
**Yadkin River Basin, Hydrologic Unit Code (HUC) 03040101**

**Data Collection Period:**  
September 2020 – November 2020

**Submission Date:**  
December 2020

**Ecosystem Planning and Restoration**  
1150 SE Maynard Road, Suite 140  
Cary, NC 27511

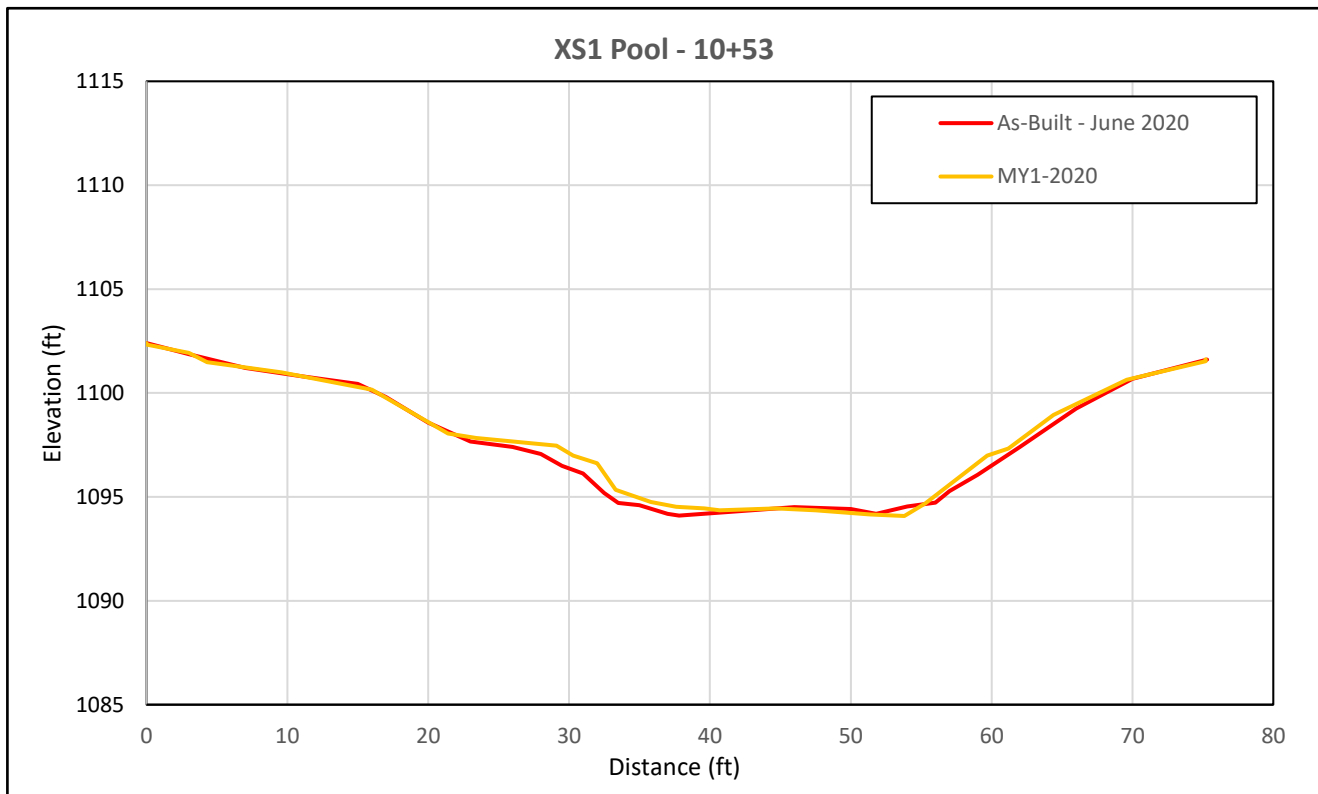
### Cross Section Plot - MY1 - October 2020

MY0	MY1	MY2	MY3	MY4	MY5	MY+
Bankfull Elevation - Based on AB Bankfull Area	1097.06	1097.29					
Bank Height Ratio - Based on AB-Bankfull Area	1.20	1.05					
Thalweg Elevation	1094.10	1094.08					
LTOB Elevation	1097.67	1097.46					
LTOB Max Depth	3.57	3.38					
LTOB Cross Sectional Area	93.76	77.33					
Entrenchment Ratio	N/A	N/A

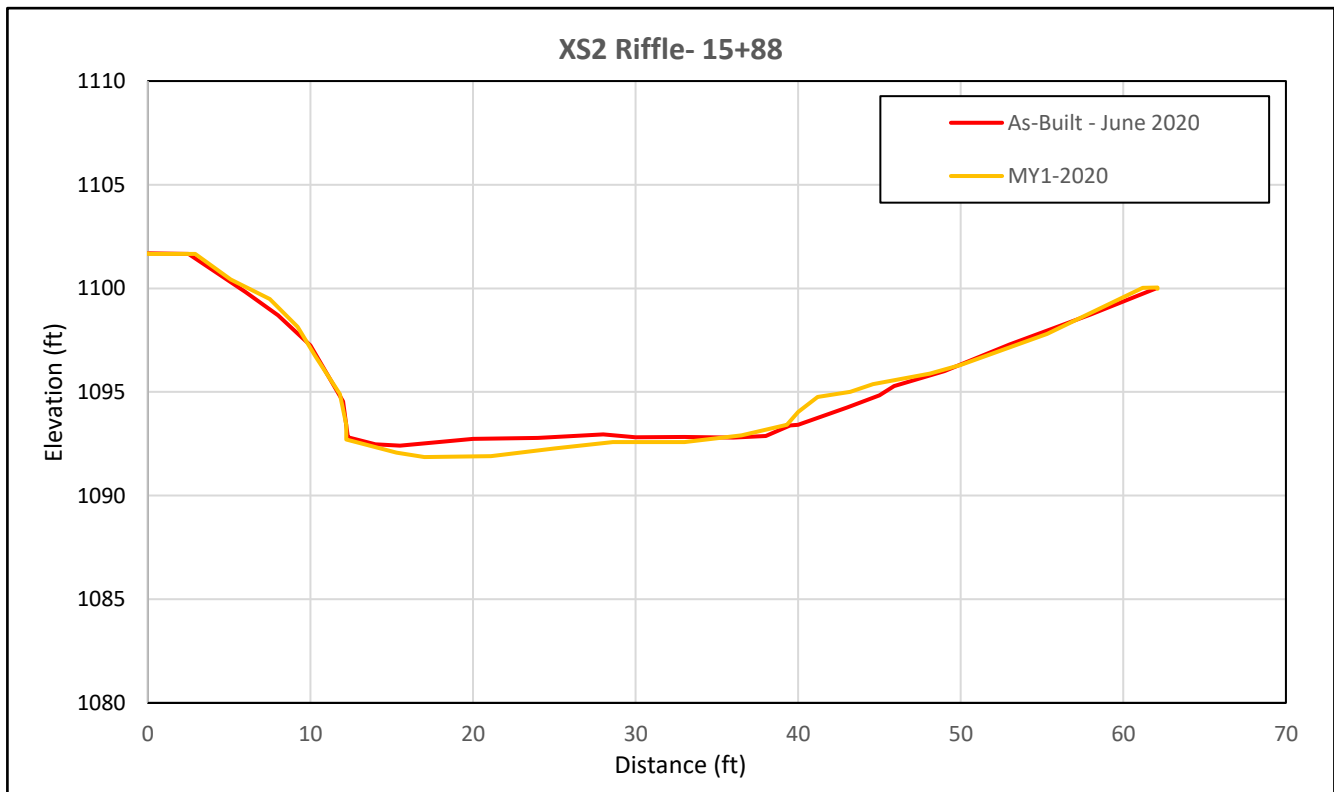
### Cross Section Plot - MY1 - October 2020

MY0	MY1	MY2	MY3	MY4	MY5	MY+
Bankfull Elevation - Based on AB Bankfull Area	1094.84	1094.64					
Bank Height Ratio - Based on AB-Bankfull Area	1.18	1.04					
Thalweg Elevation	1092.41	1091.86					
LTOB Elevation	1095.28	1094.76					
LTOB Max Depth	2.87	2.90					
LTOB Cross Sectional Area	75.98	65.20					
Entrenchment Ratio	1.29	1.54

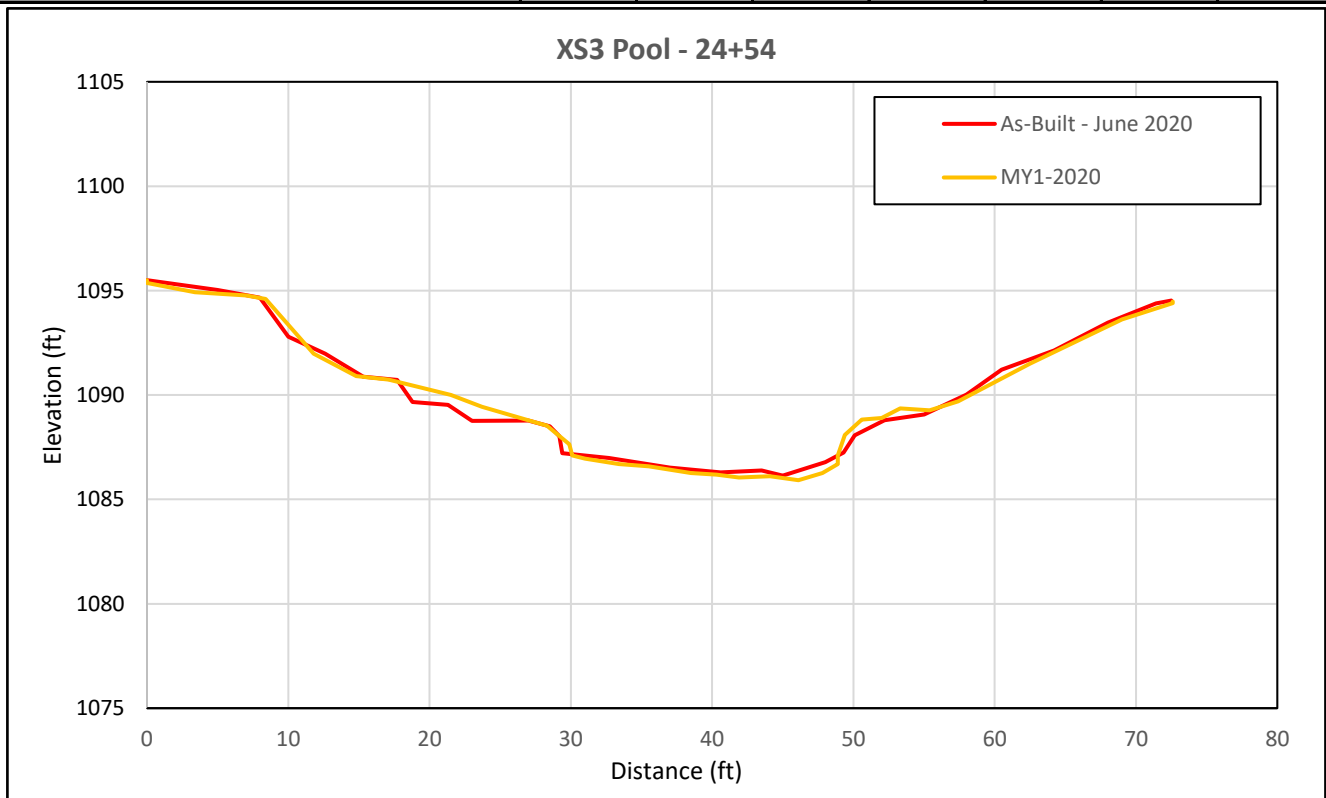
### Cross Section Plot - MY1 - October 2020

MY0	MY1	MY2	MY3	MY4	MY5	MY+
Bankfull Elevation - Based on AB Bankfull Area	1088.77	1088.67					
Bank Height Ratio - Based on AB-Bankfull Area	1.00	1.06					
Thalweg Elevation	1086.14	1085.92					
LTOB Elevation	1088.77	1088.82					
LTOB Max Depth	2.63	2.90					
LTOB Cross Sectional Area	45.04	48.74					
Entrenchment Ratio	N/A	N/A

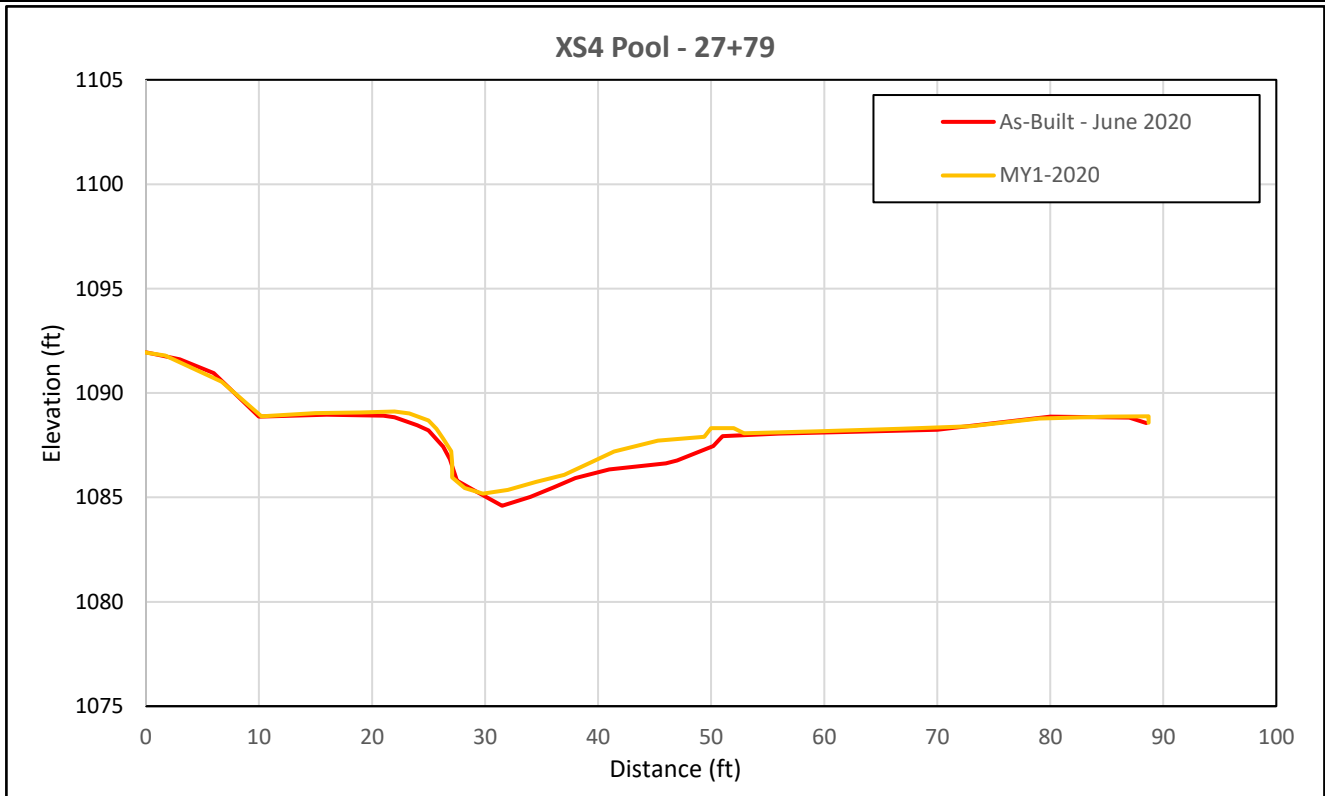
### Cross Section Plot - MY1 - October 2020

MY0	MY1	MY2	MY3	MY4	MY5	MY+
Bankfull Elevation - Based on AB Bankfull Area	1087.94	1088.59					
Bank Height Ratio - Based on AB-Bankfull Area	1.00	0.80					
Thalweg Elevation	1084.60	1085.18					
LTOB Elevation	1087.94	1087.91					
LTOB Max Depth	3.34	2.73					
LTOB Cross Sectional Area	47.12	31.39					
Entrenchment Ratio	N/A	N/A

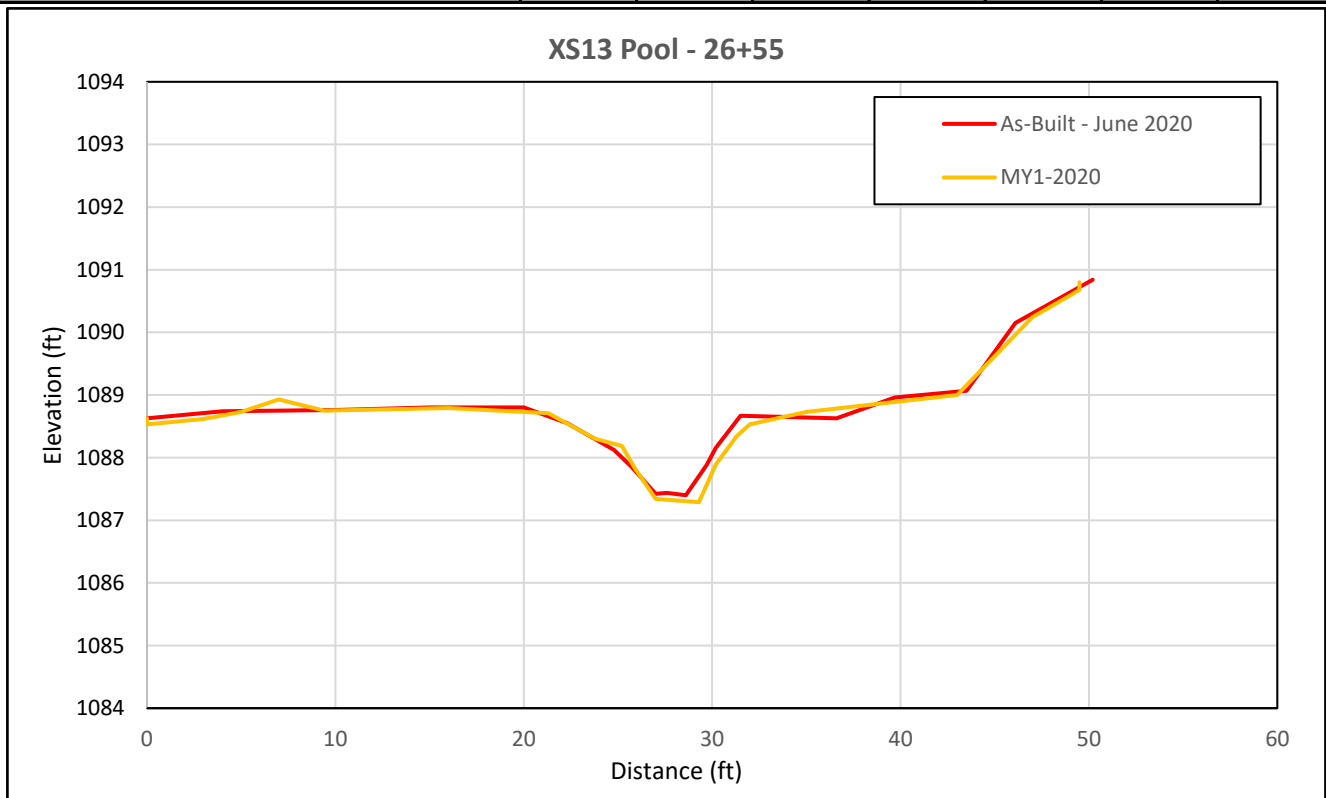
### Cross Section Plot - MY1 - October 2020

MY0	MY1	MY2	MY3	MY4	MY5	MY+
Bankfull Elevation - Based on AB Bankfull Area	1088.55	1088.46					
Bank Height Ratio - Based on AB-Bankfull Area	1.10	1.23					
Thalweg Elevation	1087.40	1087.29					
LTOB Elevation	1088.67	1088.73					
LTOB Max Depth	1.27	1.44					
LTOB Cross Sectional Area	6.64	8.60					
Entrenchment Ratio	N/A	N/A
