**Monitoring Year 3 FINAL Monitoring Report**  
**Stewarts Creek Tributaries Stream Restoration Project**  
**Surry County, North Carolina**  
**Yadkin River Basin, Hydrologic Unit Code (HUC) 03040101**

**Data Collection Period:**  
October 2022 – January 2023

**Submission Date:**  
February 2023

NCDEQ Contract No. 7183  
DMS ID No. 100023  
RFP# 16-006993 (Issued 9/16/2016)  
USACE Action ID No. SAW-2017-01508  
DWR ID No. 20171043

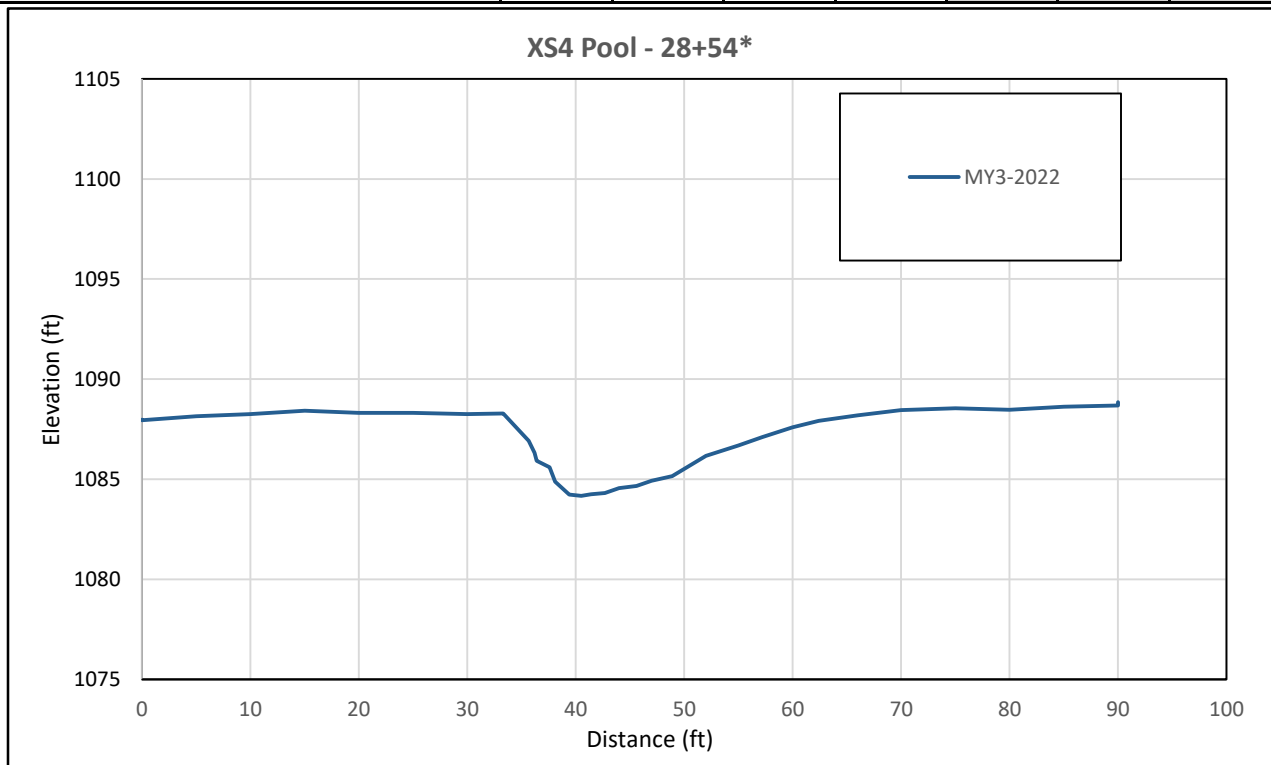
\* Stationing from AMP. The cross section location was relocated and stationing has been updated. MY0 through MY2 data not applicable due to the cross section being relocated.

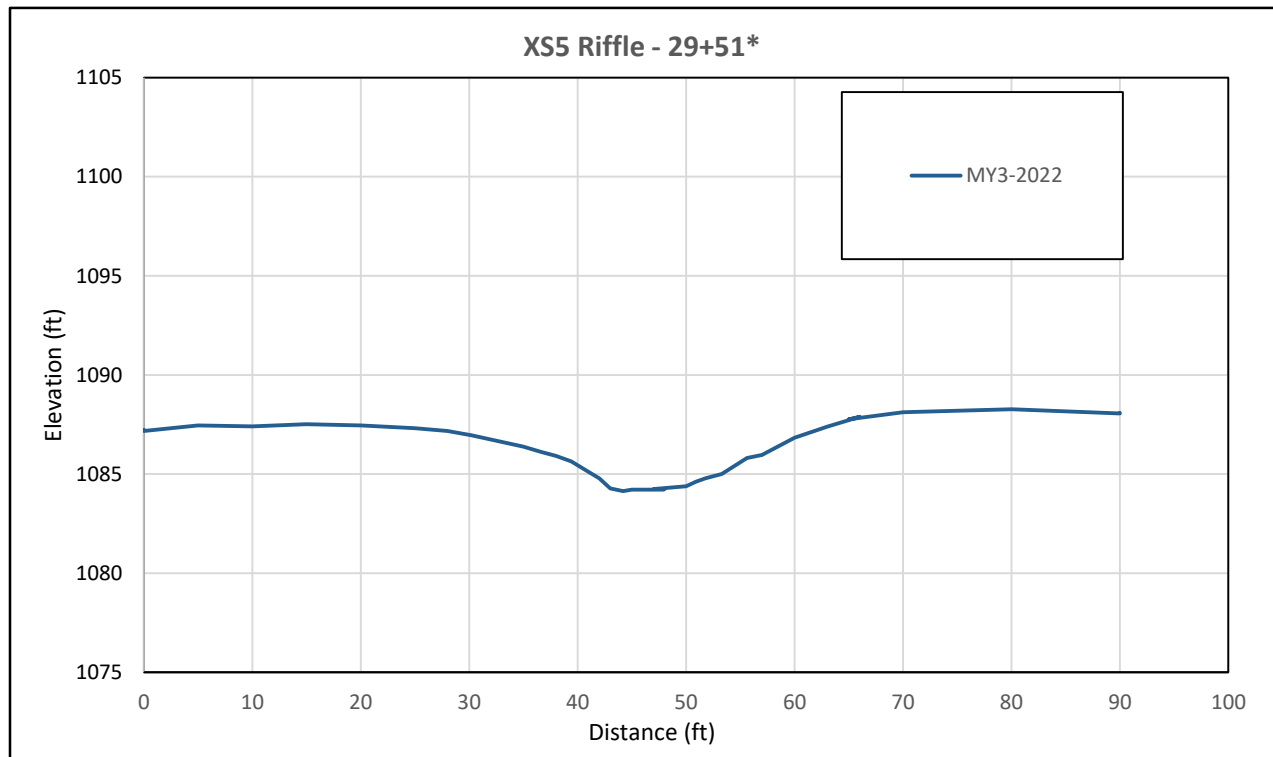
\* Stationing from AMP. The cross section location was relocated and stationing has been updated. MY0 through MY2 data not applicable due to the cross section being relocated.

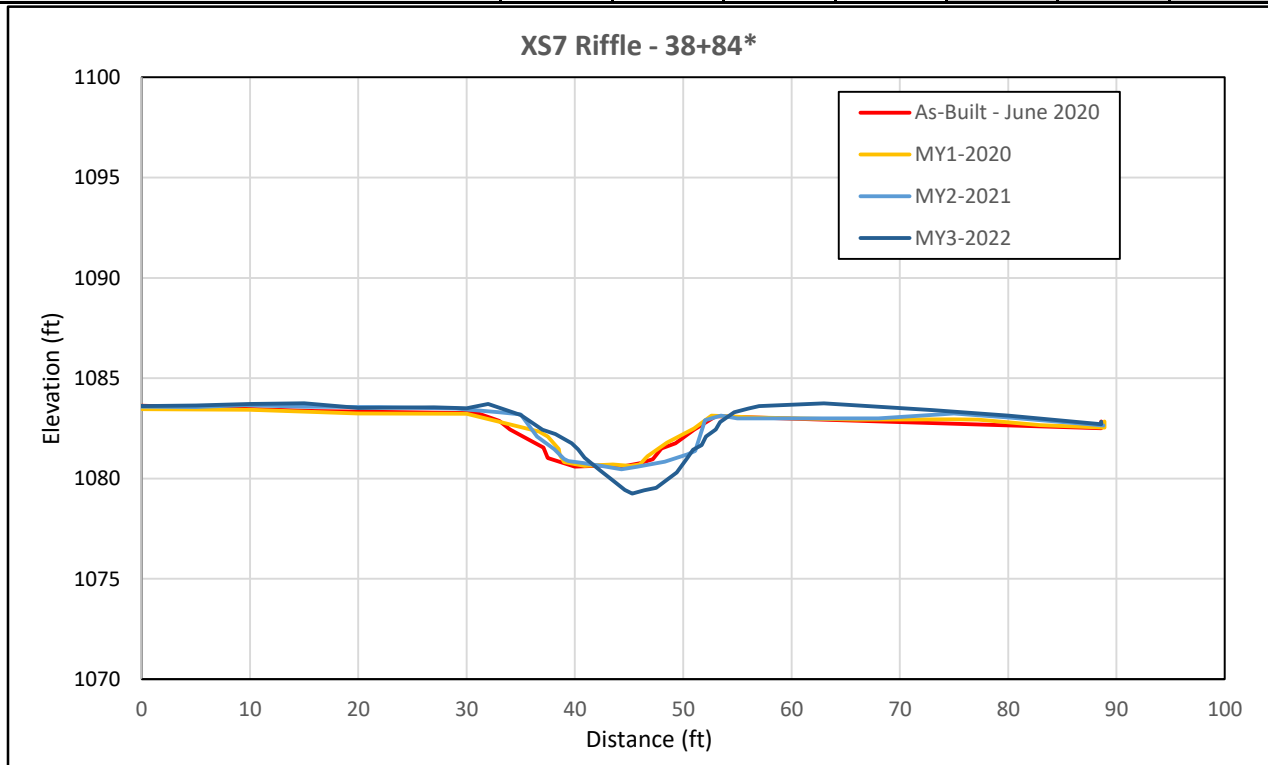
\* Stationing from AMP. The stationing has been updated. This cross section was impacted by AMP construction and the right bank was rebuilt with additional toewood.
