STILLHOUSE CREEK STREAM RESTORATION – Project # 363
First Annual Monitoring Report –Final
February 2008

CONDUCTED FOR THE NORTH CAROLINA DEPARTMENT OF ENVIRONMENT
AND NATURAL RESOURCES

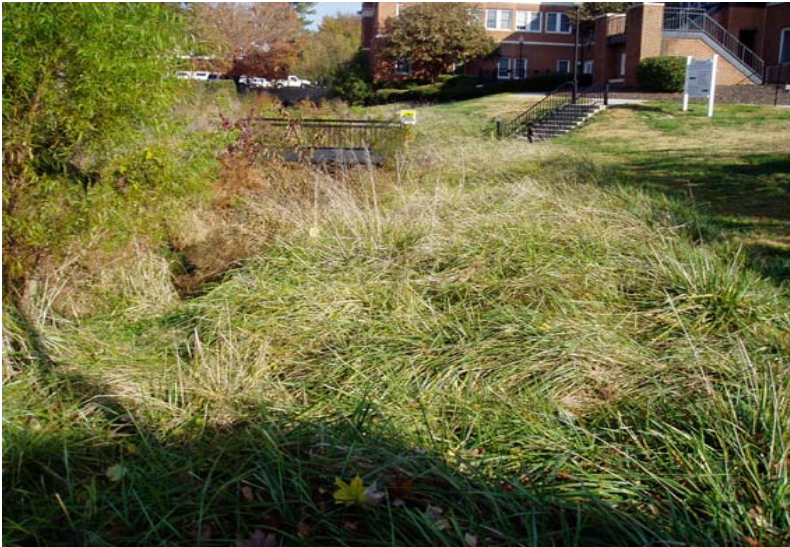
Three vegetation problem areas were identified in Reach 2 (Figure A1, Table 1). The area close to the first foot-bridge (Stations 235-300) was probably insufficiently planted at the time of construction. Compacted or nutrient deficient soil could be the cause of the smallest problem area near the pocket wetlands (Stations 400-430) where non-woody vegetation, including sedges and coneflowers, have helped stabilize the soil. The third and largest vegetation problem area in Reach 2 (Stations 320-580) has experienced poor survival of planted woody stems and is currently dominated by fescue. At this point, no remedial action is recommended, but the areas should be observed and replanting may be necessary in the future.

Feature/Issue	Station/Range	Probable Cause	Photo #
Limited woody stem planting	235-300	Planting Oversight	VP1
Low planted woody stem success	400-430	Soil Compaction	VP2
Low planted woody stem success	320-580	Soil Compaction	VP1
Low planted woody stem vigor	715-830	Soil Compaction	VP3
Low planted woody stem success	1000-1060	Soil Compaction	VP4

VP1. Limited woody stem planting

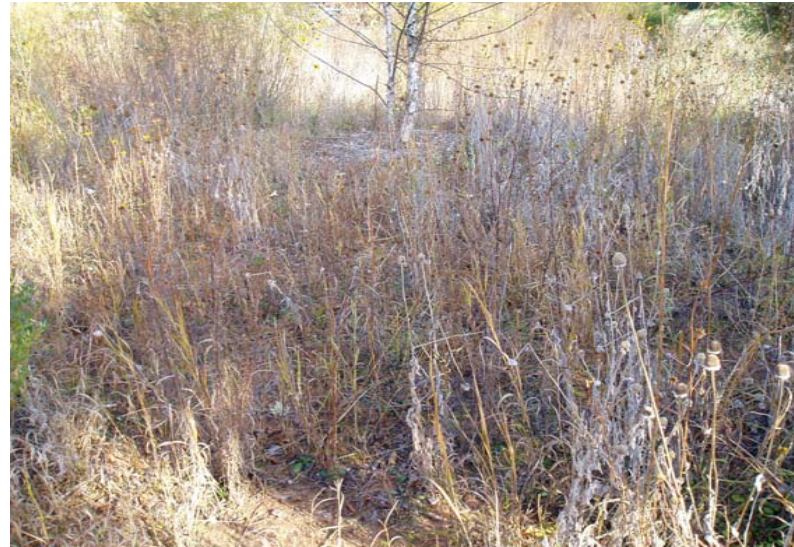
VP2. Low planted woody stem success

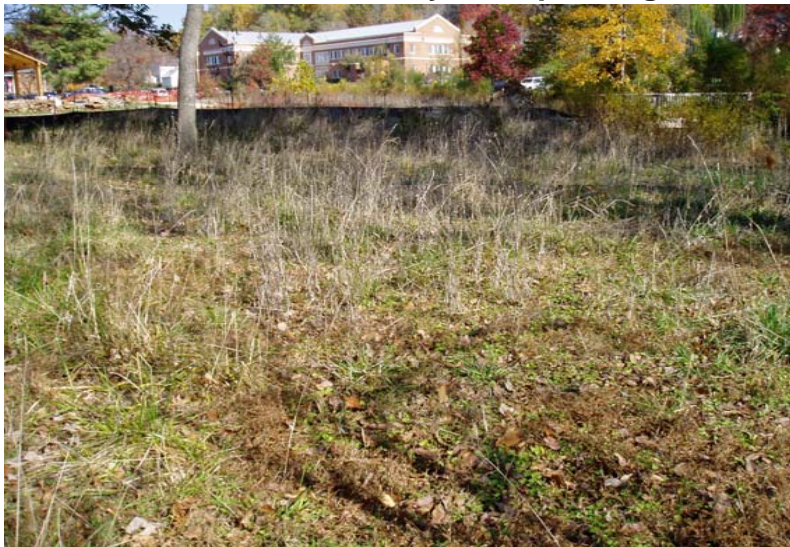
In Reach 3 (Figure A1) the terrace across from vegetation monitoring plot 3 (Stations 715-830) has sufficient planted stem survival, but vigor is low. This may be due to poor soils or soil compaction that occurred prior to or during construction. The right top of bank area near cross-sections 4 and 5 (Stations 1000-1060) has a low survival of planted woody vegetation. Although, sedges and other non-woody vegetation are well-established in this area, it should be monitored in case remedial action is needed in the future. No remediation is recommended at this time.

VP3. Low planted woody stem vigor

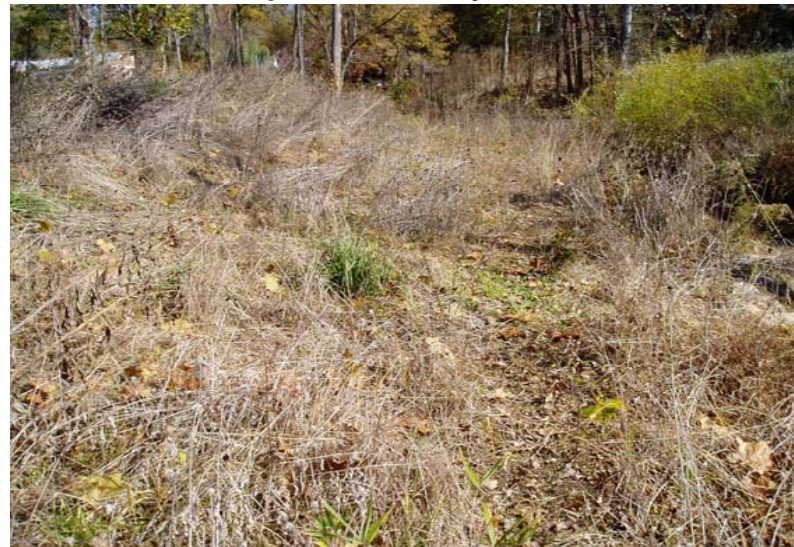
VP4. Low planted woody stem success

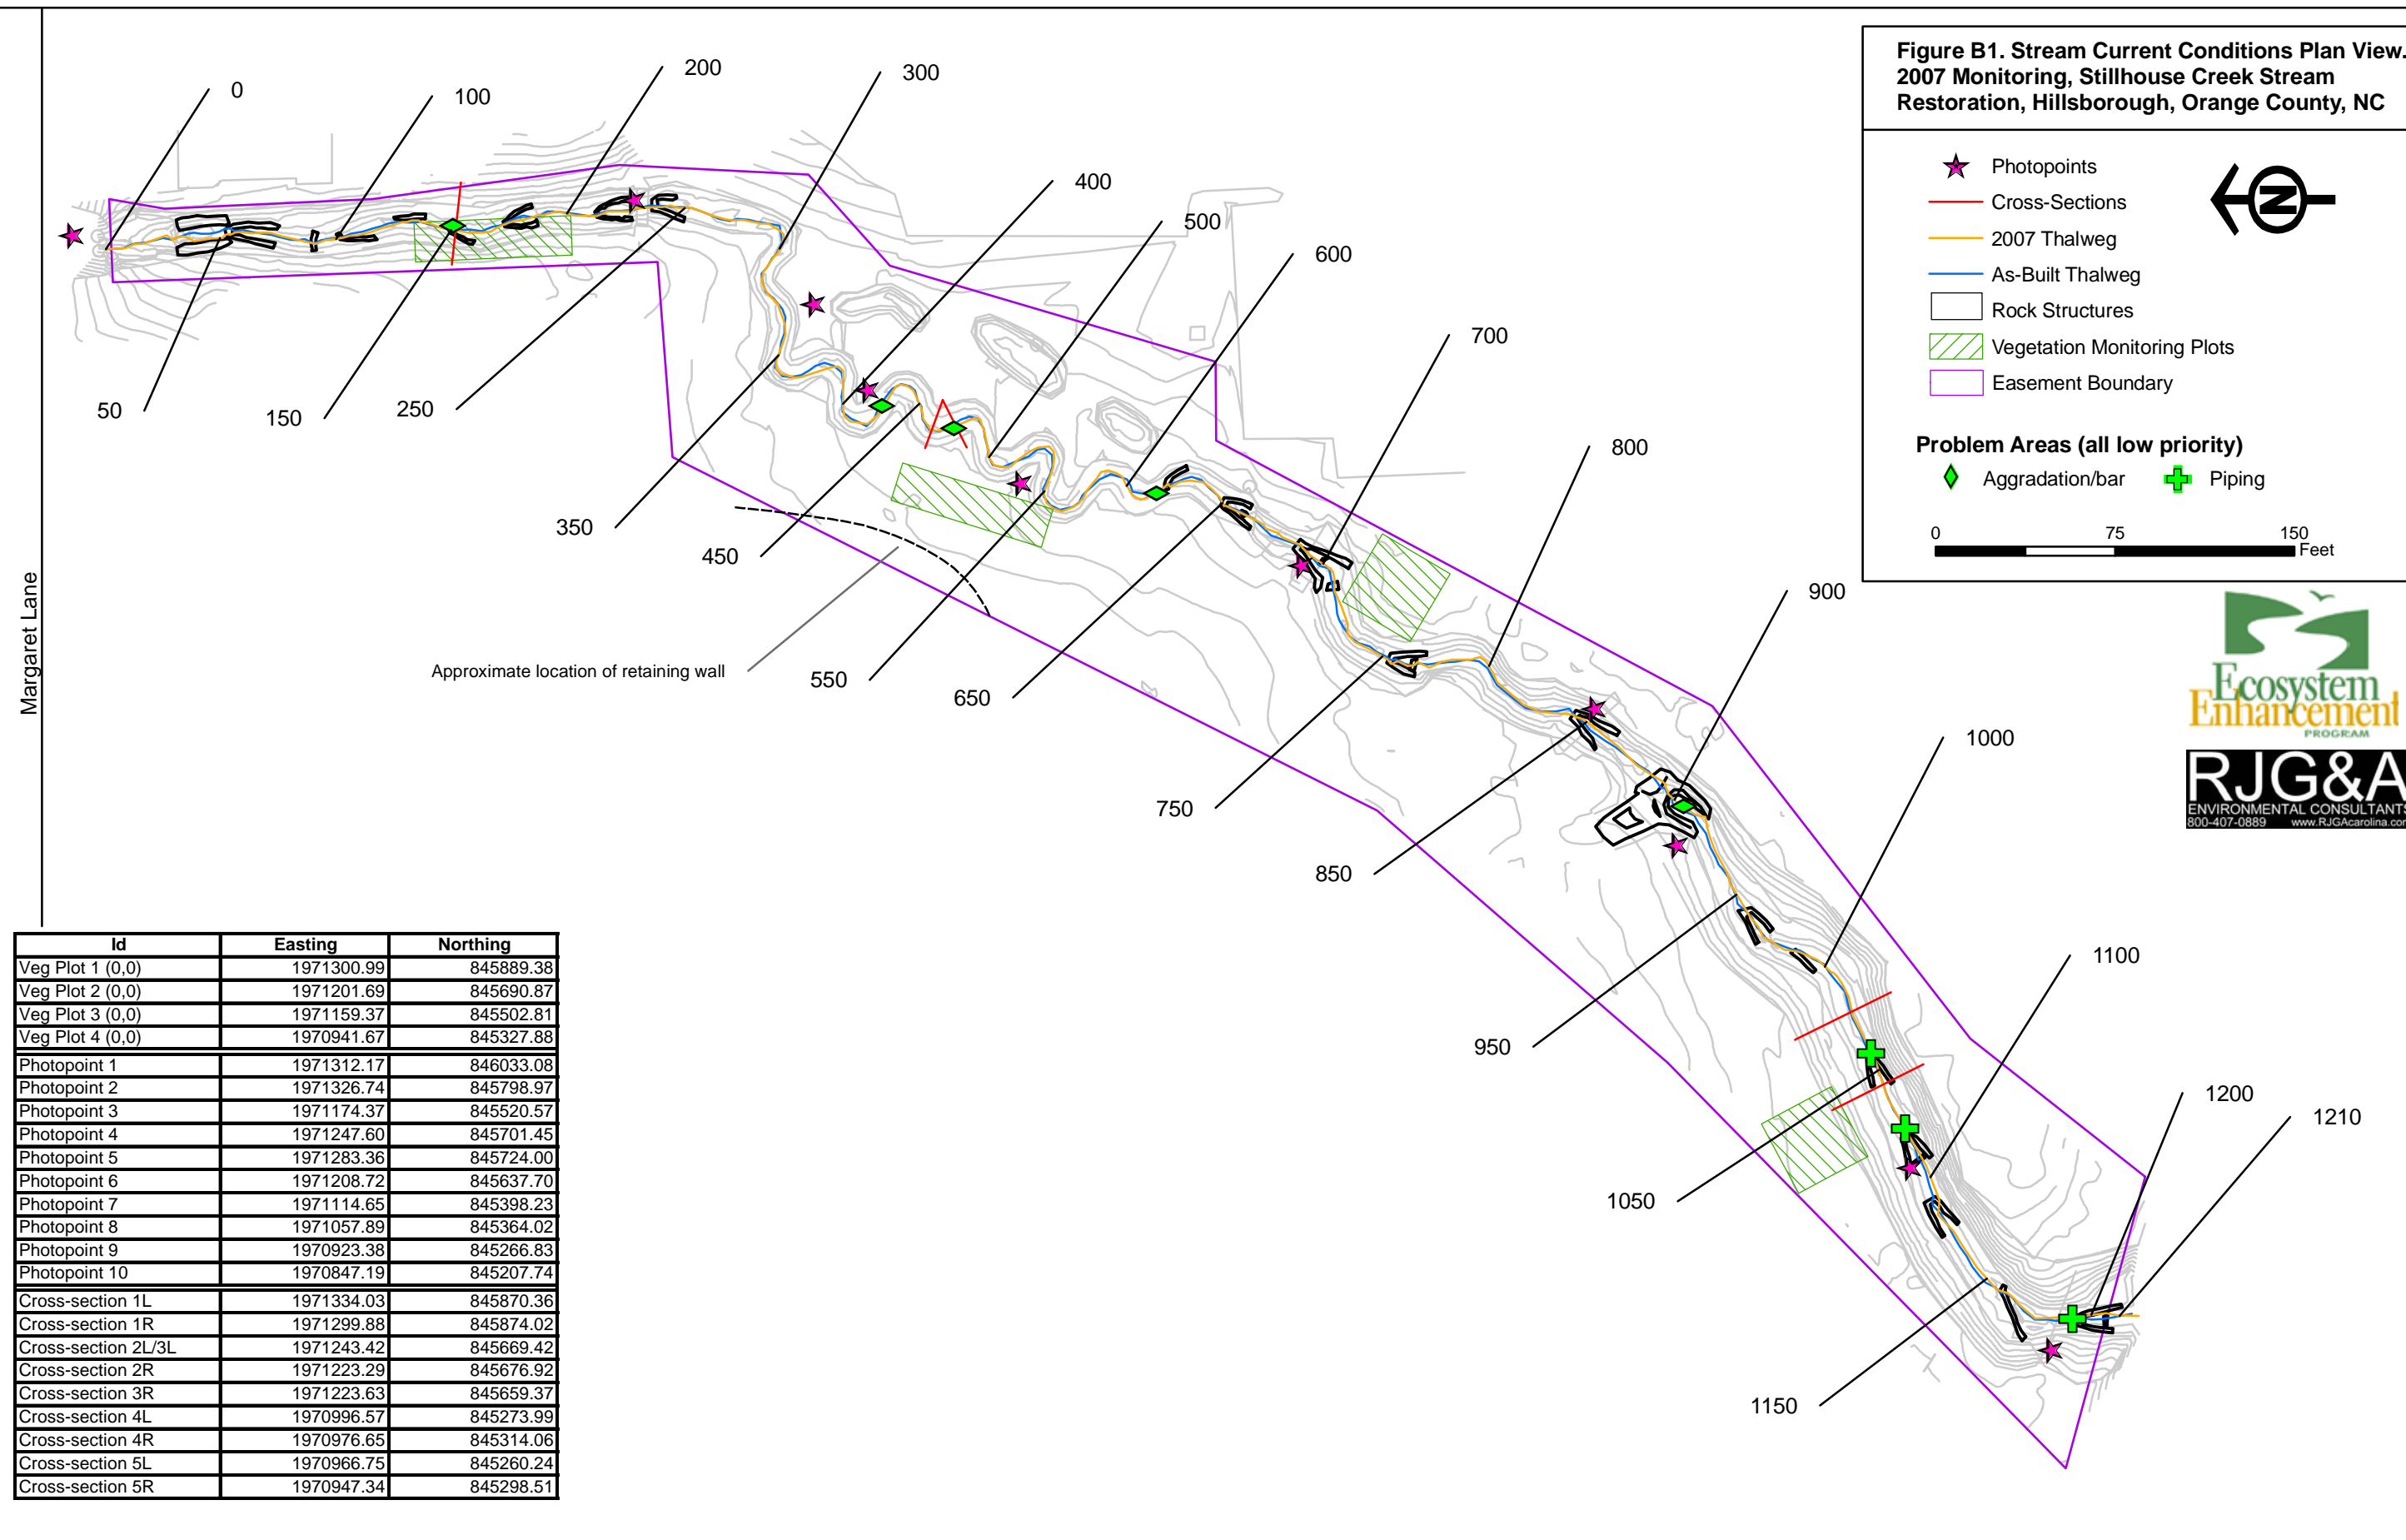
Figure B1. Stream Current Conditions Plan View. 2007 Monitoring, Stillhouse Creek Stream Restoration, Hillsborough, Orange County, NC

Minor problem areas were observed in November 2007 including the formation of small bars along riffles, piping, and bank scour. Exhibit Table B.1 in Appendix B identifies these problem areas by station, along with suspected causes and representative photos. In all cases, the problems are considered a low-priority and are probably due primarily to the low flow in the channel resulting from this year's drought. These areas should be monitored, especially if record-low rainfall levels continue into 2008.

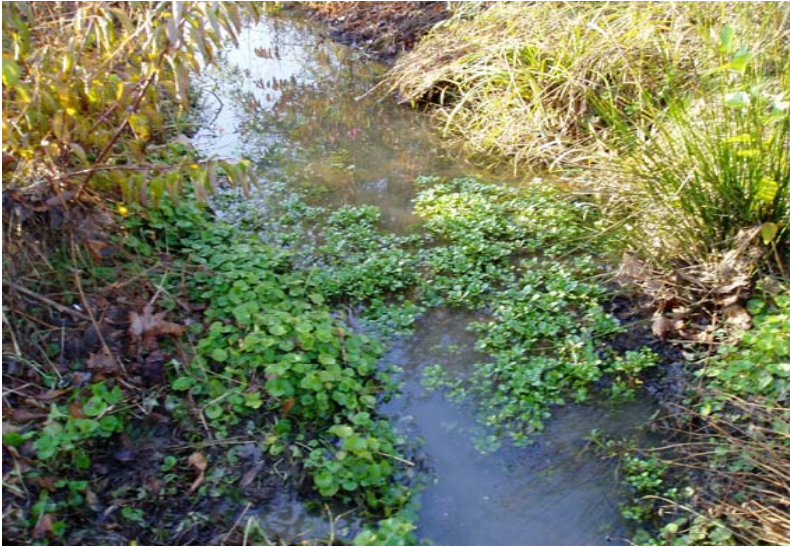
ETableB.. Stream Problem Areas - Stillhouse Creek Stream Restoration - EEP Project #363			
Feature/Issue	Station	Suspected Cause	Photo #
Reach 1			
Aggradation/bar in riffle	152	Low flow due to drought	SP1
Reach 2			
Aggradation/bar in riffle	430	Low flow due to drought	SP1
Aggradation/bar in riffle	474	Low flow due to drought	SP1
Aggradation/bar in riffle	618	Low flow due to drought	SP1
Reach 3			
Aggradation/bar in riffle	905	Low flow due to drought	SP1
Piping under cross-vane	1042	Low flow due to drought	SP2
Piping under cross-vane	1075	Low flow due to drought	SP2
Piping under cross-vane	1190	Low flow due to drought	SP2

SP1. Aggradation/bar in riffle

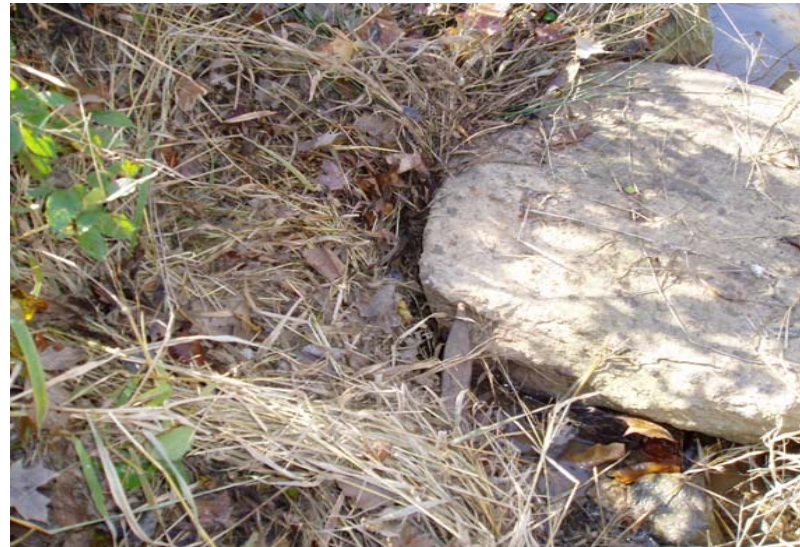
SP2. Piping under cross-vane
