STILLHOUSE CREEK STREAM RESTORATION – Project # 363
2009 FINAL MONITORING REPORT – YEAR 3
January 2010

STILLHOUSE CREEK STREAM RESTORATION – PROJECT #363
2009 FINAL MONITORING REPORT – YEAR 3

CONDUCTED FOR THE NORTH CAROLINA DEPARTMENT OF ENVIRONMENT
AND NATURAL RESOURCES

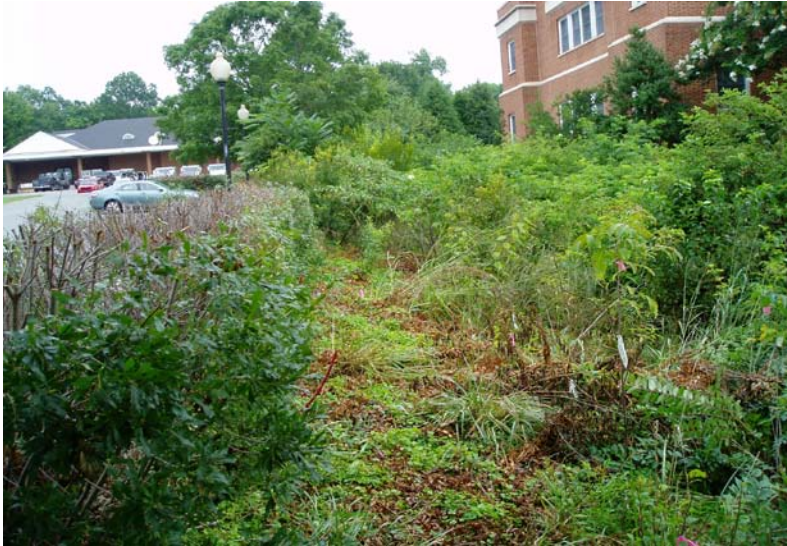
VP1. Landscape debris thrown in buffer (8/16/2009)

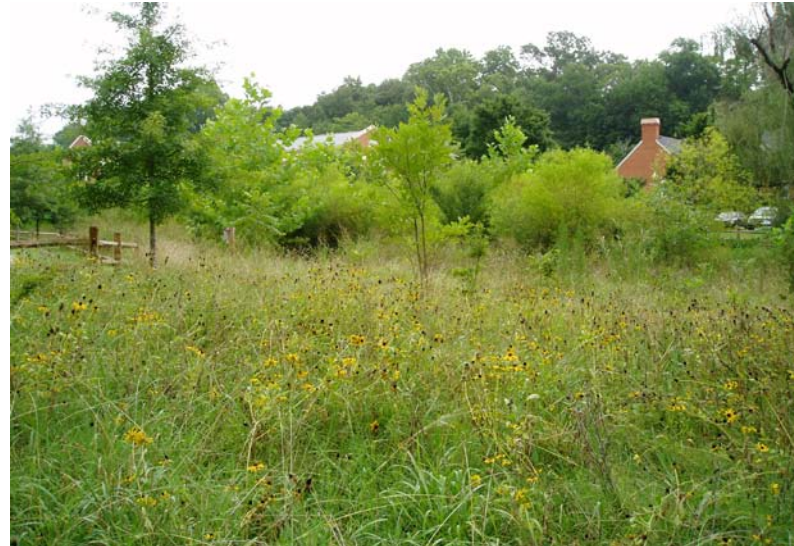
VP2. Low planted stem density (8/16/2009)

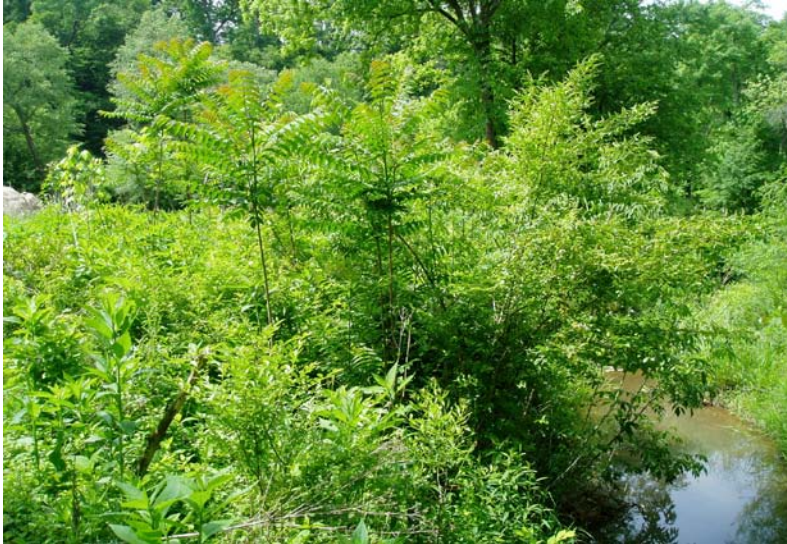
VP3. *Ailanthus altissima* near station 860 (8/16/2009)

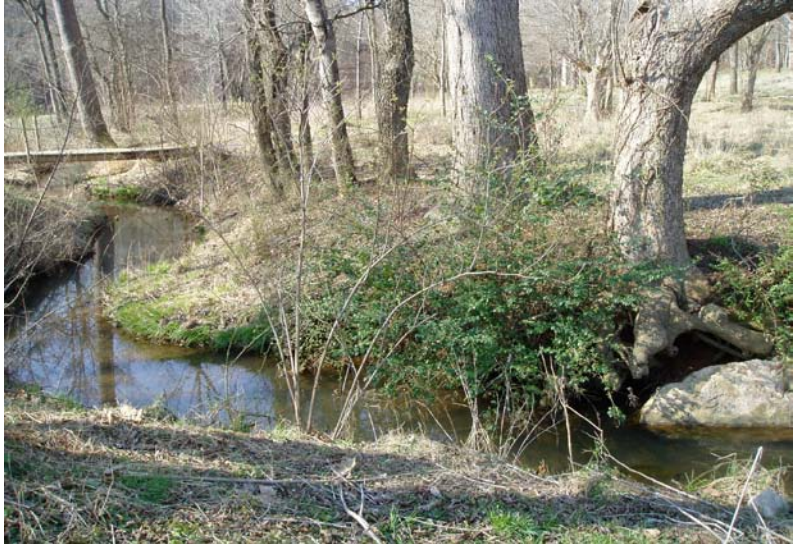
VP4. *Ligustrum sinense* near station 800 (3/6/2009)
