STILLHOUSE CREEK STREAM RESTORATION – Project # 363
2010 FINAL MONITORING REPORT – YEAR 4
January 25, 2011

STILLHOUSE CREEK STREAM RESTORATION – PROJECT #363
2010 FINAL MONITORING REPORT – YEAR 4

CONDUCTED FOR THE NORTH CAROLINA DEPARTMENT OF ENVIRONMENT
AND NATURAL RESOURCES

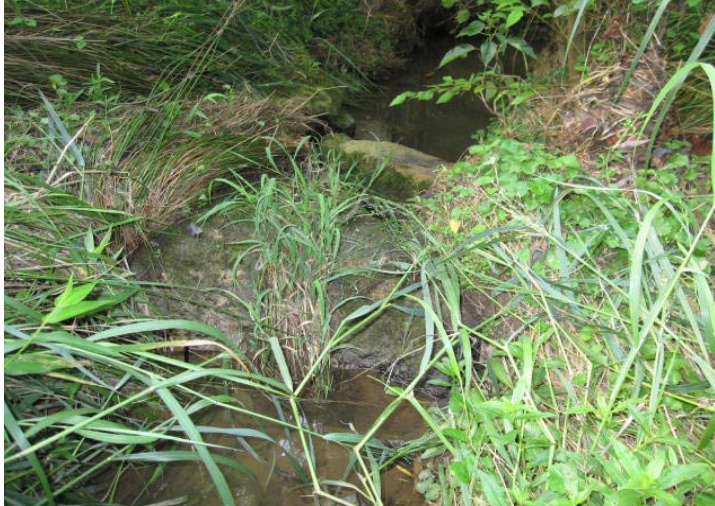
SP1. Too-high structure resulting in upstream grade loss. Looking downstream.

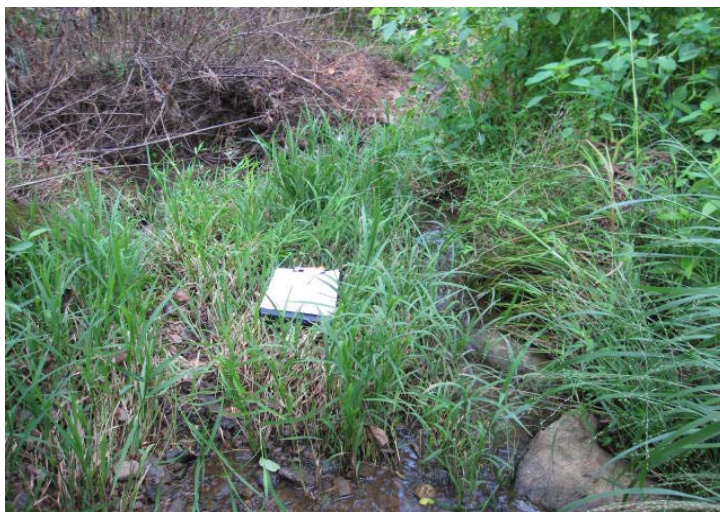
SP2. Aggradation/bar formation at station 910-925. Looking downstream.

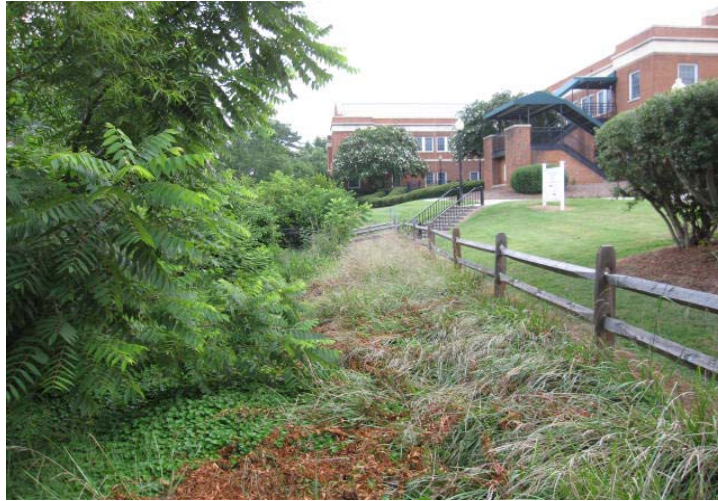
VP1. Low planted stem density, looking north towards first footbridge.

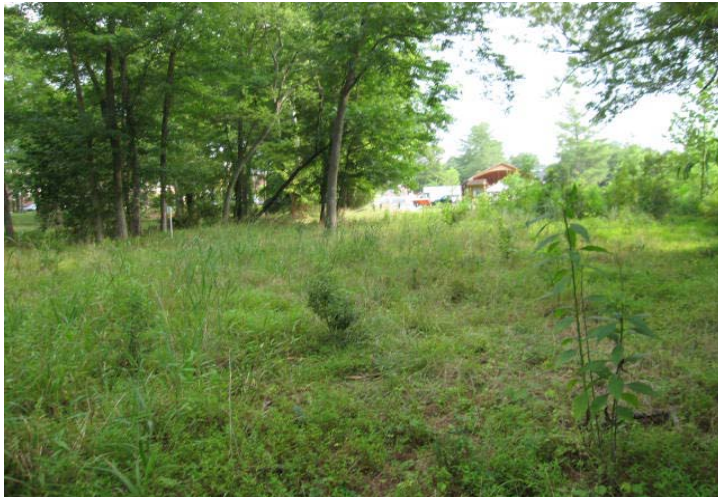
VP2. Low planted stem density, Reach 3.
