STILLHOUSE CREEK STREAM RESTORATION – Project # 363
2011 FINAL MONITORING REPORT – YEAR 5
September 19, 2011

STILLHOUSE CREEK STREAM RESTORATION – PROJECT #363
2011 FINAL MONITORING REPORT – YEAR 5

CONDUCTED FOR THE NORTH CAROLINA DEPARTMENT OF ENVIRONMENT
AND NATURAL RESOURCES

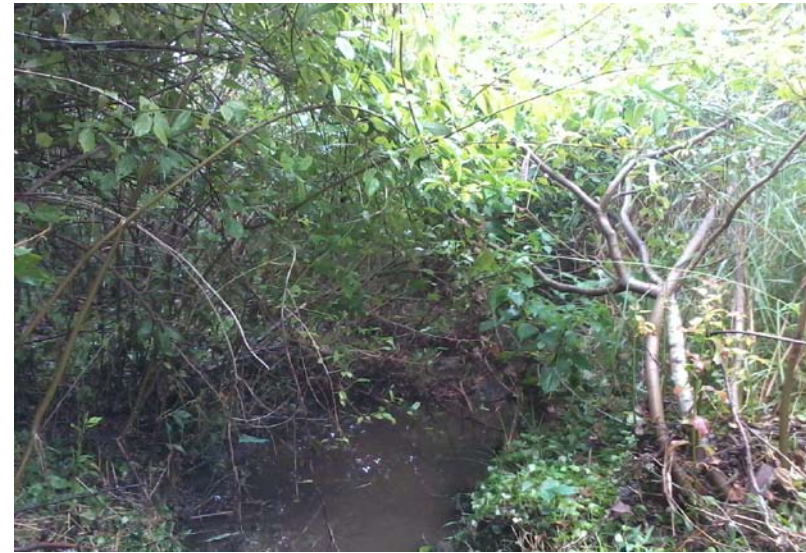
View of cross-section Stillhouse XS-1 looking downstream

Stream Type: B5

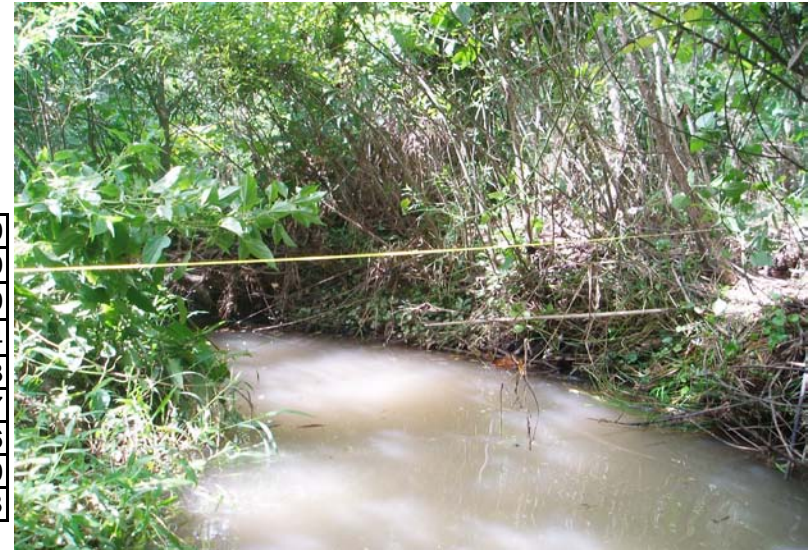
View of cross-section Stillhouse XS-2 looking downstream

Stream Type: C5

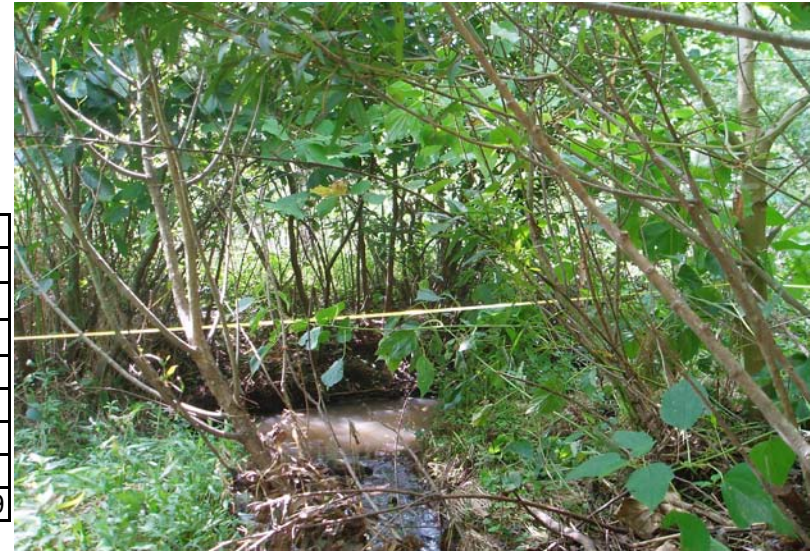
XS3, Riffle, Sta. 4+74

View of cross-section Stillhouse XS-3 looking downstream

Stream Type: C4

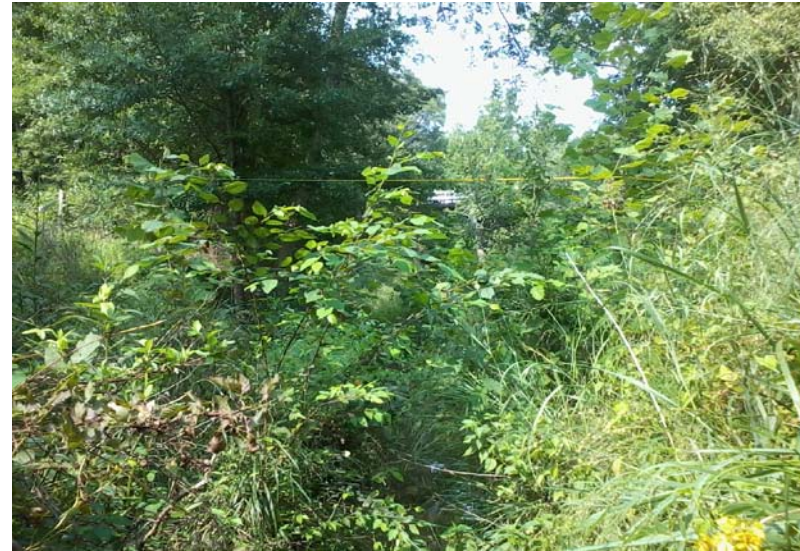
View of cross-section Stillhouse XS-S looking downstream

Stream Type: B4
