STONEBRIDGE STREAM MITIGATION PROJECT

AS-BUILT REPORT

Prepared by
WK Dickson & Company, Inc.
3101 John Humphries Wynd
Raleigh, North Carolina 27612
(919) 782-0495

April 27, 2006

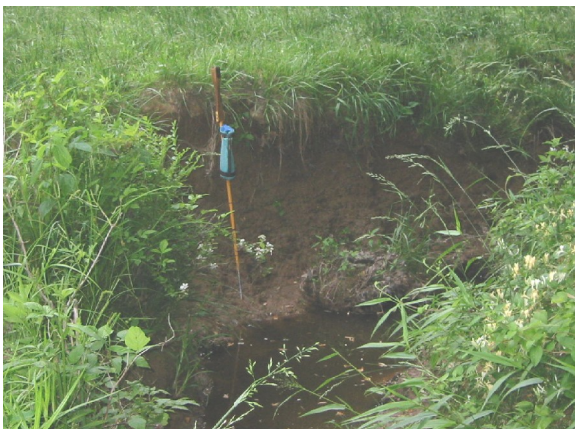
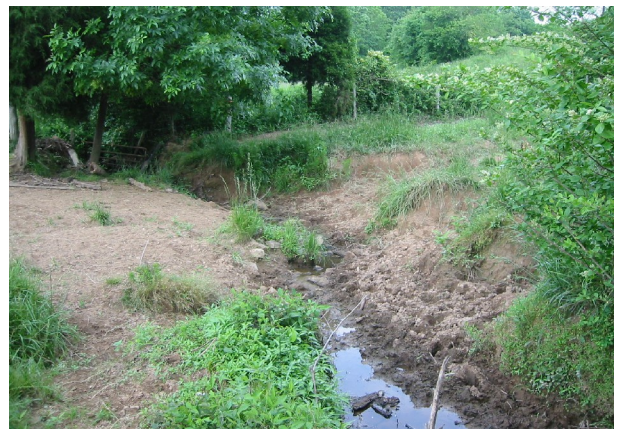
Figure 1. Typical pre-restoration conditions at the Stonebridge Stream Mitigation Project.
