# Stonebridge Stream Mitigation Project

## Year 1 Monitoring Report

December 2006

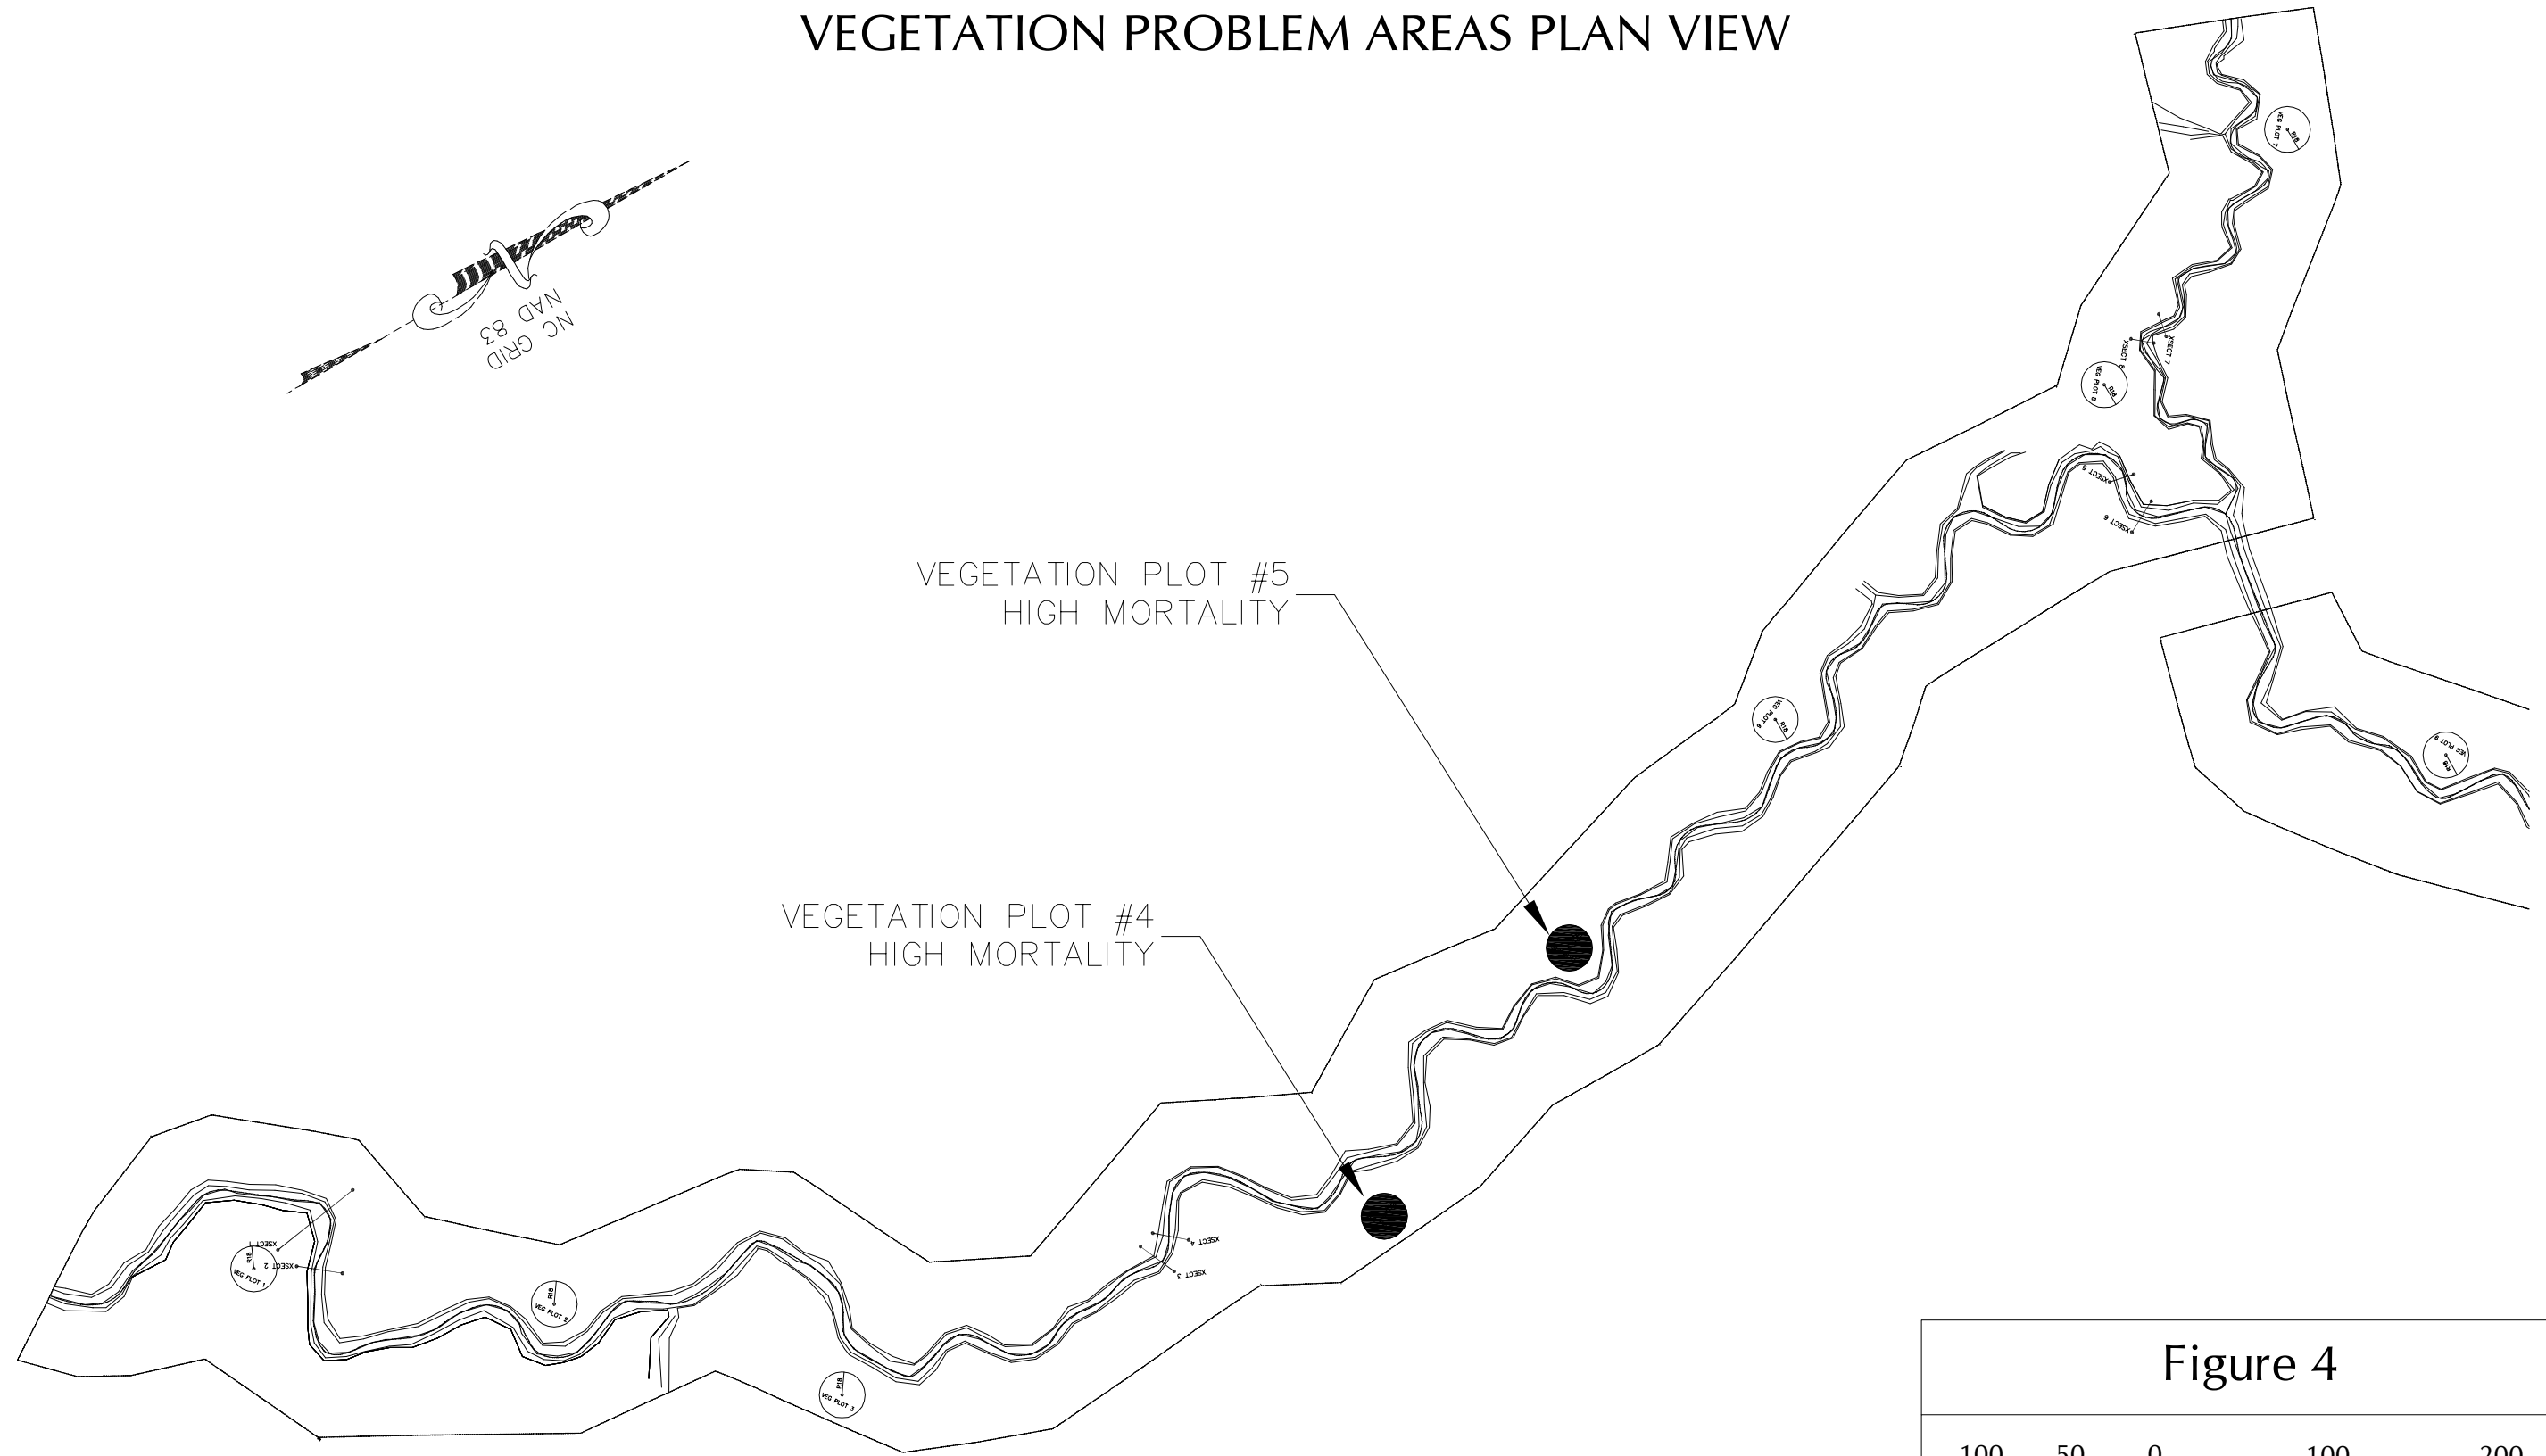
<b>Type of Problem</b>	<b>Location/ Station</b>	<b>Probable Cause</b>	<b>Photo ID</b>
Mortality of Planted Woody Species	Vegetation Plot 4	Insects , human disturbance, dry conditions	VP 4
Mortality of Planted Woody Species	Vegetation Plot 5	Insects, dry conditions	VP 5

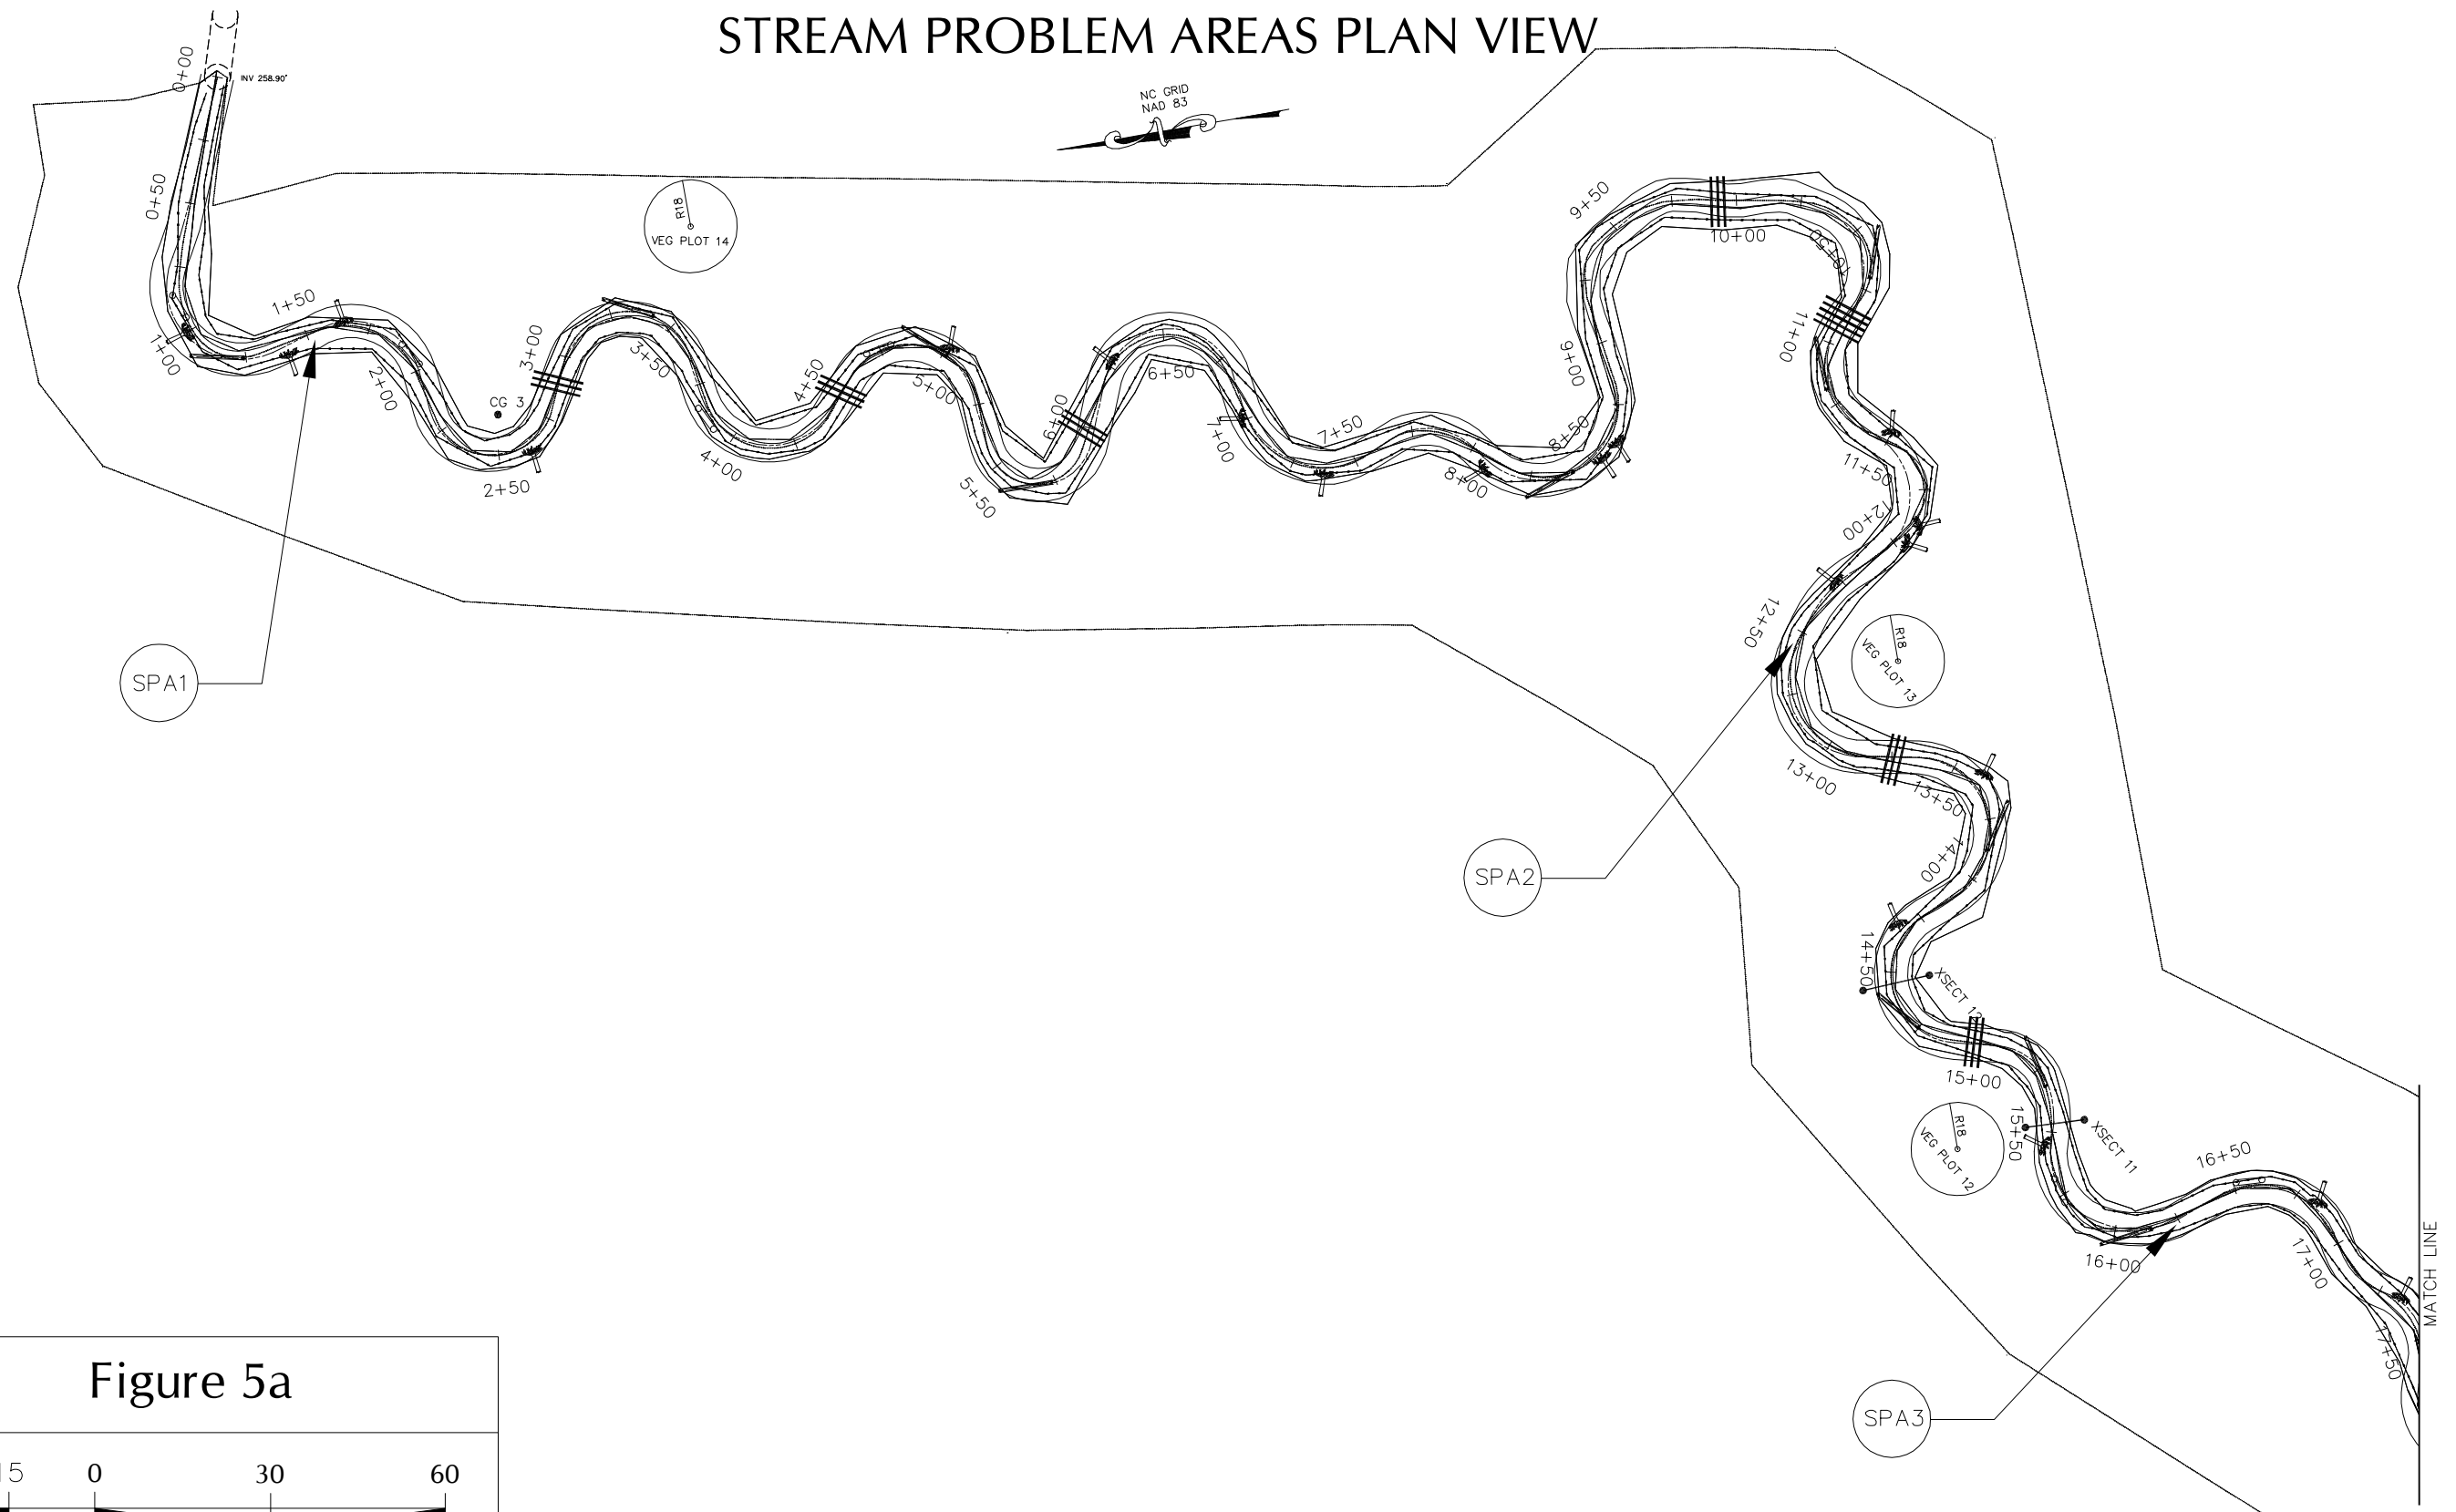
Figure 5a

<b>Feature Issue</b>	<b>Station Numbers</b>	<b>Suspected Cause</b>	<b>Photo Number</b>
Erosion matting coming up	1 + 50	Lack of vegetation to hold onto the bank	SPA1
Erosion beneath matting	12 + 00	Bank scour	SPA2
Log vane washing out	16 + 25	Installed at incorrect elevation	SPA3
Erosion beneath matting	19 + 65	Bank scour	SPA4

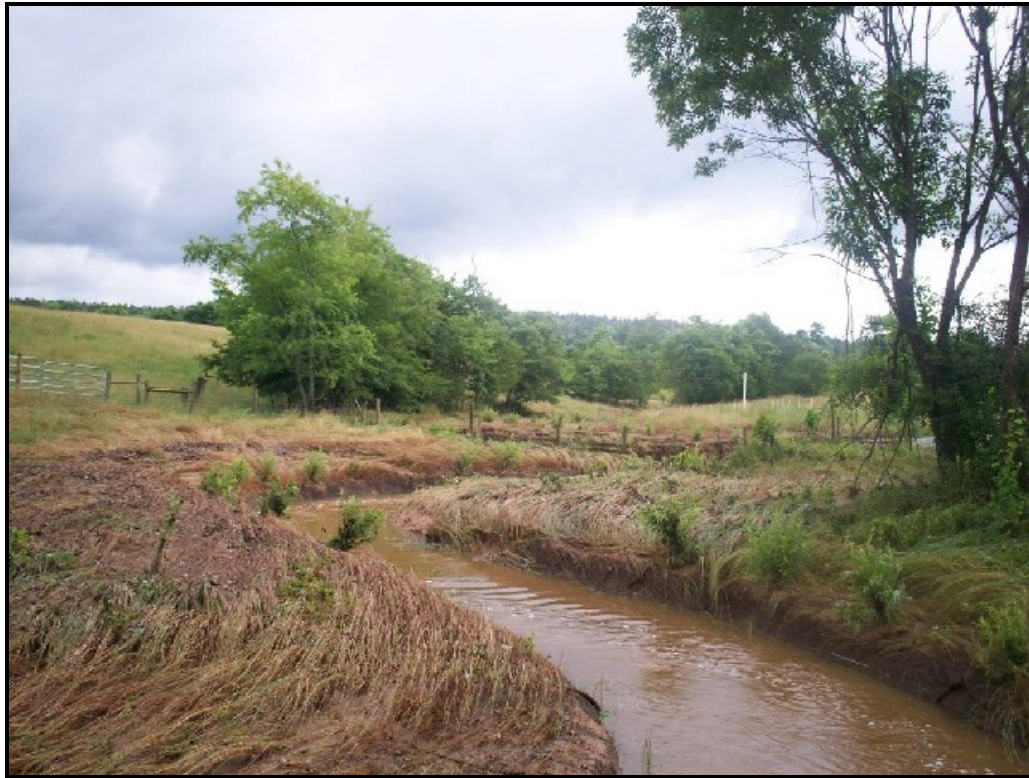
**Photo 8. Stream channel after Hurricane Alberto-looking downstream.**

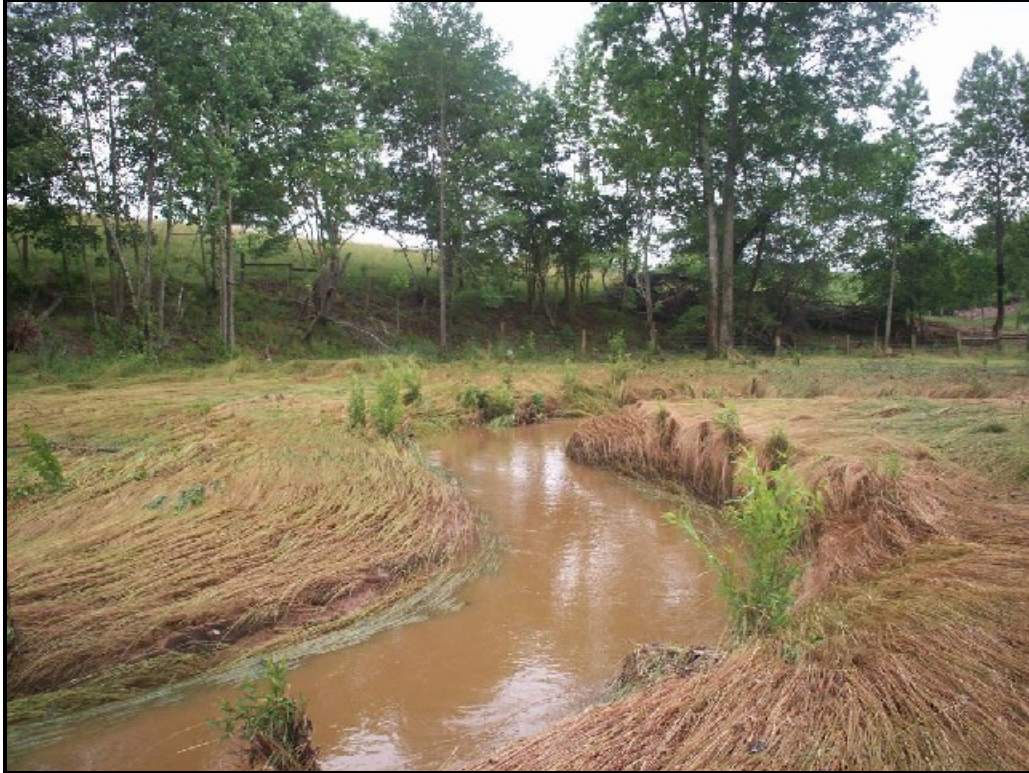
**Photo 9. Stream channel after Hurricane Alberto-looking upstream.**

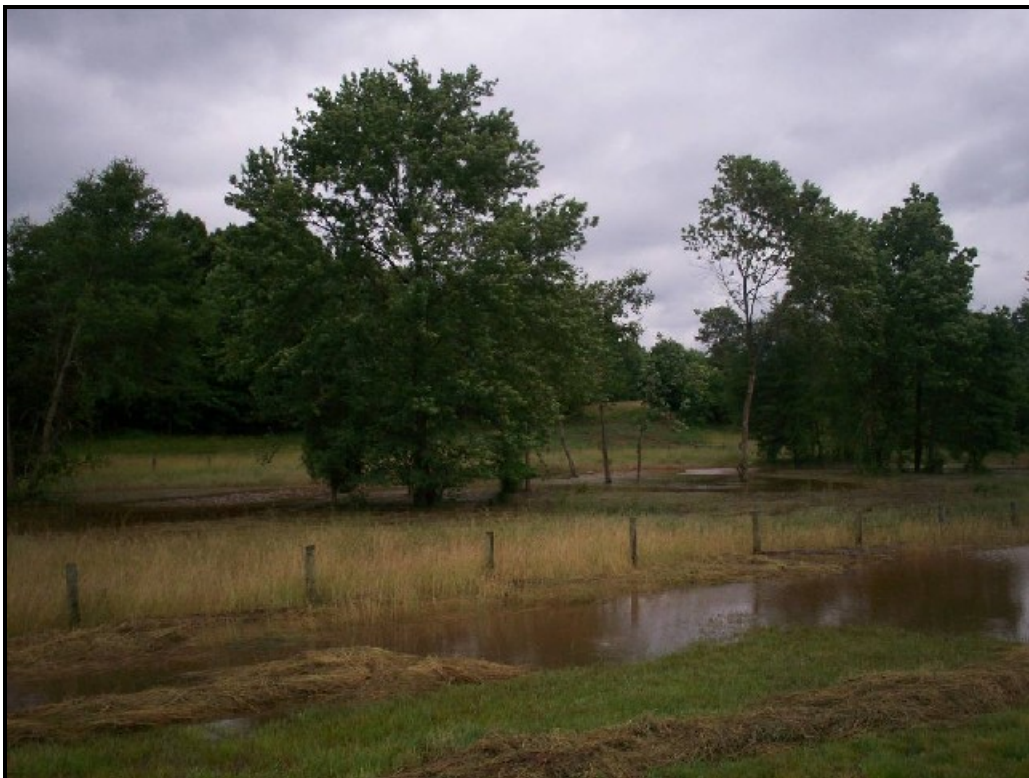
**Photo 10. Stream channel flooded from backup on Crawley Creek.**

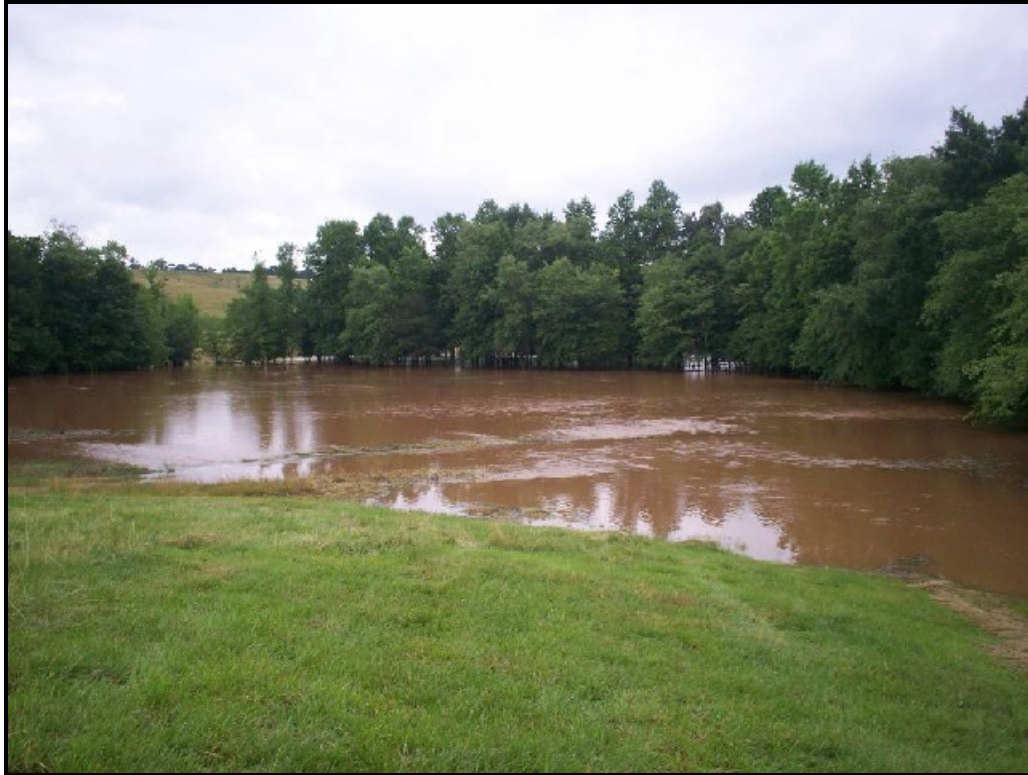
**Photo 11. Flooded field from Crawley Creek from Hurricane Alberto.**

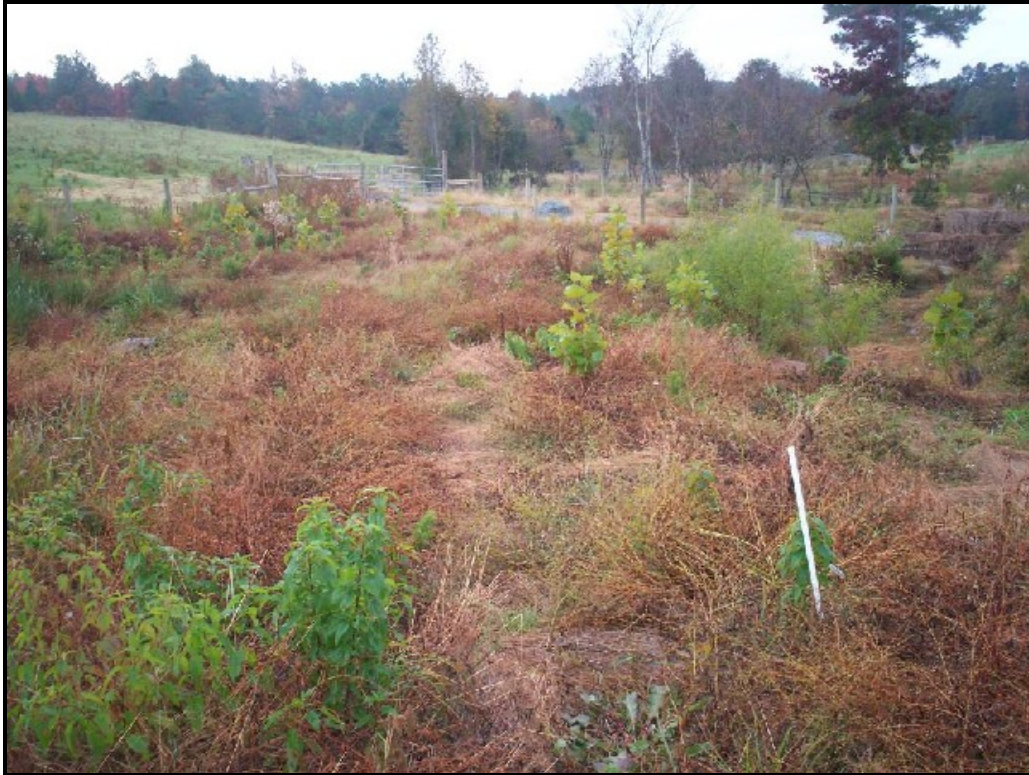
The most notable vegetation result is that the majority of yellow poplar and red oaks in two of the twelve vegetation plots (4 and 5) have not survived. There are several likely contributing factors to this mortality. These include drought conditions during the summer and an initial infestation of beetles that affected the yellow poplar. The lack of rainfall may have exacerbated the mesic conditions which would lead to desiccation of this moderately hydrophytic species. Vegetative plot 4 high mortality resulted from poor species selection, poor stock, and low planting density. Table 6 lists all problem areas with respect to vegetation identified within the project boundary. Photos of vegetation plots are included in Appendix D.

**Photo 15. Vegetation Plot #4.**

Remedial actions to be undertaken prior to the start of the next growing season suggested to improve vegetation conditions at the site includes the following: till, seed, and mulch areas on the floodplain where herbaceous vegetation could be improved. Vegetation plot 4 needs to be replanted in order for it to reach survival success criteria.

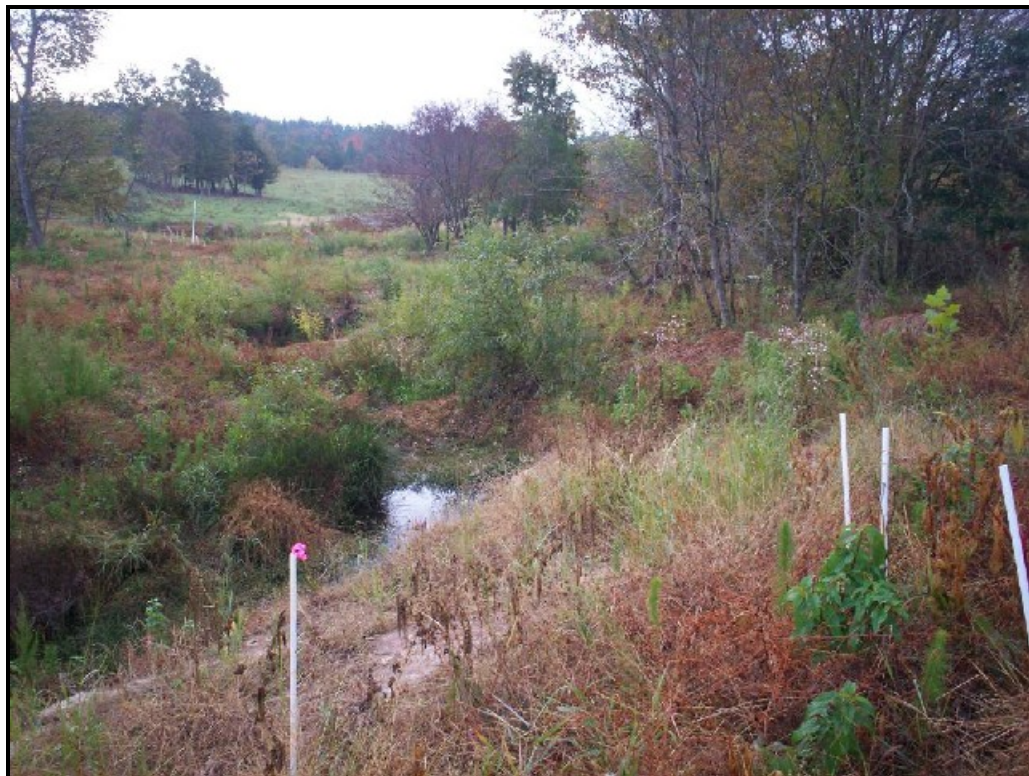
**Photo 16. Vegetation plot #5.**

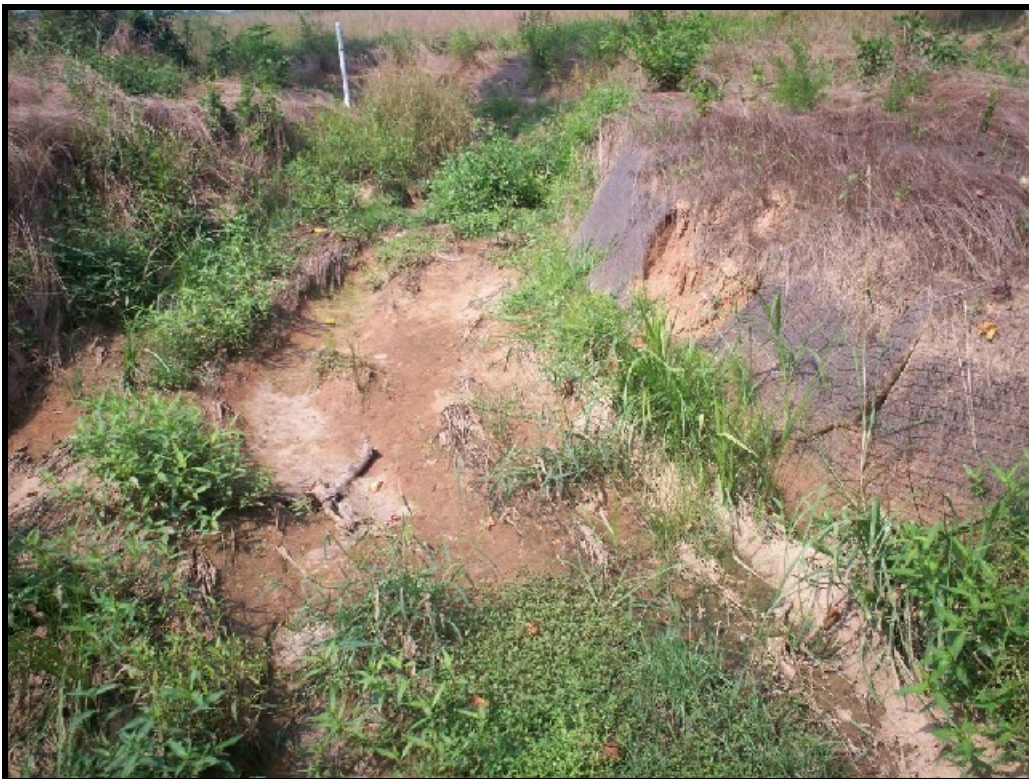
**Photo 26. SPA 1. Erosion control matting deteriorating and tearing from slope at STA 1+50.**

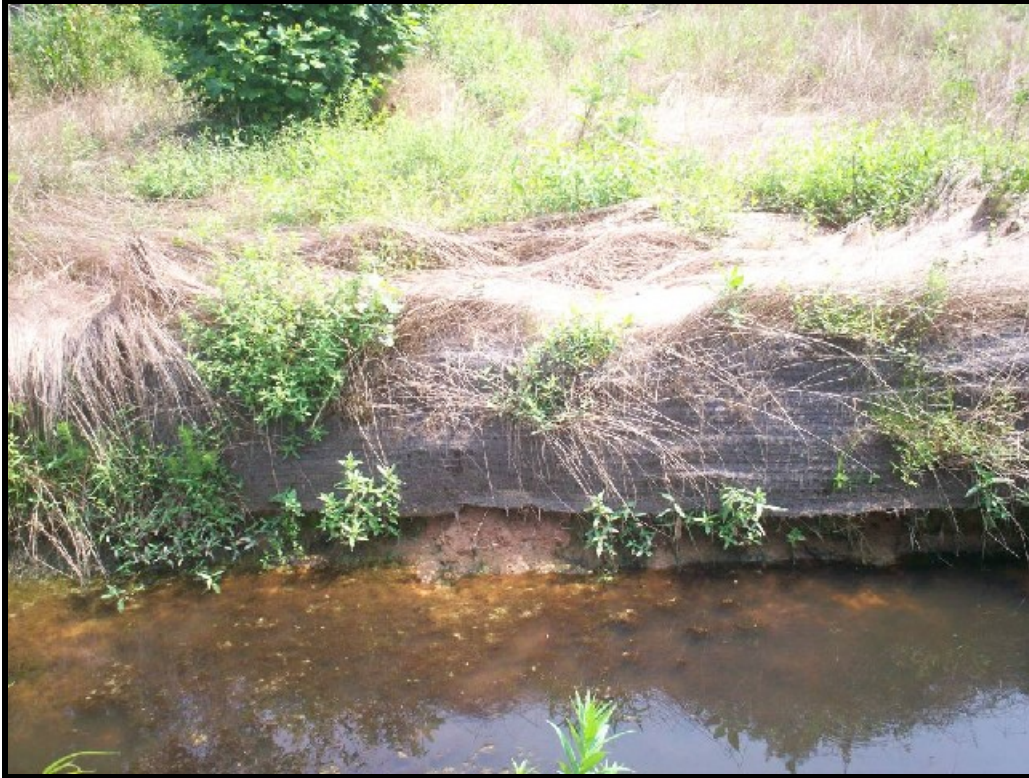
**Photo 27. SPA 2. Minor erosion occurring beneath the erosion control matting at STA 12+00.**

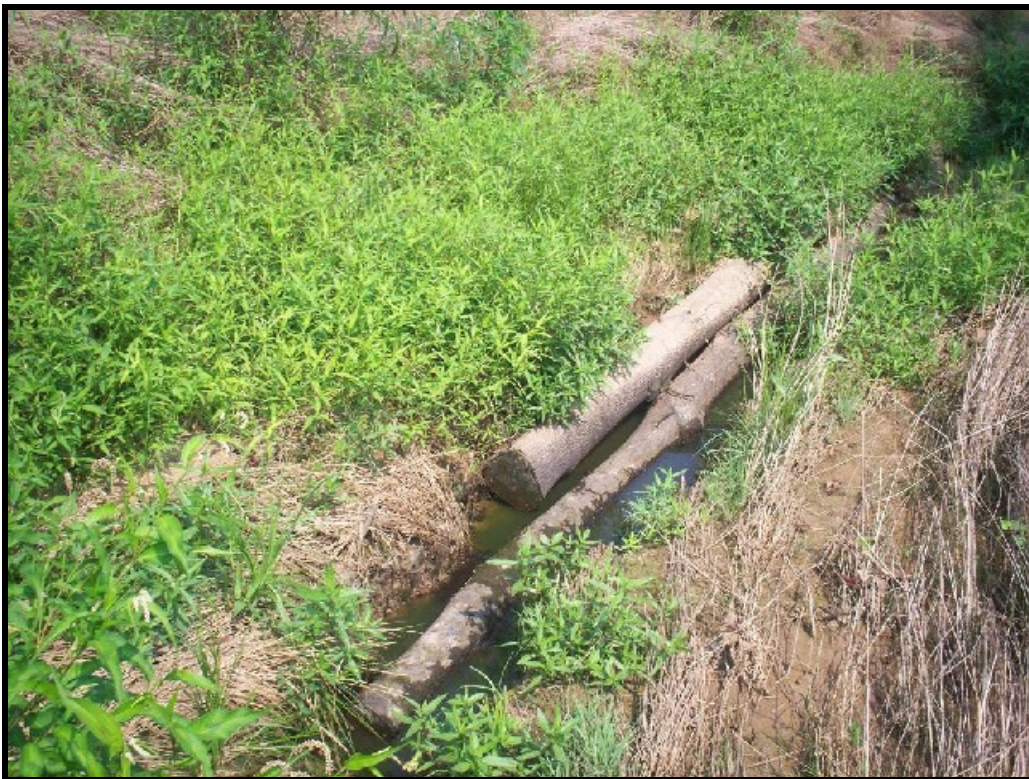
**Photo 28. SPA 3. Log toe protection footer log washing out (facing downstream) at STA 16+25.**

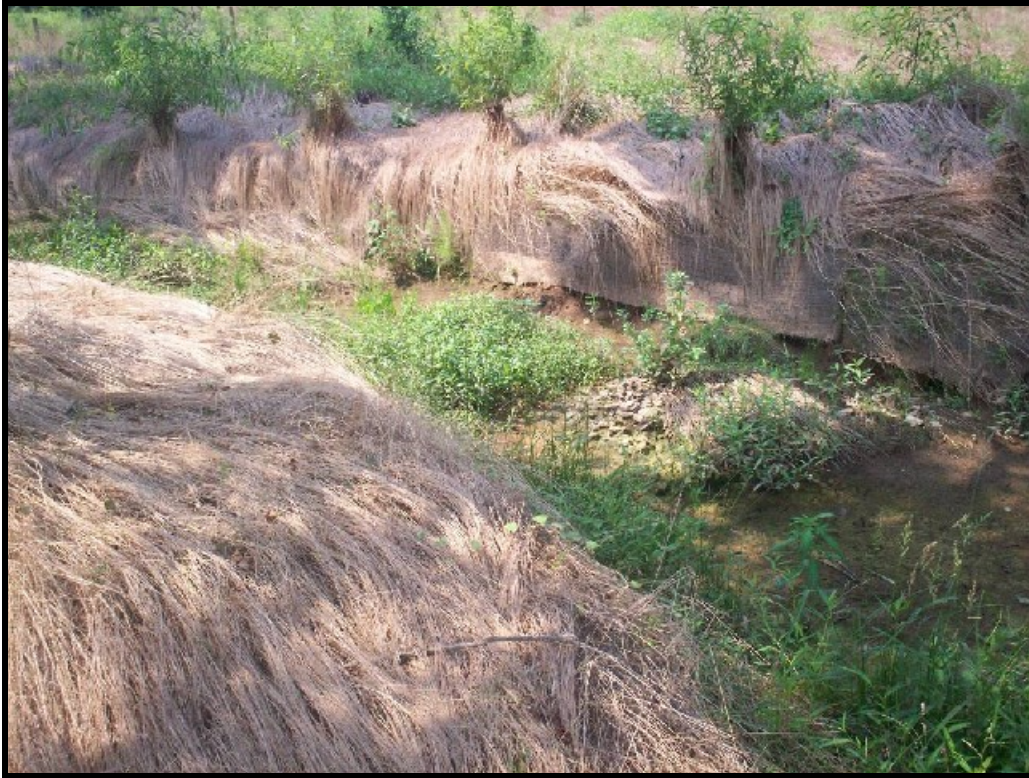
**Photo 29. SPA 4. Minor erosion beneath matting; outside of a bend at STA 19+65.**
