**Stonebridge Mitigation Project  
Moore County, North Carolina**

**Year 2 Monitoring Report**

**November 2007**

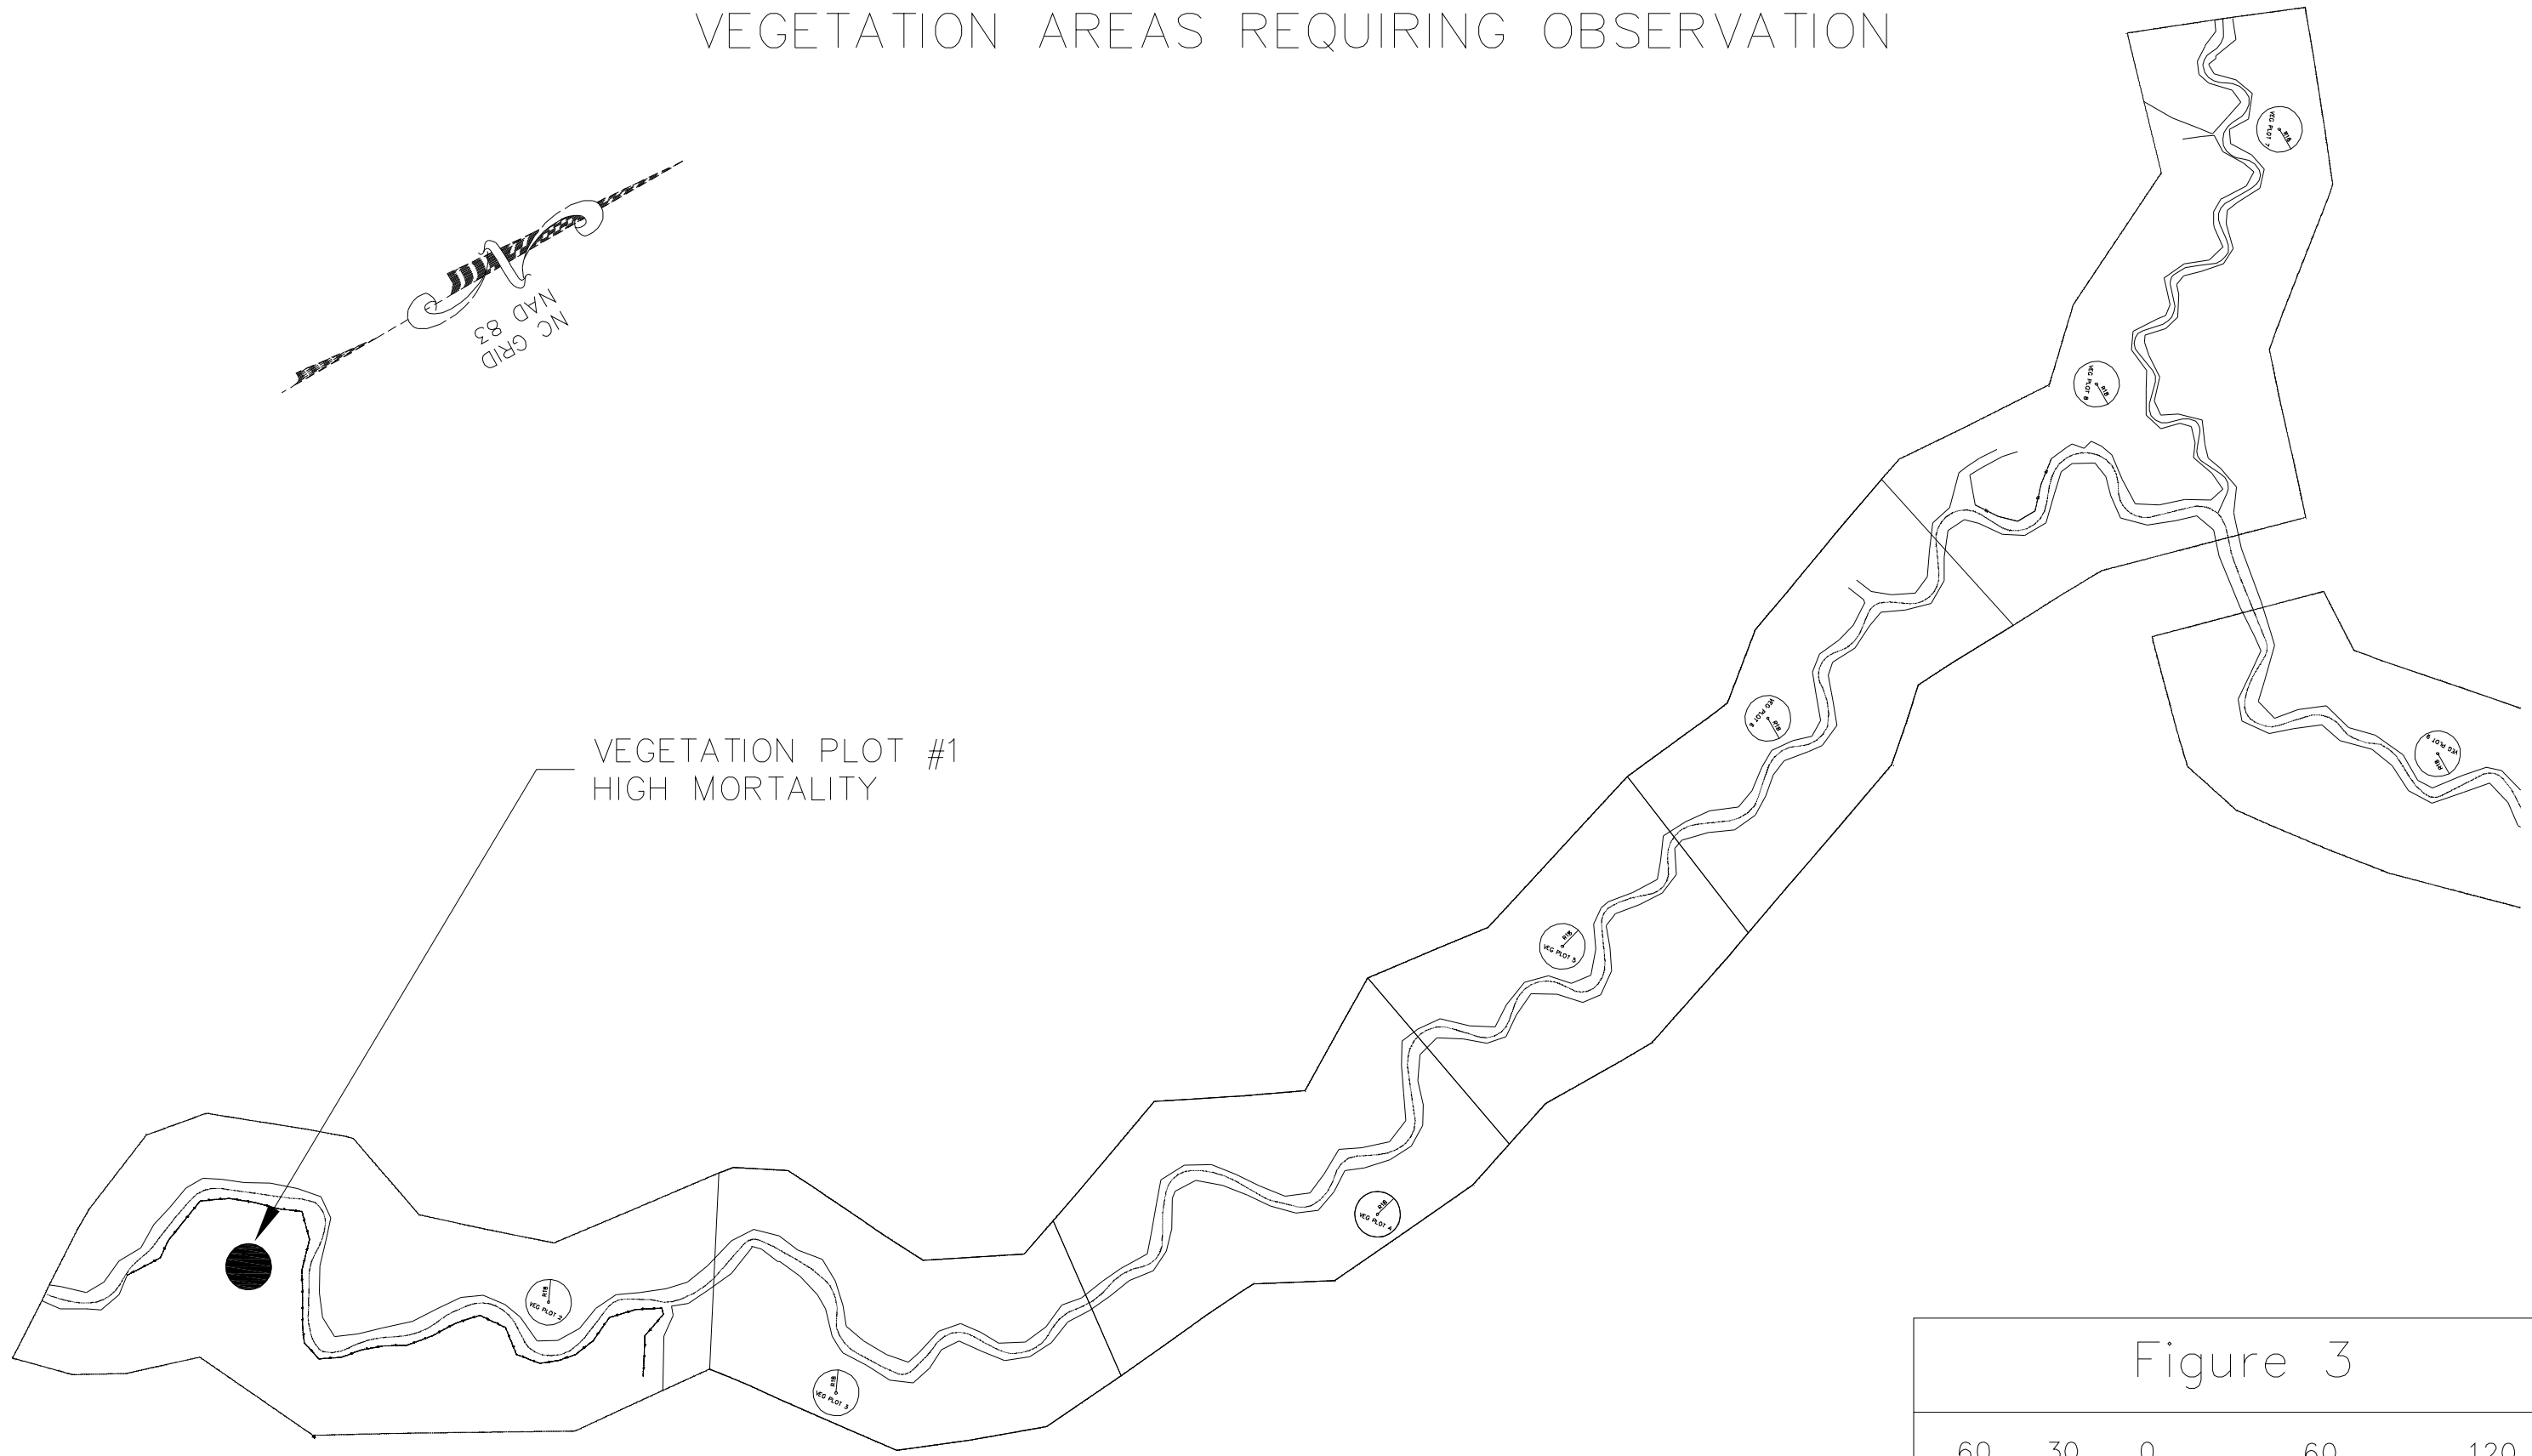
# STONEBRIDGE STREAM MITIGATION SITE VEGETATION AREAS REQUIRING OBSERVATION

Areas requiring further observation with respect to vegetation were identified within the project boundary (**Table 5**). During the current monitoring survey, Plot 1 was observed to be a potential problem area due to sparse herbaceous cover. Bare soil is exposed over much of the Plot providing less protection from drying conditions and increasing soil temperature. Areas in the vicinity of Plots 4 and 5 were replanted in March of 2007 to address low survival documented during 2006 monitoring. These plots are now on track to meet the interim success criteria. Photos of vegetation plots are included in **Appendix C**.

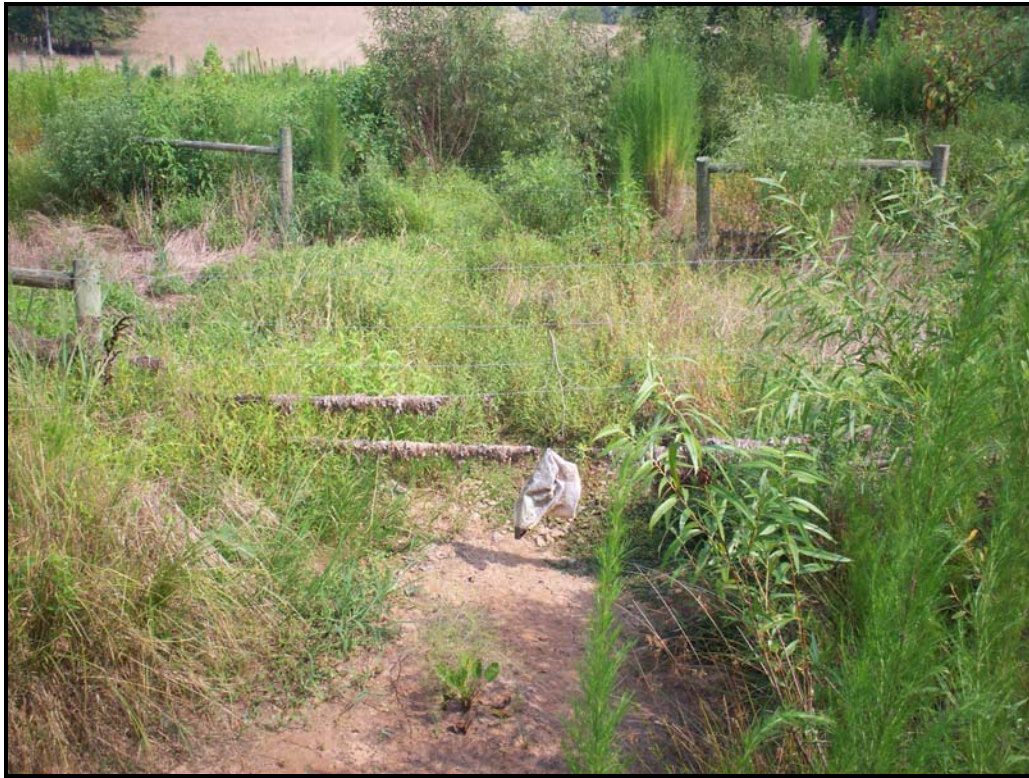
**Photo 3. Ford crossing-looking downstream; debris collected on fence from high flows at STA 7+75.**

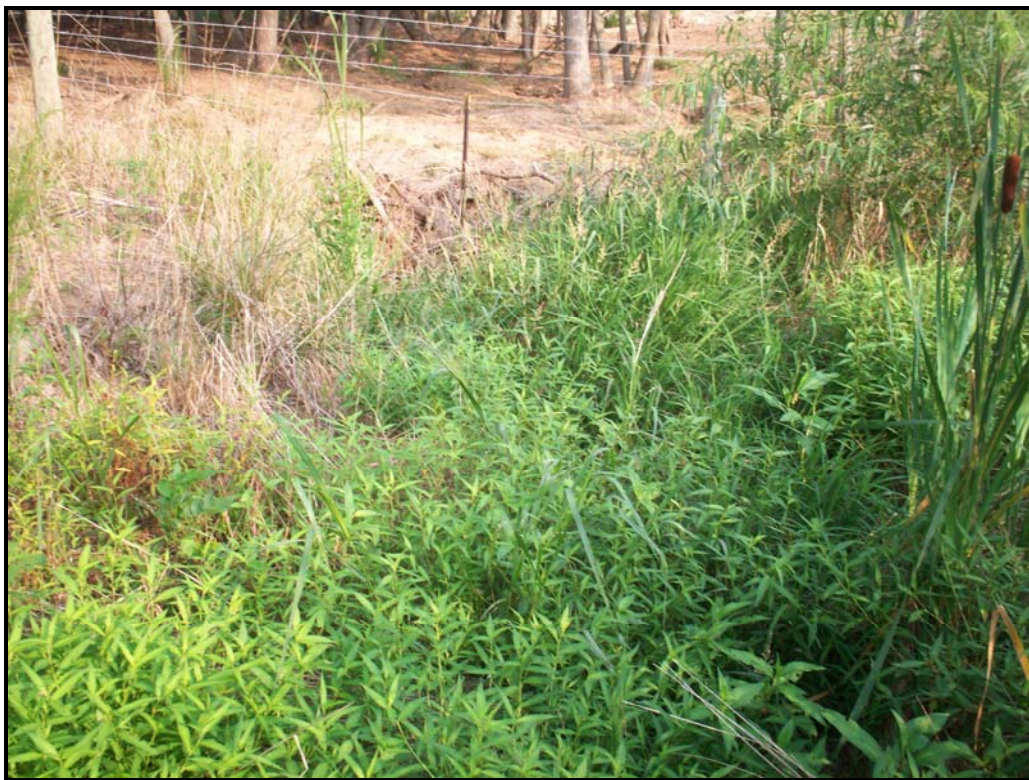
**Photo 8. Upstream end of UT-2 – looking upstream; vegetation in channel.**

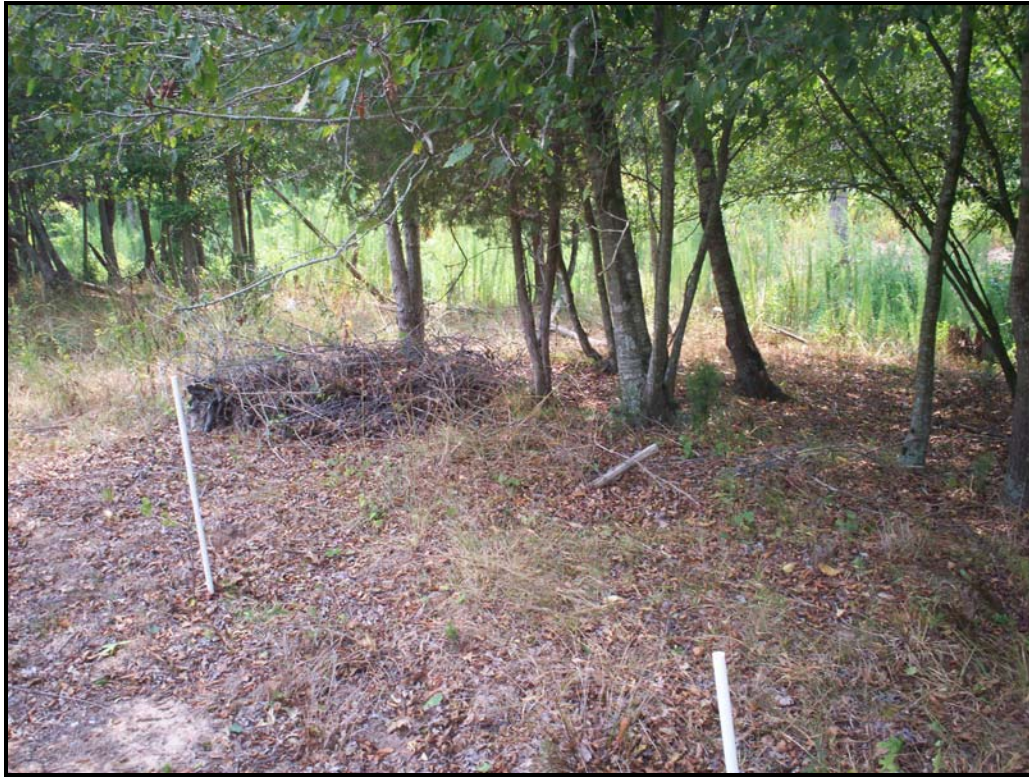
**Photo 9. Vegetation Plot #1.**

Type of Problem	Location/ Station	Probable Cause	Photo ID
Potential mortality of planted woody species.	Vegetation Plot 1	Dry conditions	Photo 9 - VP 1

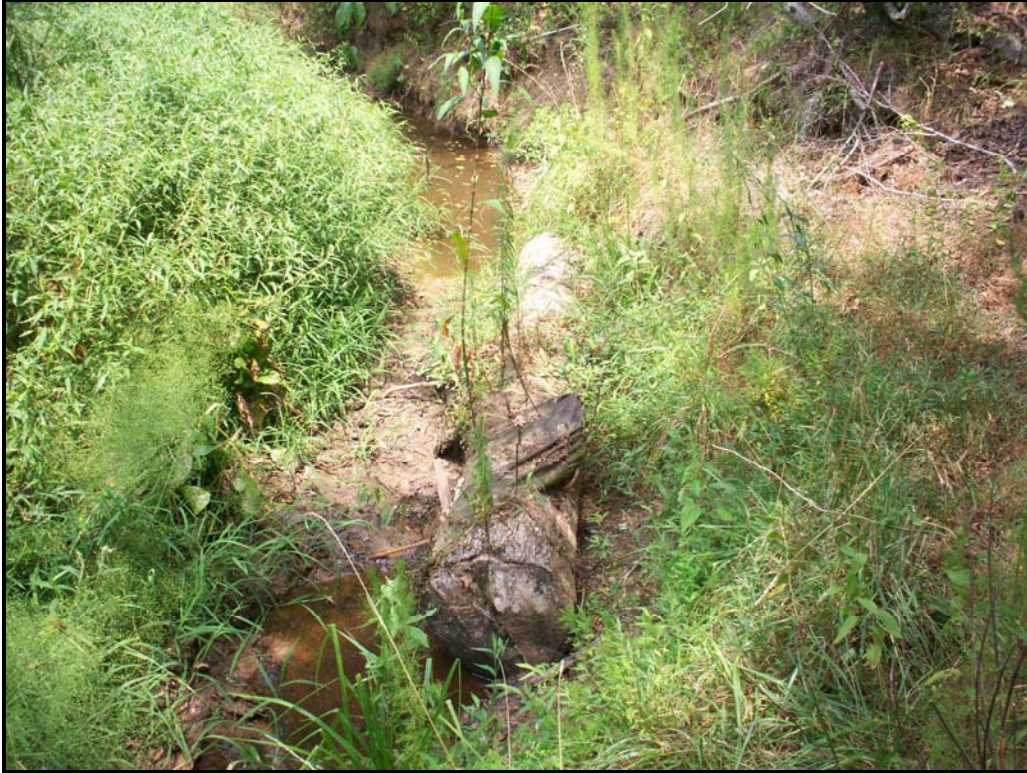
Feature Issue	Station Numbers	Suspected Cause	Photo Number
Log toe rolled into channel.	56+25	Improper installation	SPA1
Right bank erosion	46+90	Caused by deer and sparse vegetation	SPA2
Debris jam	32+50	Fallen tree blocking water flow	SPA3
Left bank erosion	30+60	Sparse vegetation	SPA4
Log vane exposed	24+85	High velocity flows, and degradation	SPA5
Grade control structure head cut	21+60	Improper installation	SPA6
Log vane exposed	13+75	High velocity flows, and degradation	SPA7

**Photo 23. SPA 1. Log toe on right bank at STA 56+25; rolled into channel.**

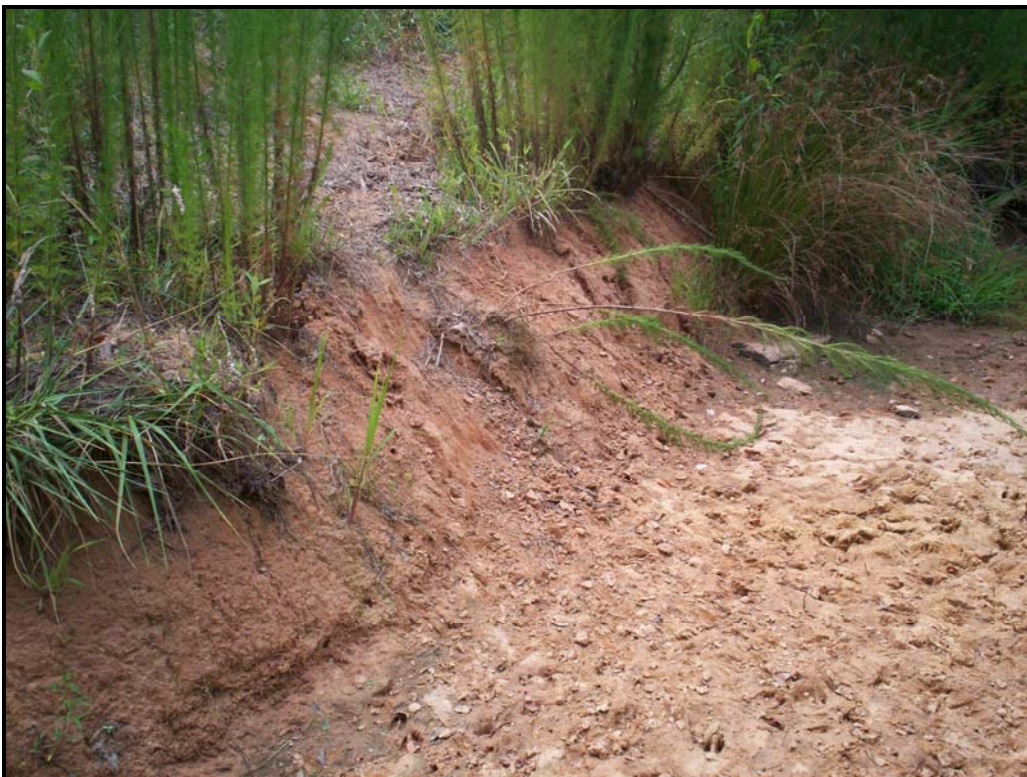
**Photo 24. SPA 2. Right bank erosion caused by deer and sparse vegetation at STA 46+90.**

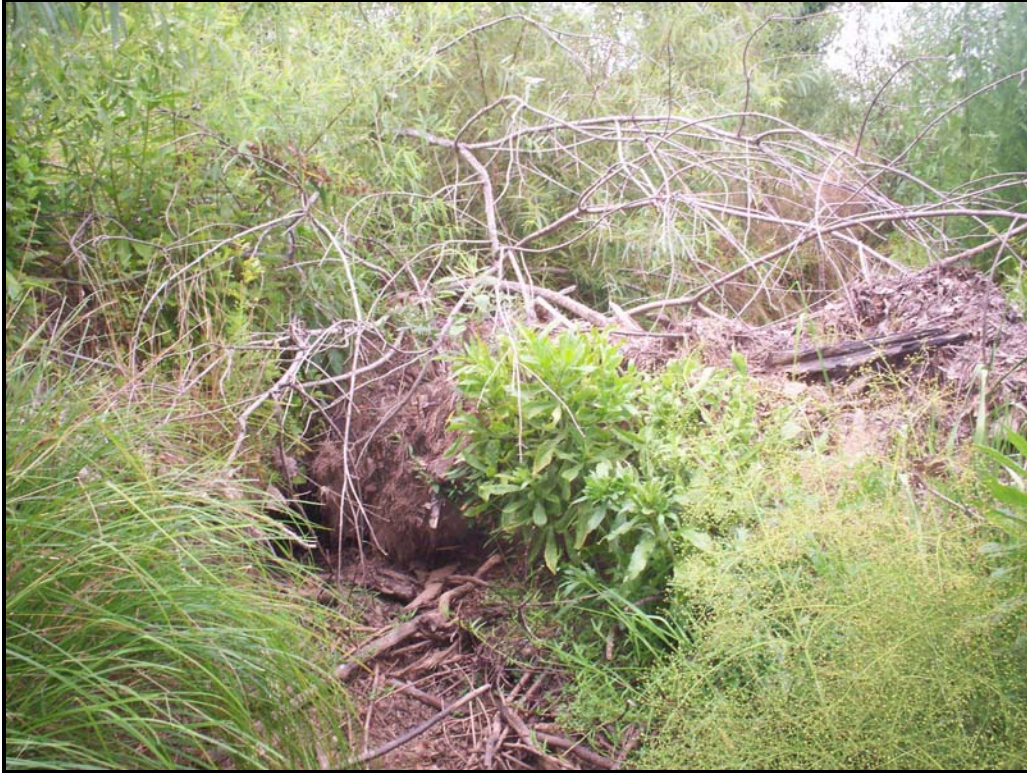
**Photo 25. SPA 3. Debris jam caused by fallen tree at STA 32+50 – looking downstream.**

The stream morphology is stable. Very little fluvial erosion was observed. Sedimentation that has occurred in the stream channel is minor and does not need to be addressed at this time. Removal of the debris jam at station 32+50 is recommended to help reduce channel blockage and reduce bank erosion. The log toe at station 56+25 should also be repaired by removing it out of the channel and replacing it to design specifications. At station 21+60, a head cut has developed just downstream of the grade control structure which needs to be repaired as well.

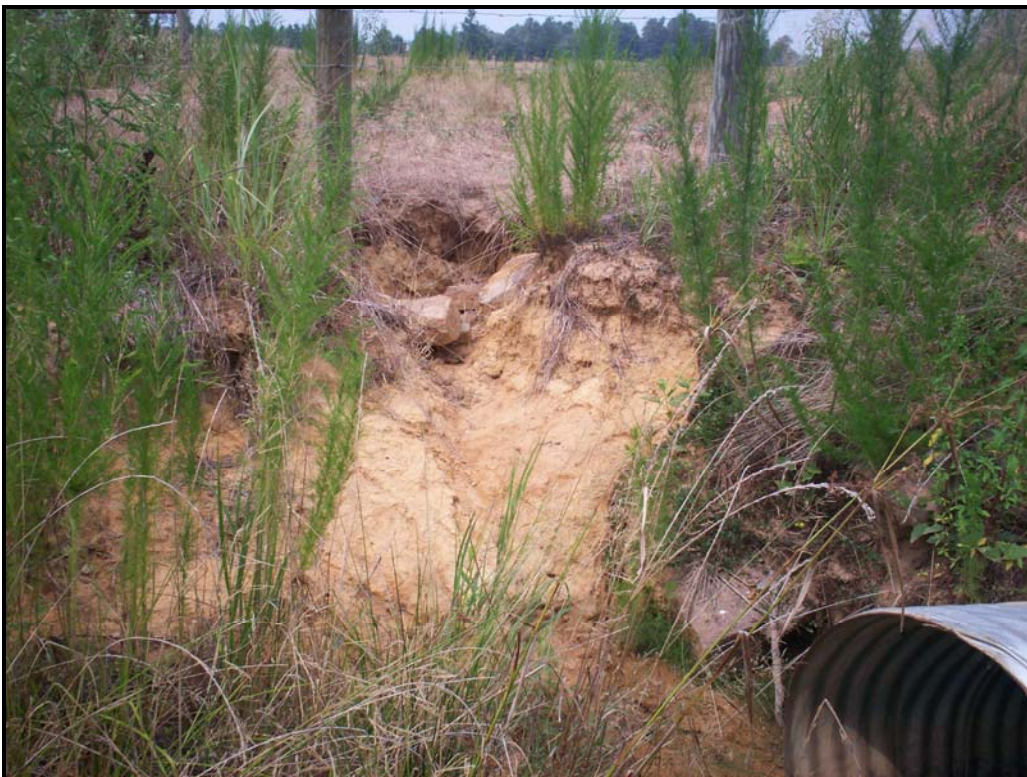
**Photo 26. SPA 4. Left bank erosion at upstream end of culvert STA 30+60.**

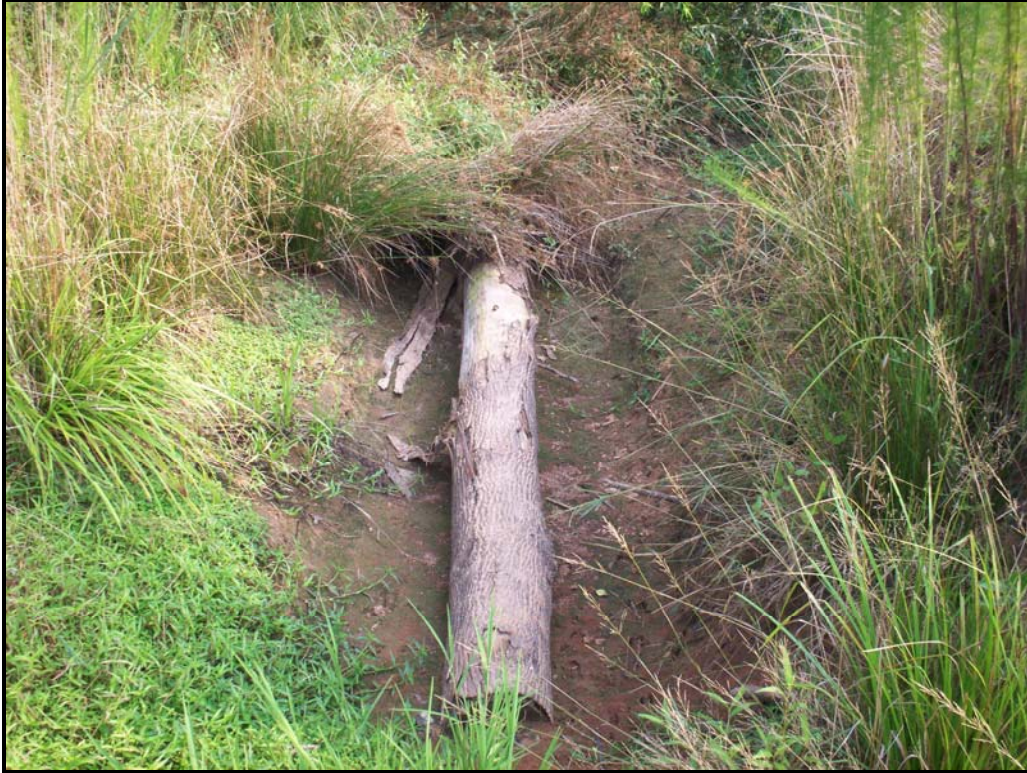
**Photo 27. SPA 5. Log vane at STA 24+85-looking downstream; US end of log vane is exposed.**

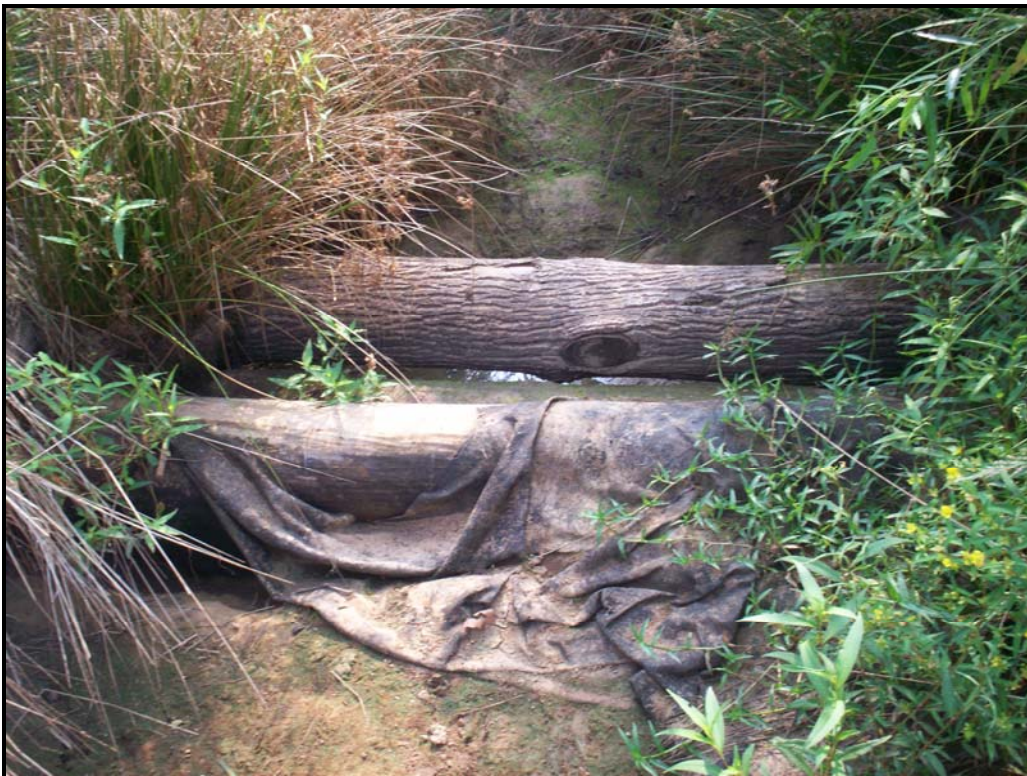
**Photo 28. SPA 6. Grade control structure at STA 21+60-looking upstream; structure is not performing properly and has formed a head cut behind the structure.**

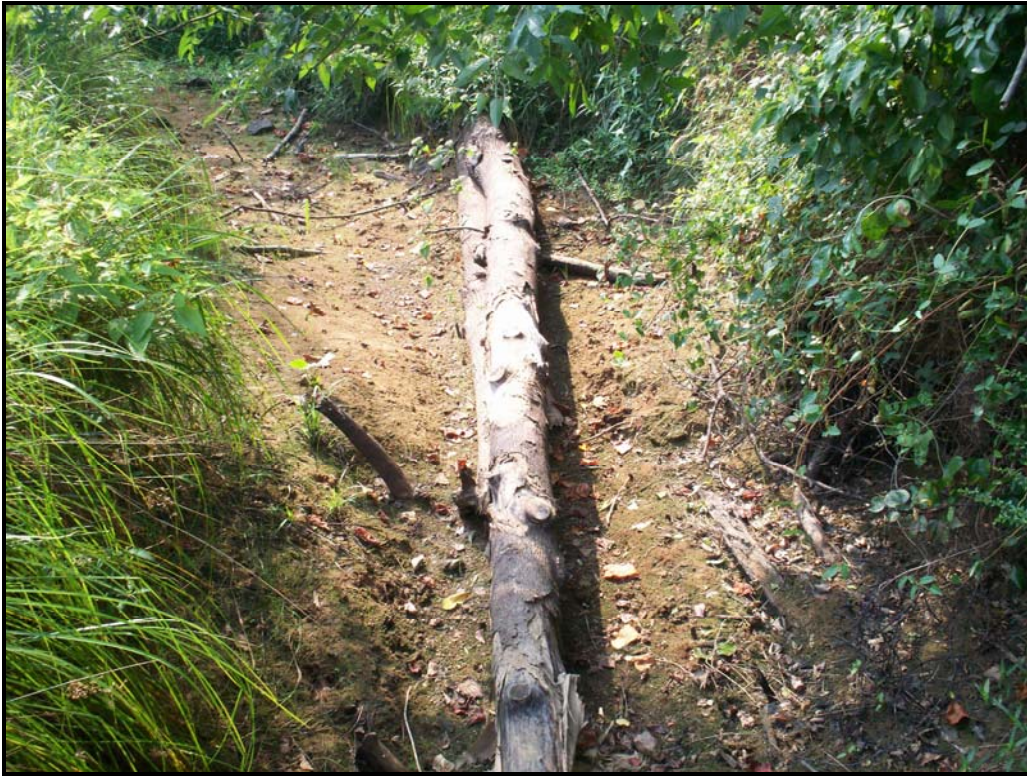
**Photo 29. SPA 7. Log vane at STA 13+75 -looking downstream; US end of log vane is exposed.**
