**Stonebridge Mitigation Project
Moore County, North Carolina**

Year 3 Monitoring Report

October 2008

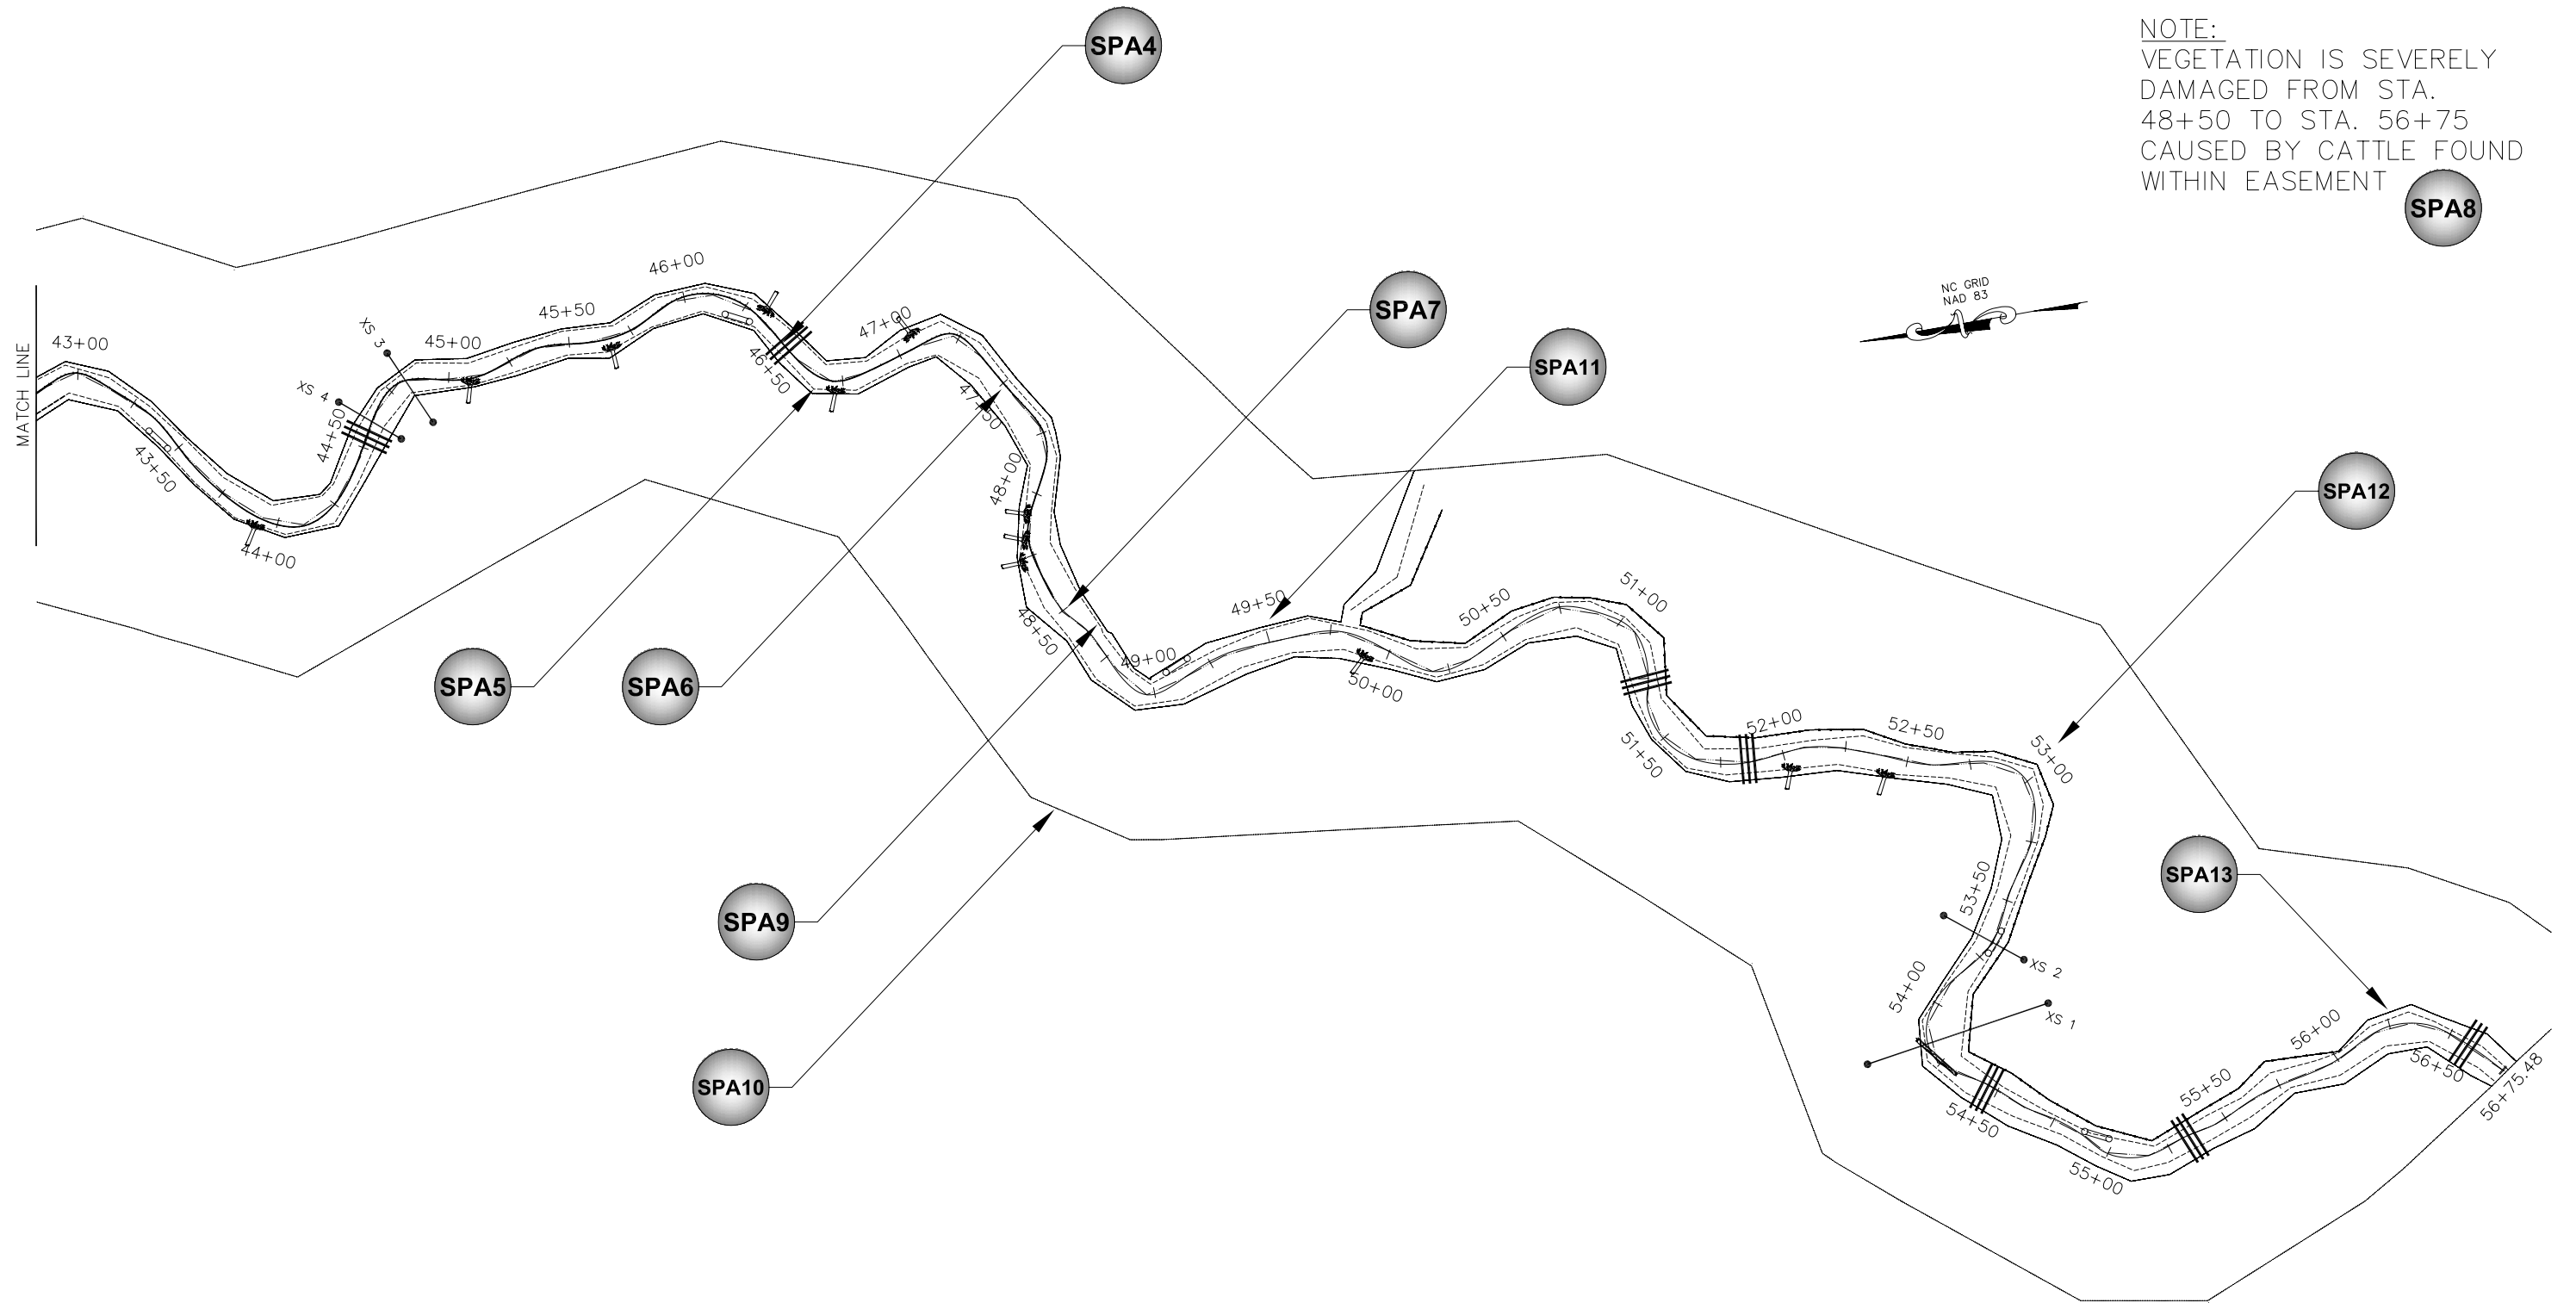
Figure 4D

NOTE:
 VEGETATION IS SEVERELY
 DAMAGED FROM STA.
 48+50 TO STA. 56+75
 CAUSED BY CATTLE FOUND
 WITHIN EASEMENT

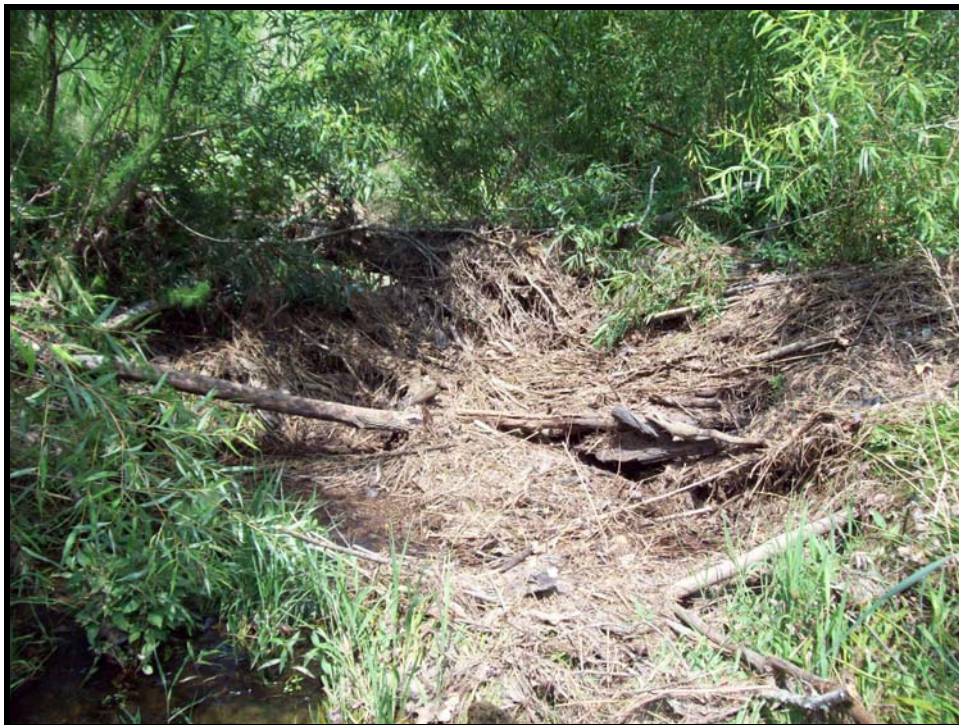
| SPA | Reach | Station | Description | Recommended Action |
|---|---|---|---|--|
| 4 | UT1 | 46+50 | Debris jam caused by fallen tree blocking water flow | Remove debris jam |

SPA 4. Debris jam caused by fallen tree blocking water flow at Station 46+50.

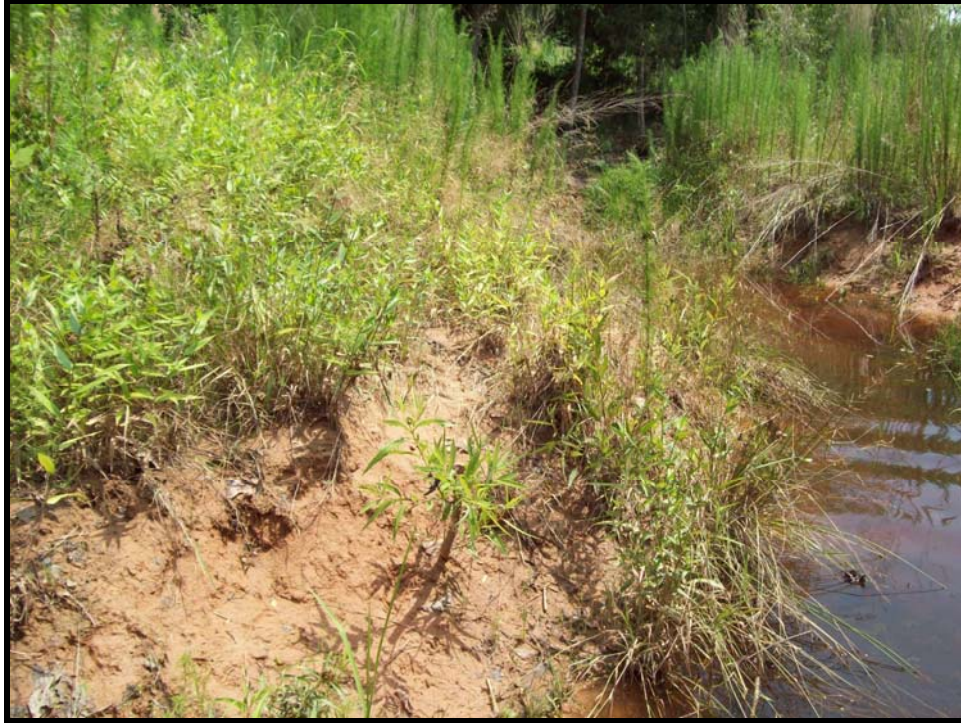
SPA 5. Minor erosion on right bank at Station 46+65.

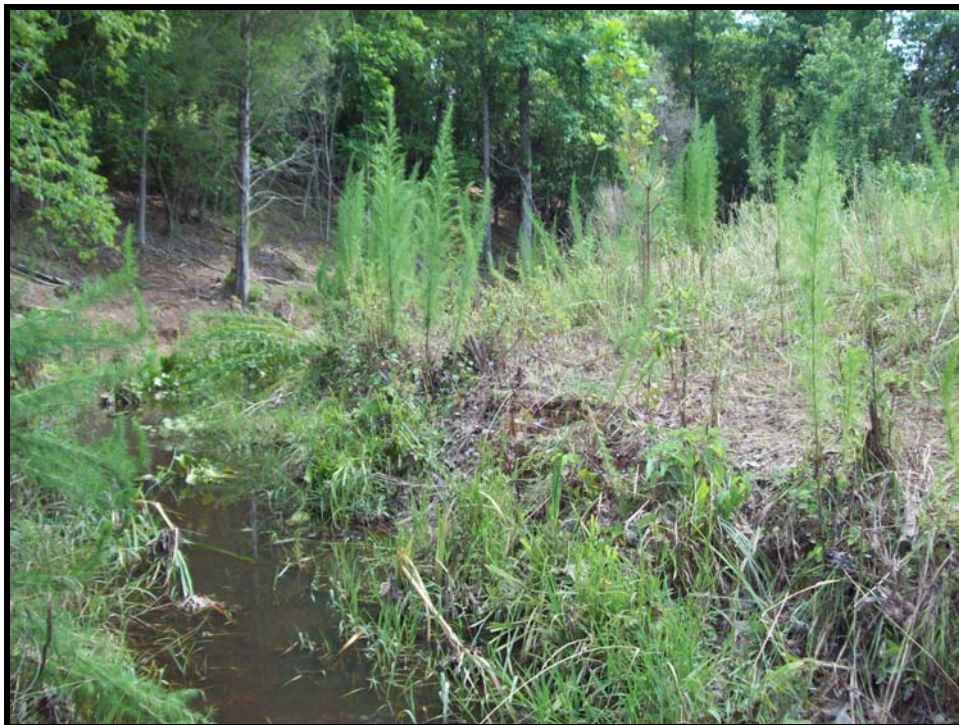
| SPA | Reach | Station | Description | Recommended Action |
|---|---|---|---|--|
| 8 | UT1 | 48+50 to 56+75 | Severe damage to vegetation and bank erosion caused by cattle within easement | None |

SPA 8. Severe damage to vegetation and bank erosion caused by cattle within easement from Station 48+50 to 56+75.

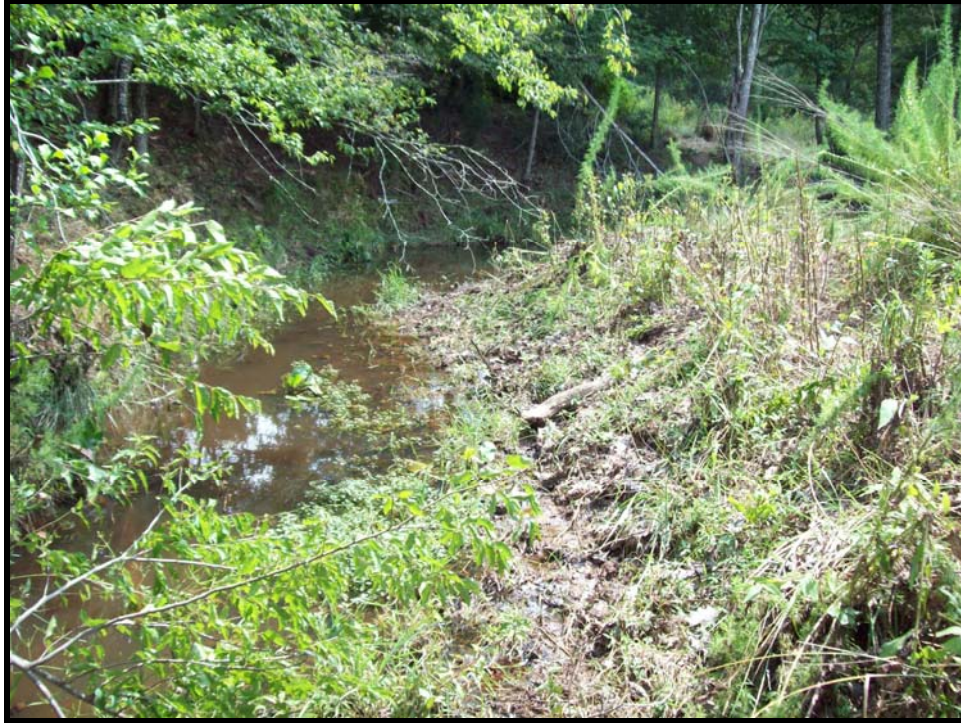
SPA 8. Damage to vegetation and bank erosion caused by cattle within easement from Station 48+50 to 56+75.

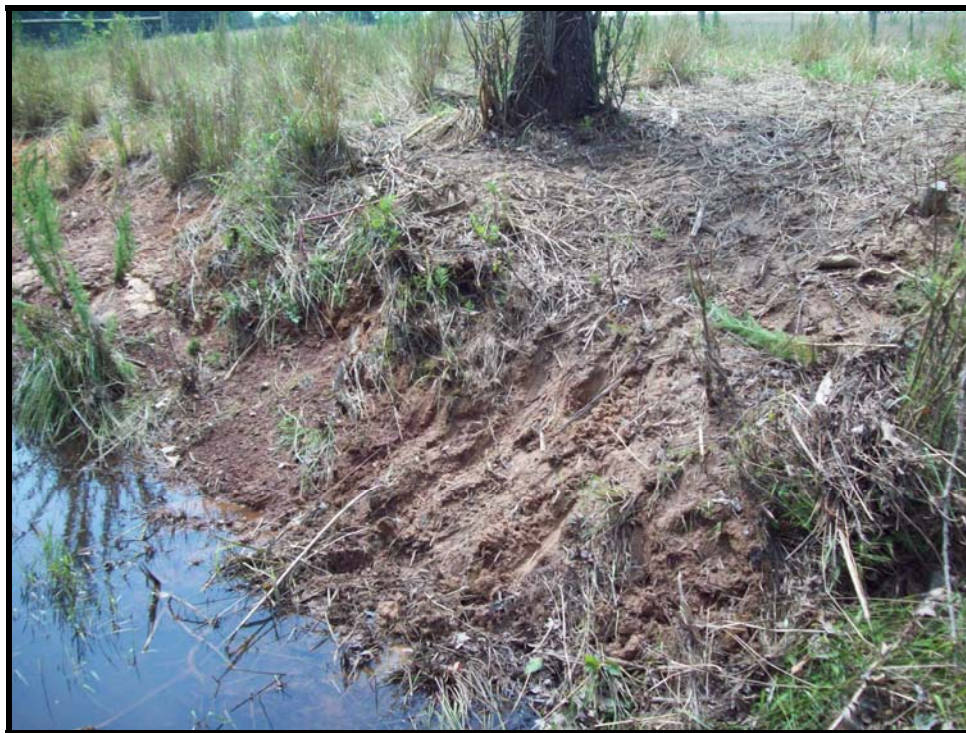
SPA 9. Erosion on left bank due to hoof shear from cattle at Station 48+60.

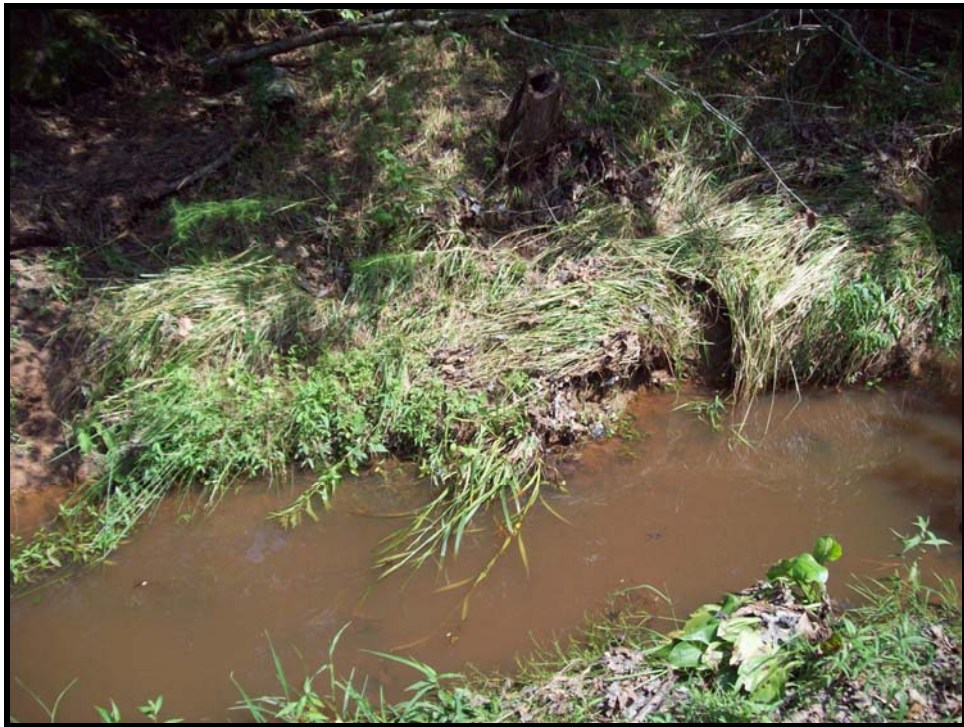
| SPA | Reach | Station | Description | Recommended Action |
|---|---|---|---|--|
| 13 | UT1 | 56+25 | Log toe structure missing | None |

SPA 13. Log toe structure missing at Station 56+25.
