**Stonebridge Mitigation Project
Moore County, North Carolina**

FINAL Year 4 Monitoring Report

September 2009

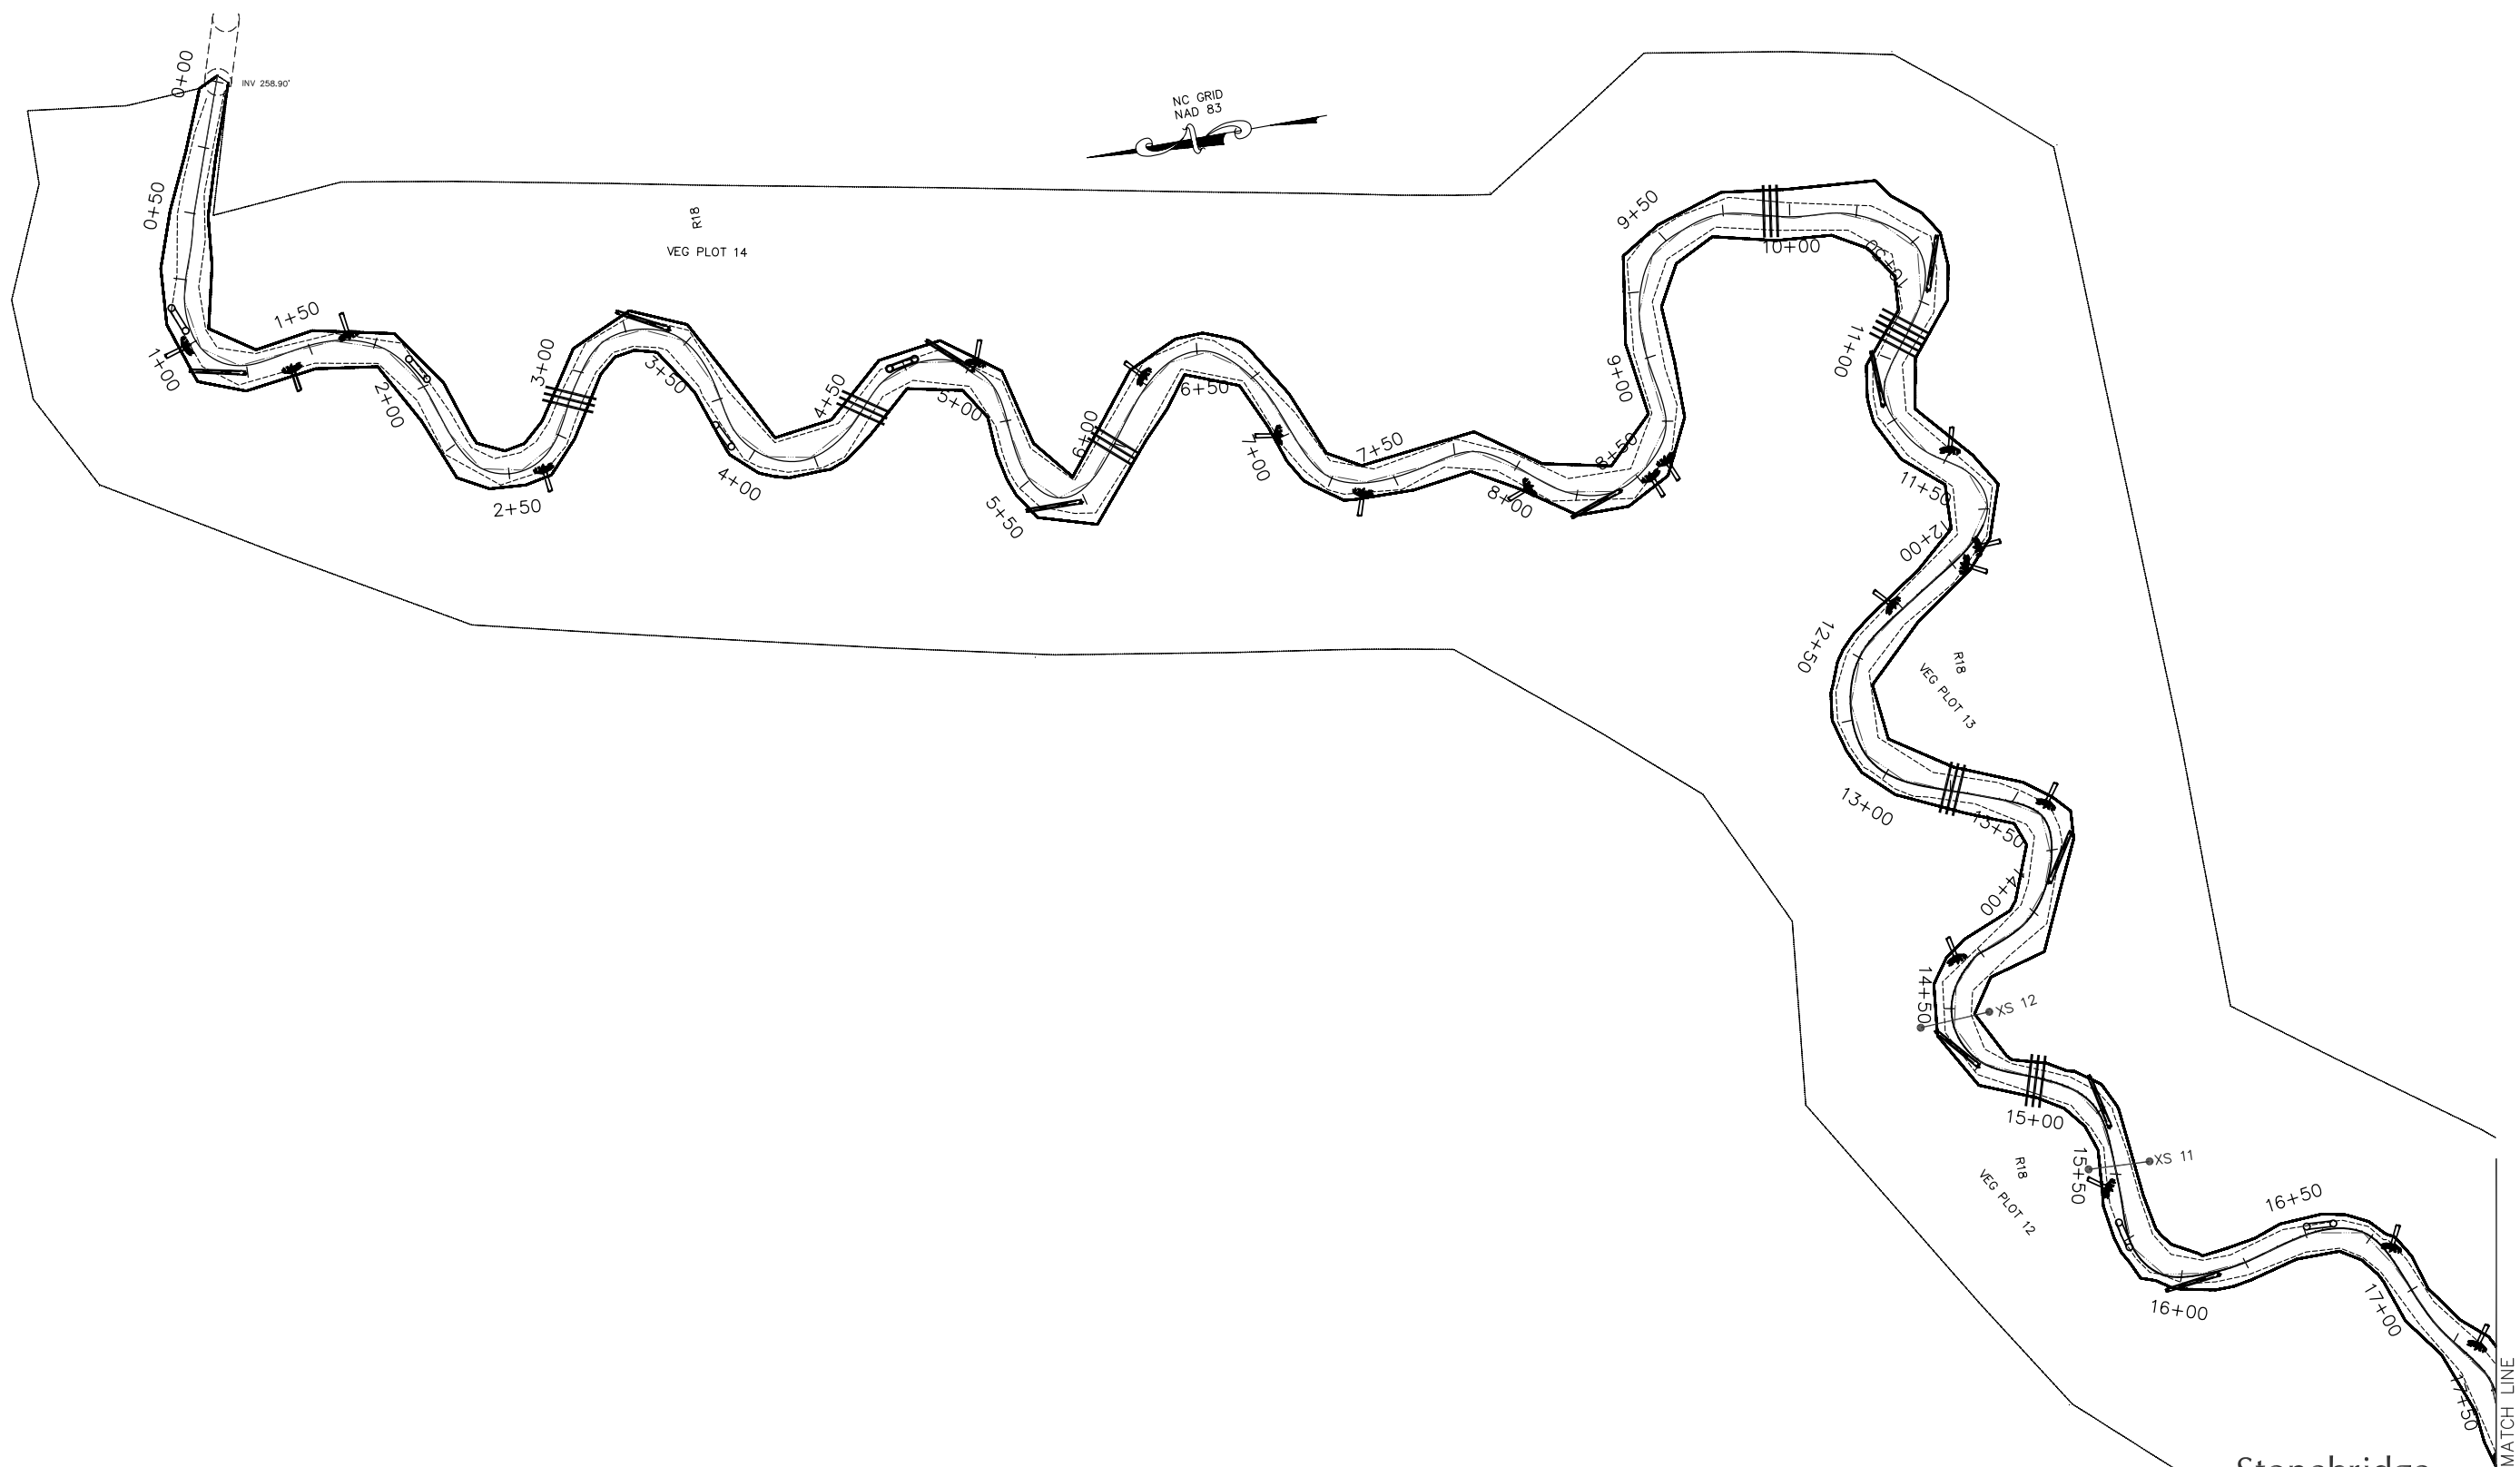
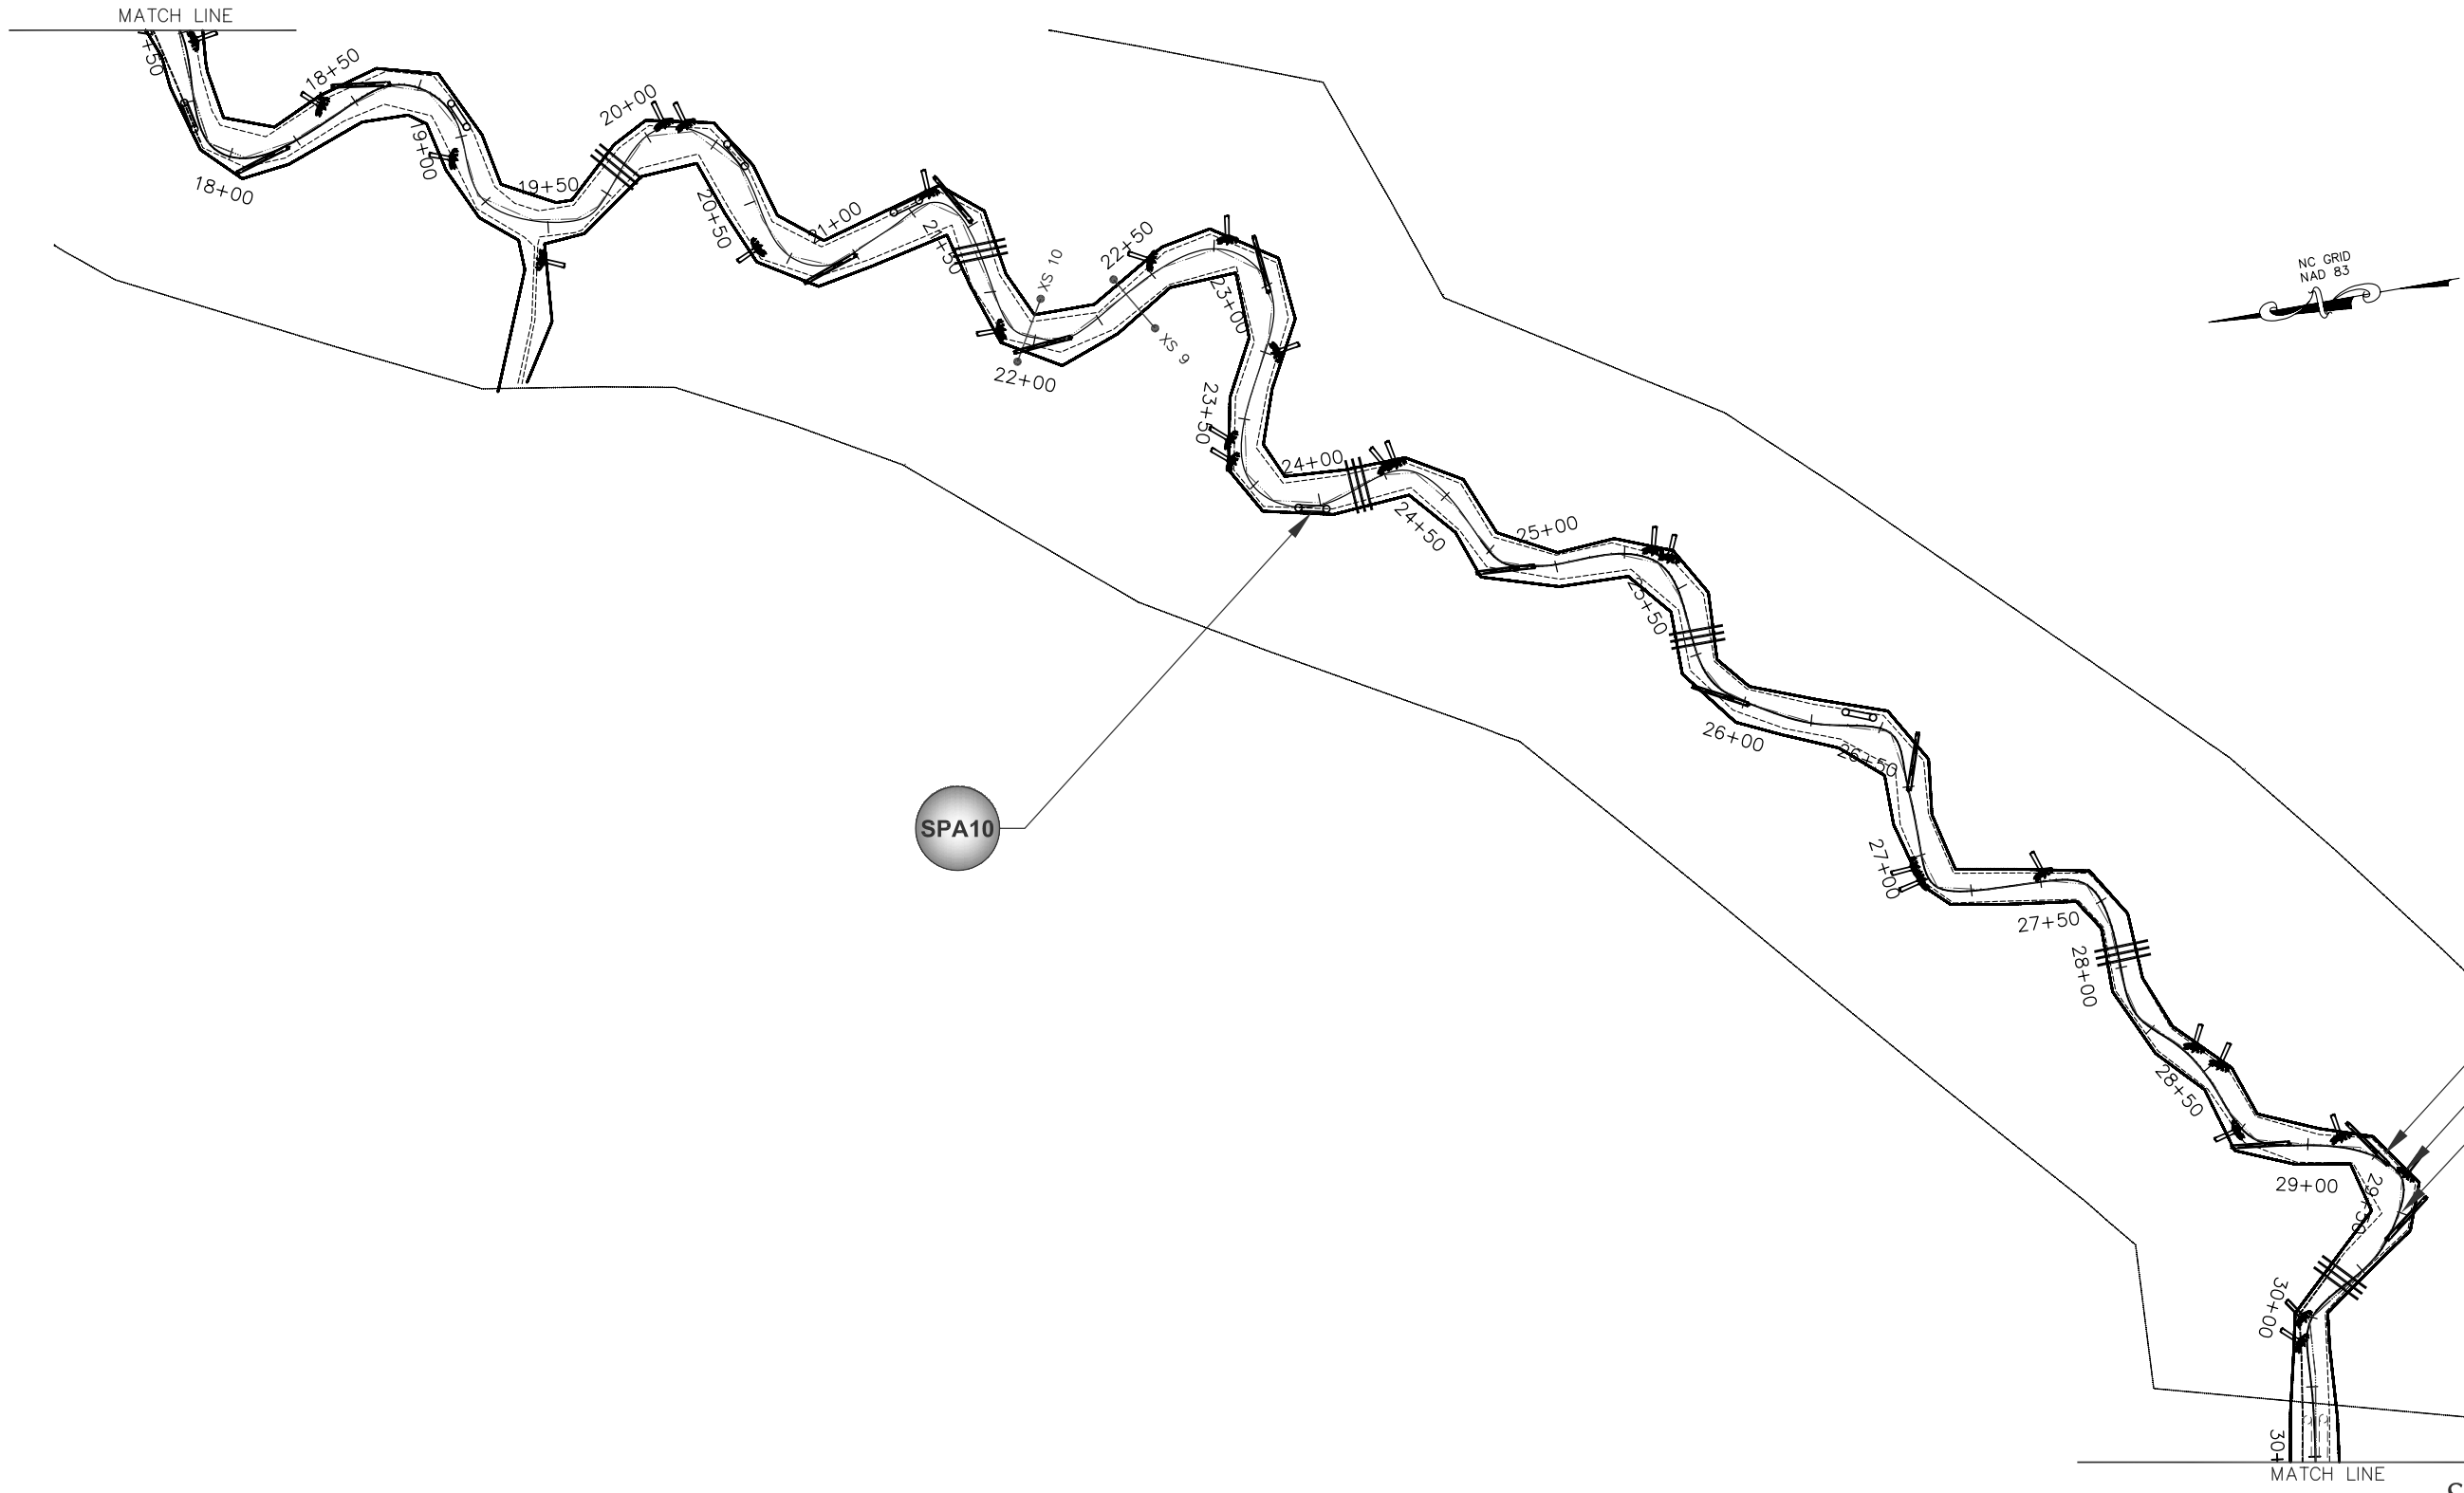
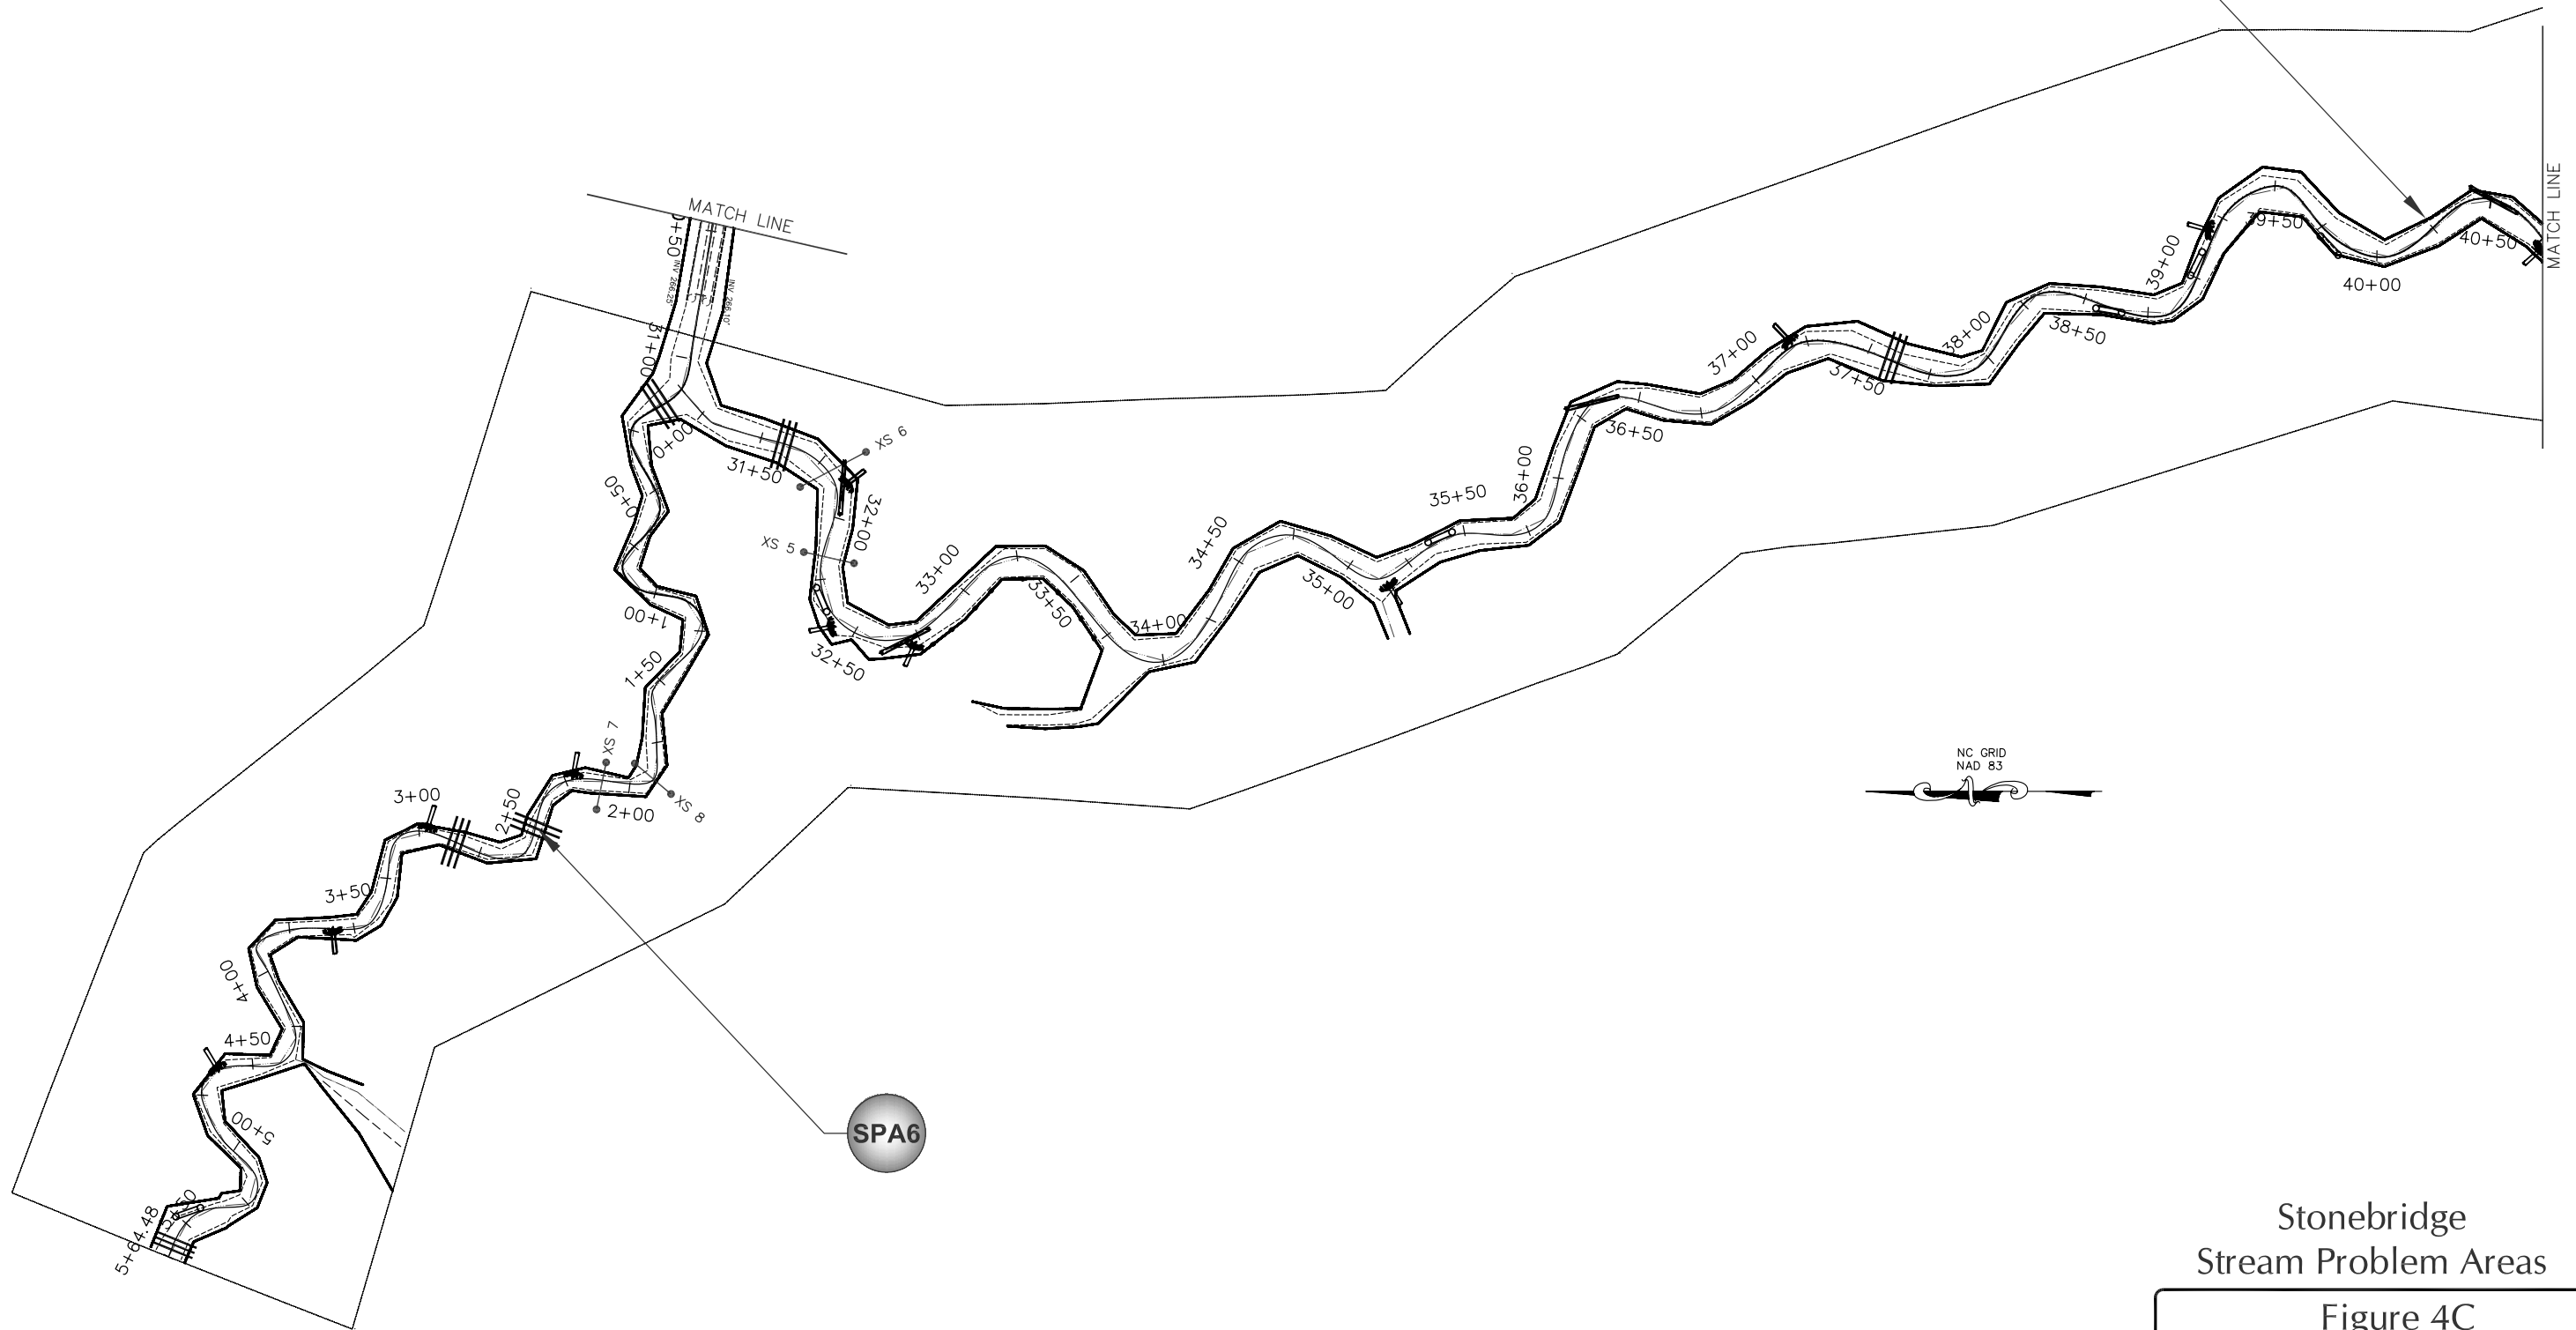
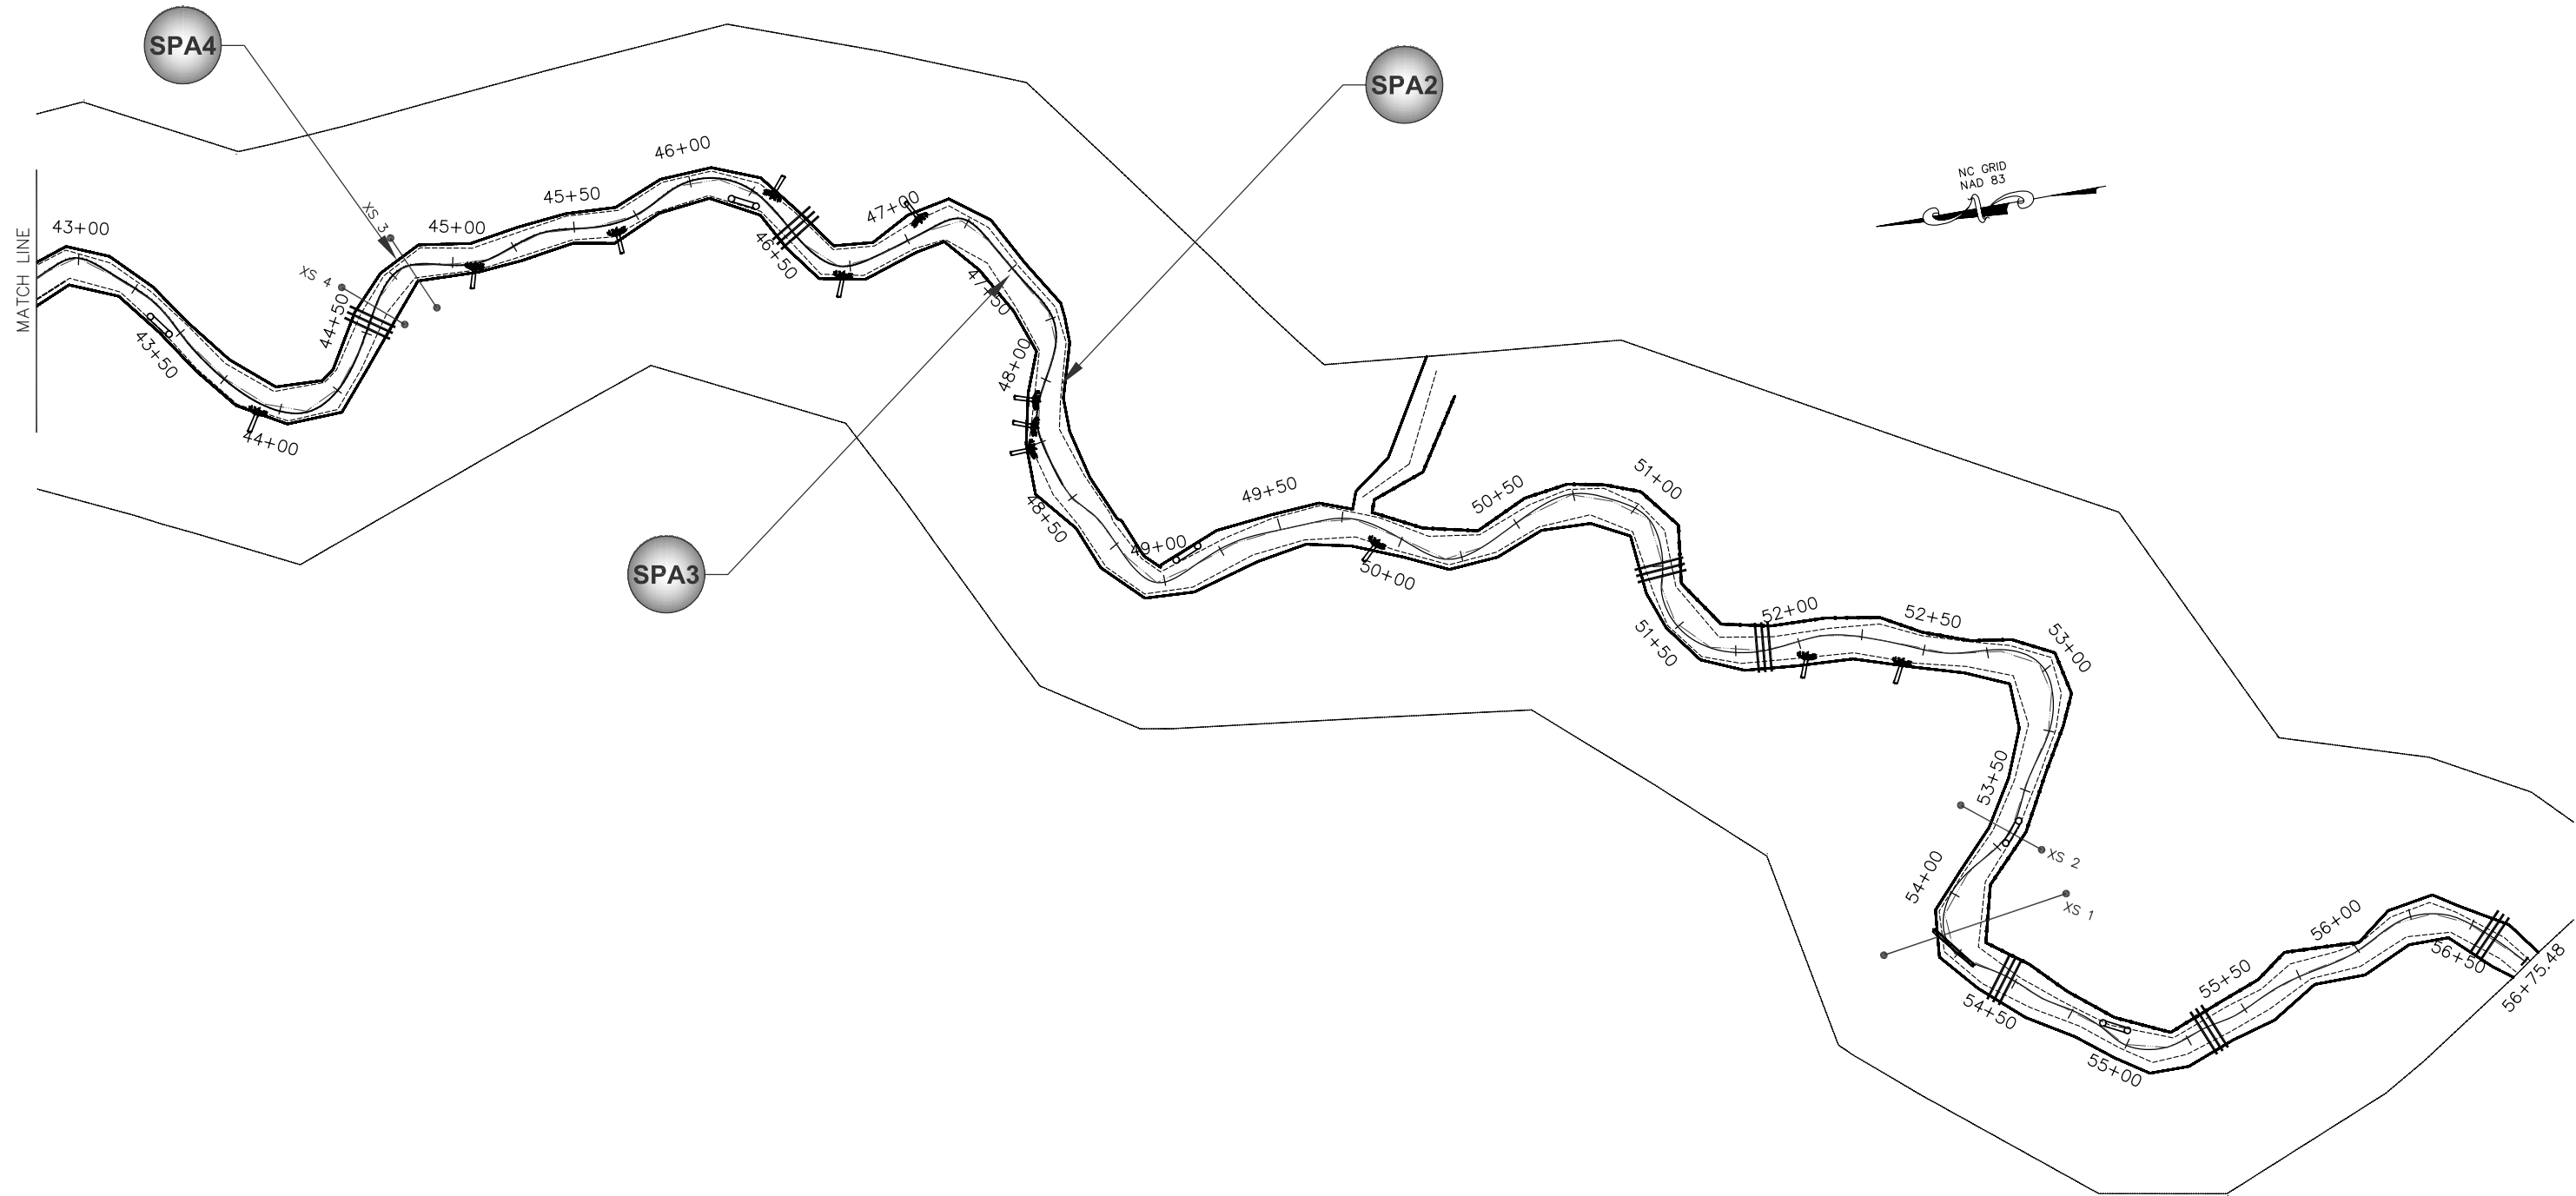
NOTE:
HEAVY VEGETATION IN CHANNEL
THROUGHOUT REACH UT1

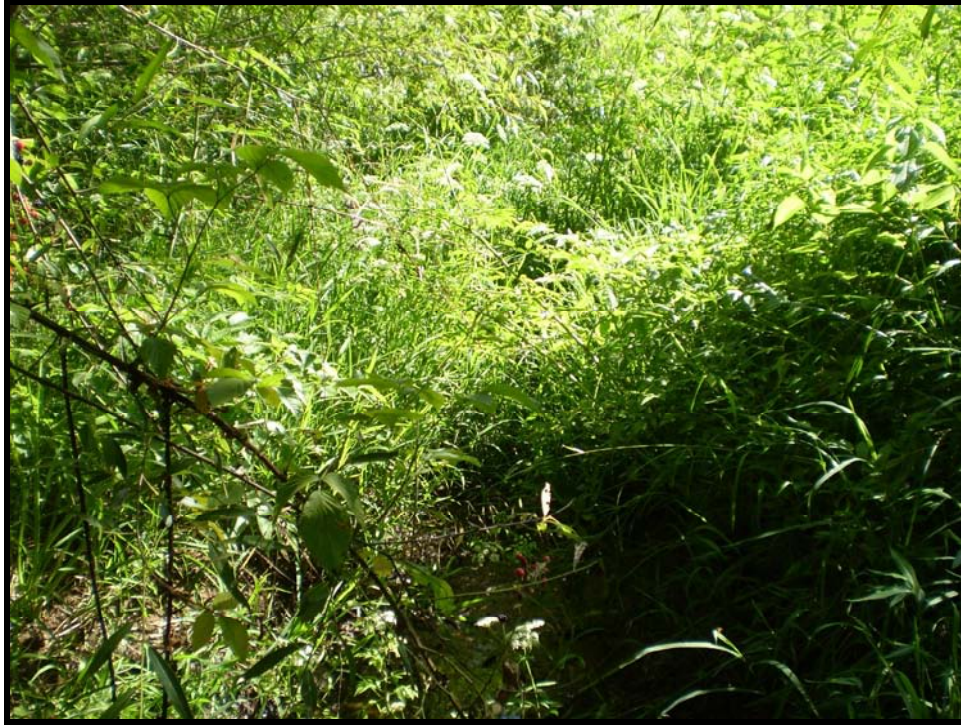
Feature	STA	Description	Photo Number
Mid Channel Bar	Throughout UT1	Sediment in channel allowing vegetation to root in the channel, no action recommended	SPA 1
Damaged Fence	UT1 48+00	Fallen trees and debris have damaged fence, repair is needed in order to prevent cattle from entering easement	SPA2
Right Bank Erosion	UT1 47+50 to 47+80	Minor erosion on right bank, will continue to monitor	SPA3
Left Bank Erosion	UT1 44+60 to 45+10	Minor erosion on left bank, will continue to monitor	SPA4
Right Bank Erosion	UT1 40+10 to 40+50	Minor erosion on right bank, will continue to monitor	SPA5
Log Grade Control	UT2 2+50	Water flowing under and around log grade control causing erosion, repair is recommended to prevent headcut and additional structure failures	SPA6
Log Vane	UT1 29+50	Water flowing under and around log vane causing erosion, repair is recommended to prevent headcut and additional structure failures	SPA7

SPA 1 – Typical vegetation in channel throughout UT1.

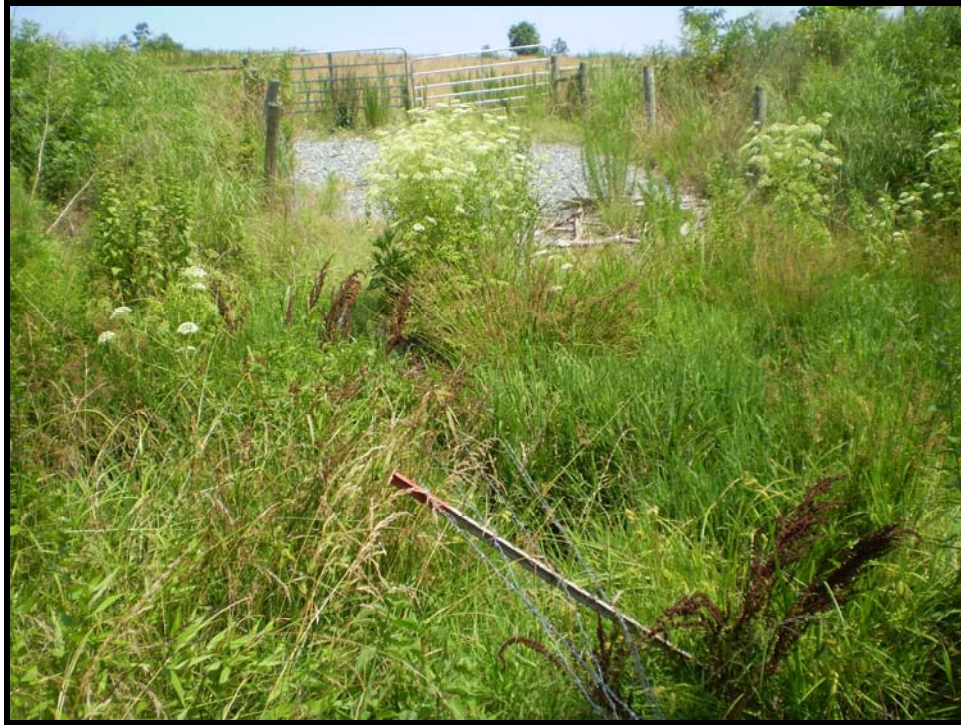
SPA 2 – Damaged fence, UT1 Sta. 48+00.

The stream morphology is stable, and little fluvial erosion was observed. Sedimentation that has occurred in the stream channel is minor and does not need to be addressed at this time. The fences along the crossing near station 48+00 should be repaired to prevent bank damage from cattle entering the channel. The vegetation is surviving well.

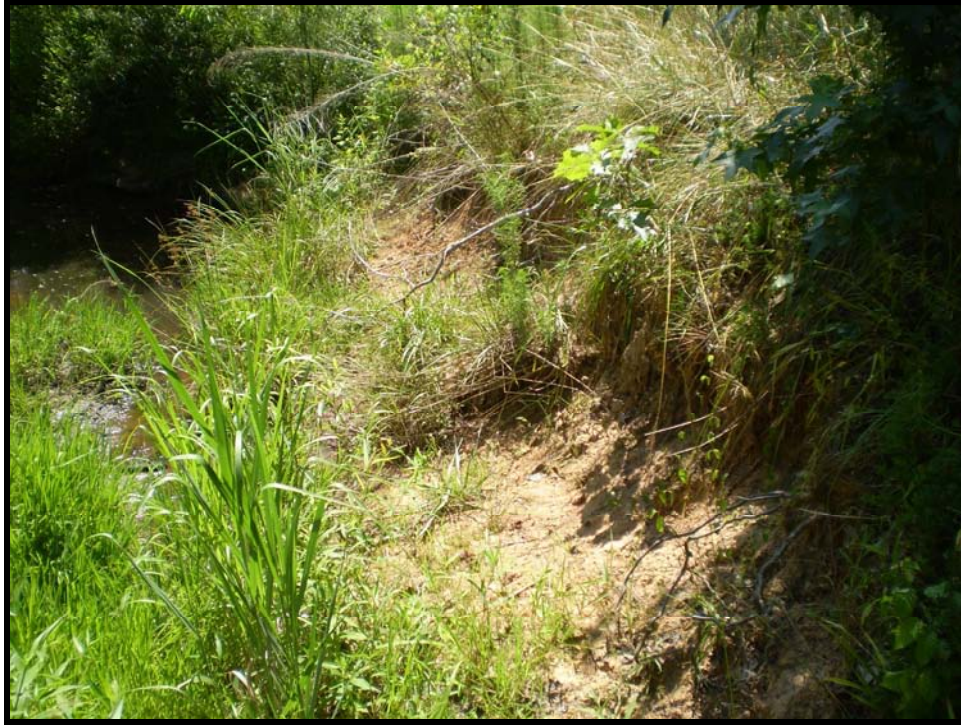
SPA 3 – Minor right bank erosion, UT1 Sta. 47+50 to 47+80.

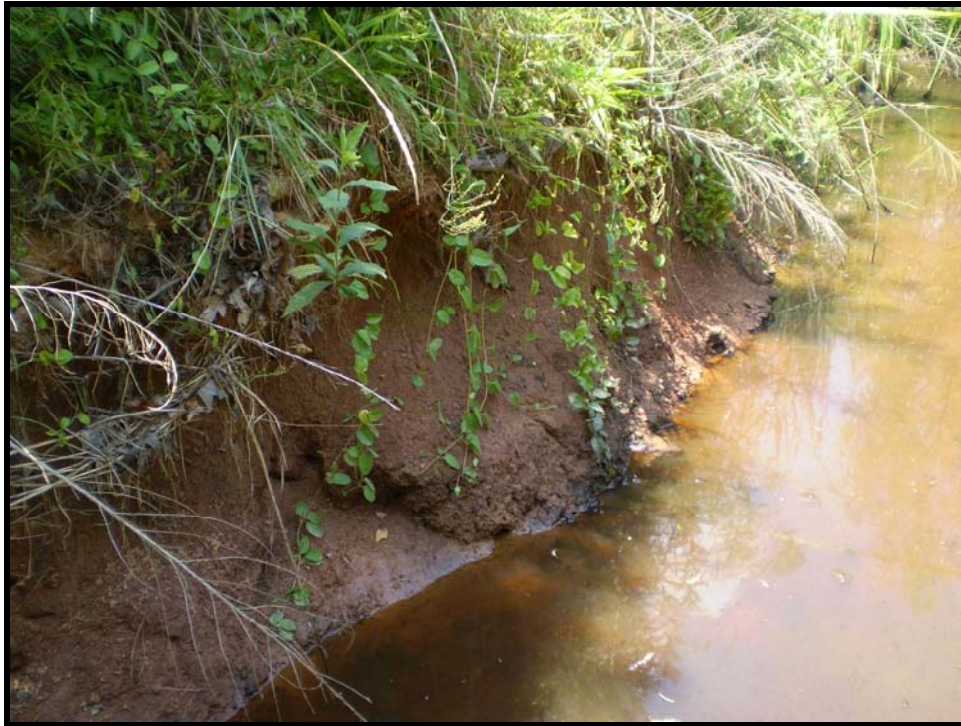
SPA 4 – Minor left bank erosion, UT1 Sta. 44+60 to 45+10.

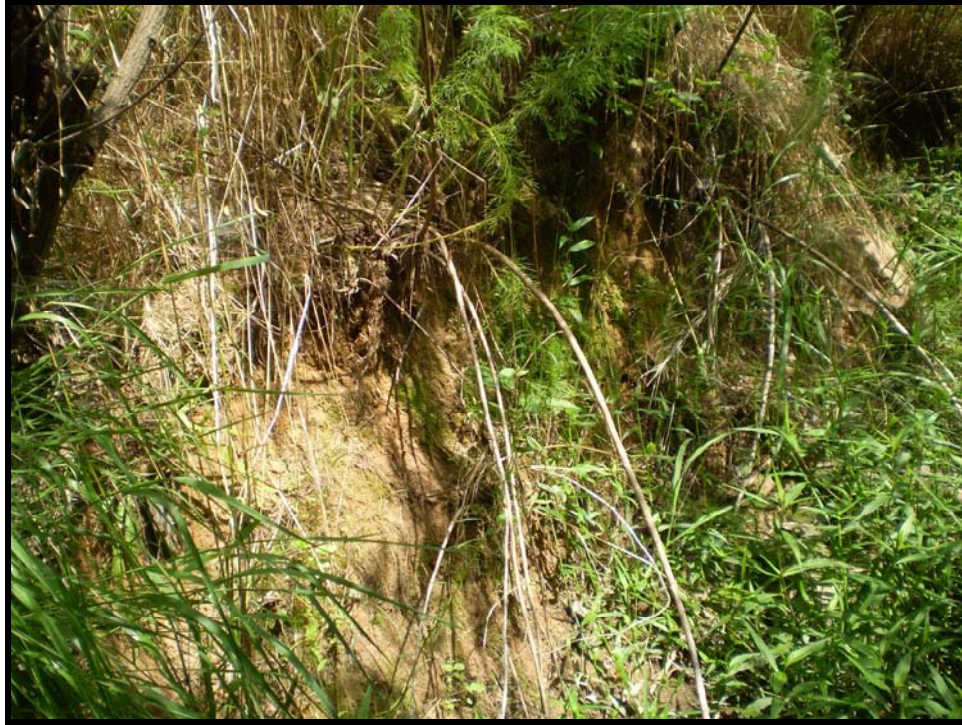
SPA 5 – Minor right bank erosion, UT1 Sta. 40+10 to 40+50.

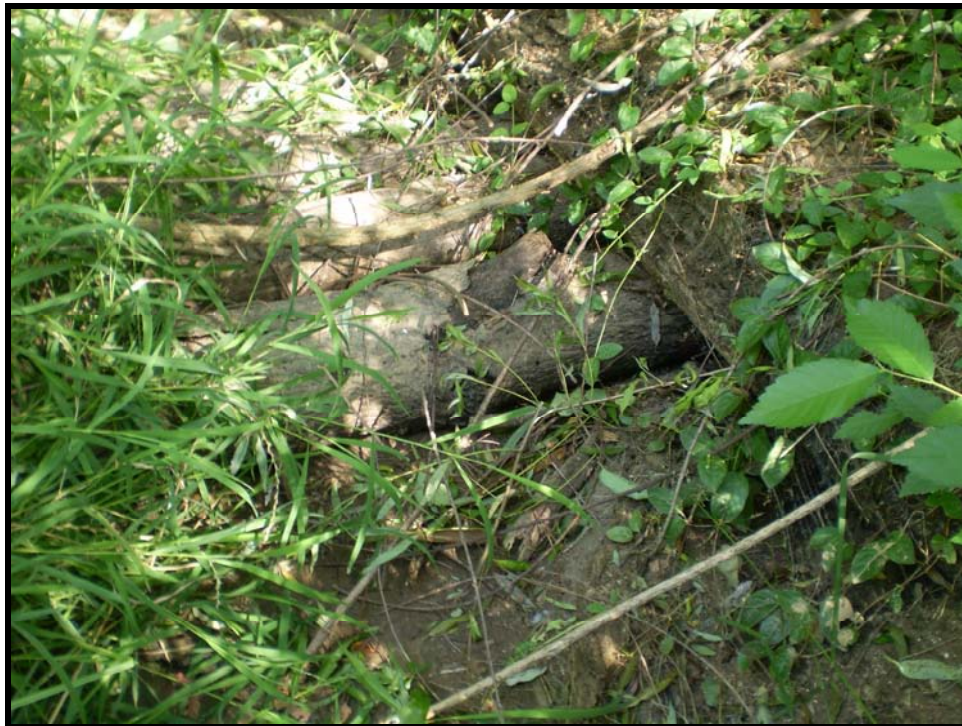
Overall, the restored stream channel has remained stable and is providing the intended habitat and hydrologic functions. Water is flowing around a log grade control structure and a log vane, causing erosion (**Table 7**, SPA6 and SPA7). It is recommended that these structures be repaired to prevent further erosion and headcuts. All monitored cross sections for 2009 show very little adjustment in stream dimension. Several bankfull events were recorded during the 2009 monitoring season, exceeding the requirement of two bankfull events within five years.

SPA 6 – Log grade control erosion, UT2, Sta. 2+50.

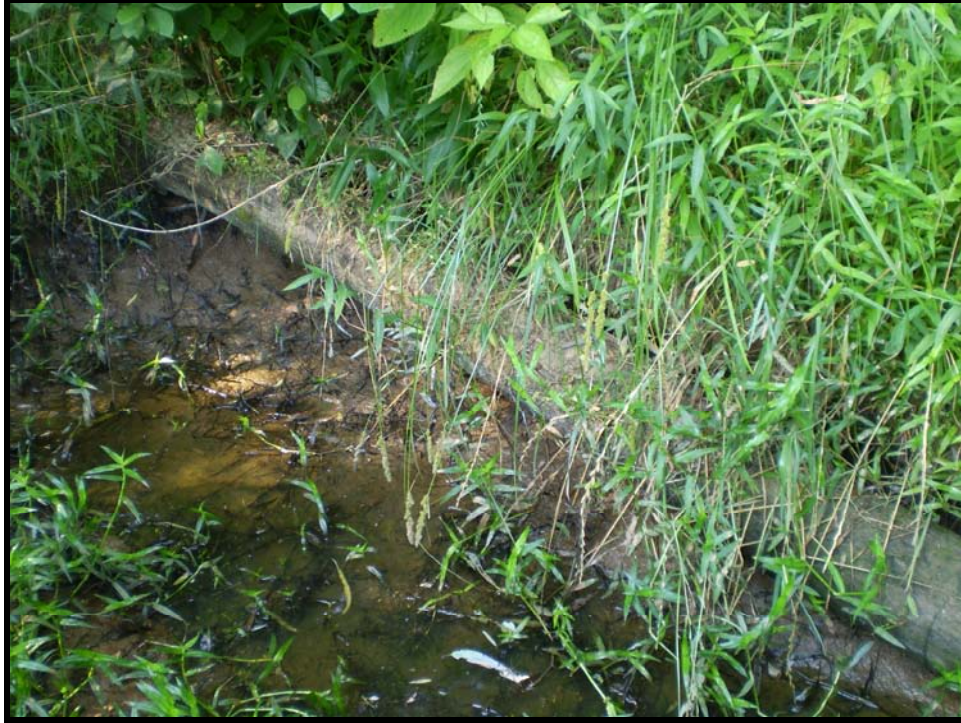
SPA 7 – Log vane erosion, UT1, Sta. 29+50.

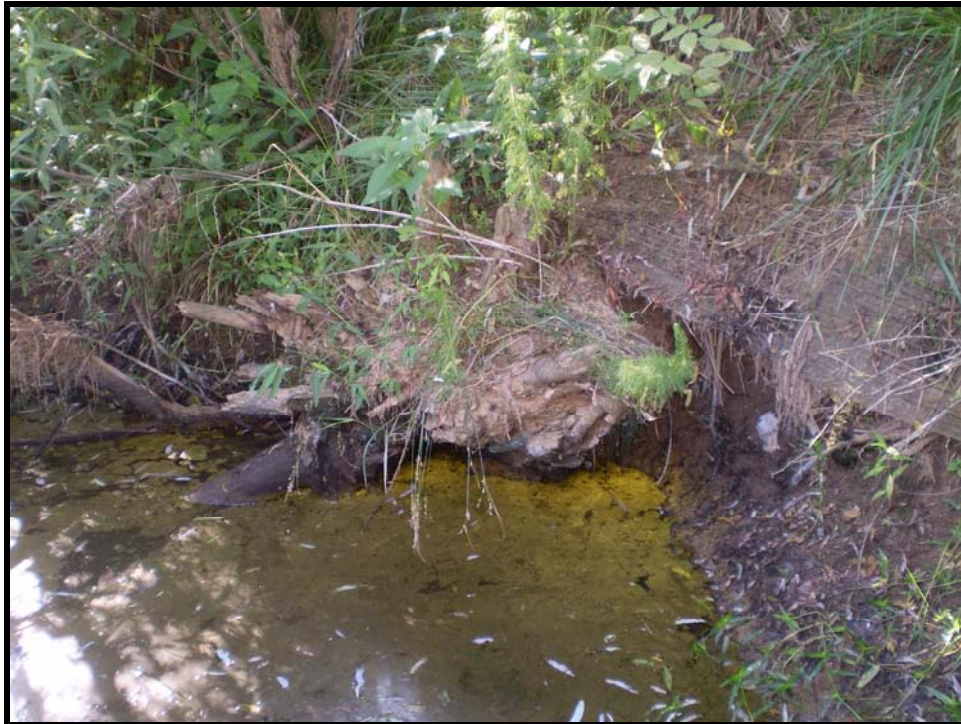
Root Wad	UT1 29+30	Erosion behind root wad, will continue to monitor	SPA8
Log Vane	UT1 29+20	Erosion along arm of log vane, will continue to monitor	SPA9
Mid Channel Bar	UT1 24+00	Sediment in channel allowing vegetation to root in the channel, no action recommended	SPA10

SPA 8 – Erosion behind root wad, UT1 Sta. 29+30.

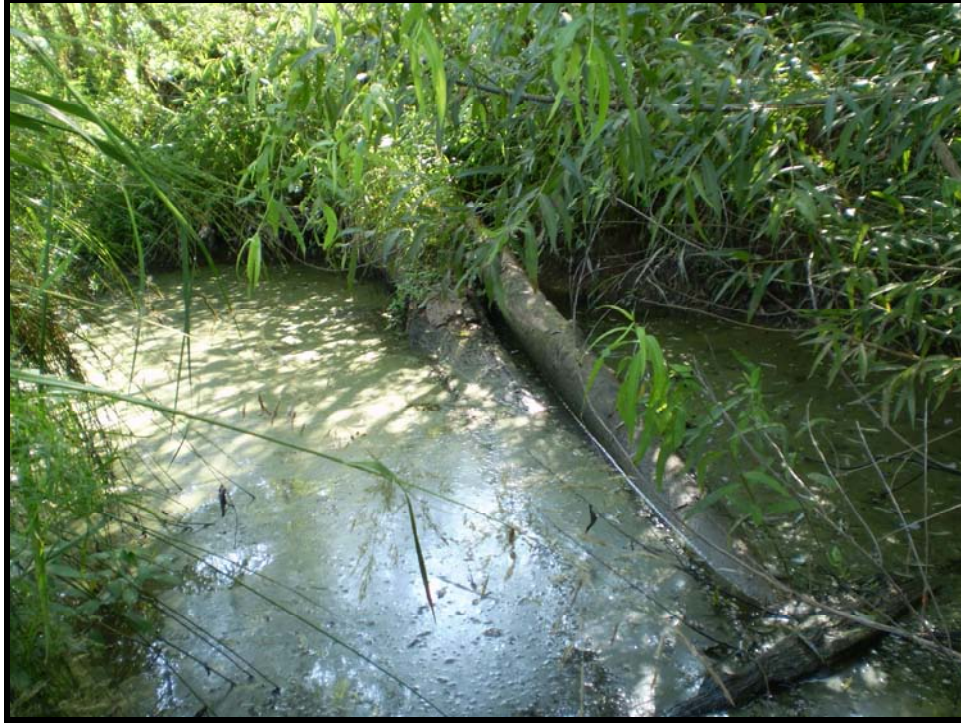
SPA 9 – Erosion behind log vane arm, UT1 Sta. 29+20.

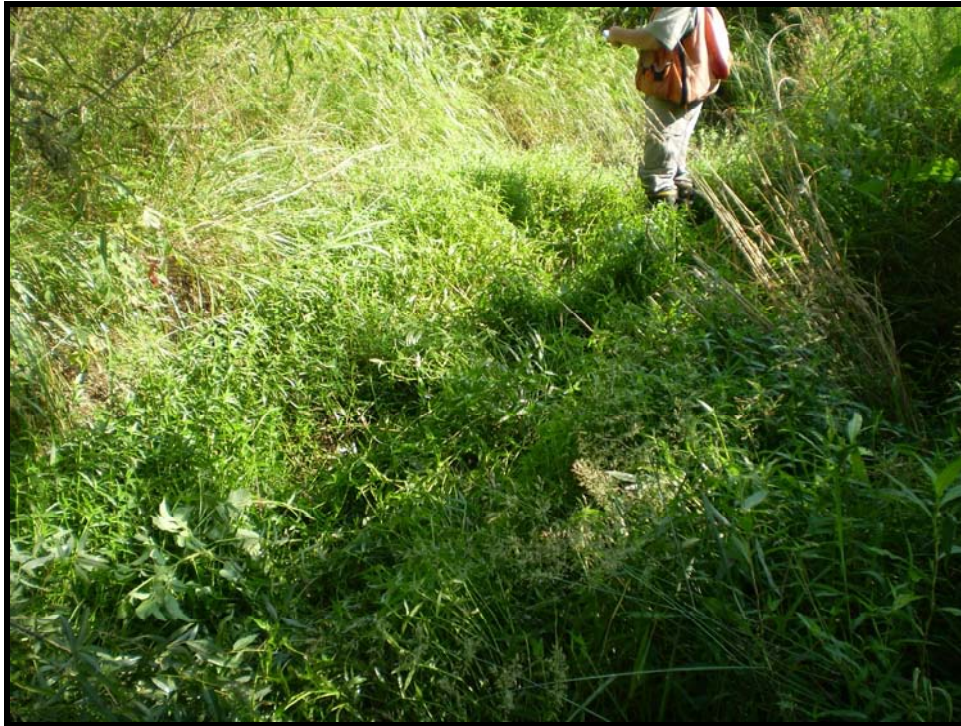
SPA 10 – Mid-channel bar, vegetation in channel, UT1 Sta. 24+00.
