**Stonebridge Mitigation Project
Moore County, North Carolina**

FINAL Year 5 Monitoring Report

September 2010

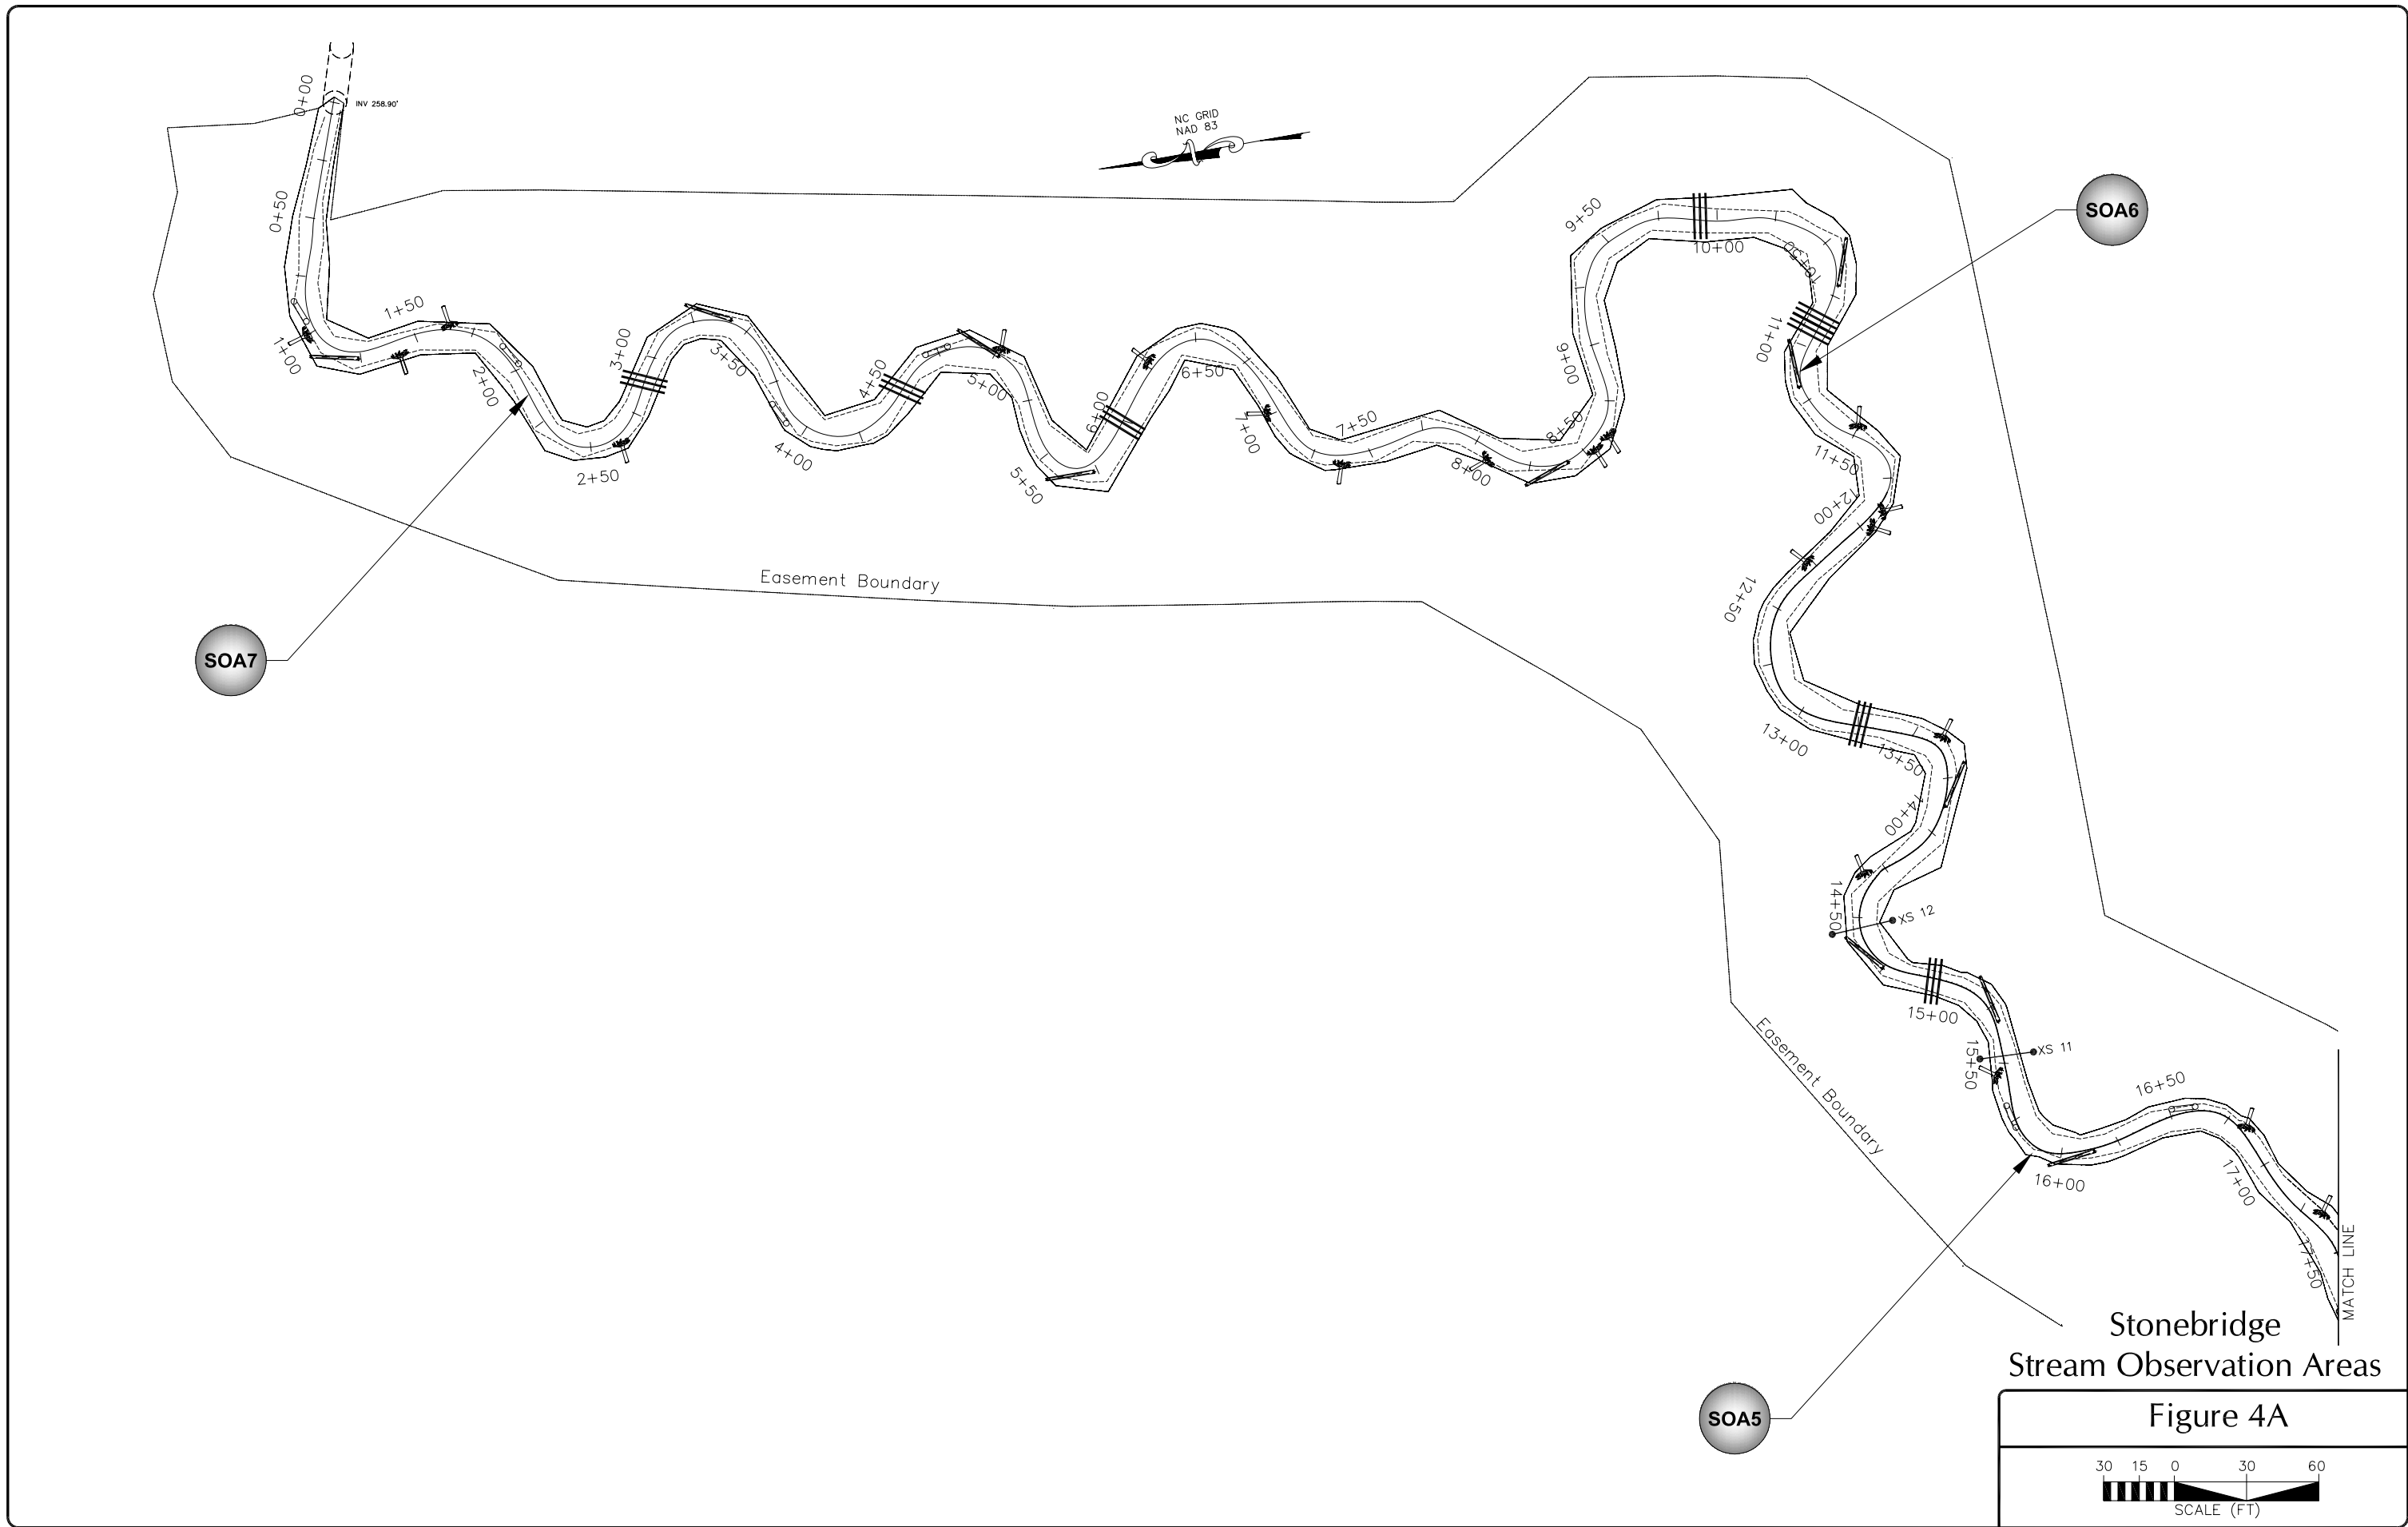
Figure 4A

A number of minor issues were observed, but no remedial action is recommended (**Table 8**). Most previous issues have stabilized or are becoming stable. Minor erosion present along some of the banks is due to the cattle intrusion described earlier, and in the buffer area, trampled herbaceous vegetation is localized. No impacts to stream stability were observed and the cattle have been removed. Water is flowing around a log grade control structure and a log vane, causing minor erosion (SOA4, SOA5, and SOA6). A minor headcut has stabilized due to vegetation.

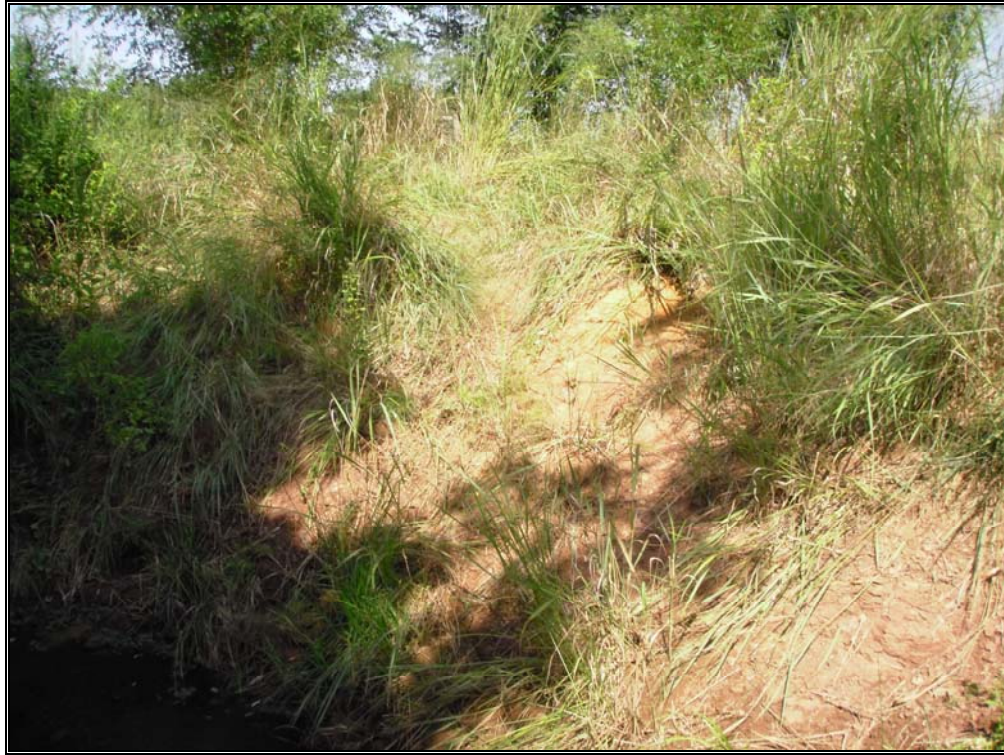
SOA 1 – Minor bank damage due to cattle incursion, upper reaches of UT1.

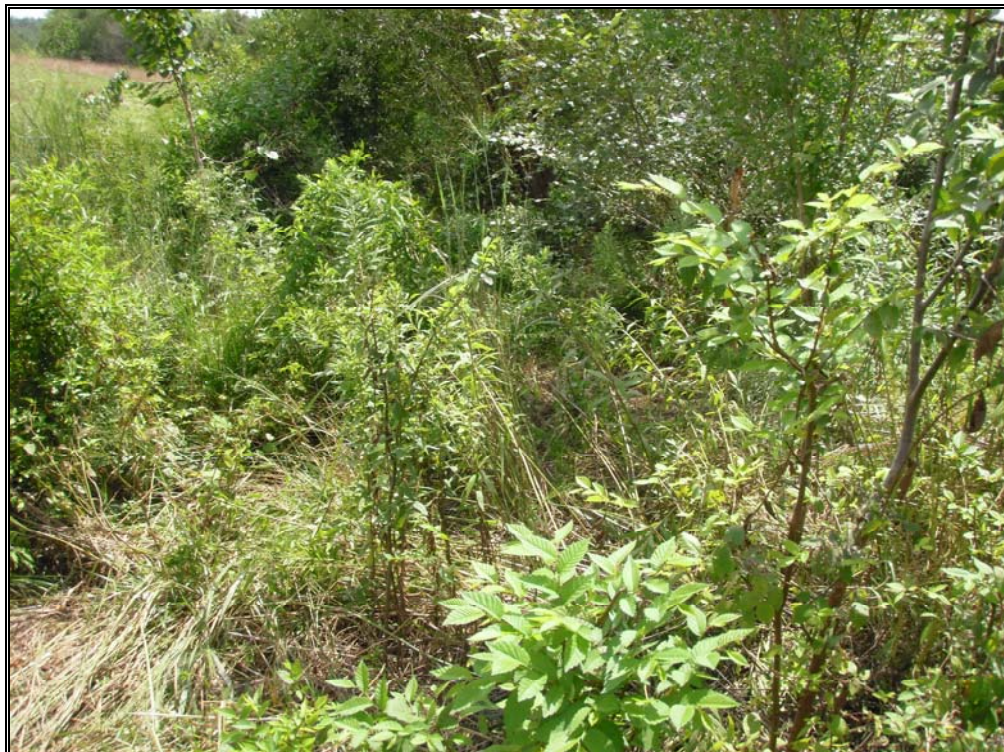
SOA 1 – Minor vegetation damage due to cattle incursion, upper reaches of UT1.

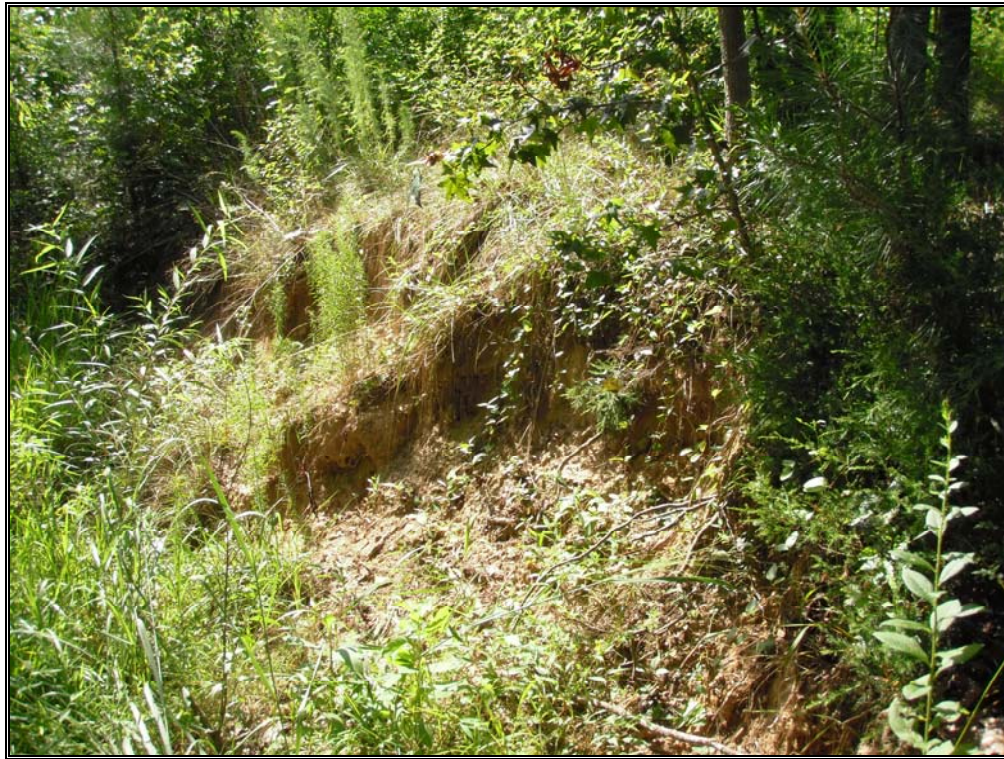
SOA 2 – Minor right bank erosion, UT1 Sta. 47+50 to 47+80.

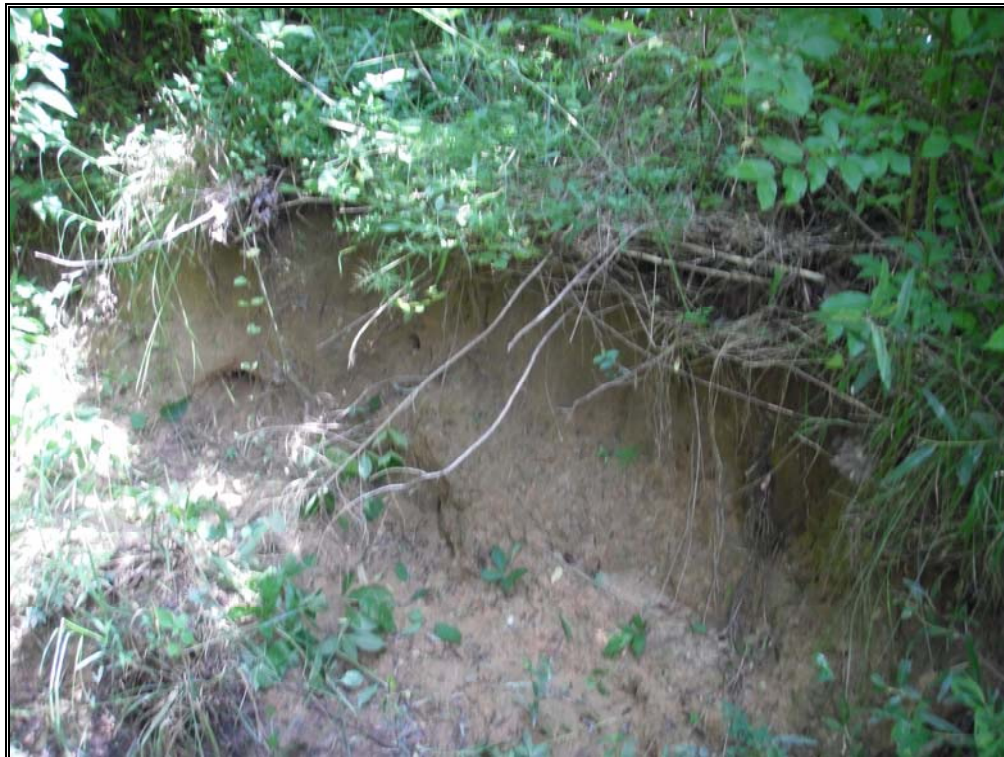
SOA 3 – Minor right bank erosion, UT1 Sta. 40+15 to 45+10.

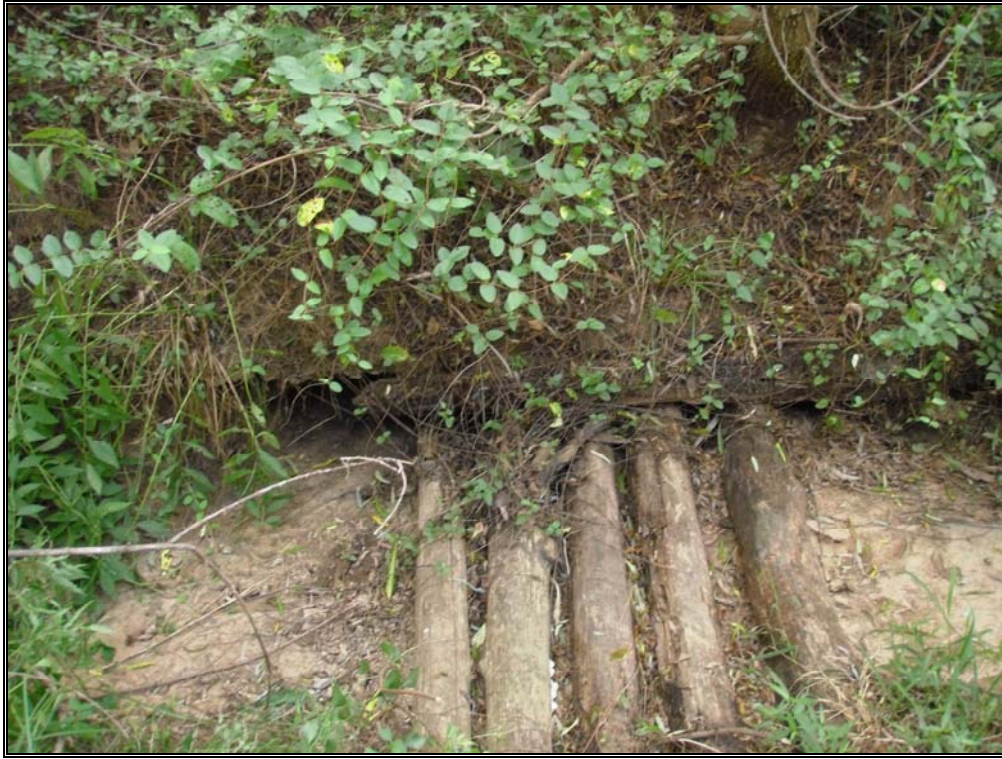
SOA 4 – Bank undercut along right bank at log grade control, UT2 Sta. 2+50.

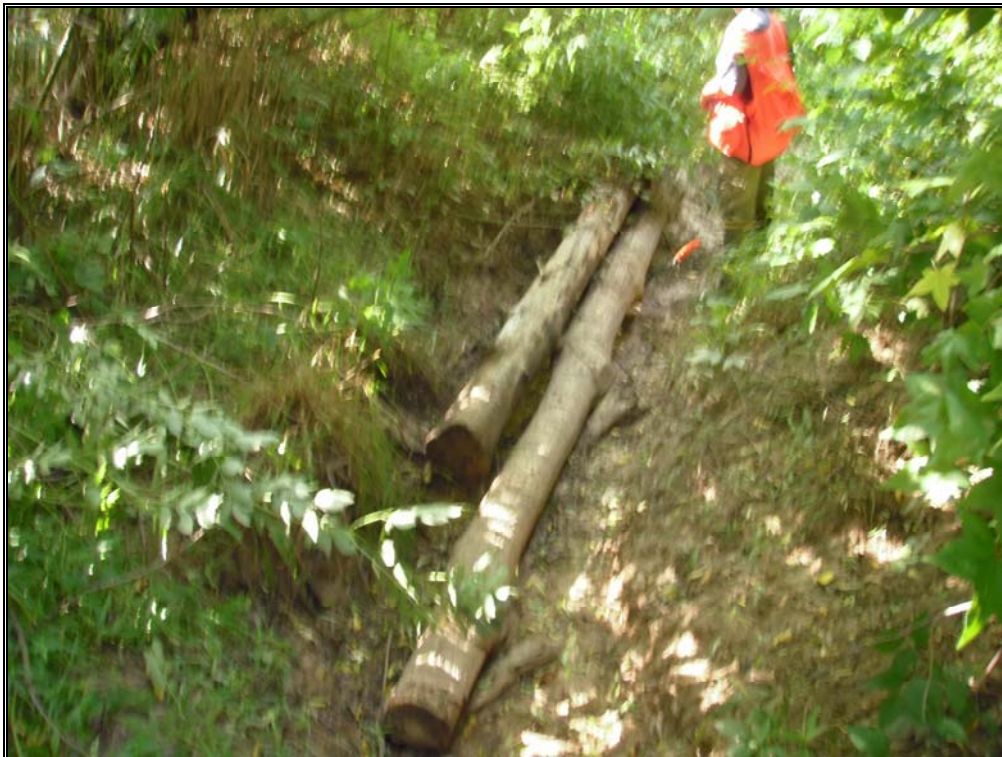
SOA 5 – Log vane undercut, UT1, Sta. 16+00.

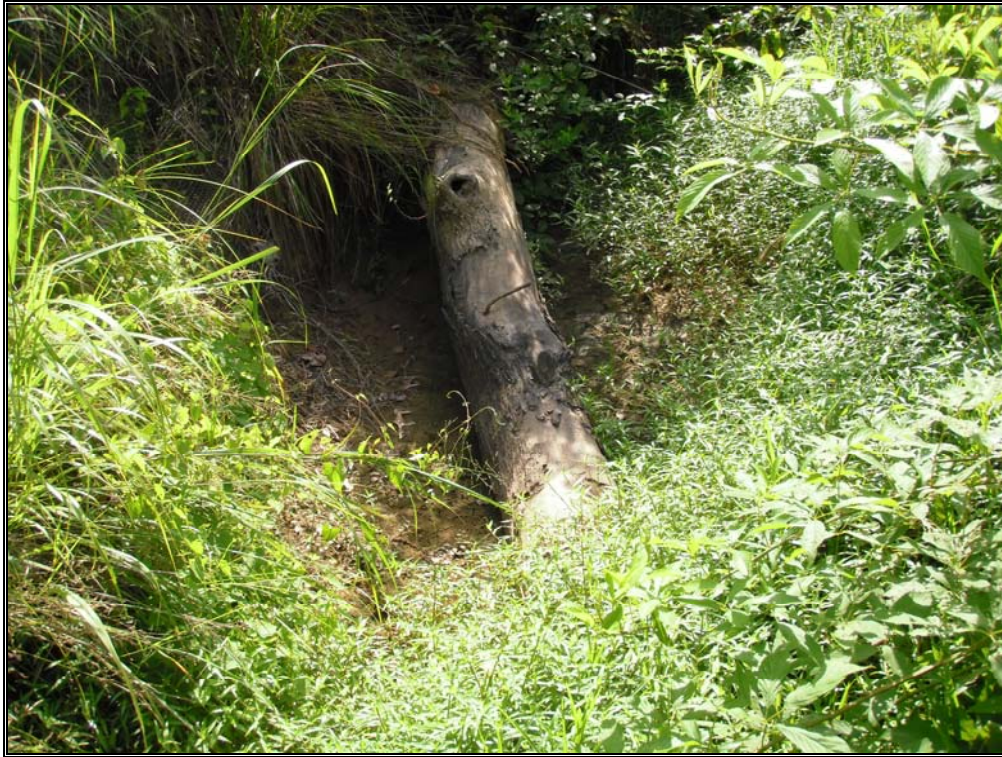
SOA 6– Log vane undercut., UT1, Sta. 11+00.

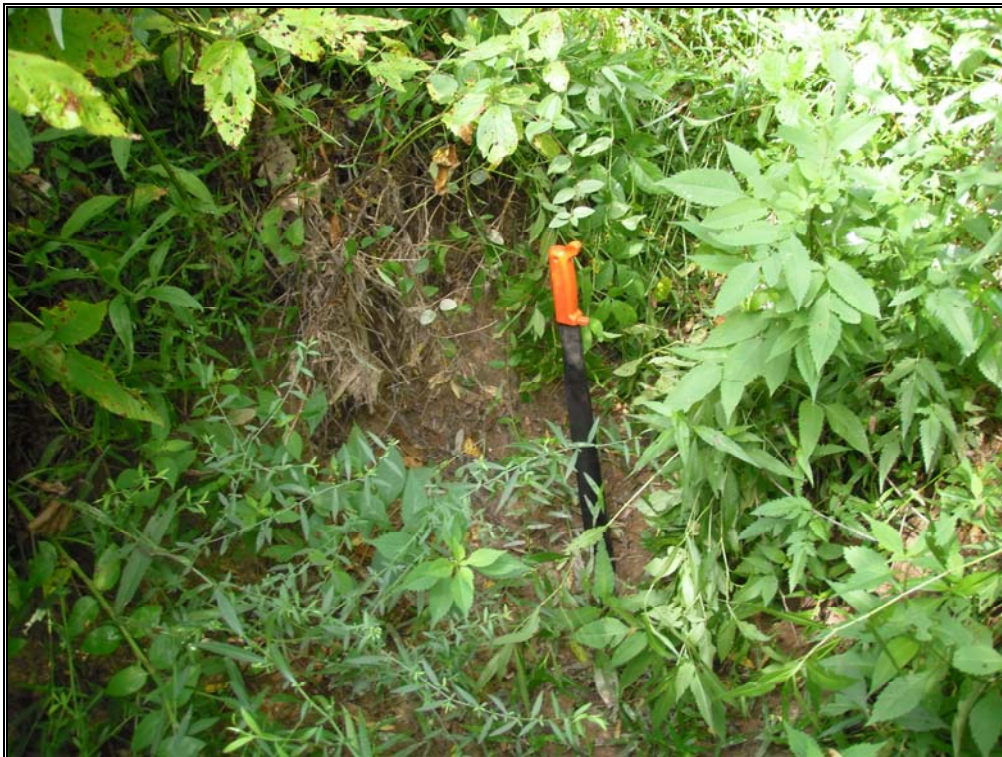
SOA 7 – Minor headcut. Vegetation has stabilized the channel., UT1 Sta. 2+15.

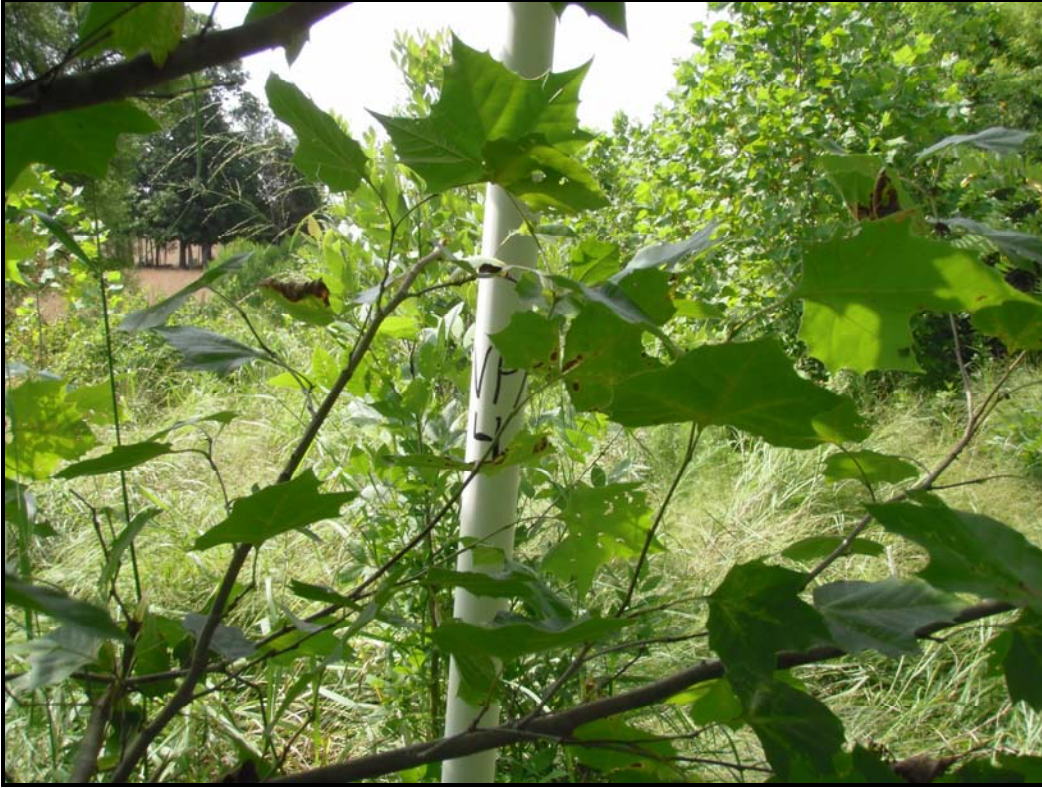
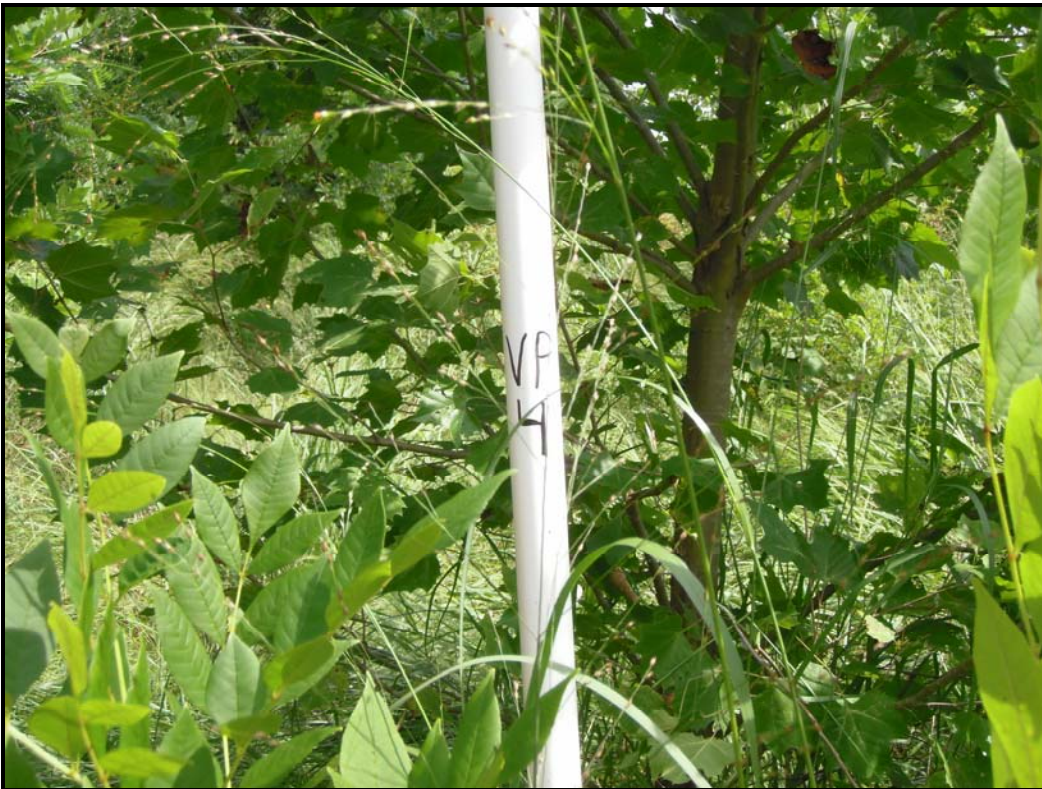
Plot 4 has the lowest density, but with 324 stems per acre, it still meets the final success criteria of 260 stems per acre after 5 years. The higher mortality experienced in this plot over the three previous monitoring years appears to be due to locally shallow bedrock around this plot.
