East Prong of the Roaring River 2004 Annual Monitoring Report

2004 The East Prong of the Roaring River Monitoring Abstract

This is the 4th year of the 5-year monitoring plan for the East Prong of the Roaring River

Date of Completion	October 2000
Monitoring Dates	2001, 2002, 2003, October 2004

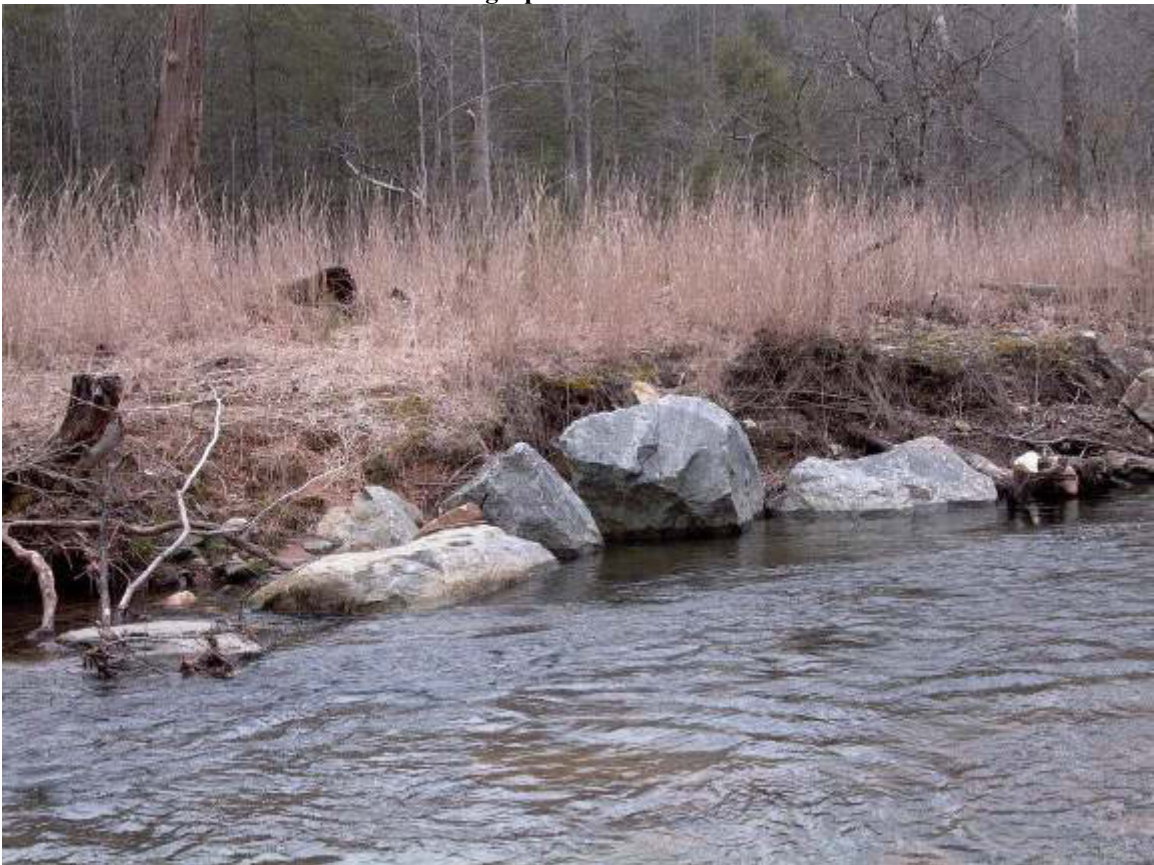
Looking Downstream at Left Bank Scour near J-Hook STA ~3+10

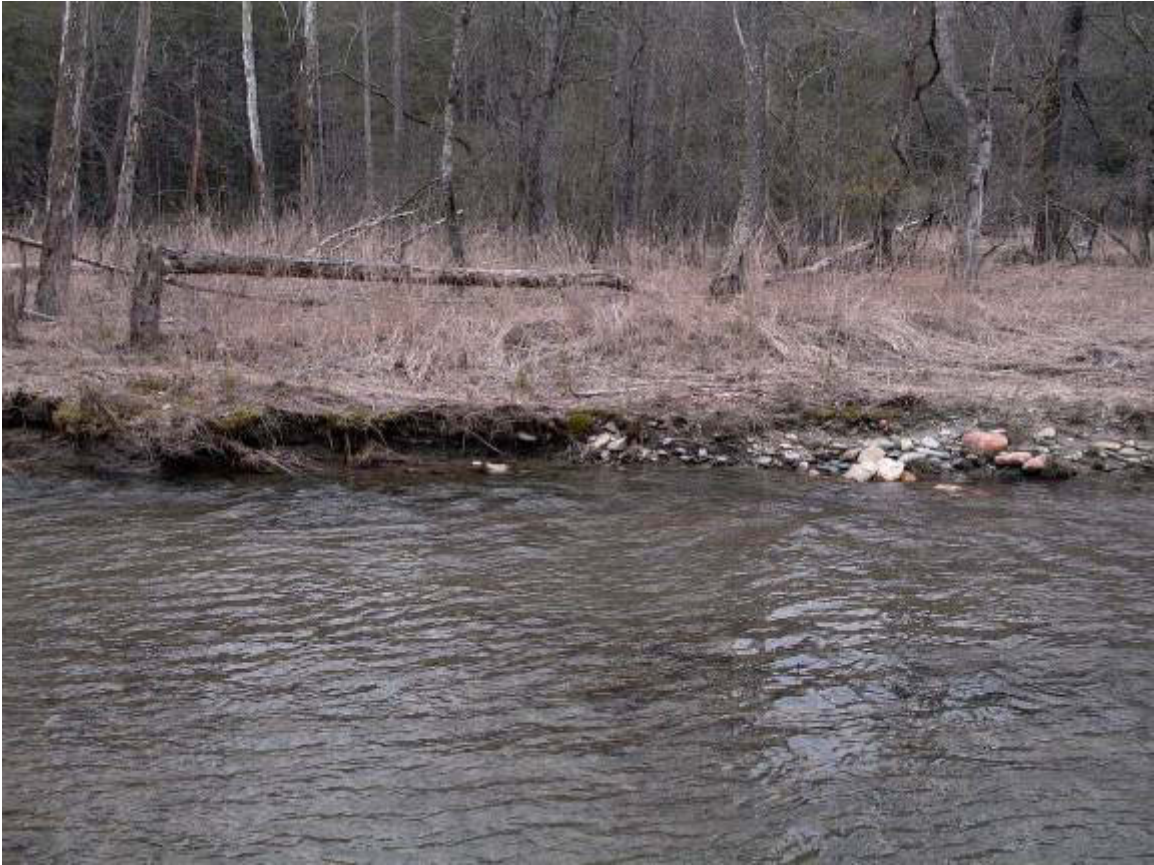
Looking Downstream at Left Bank Erosion STA ~ 5+00

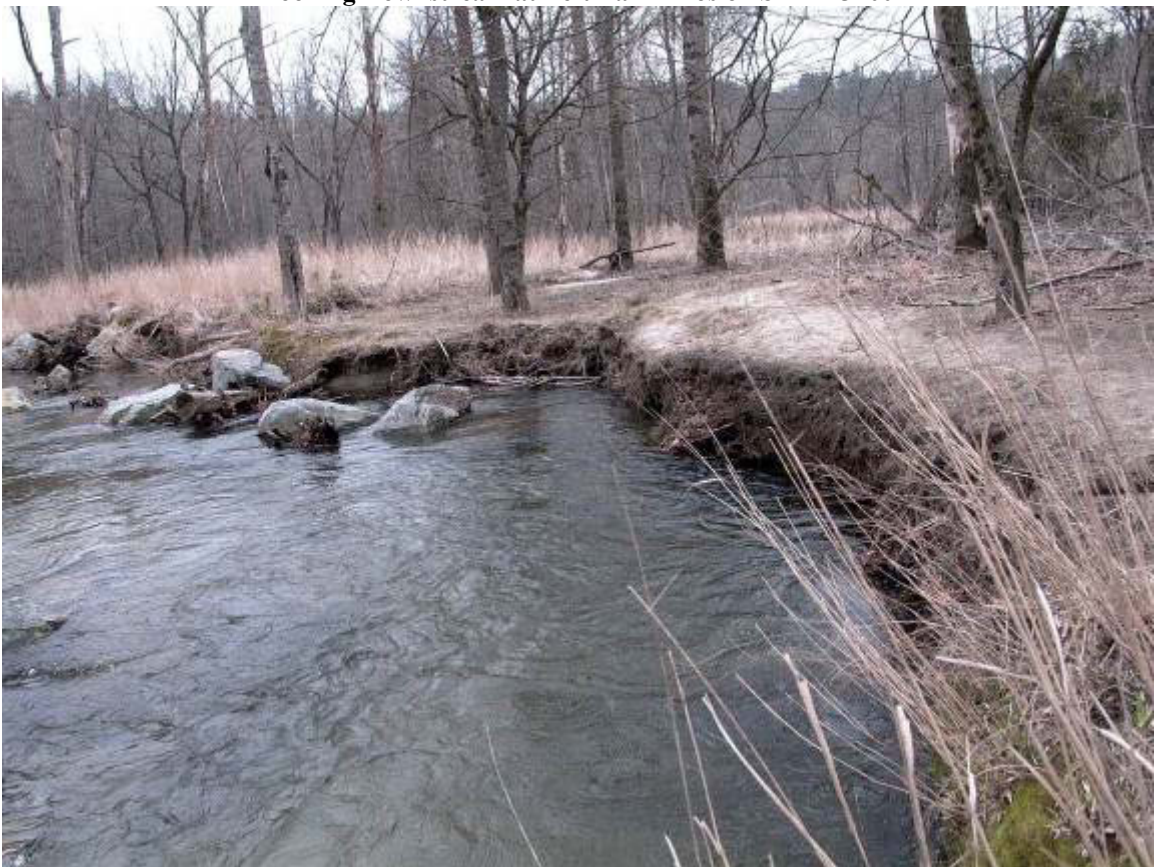
Looking Downstream at Right Bank Erosion and Migration STA ~ 5+60

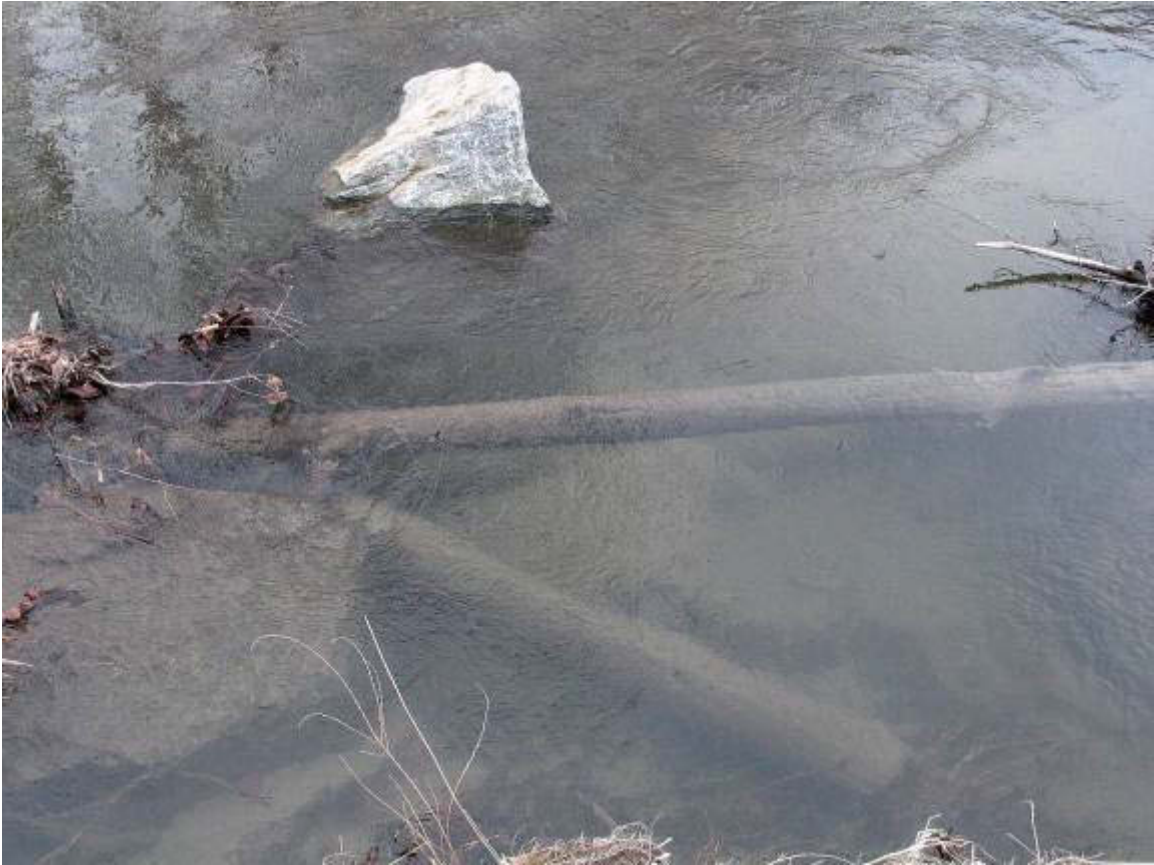
- Bank erosion on the outside of meander bends has been noted at one location on the reaches of Reach 2 at stations 6+00
 - At Station 6+00 there is bank erosion on the outside of a meander bend the bank still has a High BEHI with a Moderate NBS. The bank height for this bank section is ~4 ft.

Exposed Root Wads and Boulder Toe Right Bank STA ~6+00

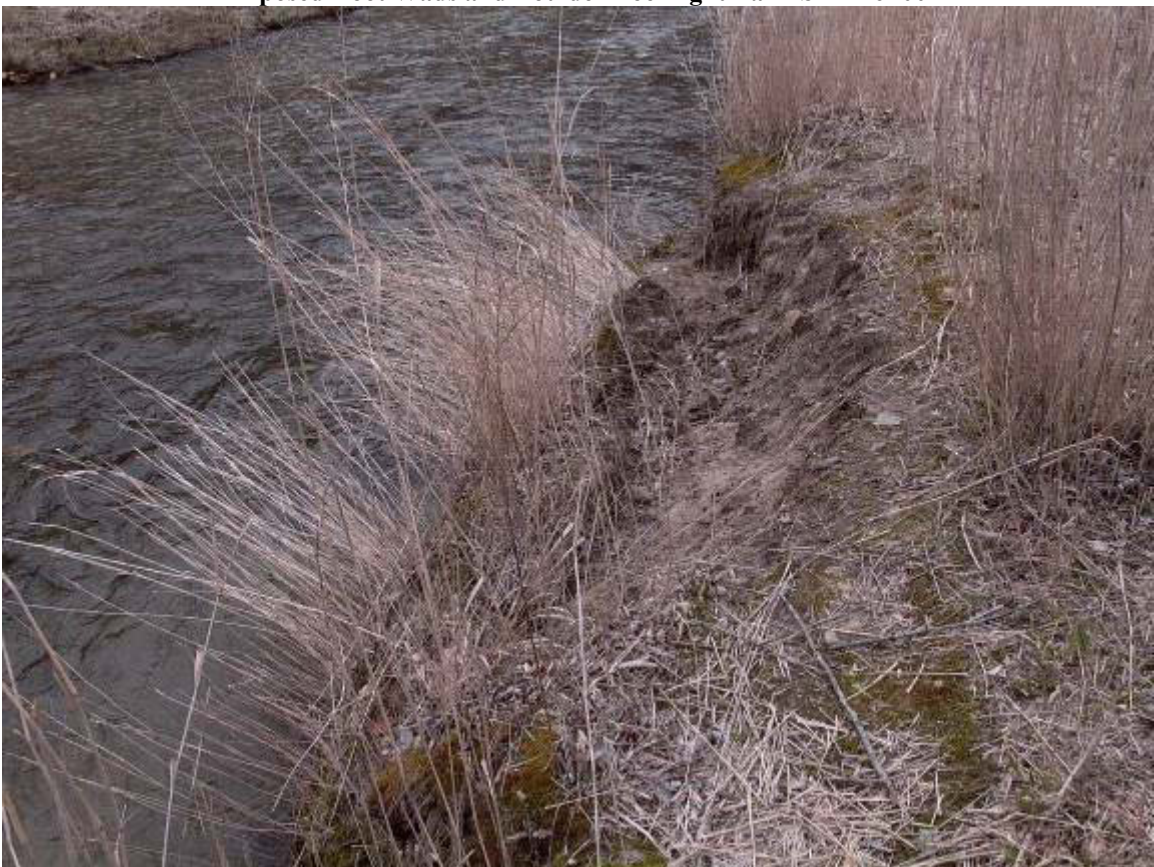
Right Bank Slump STA ~ 6+35

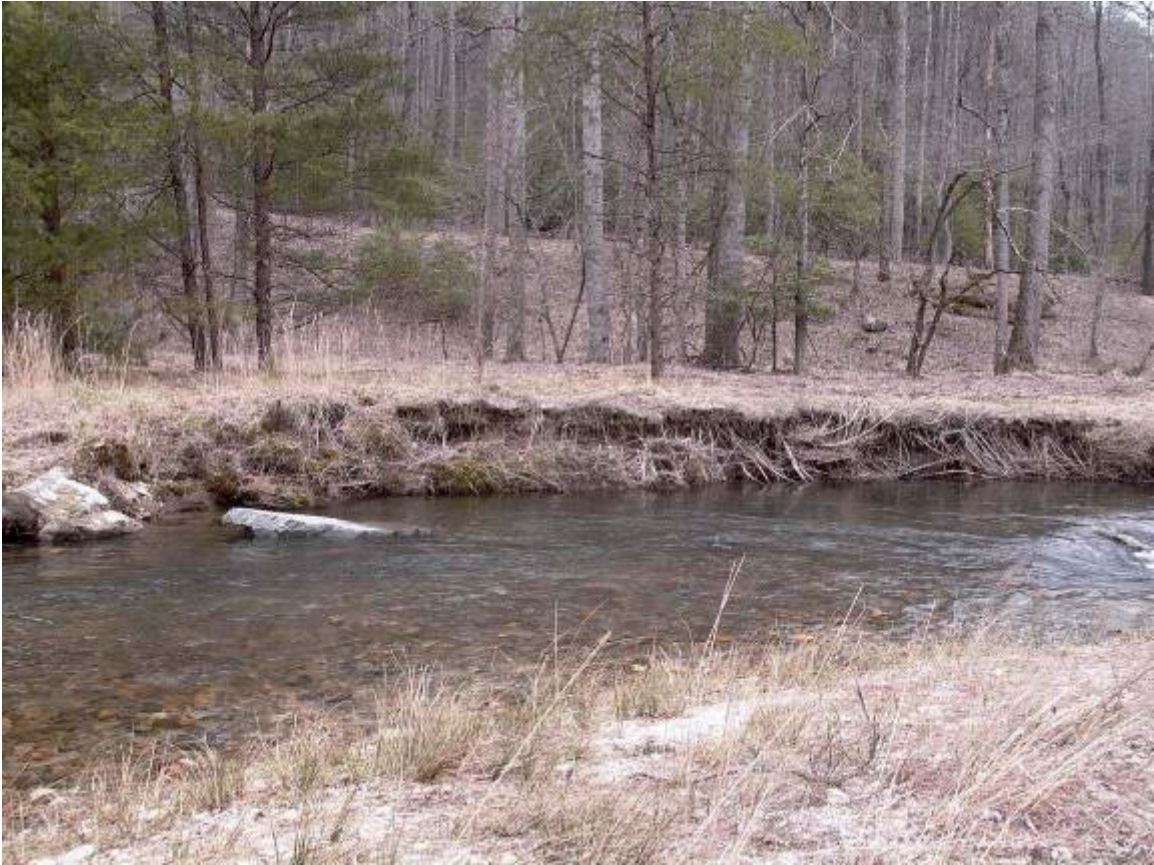
Looking Downstream at Left Bank Erosion and Migration STA ~ 8+50

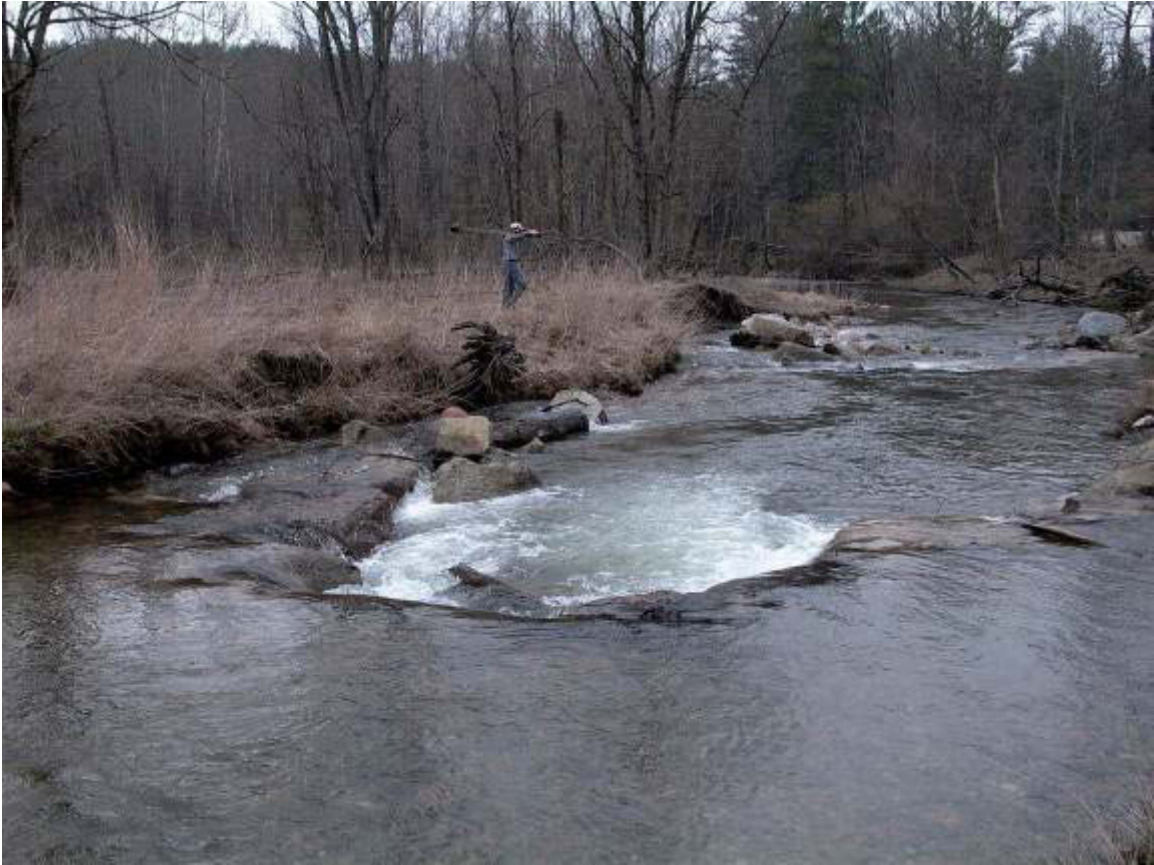
Rock cross vanes are holding the grade of the stream but the two at the end of the reach are at risk of massive failure. The river has cut around the left vane arm on both of the cross vanes at the end of the reach. The vanes are located at approximately Sta: 13+00 and 14+50. If these vanes are not repaired the river will continue to erode around the vane arms and there will be an ultimate failure of both vanes. An ultimate failure of these vanes will result in a head-cut that would continue upstream in the reach until it reached a stable grade control. There is a potential of a 4.5ft head-cut if these structures are allowed to fail this would related to a head cut approximately 500 ft or more upstream from the rock cross vane at Sta: 13+00.

- At station 13+00 there is bank erosion on the left bank and water is piping past the rock cross vane. At this point the structure is still holding grade a lower elevation but ultimate will occur if this vane is not repaired or redesigned.

Looking Downstream at Left Bank Erosion & Piping Water Around Rock Cross Vane STA ~ 12+90

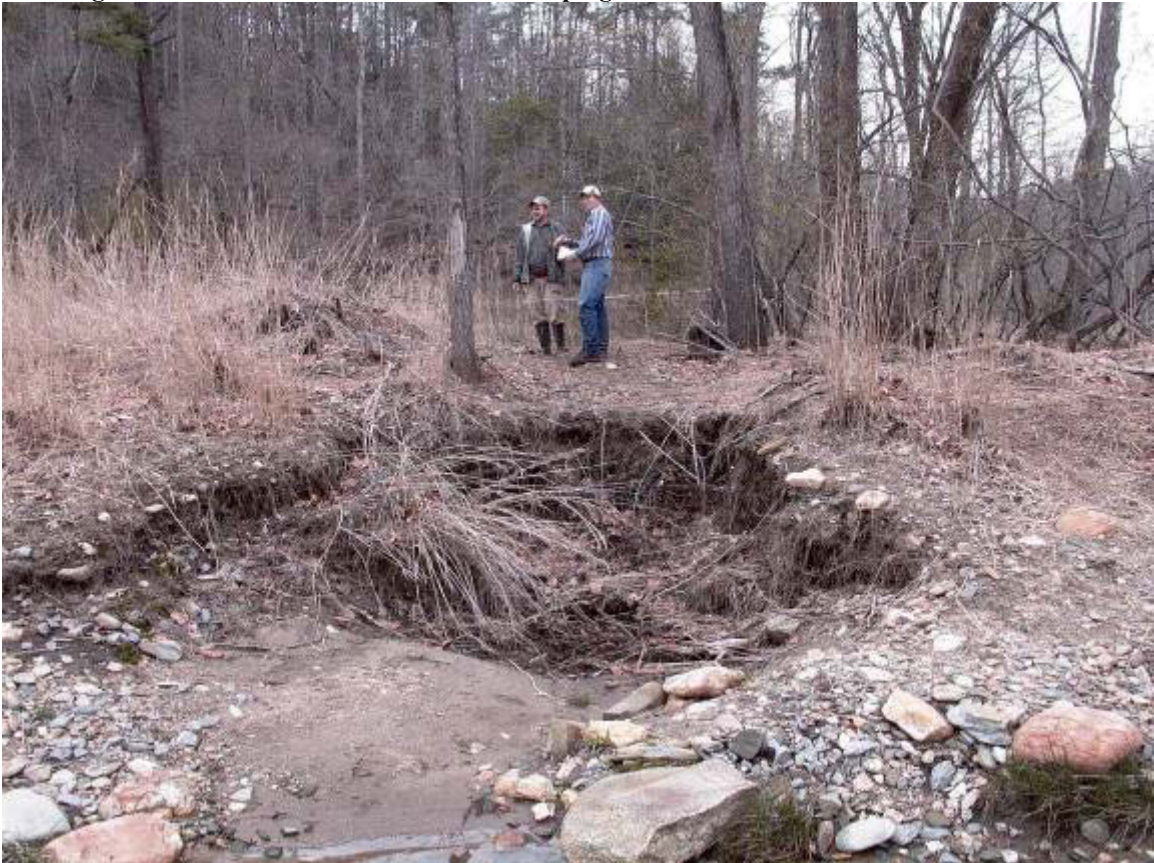
Right Bank Erosion STA ~ 13+10

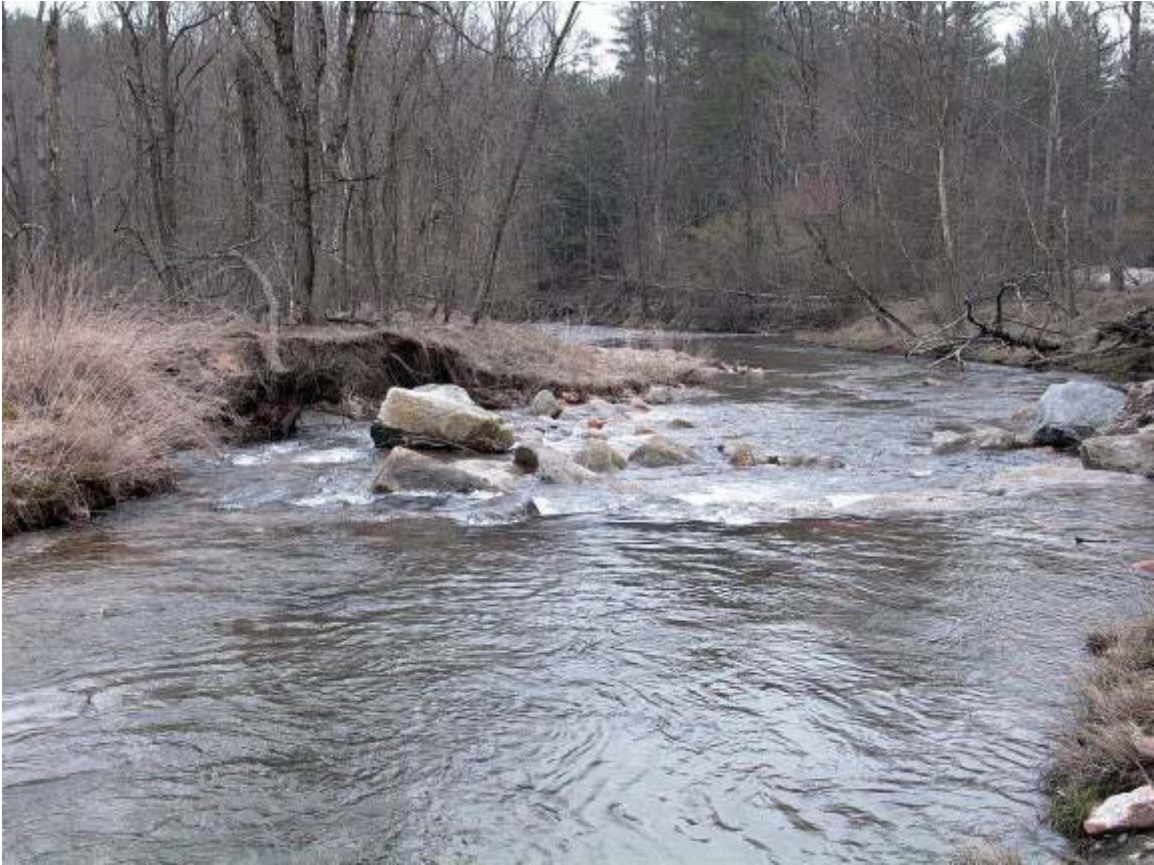
- At station 14+50 there is bank erosion on the left bank and water is piping past the rock cross vane. At this point the structure is still holding grade at a lower elevation but ultimate failure will occur if this vane is not repaired or redesigned.

Looking Downstream at Left Bank Erosion & Piping Water Around Rock Cross Vane STA ~ 13+80

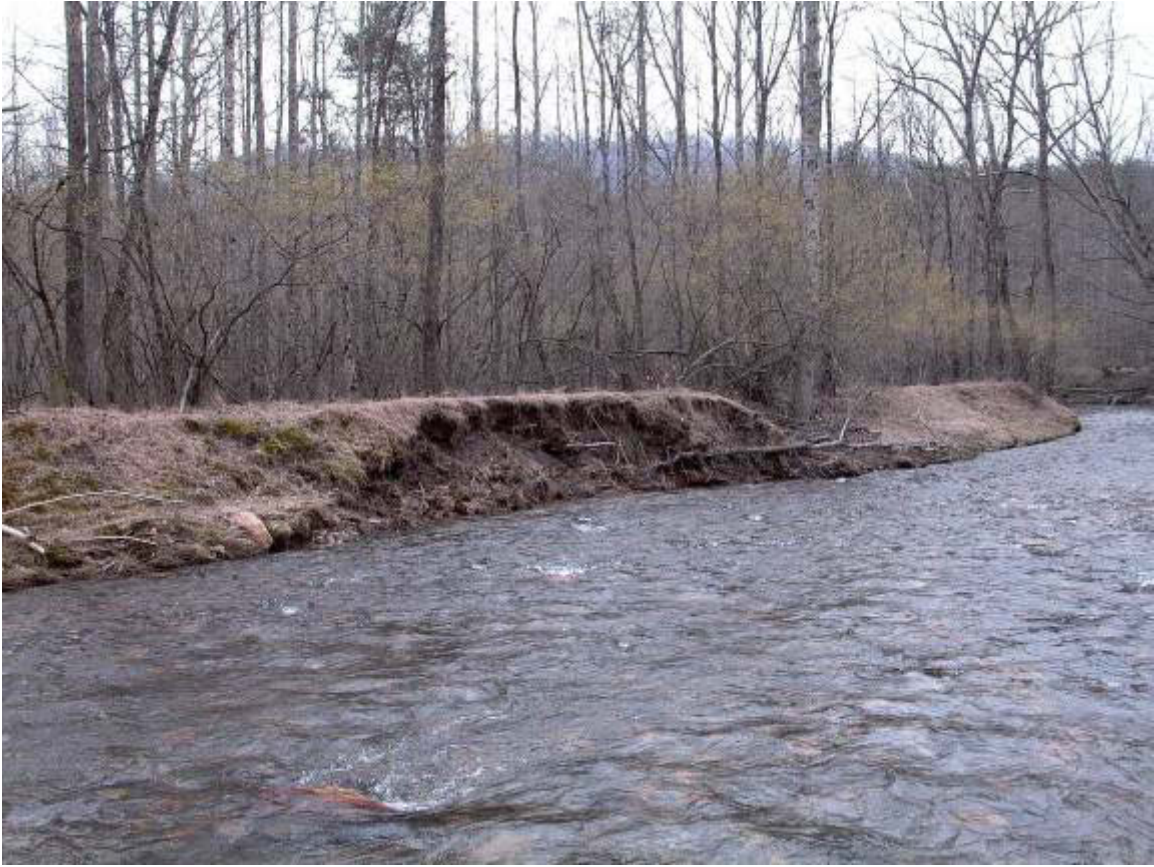
Looking Downstream at Left Bank Erosion STA ~ 3+00

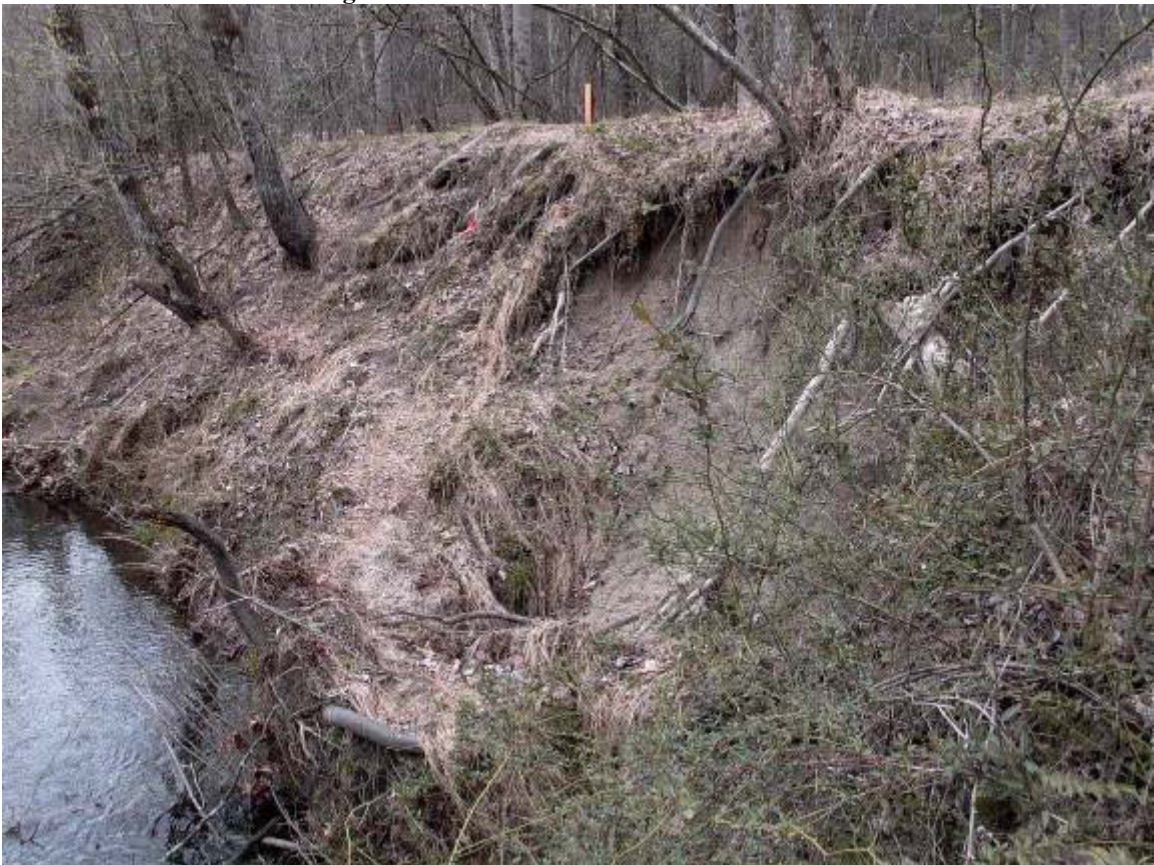
Right Bank Erosion STA ~ 6+50

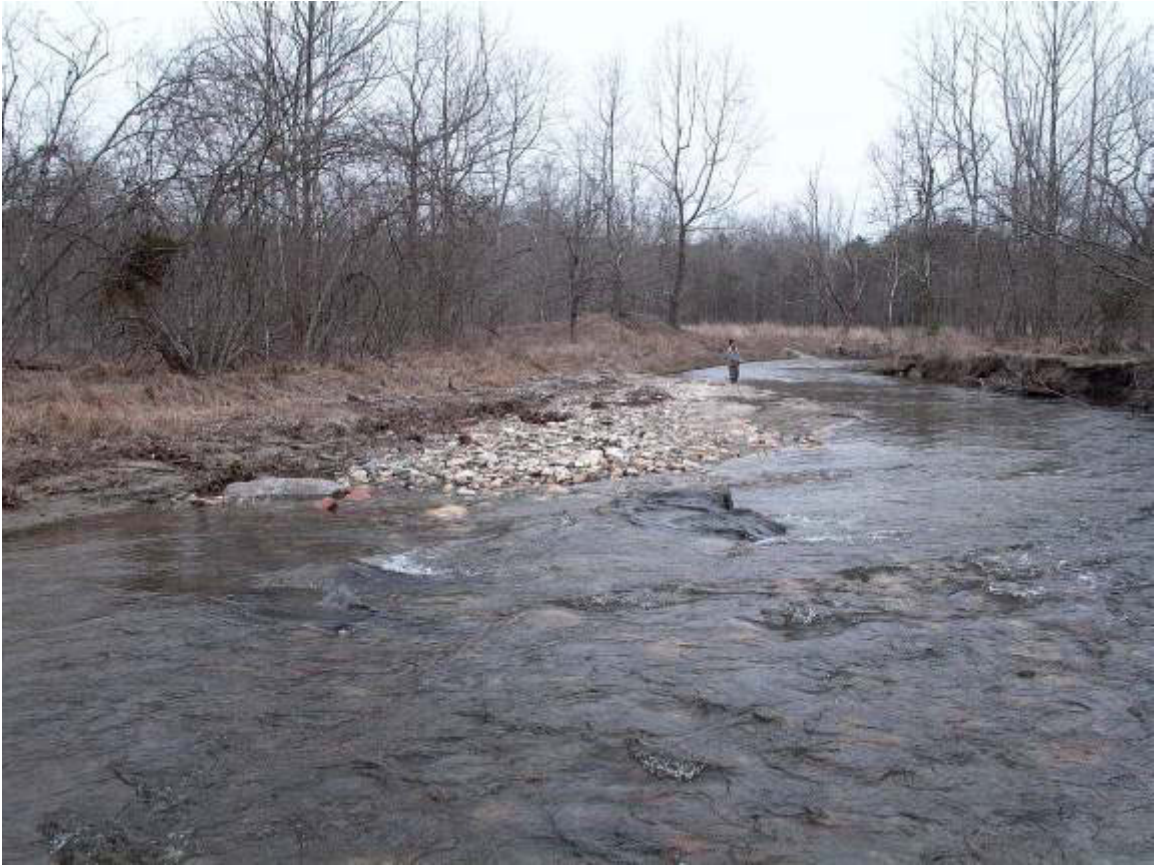
Looking Downstream at Right Bank Erosion and Migration STA ~ 8+10

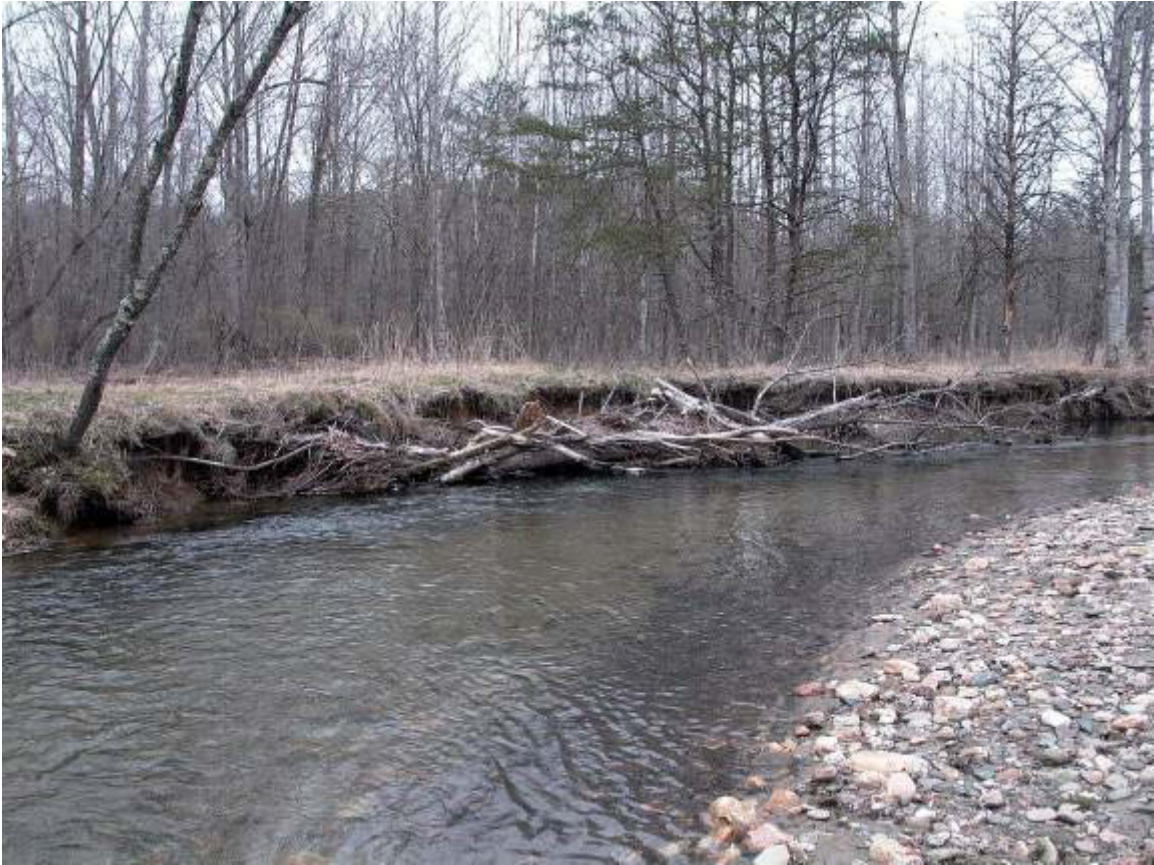
Looking Downstream at Left Bank Erosion and Migration STA ~ 20+00

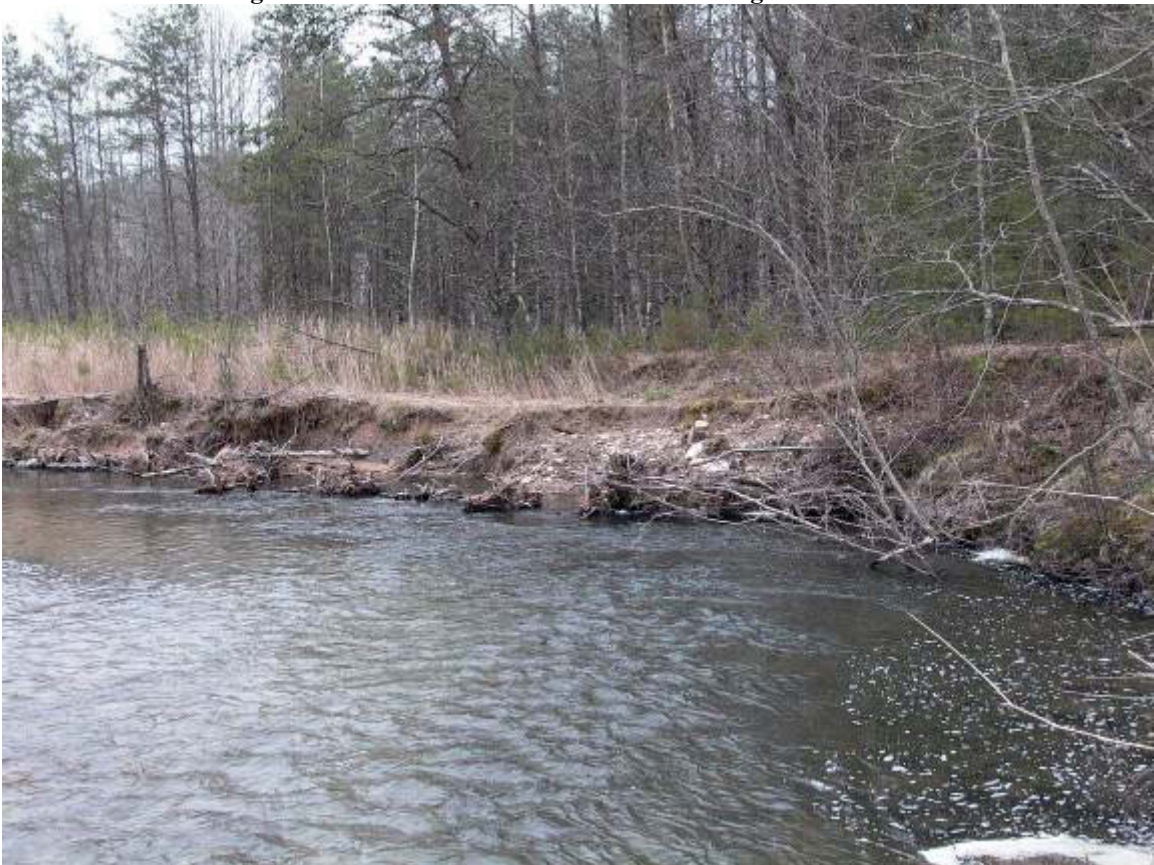
Looking Downstream at Right Bank Erosion and Migration STA ~ 23+50

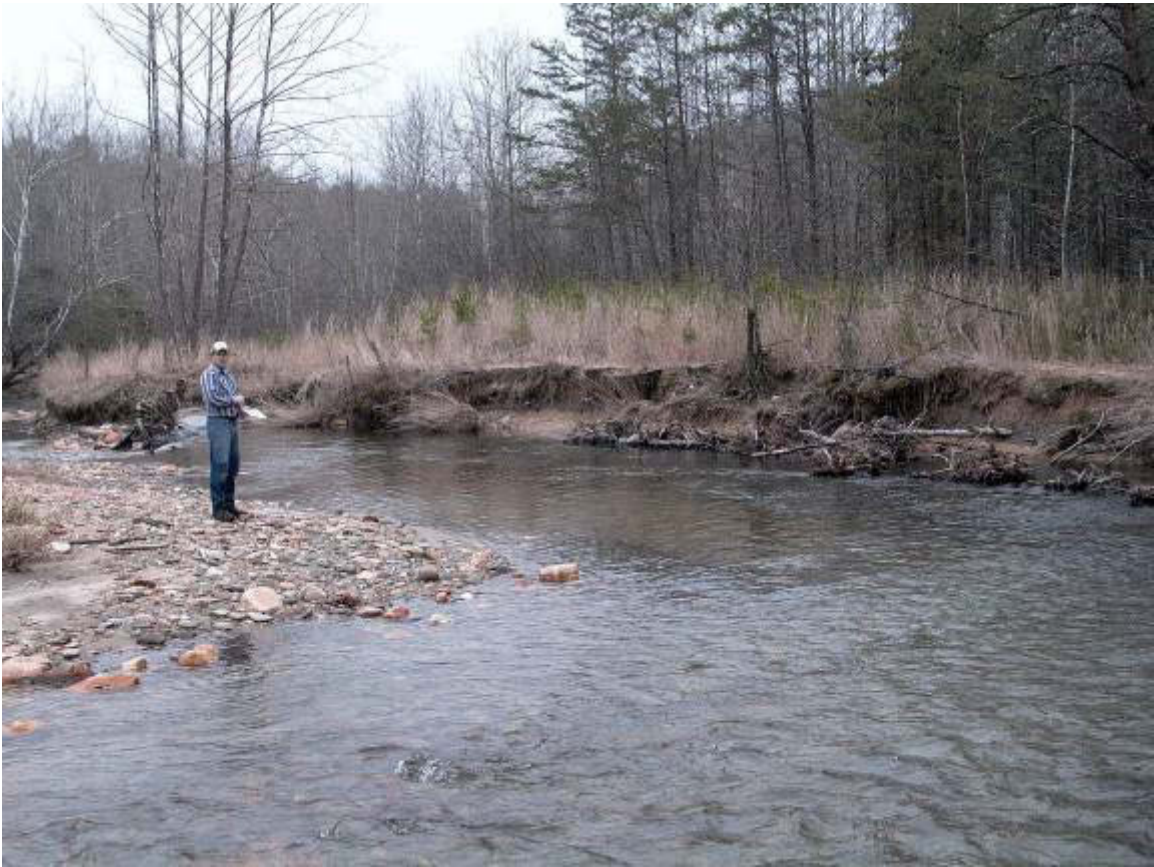
Looking Downstream at Right Bank Erosion and Migration STA ~ 23+75

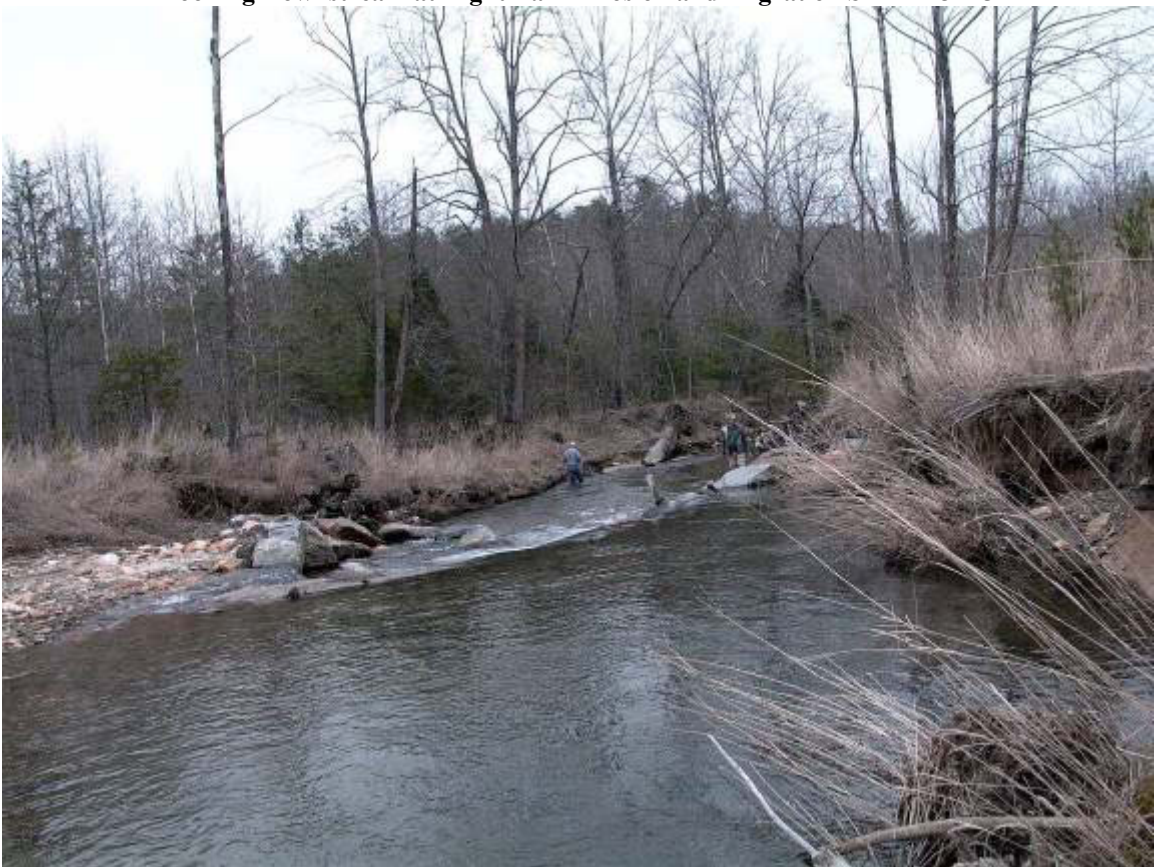
Looking Downstream at Right Bank Erosion & Piping Water around Rock Cross Vane STA ~ 24+40

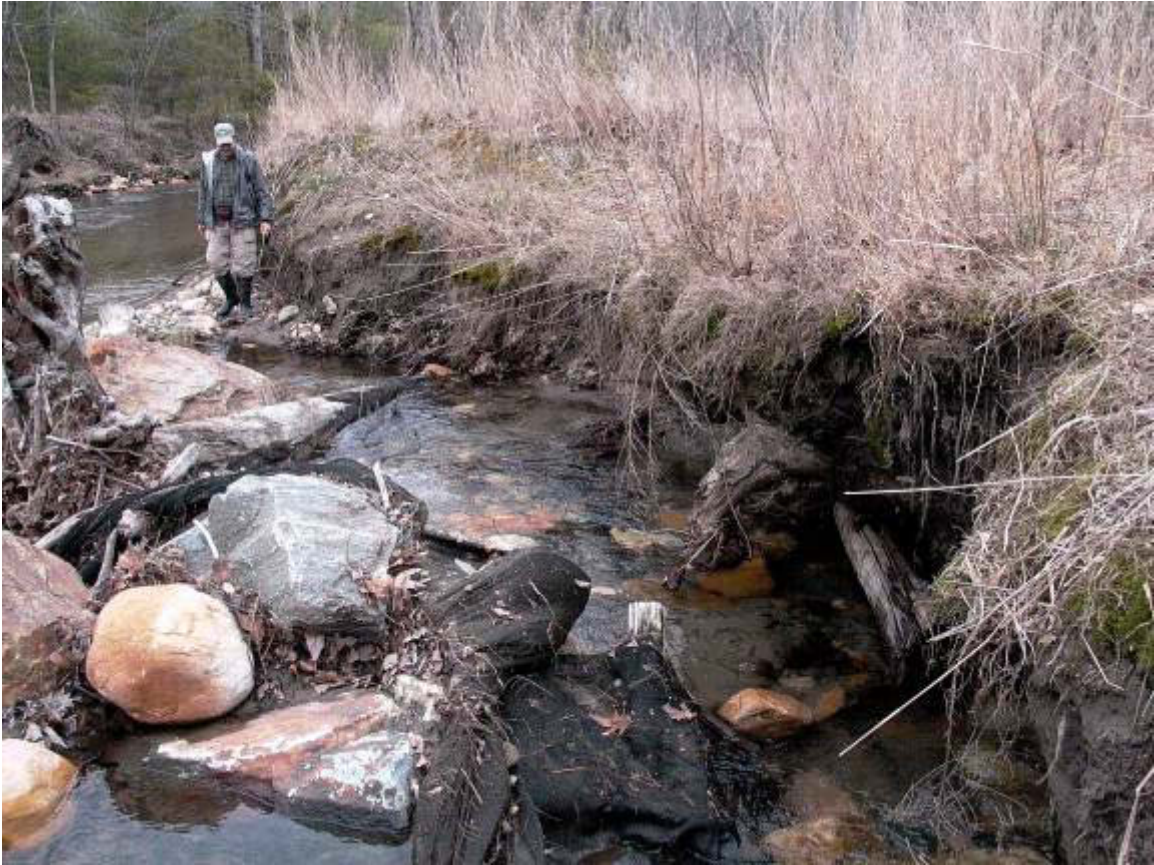
Rock cross vanes are holding the grade of the stream but the one is at risk of massive failure. The river has cut around the right vane arm on the cross vanes at Sta: 24+80. If this vanes is not repaired the river will continue to erode around the vane arms and there will be an ultimate failure of this vane. There is a potential of a 3.0ft head-cut if this structure is allowed to fail this would related to a head cut approximately 300 ft or more upstream from the rock cross vane at Sta: 22+00.

- At station 25+20 there is massive bank erosion on the right bank and water is piping past the rock cross vane. At this point the structure is not holding grade ultimate failure will occur if repairs or redesign are not pursued

Looking Downstream at Right Bank Erosion & Piping Water around Rock Cross Vane STA ~ 24+80

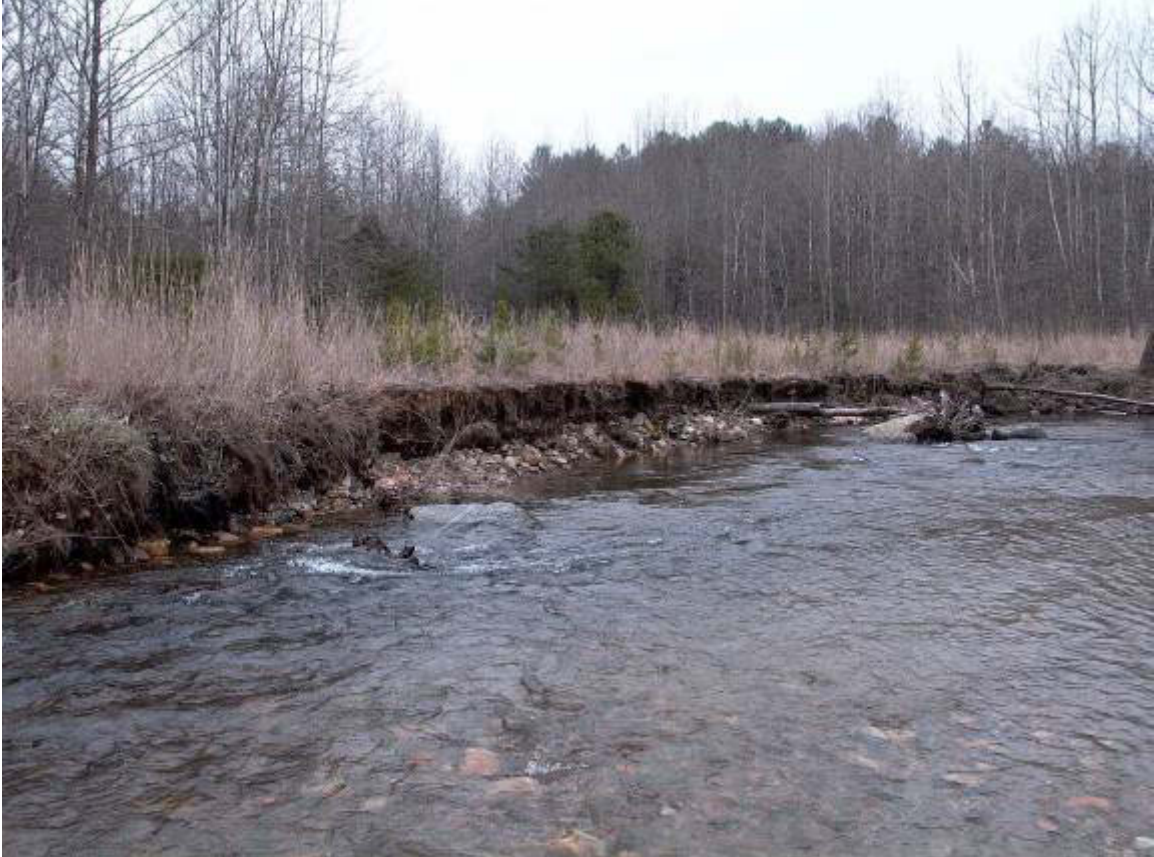
Looking Downstream at Left Bank Erosion and Migration STA ~ 28+75

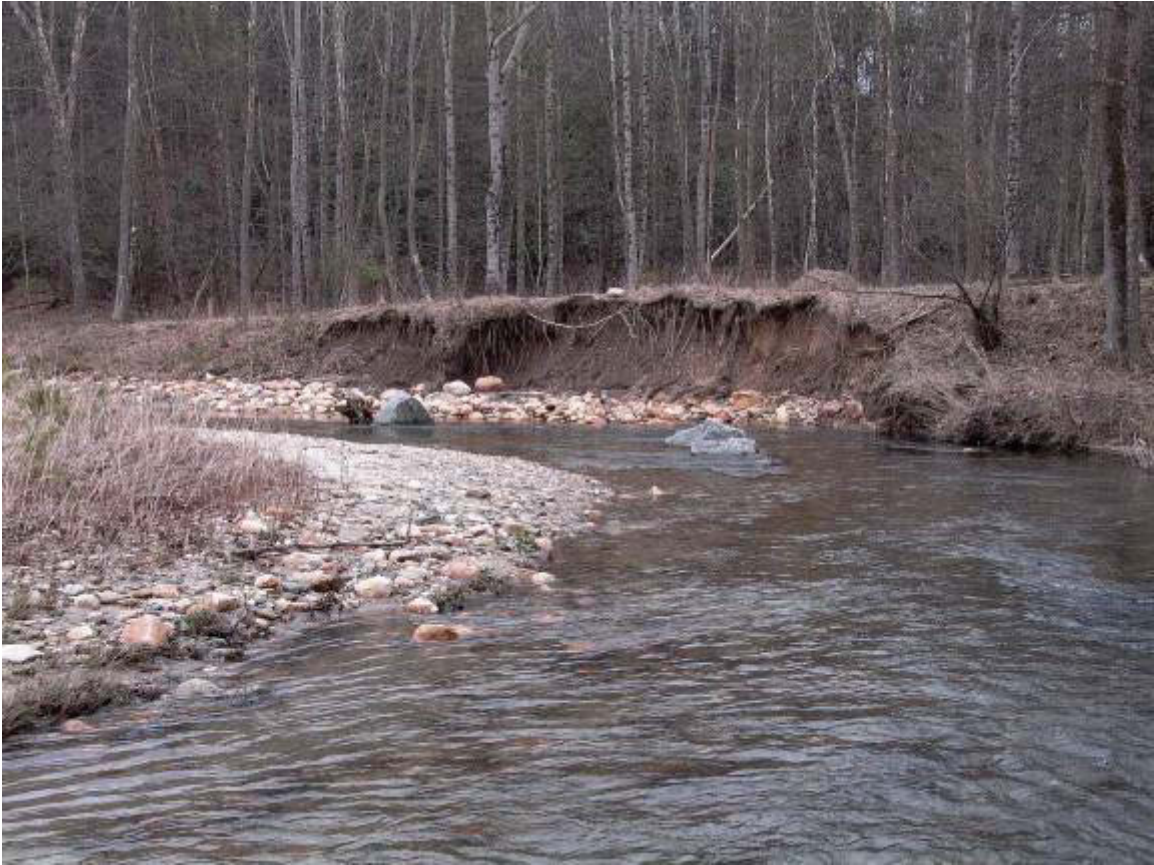
Looking Downstream at Right Bank Erosion and Migration STA ~ 32+50
