**East Prong of the Roaring River at Stone
Mountain State Park
Stream Restoration
Annual Monitoring Report
Monitoring Year: 2008
Measurement Year: 8
As-built Date: 2000
NCEEP Project Number: 364**

Draft Submitted: October, 2008
Final Submitted: May 2009

**EAST PRONG OF THE ROARING RIVER at STONE MOUNTAIN STREAM
RESTORATION
2008 MONITORING REPORT**

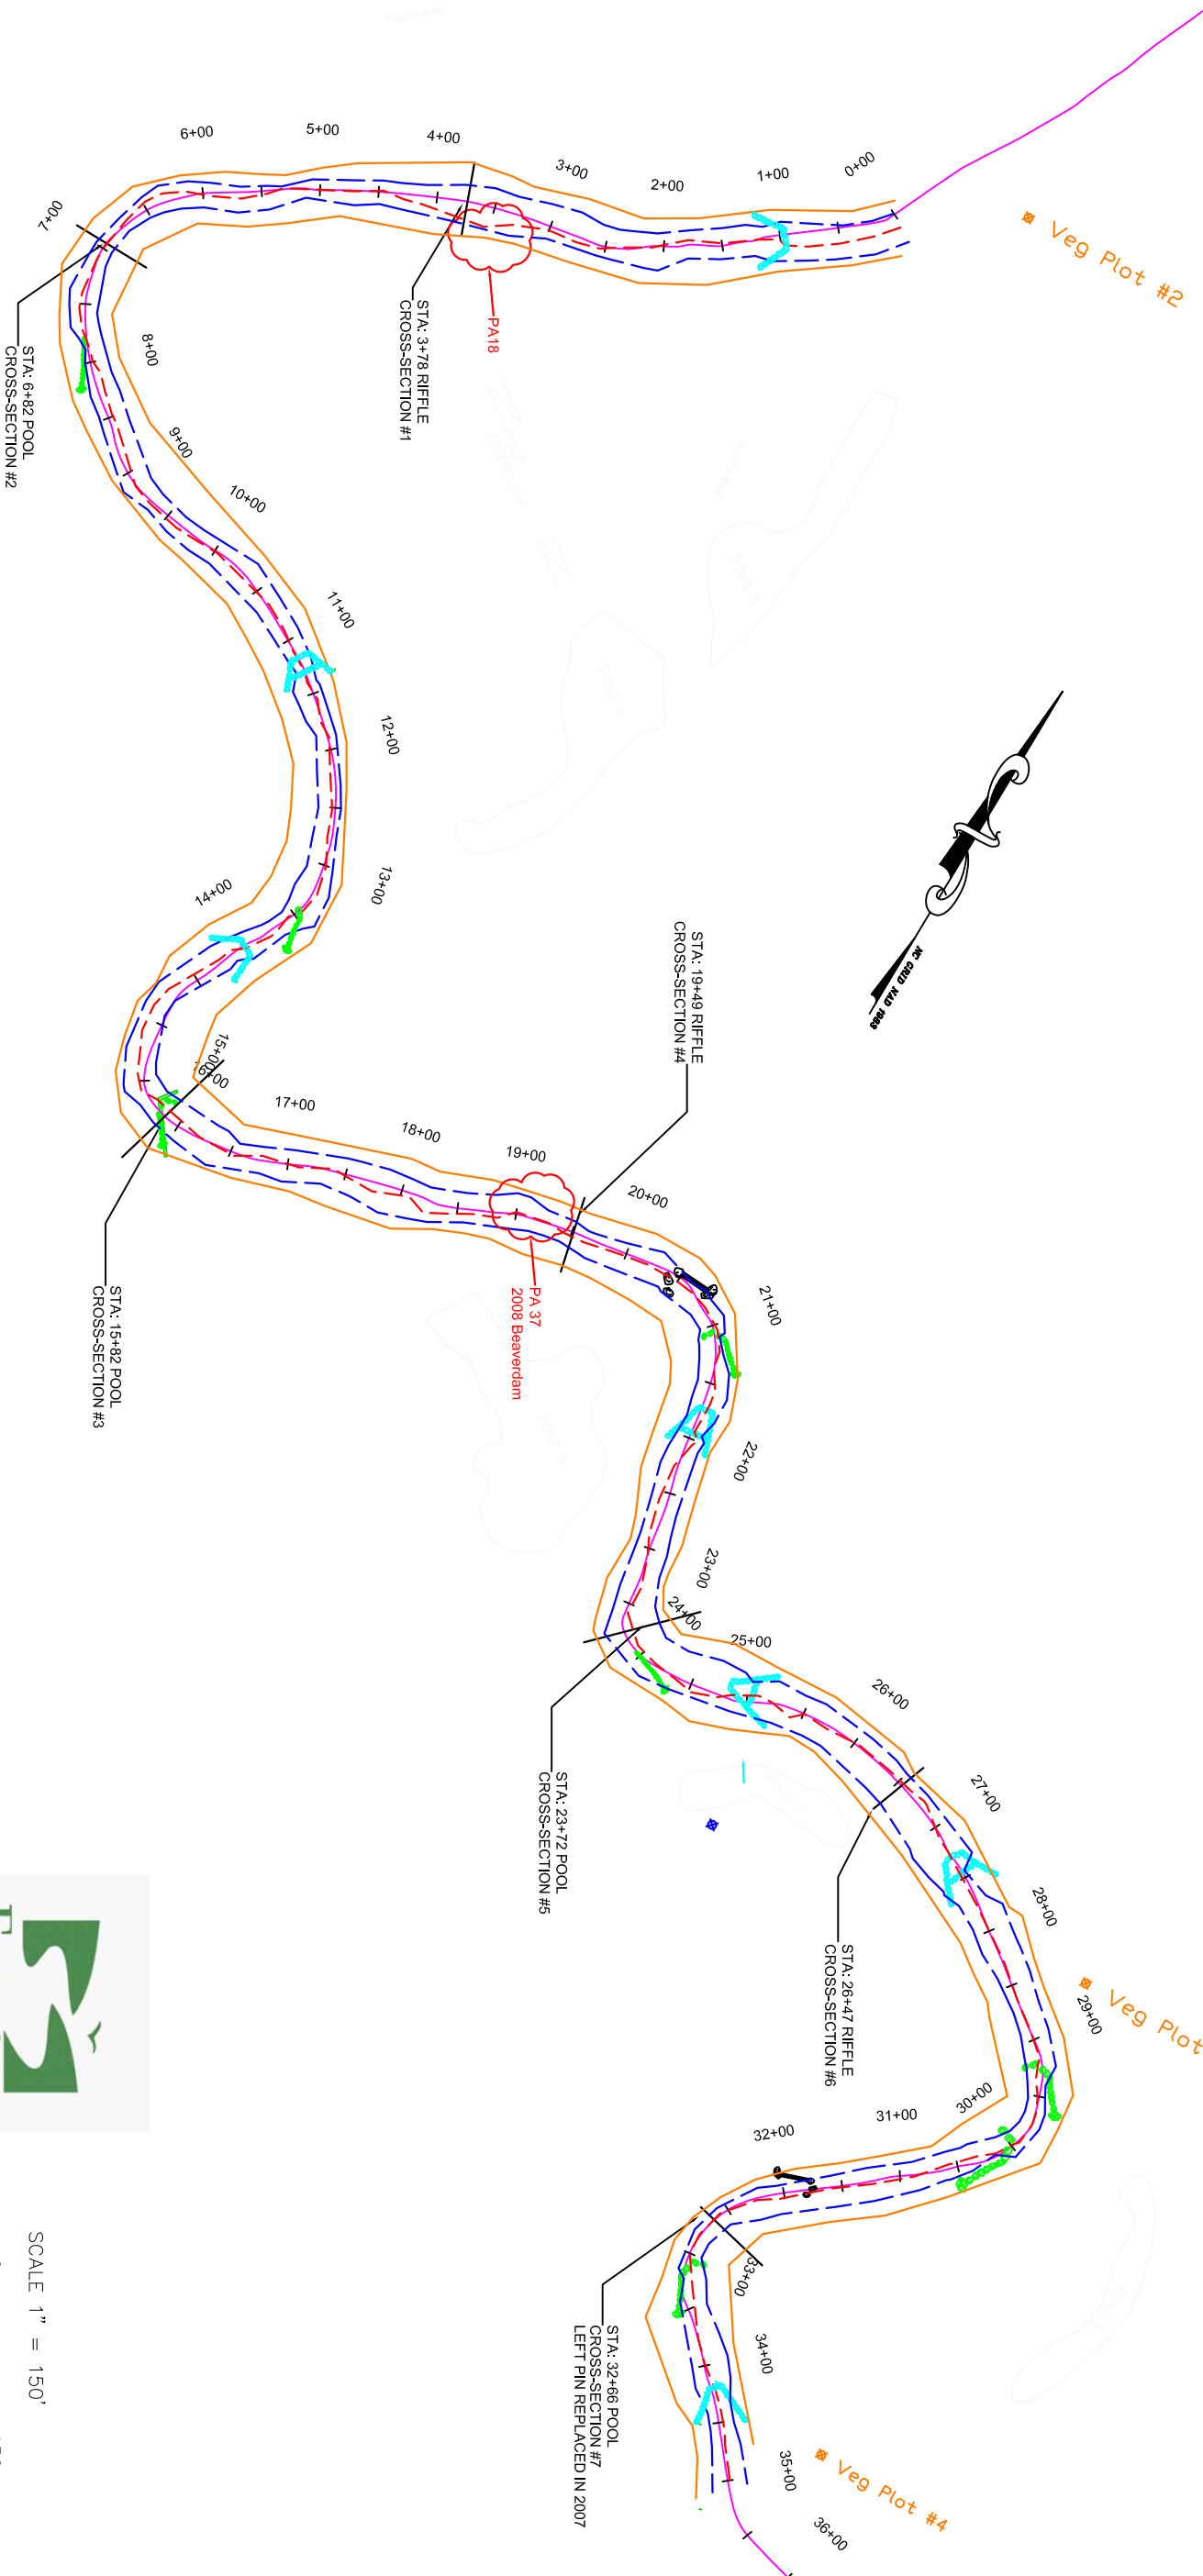
2008 CURRENT CONDITION
 PLAN VIEW REACH-4

Problem Number	Feature Issue	Station numbers	Suspected Cause
PA 18	Bank Slump on left bank	3+25 to 3+75 R4	Lack of deep rooting vegetation and steep bank slope
PA 37	Beaver dam backing up water and left bank erosion	19+00 to 19+30 R4	Beaver activity

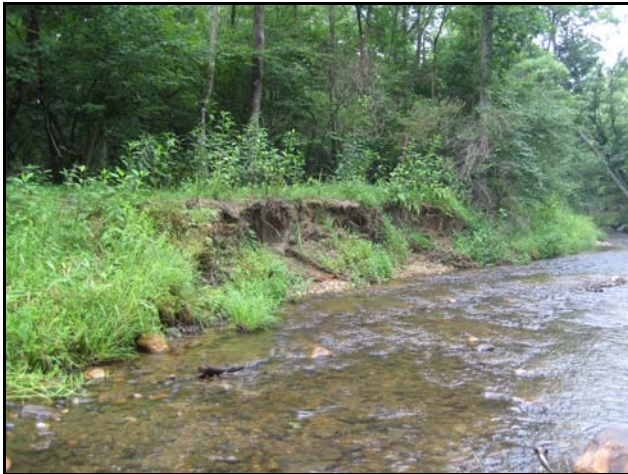
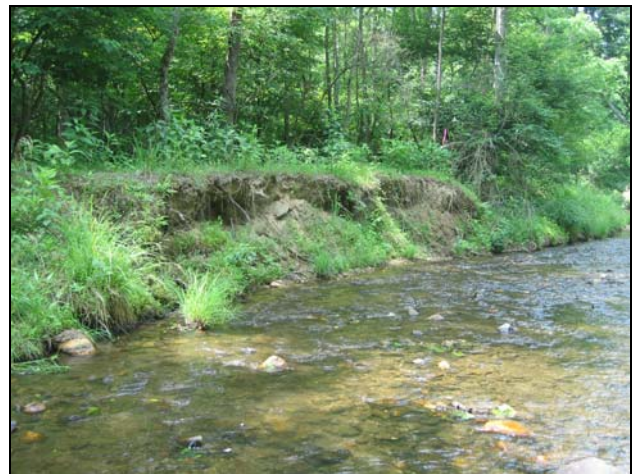
PA 18 Looking Downstream STA 3+50 Left Bank Erosion

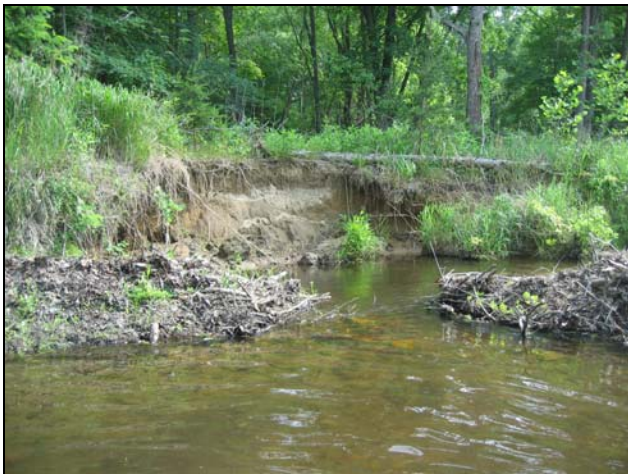
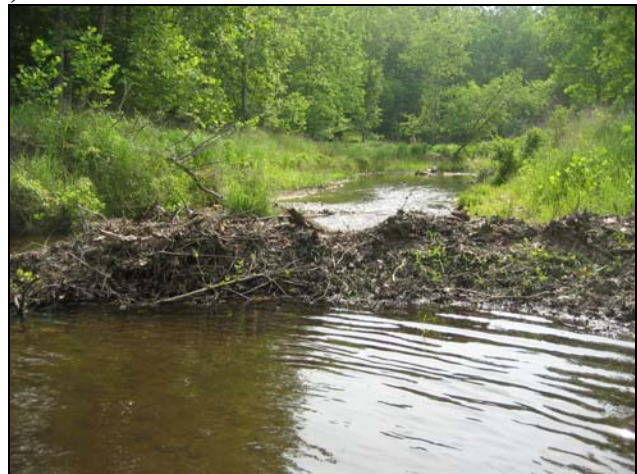
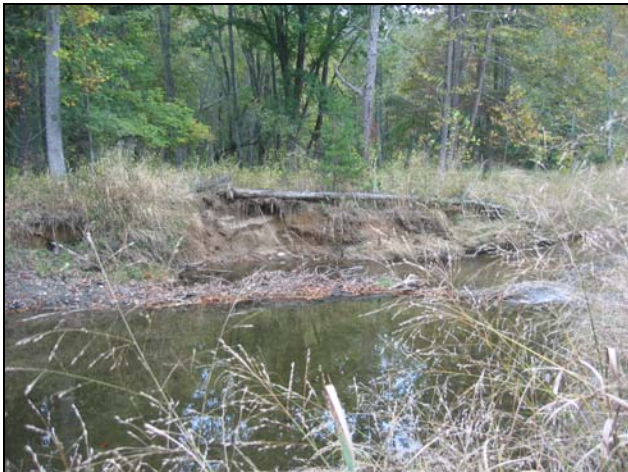
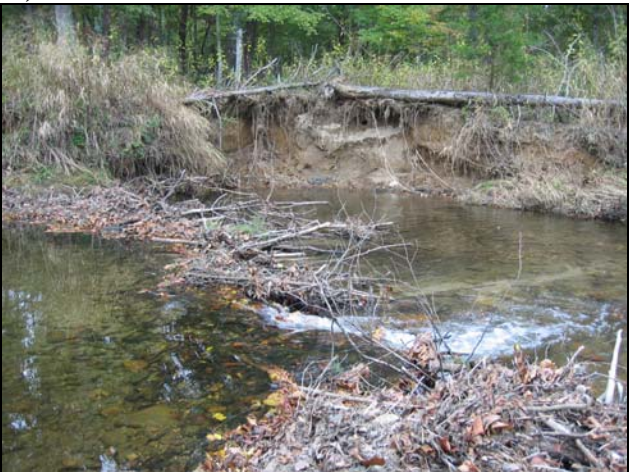
No problem areas were identified in Reach 2 during the 2008 monitoring period. Two problem areas were identified in Reach 4. Problem area 18 (PA 18) has been observed in previous monitoring reports and problem area 37 (PA 37) represents a new area of concern. This problem area consists of a beaver dam located at station 19+00, which is backing up water and obstructing flow. The beaver dam has also caused erosion on the left bank in the vicinity of the dam.

PA 37 Left Bank Erosion and Beaver Dam STA 19+00

No problem areas were identified in Reach 2 during the 2008 monitoring period. Two problem areas were identified in Reach 4. Problem area 18 (PA 18) has been observed in previous monitoring reports and problem area 37 (PA 37) represents a new area of concern. This problem area consists of a beaver dam located at station 19+00, which is backing up water and obstructing flow. The beaver dam has also caused erosion on the left bank in the vicinity of the dam. It is recommended that the beaver dam be removed so the stream can flow as intended.
