# **Monitoring Report MY04**

**Stony Fork Restoration Site  
Upper Neuse River Basin - 03020201  
Monitoring Year 04  
DMS Contract 6830**

**DMS Project Number 97085  
DWR #: 2016-0372  
USACE Action ID: 2016-00875  
Johnston County, North Carolina**

**Monitoring Data Collected: 2022  
Date Submitted: January 2022**

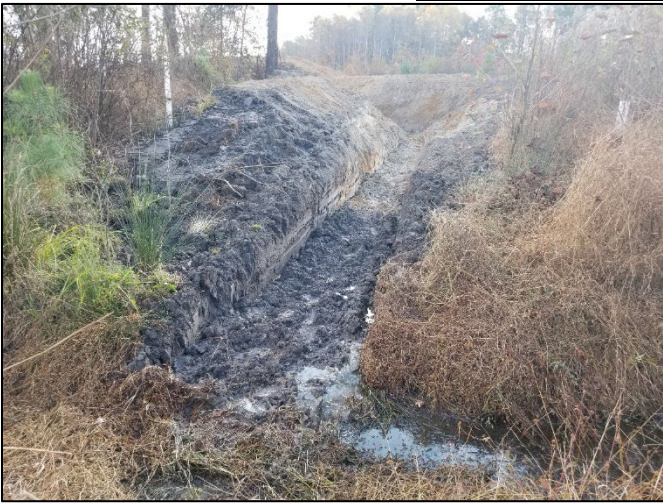
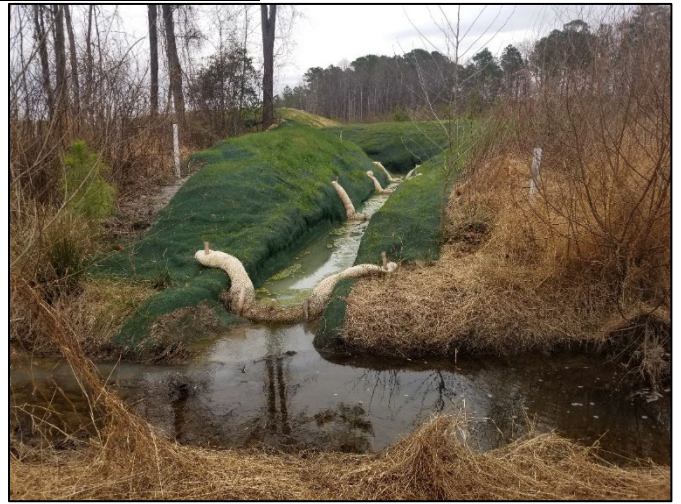
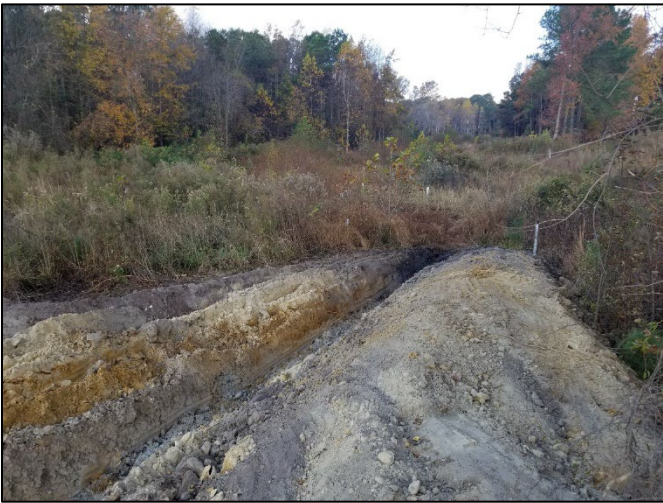
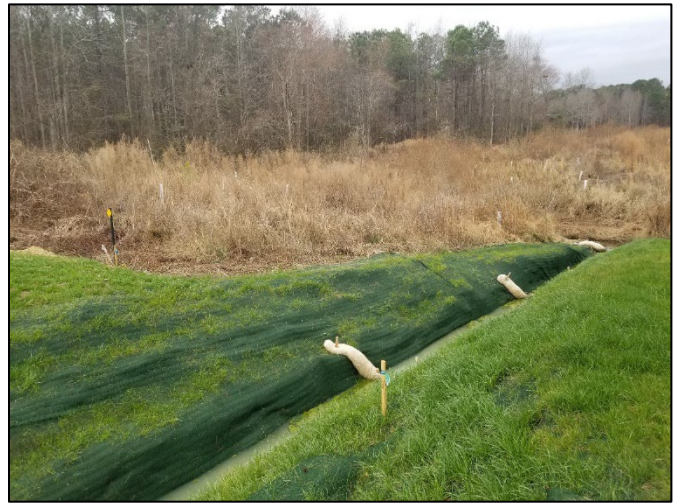
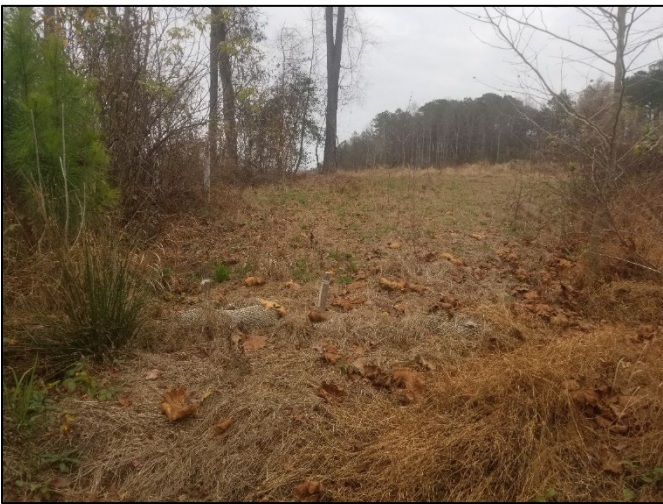
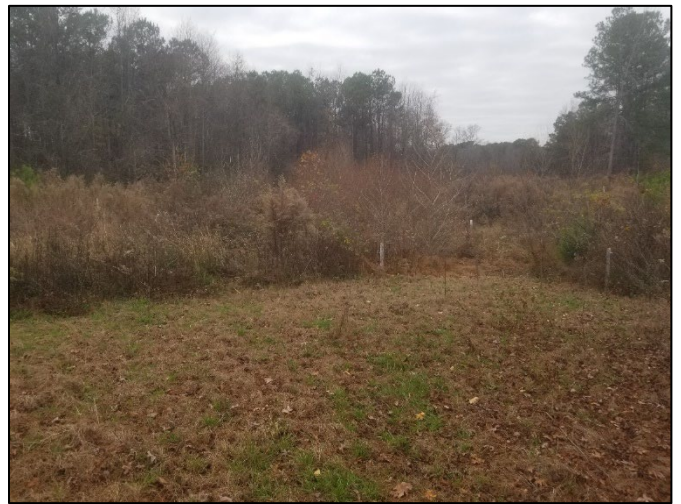
At a site visit on November 18, 2021, it was noted that an outlet from a sediment retention pond had been dug through the site easement and to the project stream. This encroachment occurred on the right bank, approximately 150 feet upstream of the crossing on Reach SF2. Upon noticing this encroachment, KCI immediately notified the developer responsible as well as the responsible agencies. The outlet and sediment pond were filled in and on May 5, 2022 the area inside the easement that had been impacted was planted with 29 one-gallon containerized trees. Please see Appendix C – Vegetation Data for a list of the species and quantity planted in this area. In addition to the above violation, several property owners in the Sherrill Farms Phase 1 subdivision have stored vehicles and a trampoline within the easement. Sherrill Farms LLC was contacted about these encroachments in 2018, 2019, and 2021. In early 2022, a fence was installed along the easement boundary where these encroachments were occurring. Please see Appendix B – Visual Assessment Data and Appendix F – Other Data for more information.

Easement Encroachment Area – 11/19/21

Easement Encroachment Area – 2/24/22

Easement Encroachment Area – 12/9/22

On June 15, 2022, a site meeting with the IRT was conducted on site. At this meeting, the IRT reviewed the remedial actions taken to address the encroachment issues described above, including the newly planted trees and newly installed fence. The IRT also viewed and discussed the culvert crossing that has been installed where Sherill Farm Dr. crosses the project stream. This crossing was originally installed with one corner inside of the easement and with the invert at a lower elevation than KCI had recommended to the developer. At the time of the IRT site visit, the culvert had been reset so that it was no longer encroaching on the easement and was at a more appropriate elevation. The IRT also viewed T3 and discussed the shift in alignment that this reach had experienced. Because the stream was not flowing at the time of the site visit, the IRT request photos of this reach when it was flowing and these can be found in Appendix B – Visual Assessment Data. The IRT also noted some invasive species growing on the site, such as Chinese privet. KCI will continue to monitor and treat the invasives on site. No further encroachments were noted on the site during this walk and KCI has been continuing to monitor the site boundaries closely.

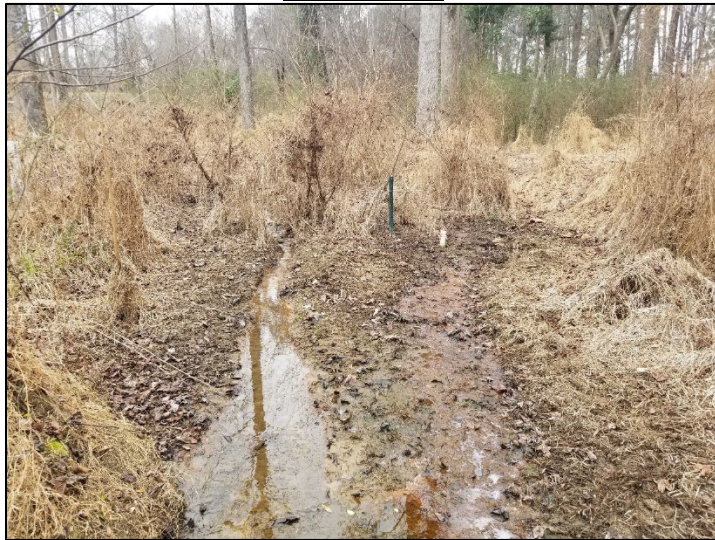
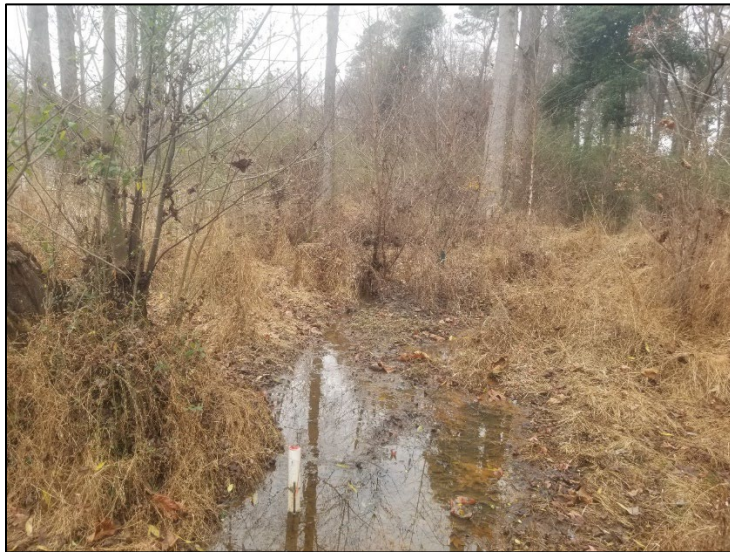
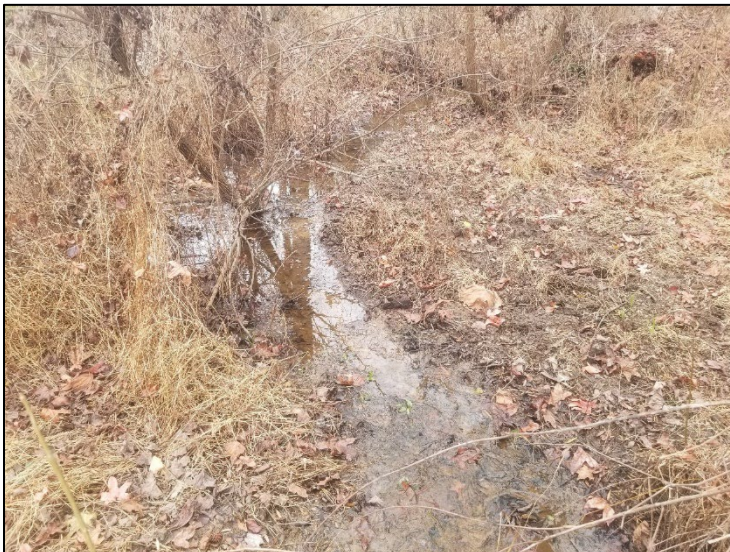
Cross-sections on the site were not surveyed in MY04, as stipulated in the Mitigation Plan. These measurements will be performed again in MY05. In MY03, it was noted that large amounts of aggradation within T3 had caused the channel to move from its original alignment. Since only the bottom 129 feet of this stream are located within the bounds of the project, there is a large sediment source in the form of heavily eroding banks and headcuts just upstream from the project reach. This issue is further compounded by the small size of this reach compared to SF1, which it flows into. When SF1 experiences an overbank event, sediment that is deposited on the floodplain is also deposited in T3. This combined with the upstream sediment source has led to large amounts of sediment being processed through this small reach. Although the stream has shifted alignment slightly, it is still functioning as a stream and has been processing this sediment. Please see Appendix B – Visual Assessment Data for photos of this reach and Appendix E – Hydrologic Data for a detailed record of the flow in this reach in 2022.

T3 – 2/24/22

T3 – 12/9/22
