# **Monitoring Report MY05**

**Stony Fork Restoration Site  
Upper Neuse River Basin - 03020201  
Monitoring Year 05  
DMS Contract 6830**

**DMS Project Number 97085  
DWR #: 2016-0372  
USACE Action ID: 2016-00875  
Johnston County, North Carolina**

**Monitoring Data Collected: 2023  
Date Submitted: January 2024**

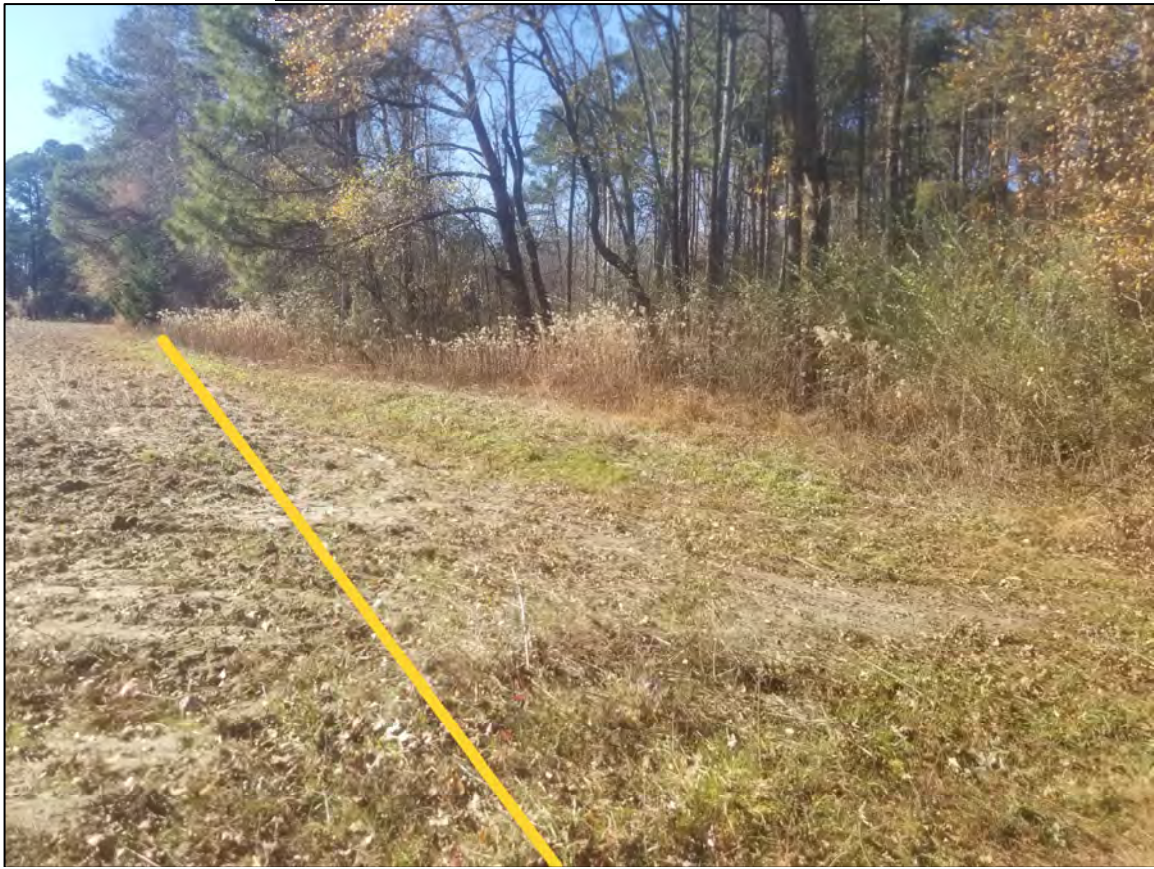
At a site visit on November 18, 2021, it was noted that an outlet from a sediment retention pond had been dug through the site easement and to the project stream. This encroachment occurred on the right bank, approximately 150 feet upstream of the crossing on Reach SF2. Upon noticing this encroachment, KCI immediately notified the developer responsible as well as the responsible agencies. The outlet and sediment pond were filled in and on May 5, 2022 the area inside the easement that had been impacted was planted with 29 one-gallon containerized trees. Please see Appendix C – Vegetation Data for a list of the species and quantity planted in this area. In addition to the above violation, several property owners in the Sherrill Farms Phase 1 subdivision have stored vehicles and a trampoline within the easement. Sherrill Farms LLC was contacted about these encroachments in 2018, 2019, and 2021. In early 2022, a fence was installed along the easement boundary where these encroachments were occurring.

KCI has been monitoring the encroachment area since it was first noted in MY03. This area was replanted in 2022 with gallon size containerized trees and has been revegetating well since then. No further signs of encroachment have been noted in this area. This area, as well as the rest of the boundary will continue to be monitored for any signs of encroachment. The site boundaries were inspected on December 7, 2023. During this inspection, several signs that had come off their posts were noted. Two areas of scalloping were also noted. The first of these is located just downstream of the confluence of T1 and the main stem and was 0.006 acres in size. The second is located at the very end of the project and was 0.059 acres in size. KCI is in contact with the landowners about these encroachments and will be installing additional easement markings in these areas, as well as repairing the other damaged signs.

Scalping near the bottom of the site, with approximate easement line – 12/7/23
