(MY1) FINAL MONITORING REPORT - *Stream Mitigation*

STRAWBERRY HILL MITIGATION PROJECT

Johnston County, North Carolina

NCDMS Project #100094

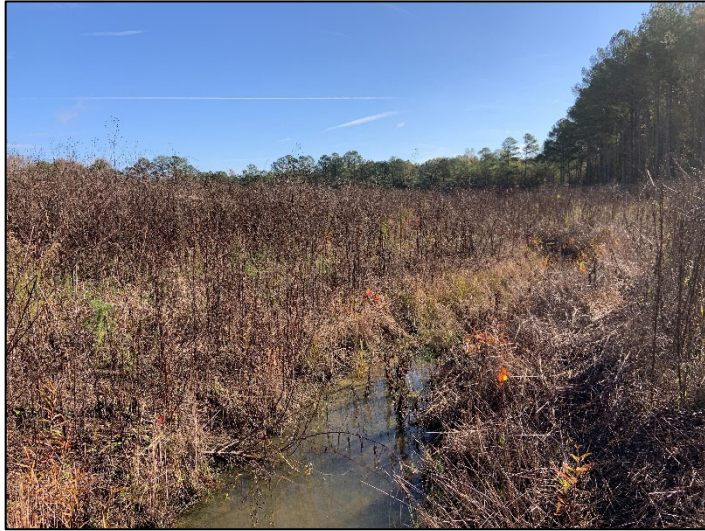
JH1-A looking upstream (11/16/2022)

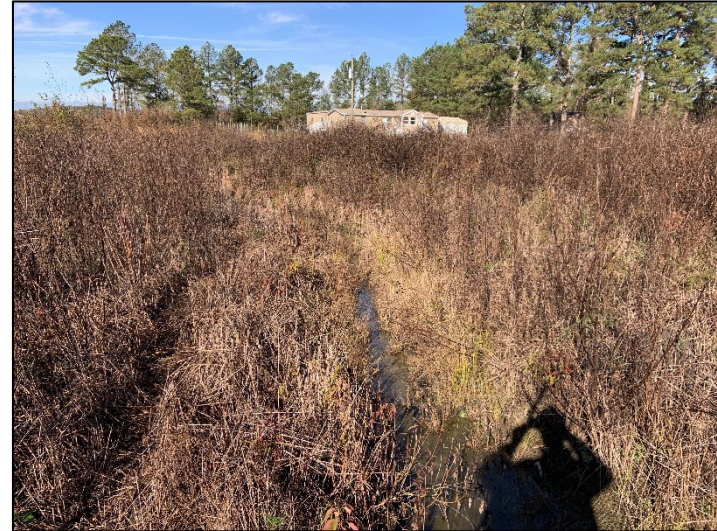
JH1-A looking downstream (11/16/2022)

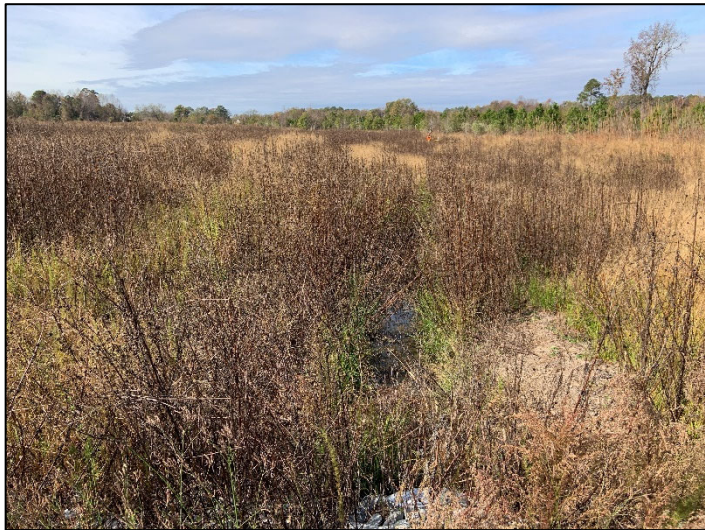
JH1-B looking downstream (11/16/2022)

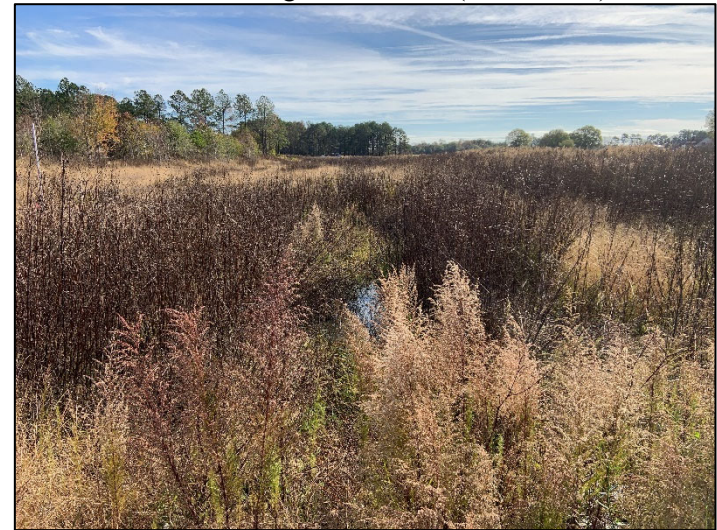
JH1-B looking upstream (11/16/2022)

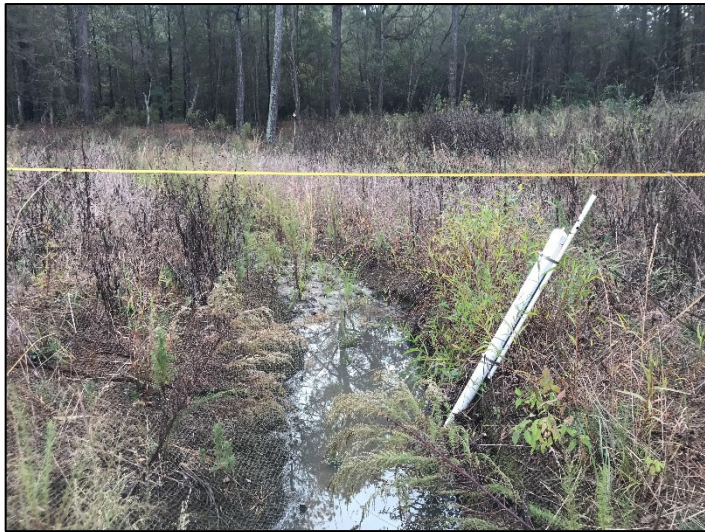
Hay bale toe with live stakes at JH1-A flow gauge (11/16/2022)

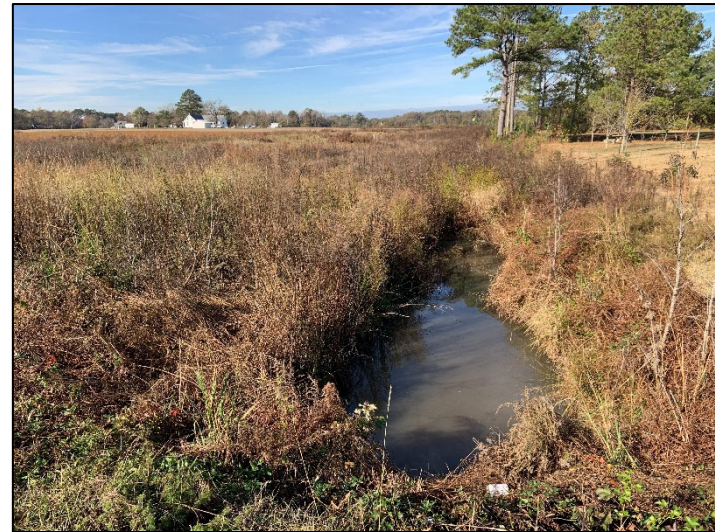
JH1-B – Looking DS from road (11/16/2022)

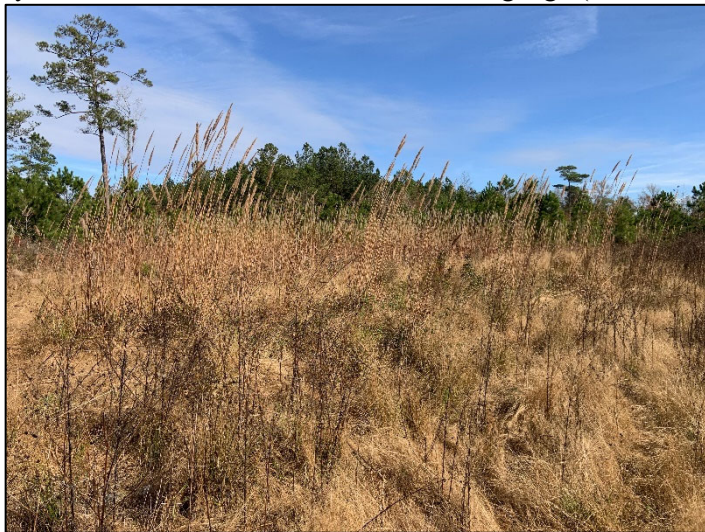
Native phragmites in wetland along JH1-B (11/16/2022)

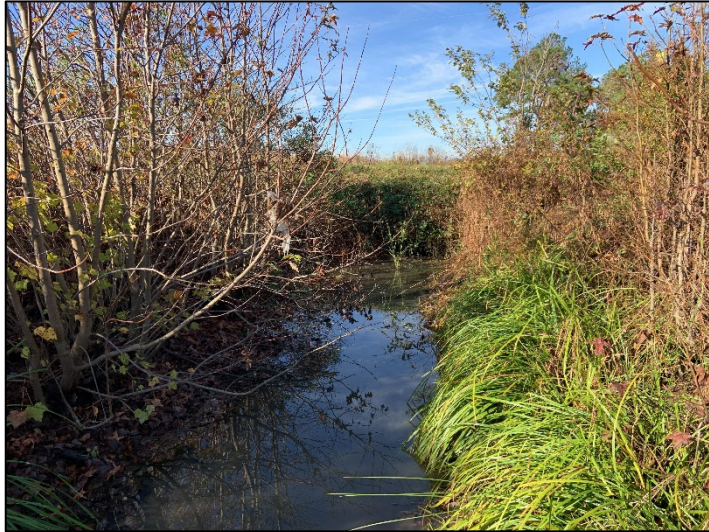
DOT Culvert at Yelverton Grove Rd. (Entrance) (11/16/2022)

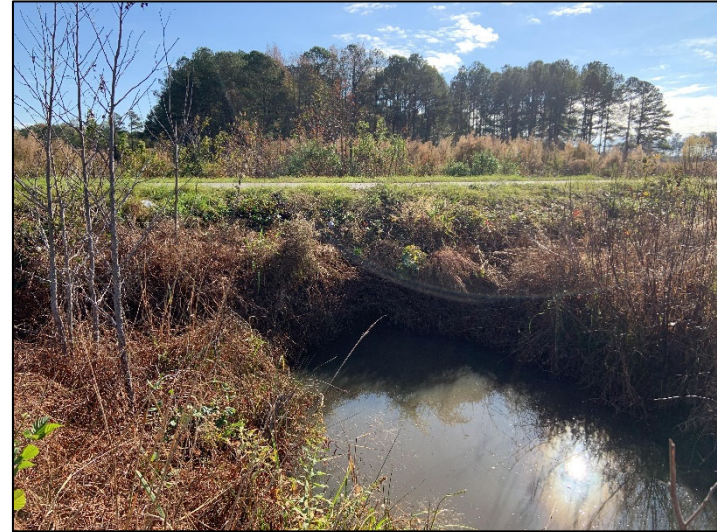
DOT Culvert at Yelverton Grove Rd. (Exit) (11/16/2022)

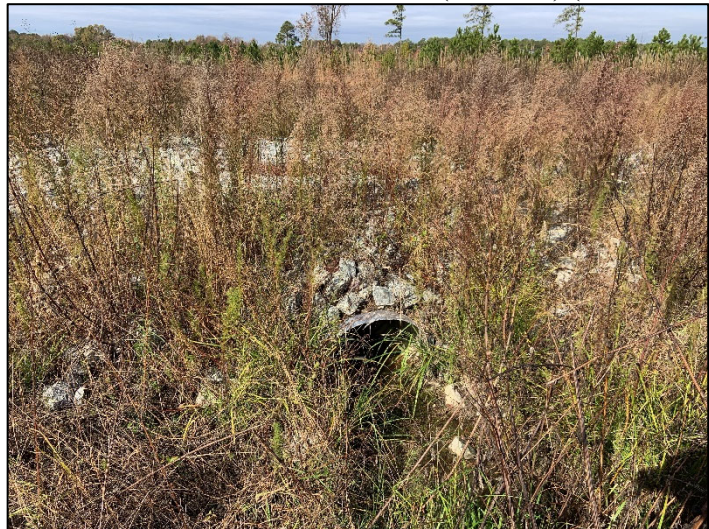
Culvert at JH1-B Crossing (Entrance) (11/16/2022)

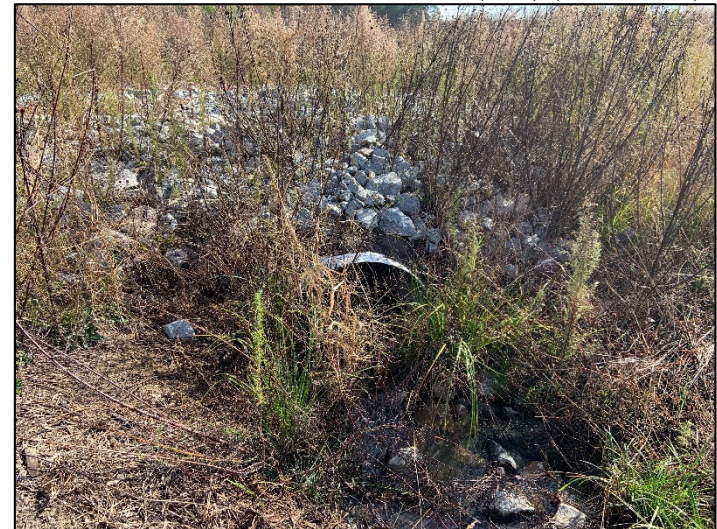
Culvert at JH1-B Crossing (Exit) (11/16/2022)

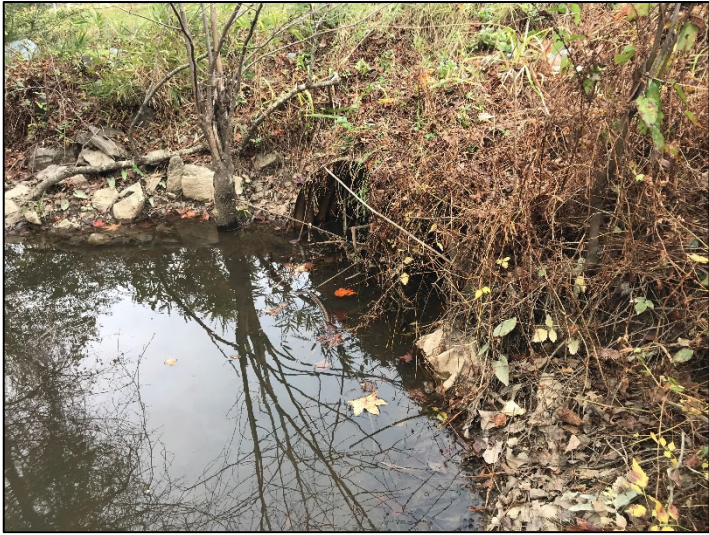
DOT Culvert at Brogden Rd. (Entrance) (11/16/2022)

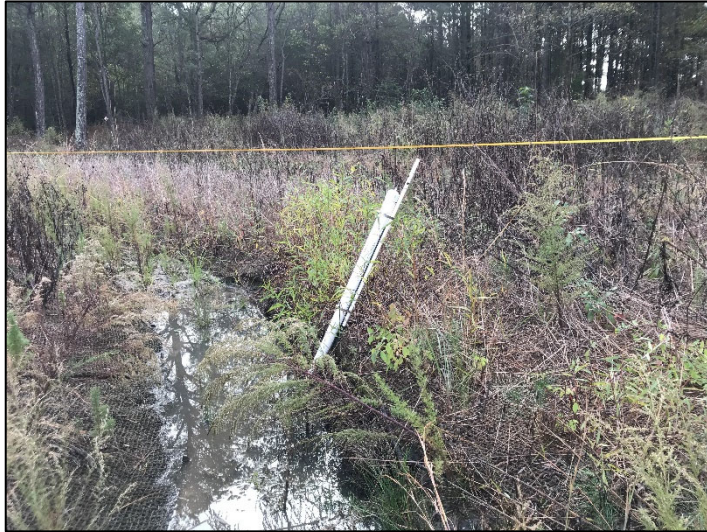
Flow Gauge JH1-A (Looking Upstream) (11/16/2022)

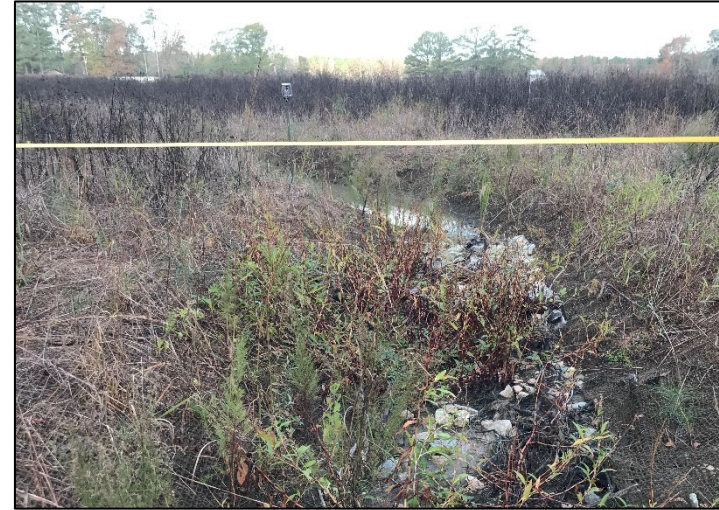
Flow Camera JH1-A (11/16/2022)

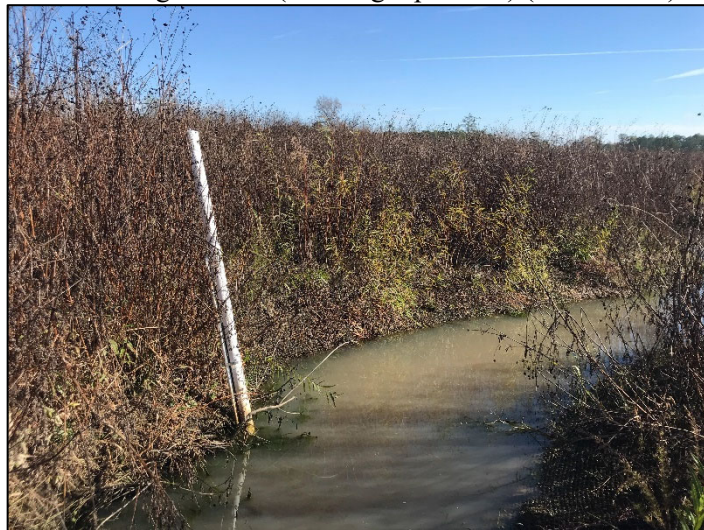
Stage Recorder JH1-B (Looking Upstream) (11/16/2022)

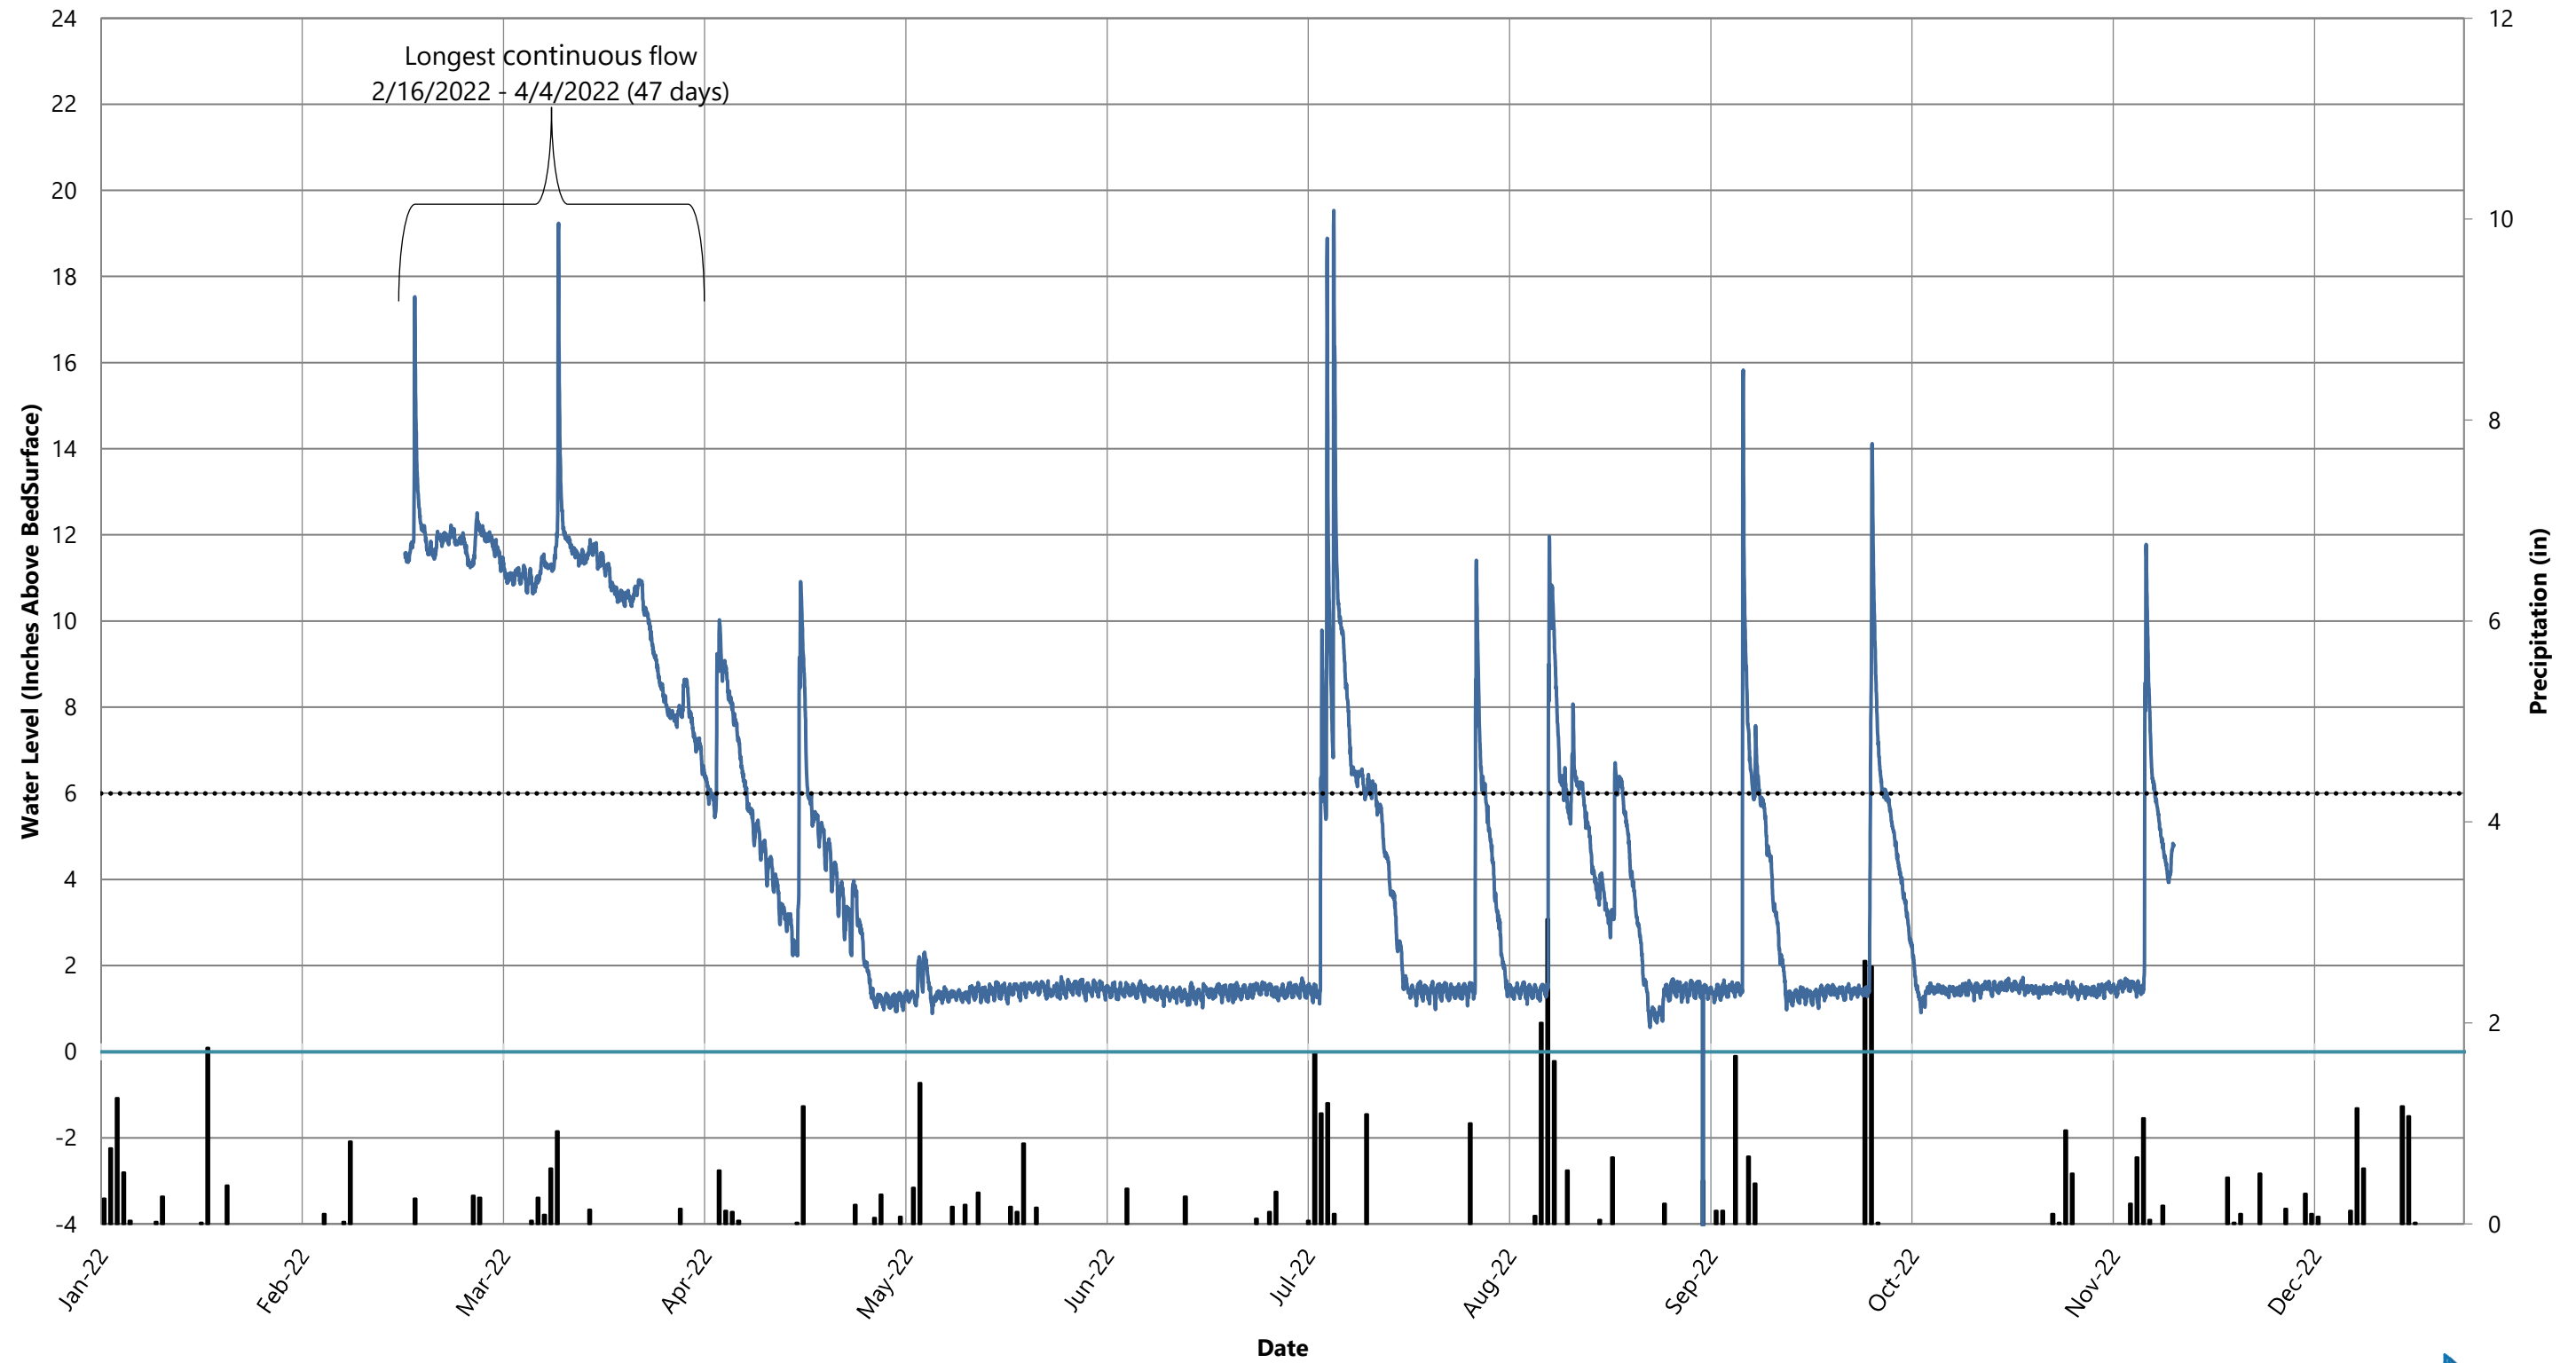
2022 Flow Gauge JH1-A

- The stage recorder on JH1-B recorded four bankfull events in MY1 with the highest stage occurring on March 12th, 2022 and measuring 0.72 feet above top of bank.
- The flow gauge on JH1-A recorded 13 flow events with the longest consecutive flow event lasting 47 days between February 16th, 2022 and April 4th, 2022.
 - o The flow camera was not installed until May 3rd, 2022, therefore missing the most significant flow event. However, since its installation, it captured daily images and indicated several flow events, with the longest flow event lasting approximately 4 days between July 8th, 2022 and July 12th, 2022, which is ultimately a positive indication in the midst of a significant drought year.
