(MY1) FINAL MONITORING REPORT – Riparian Buffer Mitigation

STRAWBERRY HILL MITIGATION PROJECT

Johnston County, North Carolina

NCDMS Project #100094 (Contract #7745)

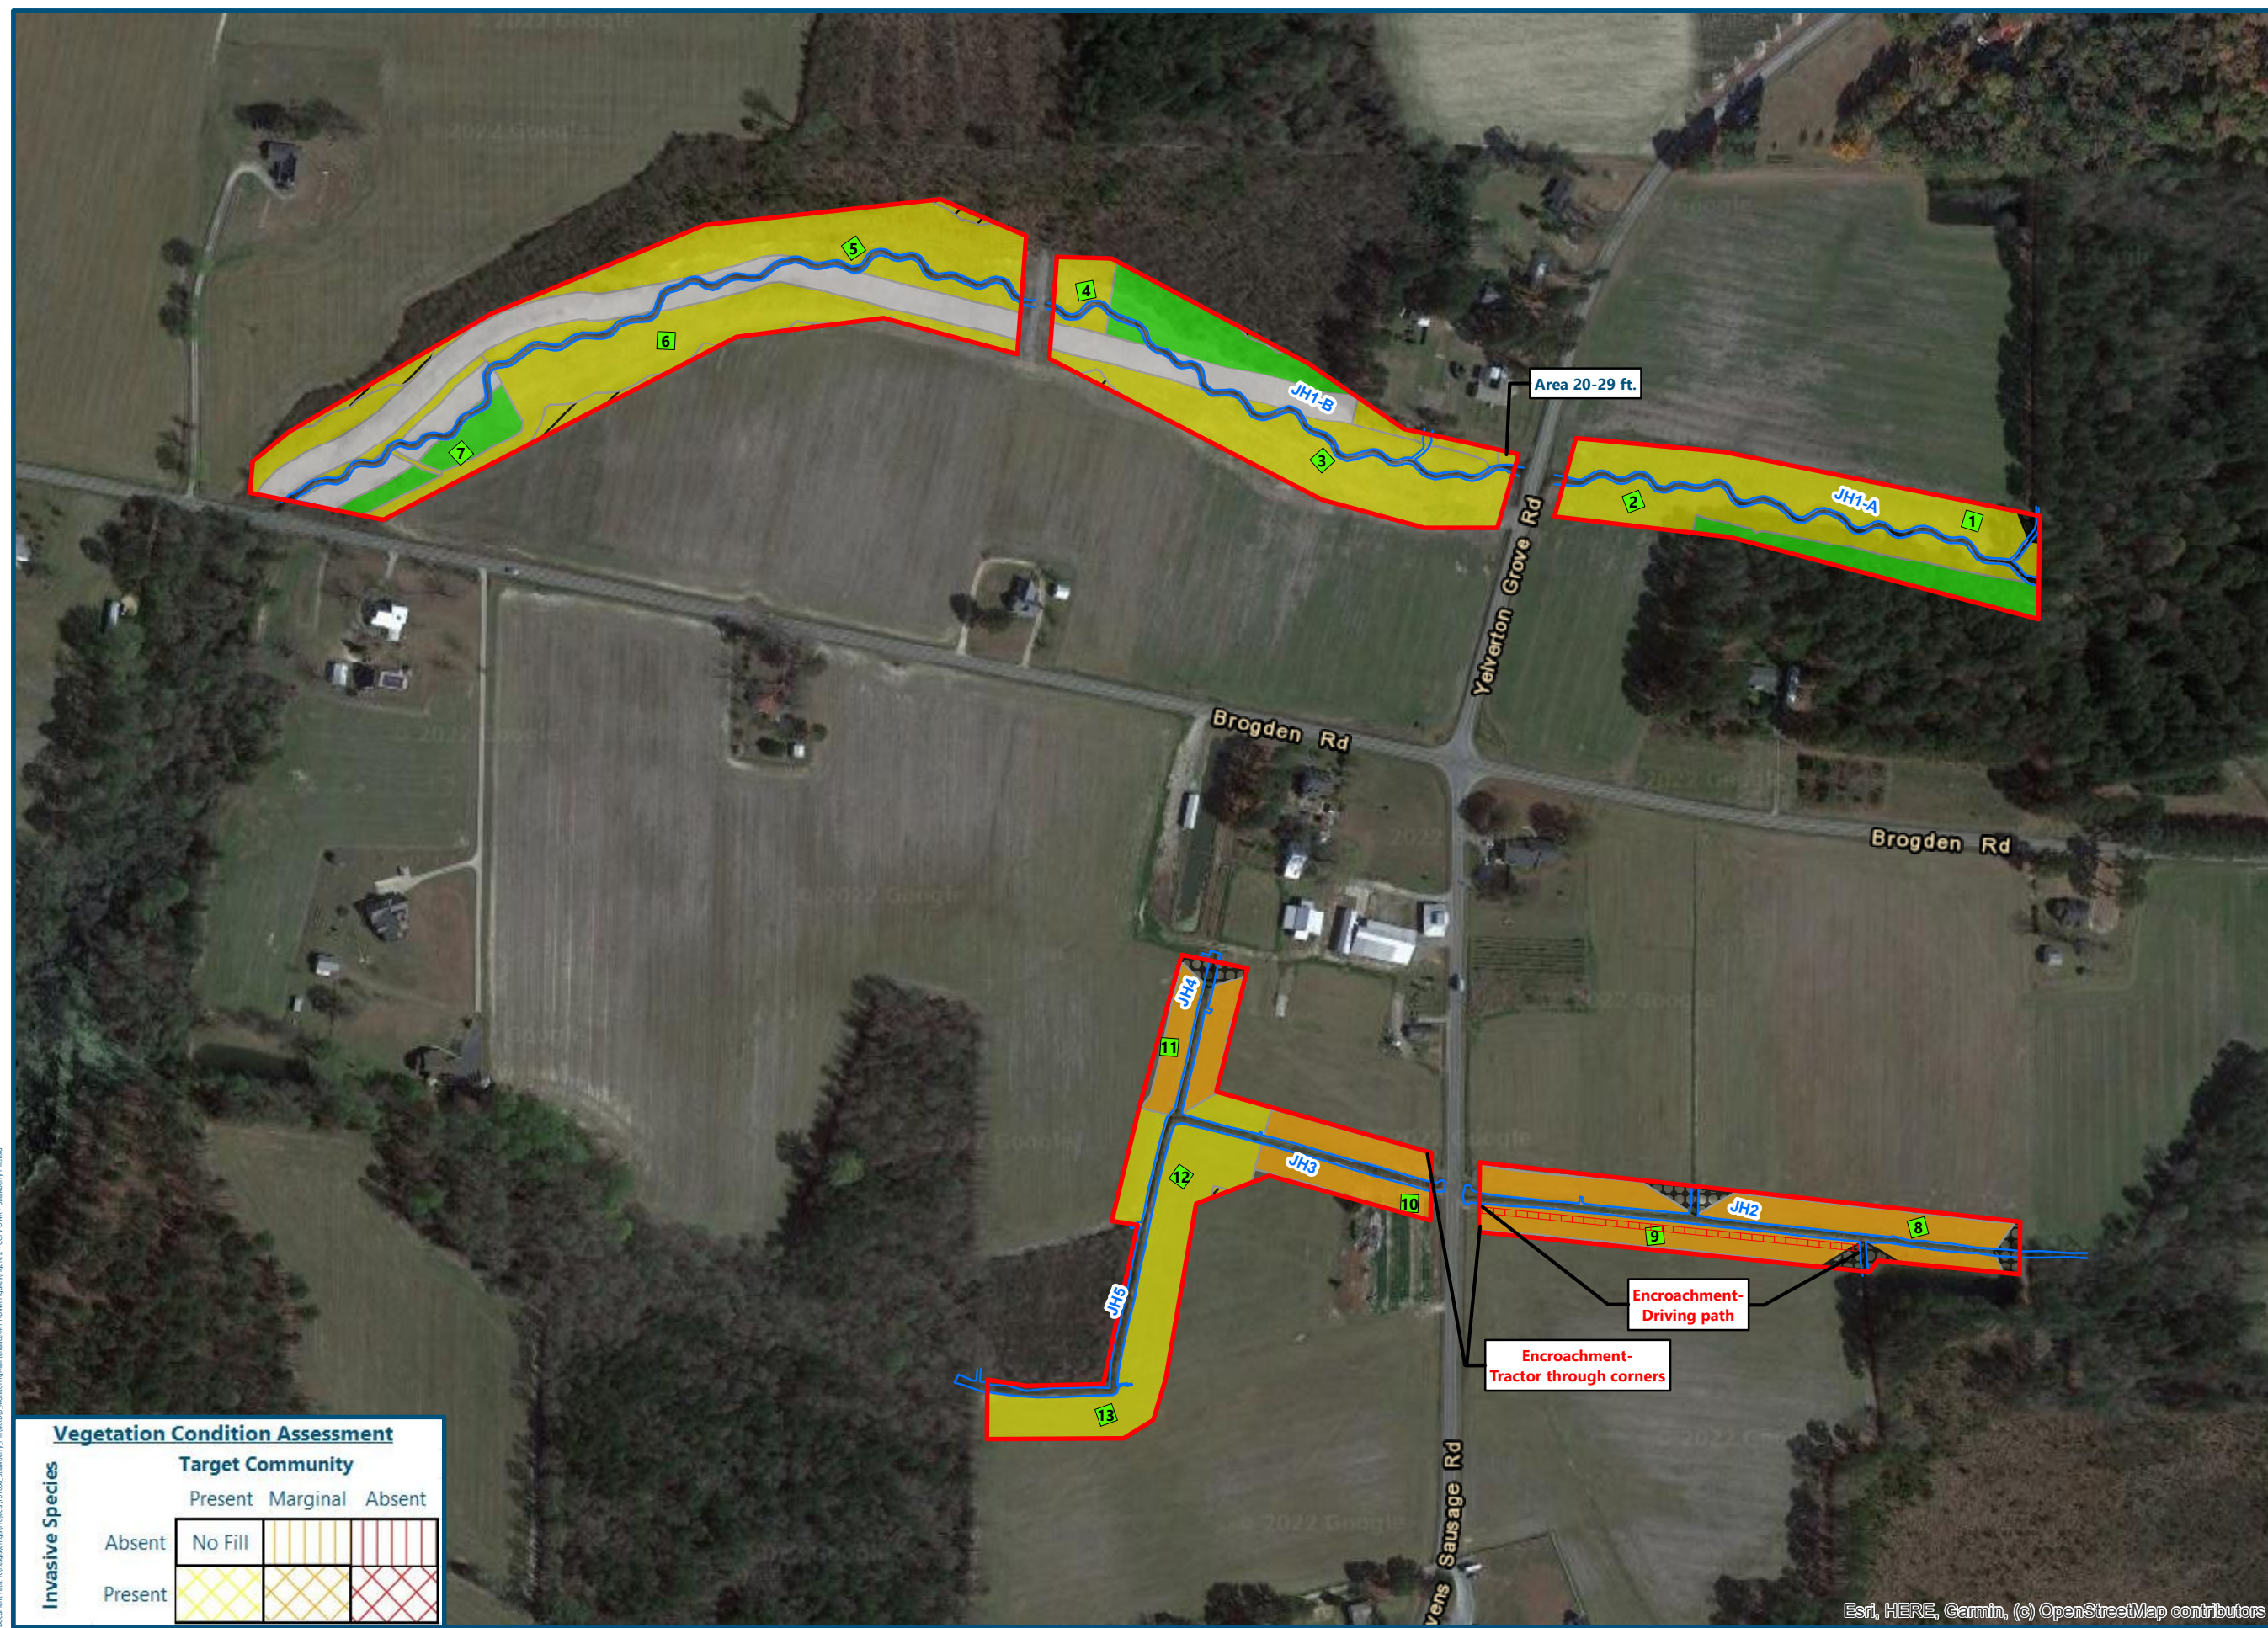
Figure 2 - CCPV MY1
Strawberry Hill Mitigation Project
Johnston County, North Carolina

Year 1 monitoring of 13 fixed vegetation plots was completed on November 16th, 2022. Vegetation tables are in **Appendix B** and associated photos are in **Appendix C**. MY1 monitoring data indicates that all plots are exceeding the success criteria of 260 planted stems per acre. Planted stem densities ranged from 324 to 809 planted stems per acre with a mean of 563 planted stems per acre across all plots. A total of 12 species were documented within the plots. One volunteer species (*Sambucus canadensis*, or common elderberry) was noted in one of the vegetation plots, while more volunteers are expected to establish in upcoming years. The average tree height observed was 1.5 feet.

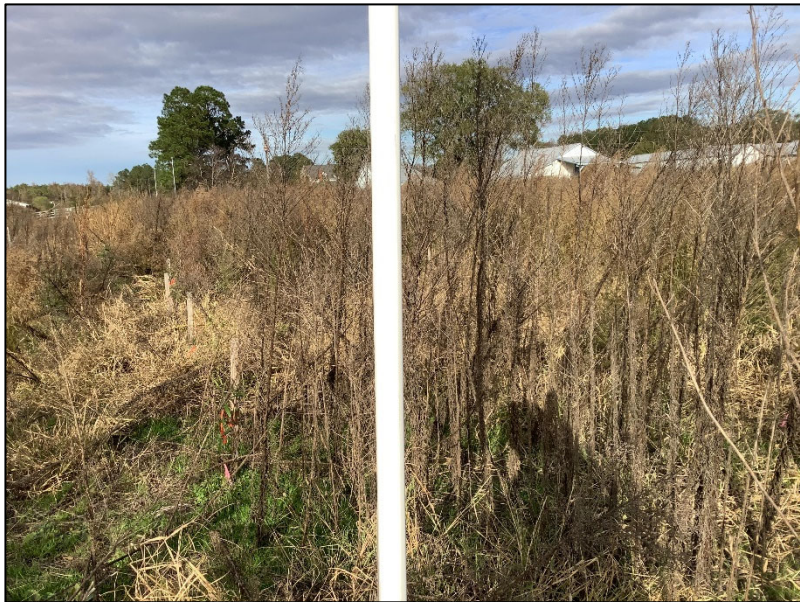
Vegetation Plot 11 (11/16/2022)

Plot #	Planted Stems/Acre	Volunteer Stems/Acre	Total Stems/Acre	Success Criteria Met?	Average Planted Stem Height
1	607	0	607	Yes	1.3
2	567	81	647	Yes	1.7
3	607	0	607	Yes	1.4
4	647	0	647	Yes	1.5
5	809	0	809	Yes	1.3
6	567	0	567	Yes	1.4
7	526	0	526	Yes	1.3
8	445	0	445	Yes	1.2
9	728	0	728	Yes	1.6
10	647	0	647	Yes	1.6
11	324	0	324	Yes	1.5
12	486	0	486	Yes	1.6
13	364	0	364	Yes	2.0
Project Avg	563	6	570	Yes	1.5

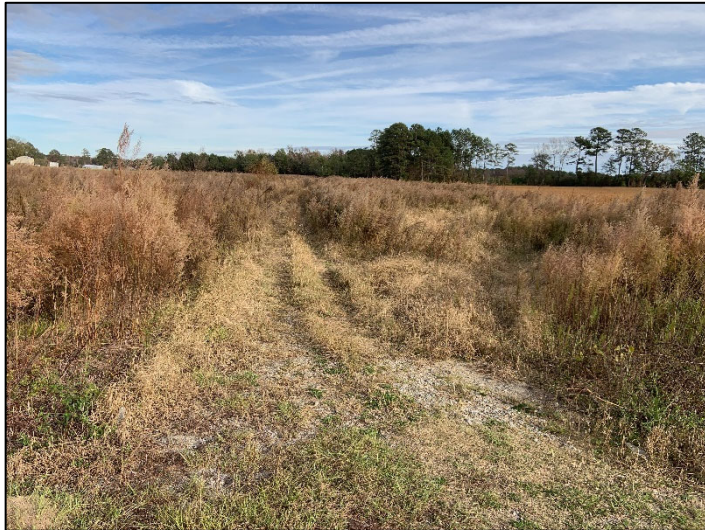
Visual assessment of vegetation outside of the monitoring plots indicates that the herbaceous vegetation is becoming well established throughout the project and no invasive species were observed. Easement boundary markers and signs are clearly visible and in good condition. However, there was some encroachment observed. RES identified some encroachment associated with ditches JH2 and JH3 along Stevens Sausage Road. One encroachment involves a path being actively driven parallel to ditch JH2 and is impeding vegetation growth. RES will be installing additional t-post markers along with horse tape to provide a physical barrier to prevent future encroachment here and will also be replanting the driving path footprint with containerized trees to ensure adequate tree density and vigor. The other encroachment involves two easement corners, on JH2 and JH3, that are being driven through by farm equipment as the farmer is attempting to access the adjacent cropland. RES is actively resolving the issue with the landowner and farmer and will also be coordinating the relocation of a roadside ditch crossing that will enable the farm equipment to access the fields at another location, away from the easement. All activities and resulting outcomes will be communicated in the next (MY2) monitoring report. Locations of encroachment areas are depicted in **Appendix A, Figure 2** and some photos of encroachment and other general site photos are in **Appendix C**. Additionally, there is no undocumented concentrated flow in the easement area.

Encroachment – From Stevens Sausage Rd. – Driving path parallel to JH2 and farm equipment path cutting through right corner (11/16/2022)

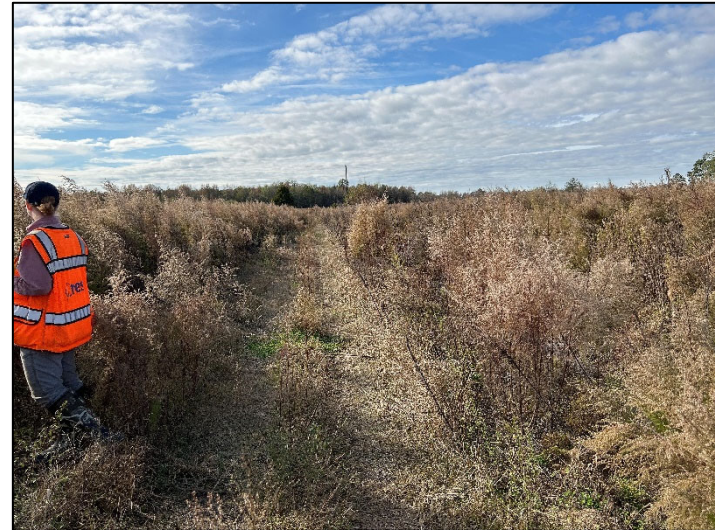
Encroachment – Driving path parallel to JH2 further “upstream” (11/16/2022)
