MY2 MONITORING REPORT - Stream Mitigation

STRAWBERRY HILL MITIGATION PROJECT

Johnston County, North Carolina

NCDMS Project #100094

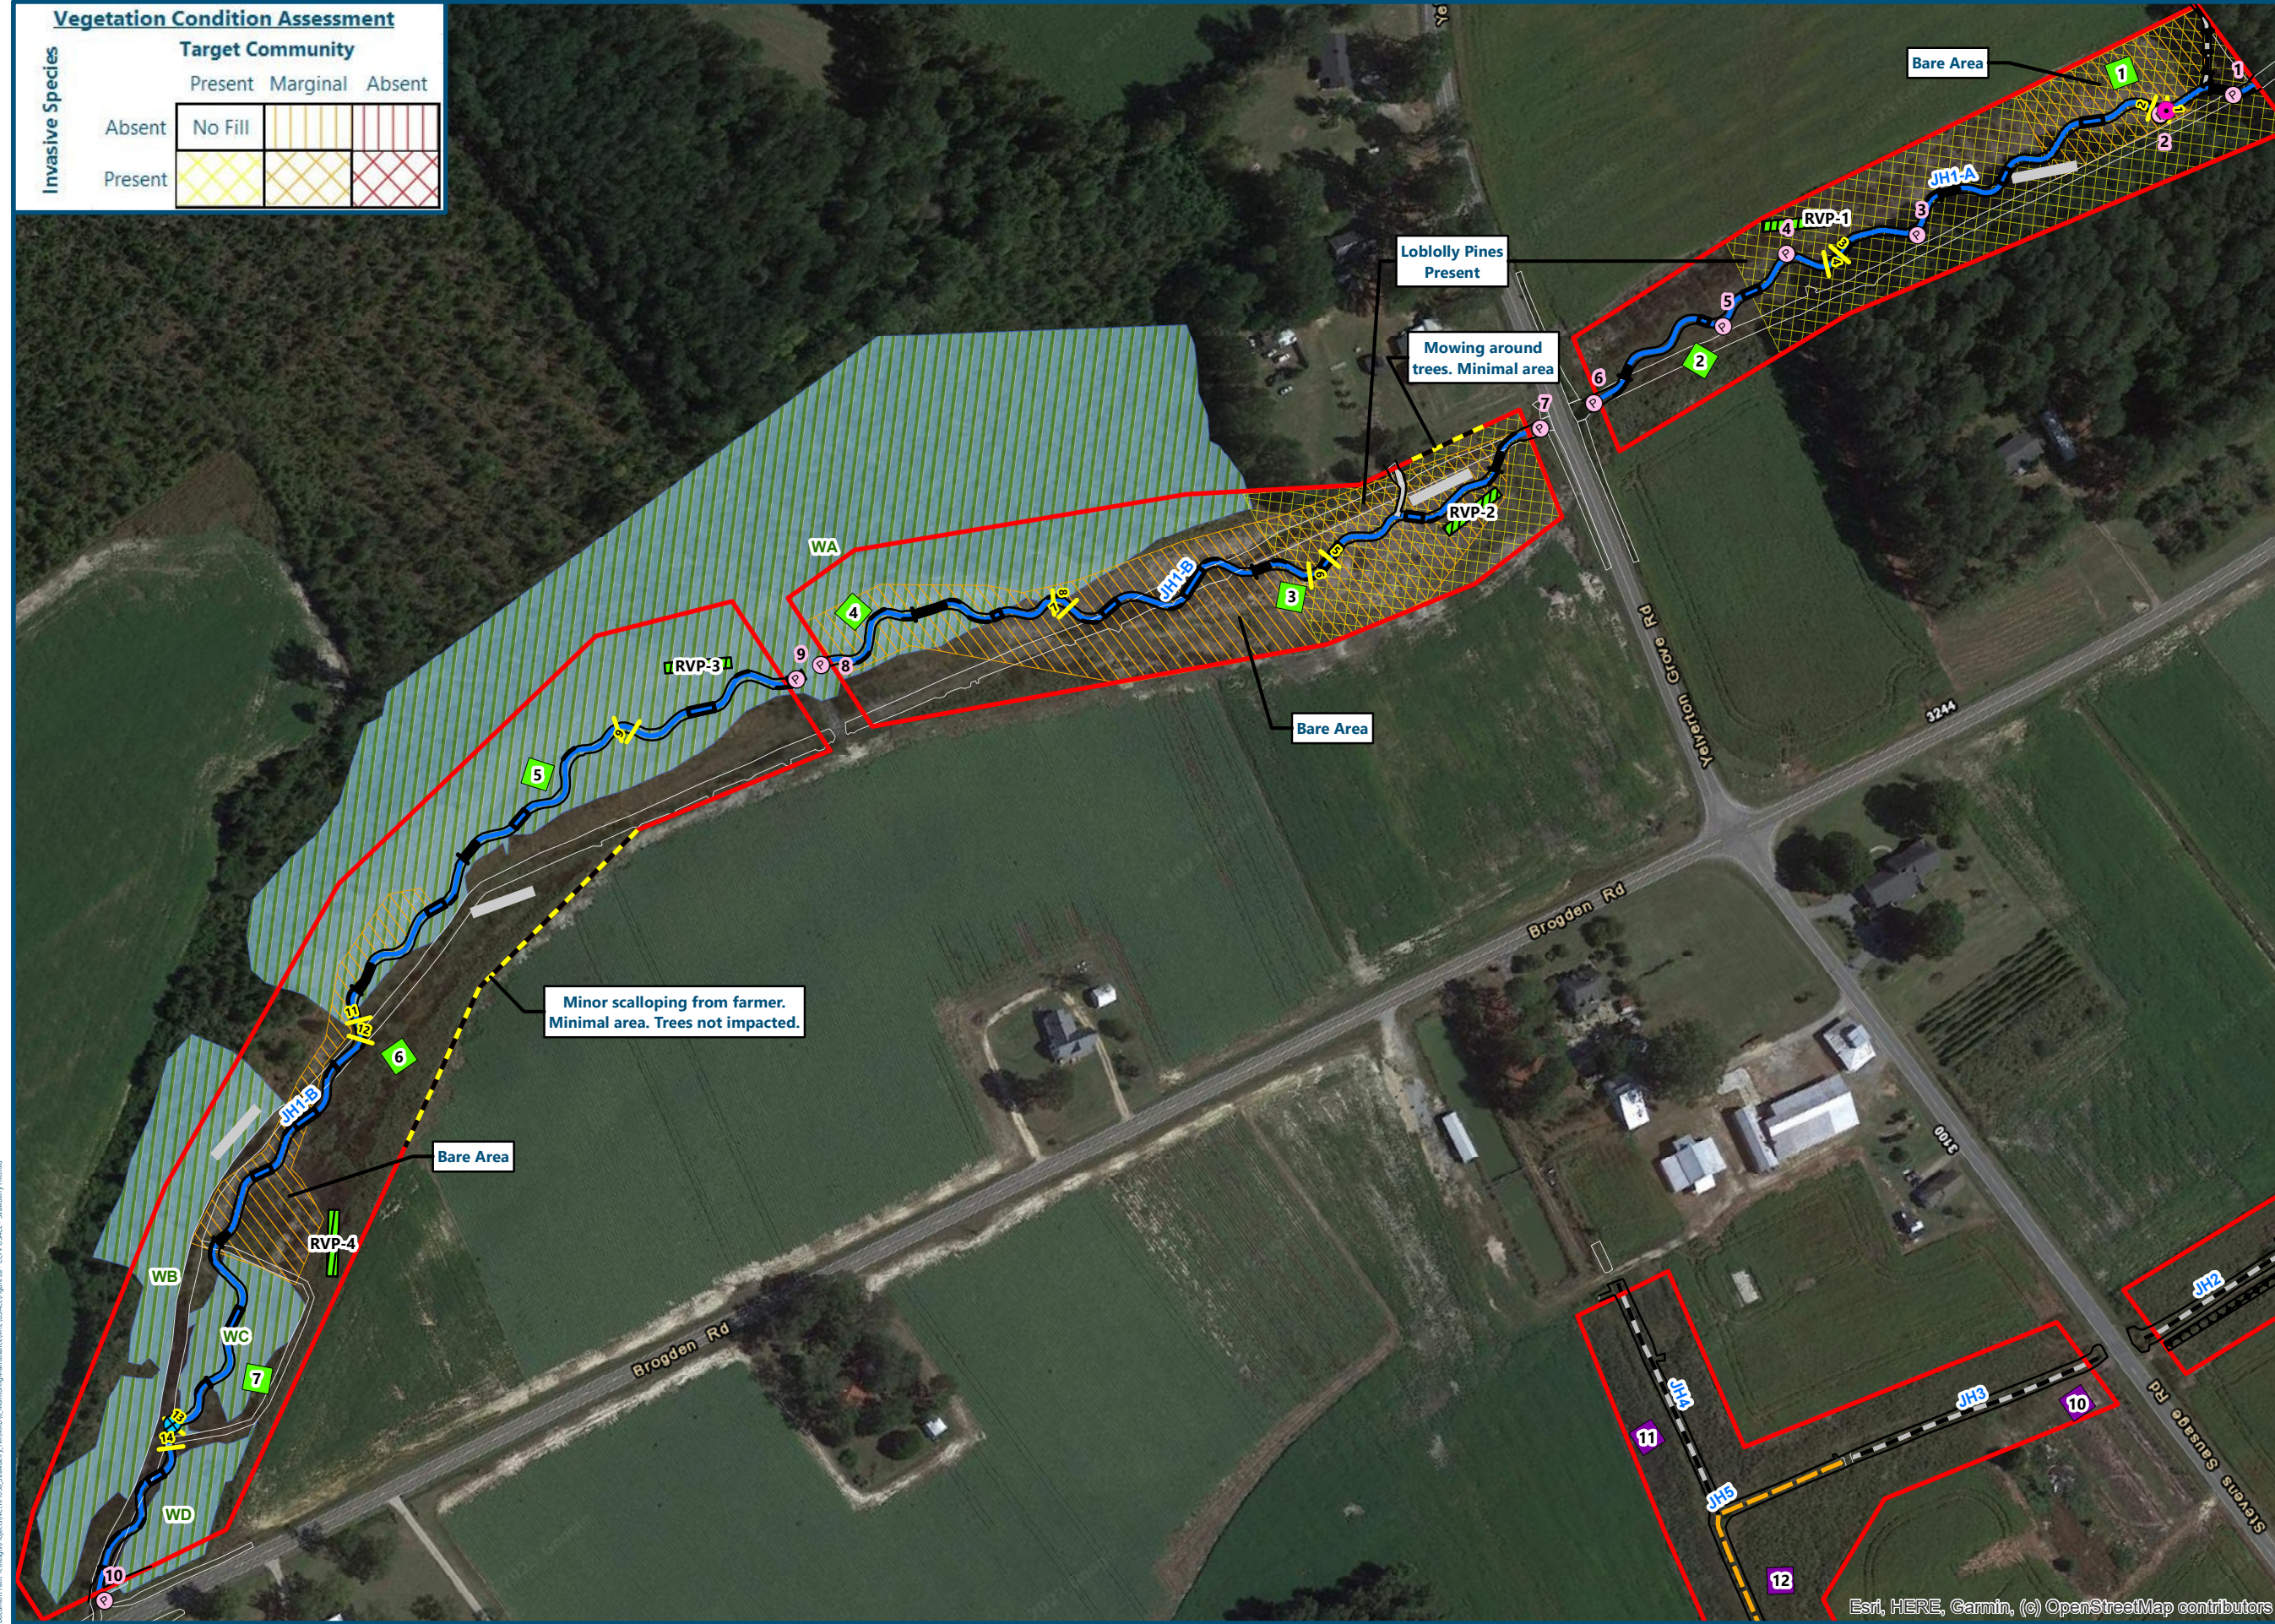
Figure 2a - CCPV MY2 2023
Strawberry Hill Mitigation Project
 Johnston County, North Carolina

4. A few minor encroachments (scalping) were identified during the 11/30 site visit. Please add these areas to the CCPV and indicate how future encroachments will be prevented in these areas. The CCPV has been revised to include these areas and discussion has been added to **Section 1.5.1**. The encroachments are very small and narrow and do not appear to result in any tree mortality. The areas are mapped as lines as the areal coverage is minimal.

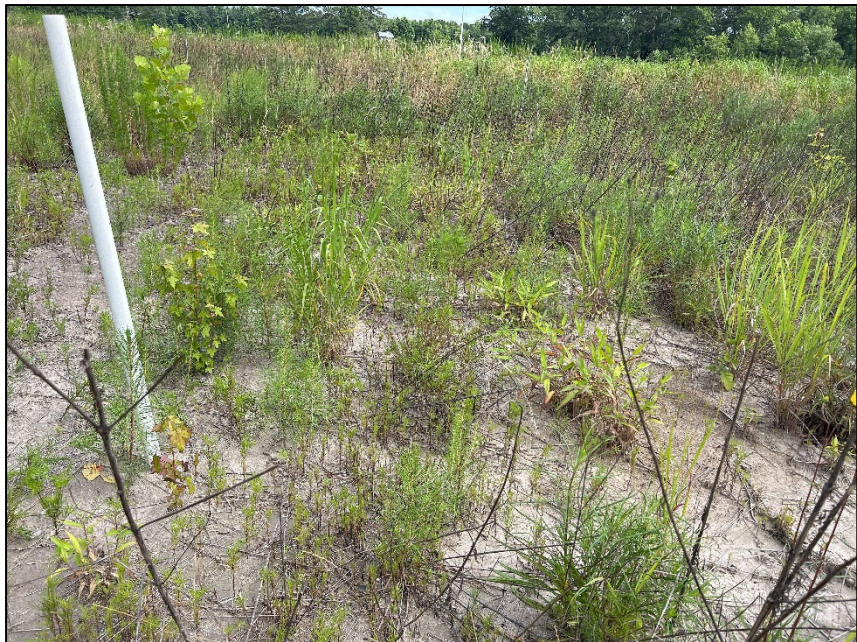
Visual assessment of vegetation outside of the monitoring plots indicates that herbaceous vegetation is establishing in much of the riparian area. However, areas where Priority II stream restoration activities involved extensive grading are struggling to establish dense vegetative cover though still have adequate tree density at this time. The total area of bare areas amounts to 3.77 acres and are depicted in **Figure 2**. In November 2023, RES applied an organic soil amendment in the form of humic acid to these areas to promote soil health and vegetative growth while minimizing damage to planted trees. RES also noted that loblolly pine (*Pinus taeda*) is establishing in some areas, totaling about 3.9 acres (**Figure 2**). The pines are still short, but RES plans to treat these promptly to minimize their competition with desirable trees.

Bare Area in JH1-A Riparian Area (10/3/2023)

[This has been revised to clarify that the amendment is a liquid humic acid fertilizer.](#)

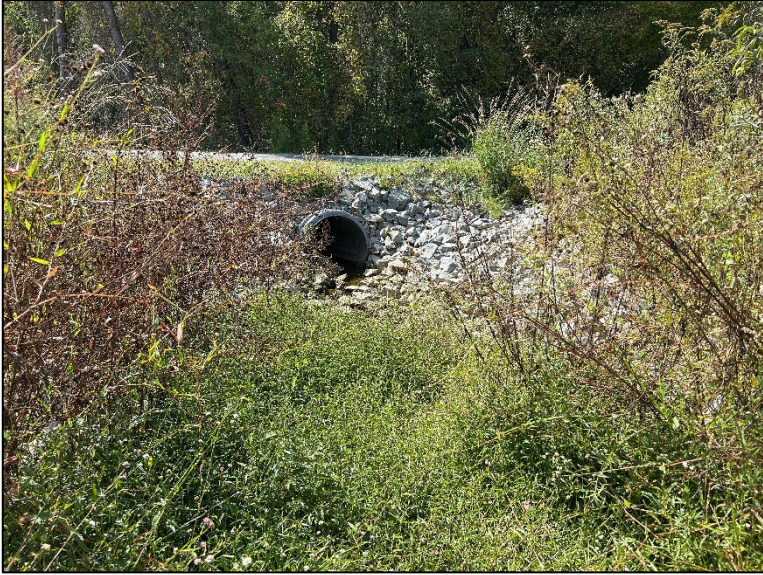
Visual assessment of the stream channel was performed to document signs of instability, such as eroding banks, structural instability, or excessive sedimentation. The channel is transporting sediment as designed and will continue to be monitored for aggradation and degradation (**Appendix C**). RES also established permanent photo points (PP-1 through PP-5) at all the constructed "hay bale toes" on reach JH1-A as these structure types have received considerable attention from the IRT in recent years. RES intends to take photos of their condition each year to present their ongoing condition. As of MY2, the hay bale toes appear stable and are absorbing sediment and live stake trees are successfully rooting in them. Photos are in **Appendix A** and corresponding photo point locations are depicted in **Figure 2**. RES also noted that NCDOT has replaced the culvert at Brogden Road and reach JH1-B, just below the downstream extent of the Project. The construction of the new crossing appears to have involved the removal of the suspected beaver dam downstream; therefore, water is no longer backing up within JH1-B. Photos of the new culvert are in **Appendix B**.

PP-10 New DOT Culvert at Brogden Rd. (Entrance) (10/3/2023)

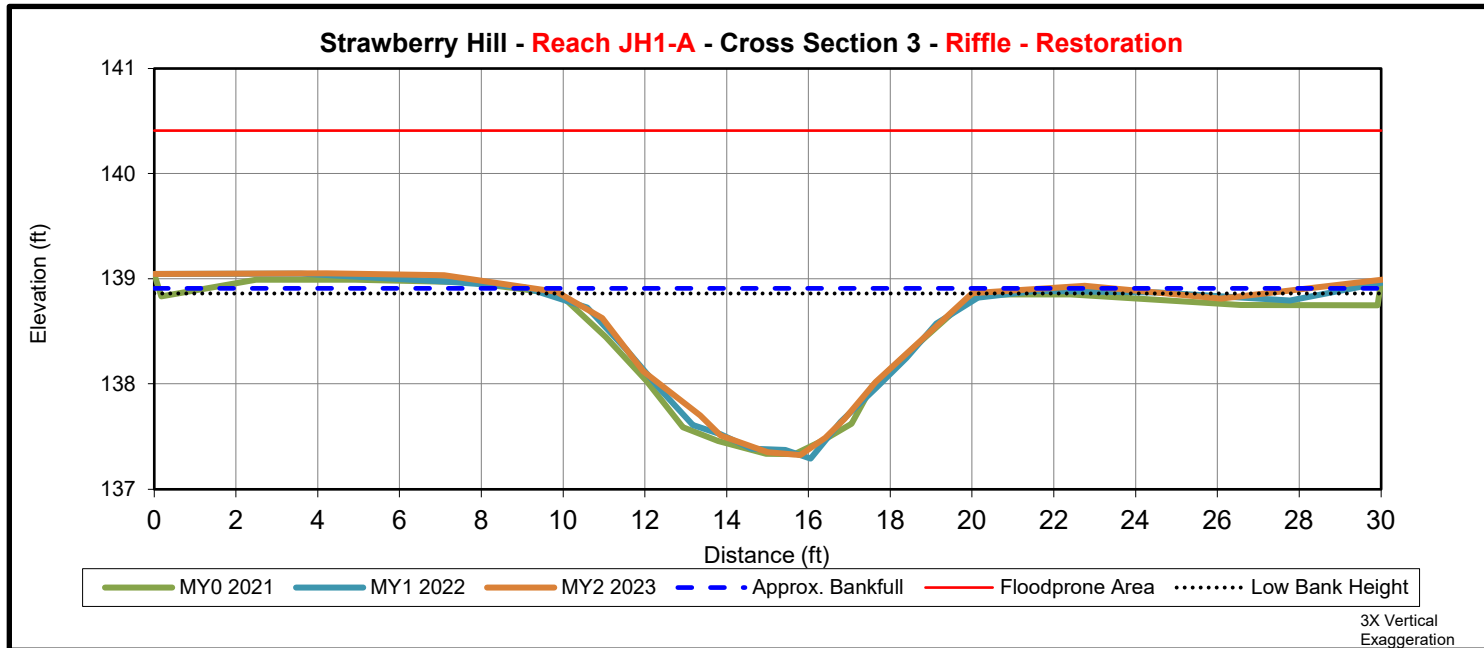
3. Please review cross sections. Some cross section BHRs are not reproducible with the numbers in the report. For example, XS-3 calculates to a 0.95 BHR based on report numbers (using formula *LTOB Max Depth / [BKFL Elev. Based on MY0 XSA – Thalweg Elevation]*) but is reported as 1.00. Reviewing the submitted Excel data (again using XS-3 as an example) to remove possibility of rounding errors produces similar results. We can reproduce all MY1 BHRs with the method described above.

Cross Section 3 (Riffle - JH1-A)						
	MY0	MY1	MY2	MY3	MY5	MY7	MY+
Bankfull Elevation (ft) - Based on AB-Bankfull ¹ Area	138.85	138.88	138.91				
Bank Height Ratio - Based on AB Bankfull ¹ Area	1.00	0.96	0.97				
Thalweg Elevation	137.34	137.29	137.33				
LTOB ² Elevation	138.85	138.82	138.86				
LTOB ² Max Depth (ft)	1.5	1.53	1.53				
LTOB ² Cross Sectional Area (ft ²)	9.20	8.60	8.70

[BHRs and Max Depths have been revised for all cross sections and respective morphology tables have been updated. The discrepancy stemmed from entering rounded numbers in the morph tables instead of the raw calculations. Then, the formulas in Table 11 Morphology data table were overwritten with the rounded calculations. These issues have been corrected and the updated calculations for BHR and Max Depth are accurate.](#)
