# Stricker Branch Stream Restoration Project Contract # D06054-G

County: Cabarrus  
Cataloging Unit: Yadkin 03040105; Targeted Watershed 020040  
Monitoring Firm POC: Mid-Atlantic Mitigation, LLC  
Rich Mogensen (704) 782-4133  
Prepared For: Ecosystem Enhancement Program

## Year 1 (2008) Monitoring Report

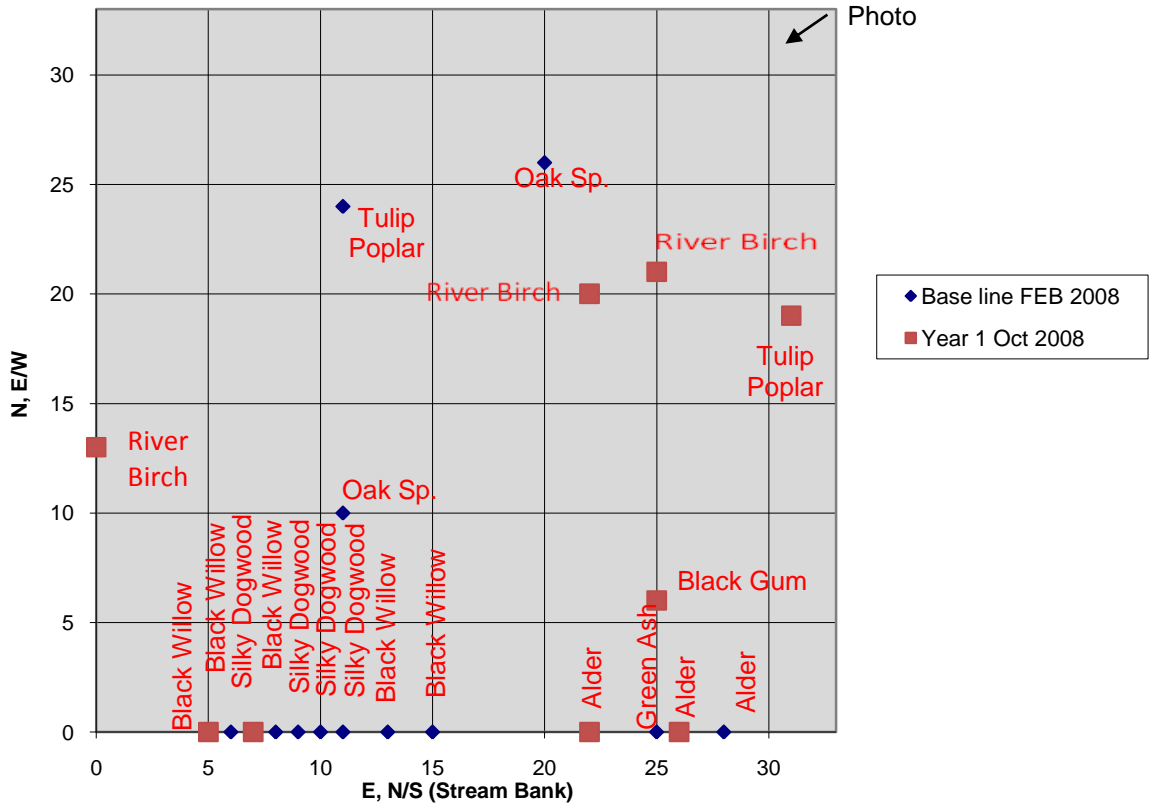
VP 5

As mentioned above in the Section 3.1.2, Plots 5 and 6 are overgrown with a particularly robust variety of polygonum, with stems up to an inch in diameter. Several live individuals were found hidden under this polygonum growth, however not all individuals were located and pulled free. This means that some missing individuals could still be alive and may re-emerge when the polygonum dies back and the herbaceous community finds equilibrium. While the stem counts on Plots 5 and 6 are below success criteria, MAM believes it is best to wait until after the Year 2 count to determine if any missing individuals can be located. If the polygonum over growth persists into year 2 and stem counts in these plots are still below success criteria, treatment of the polygonum and/or a supplemental planting will be considered. Herbaceous cover was 100% with polygonum dominating. Three “extra” river birches were noted in Plot 5 indicating that these may indeed be volunteers not individuals missed during the baseline count. Overall, without the missing and dead individuals, the plant count indicates 58% survival and 367 stems per acre for the site. Counting of four cottonwood volunteers and four river birches that are volunteers and /or may have been missed during the baseline count, brings the stem count to 420 overall.

Couldn't find northern corners  
 half of plot is over grown with extremely hearty polygonum  
 3 new river birches found in plot, must be vols?

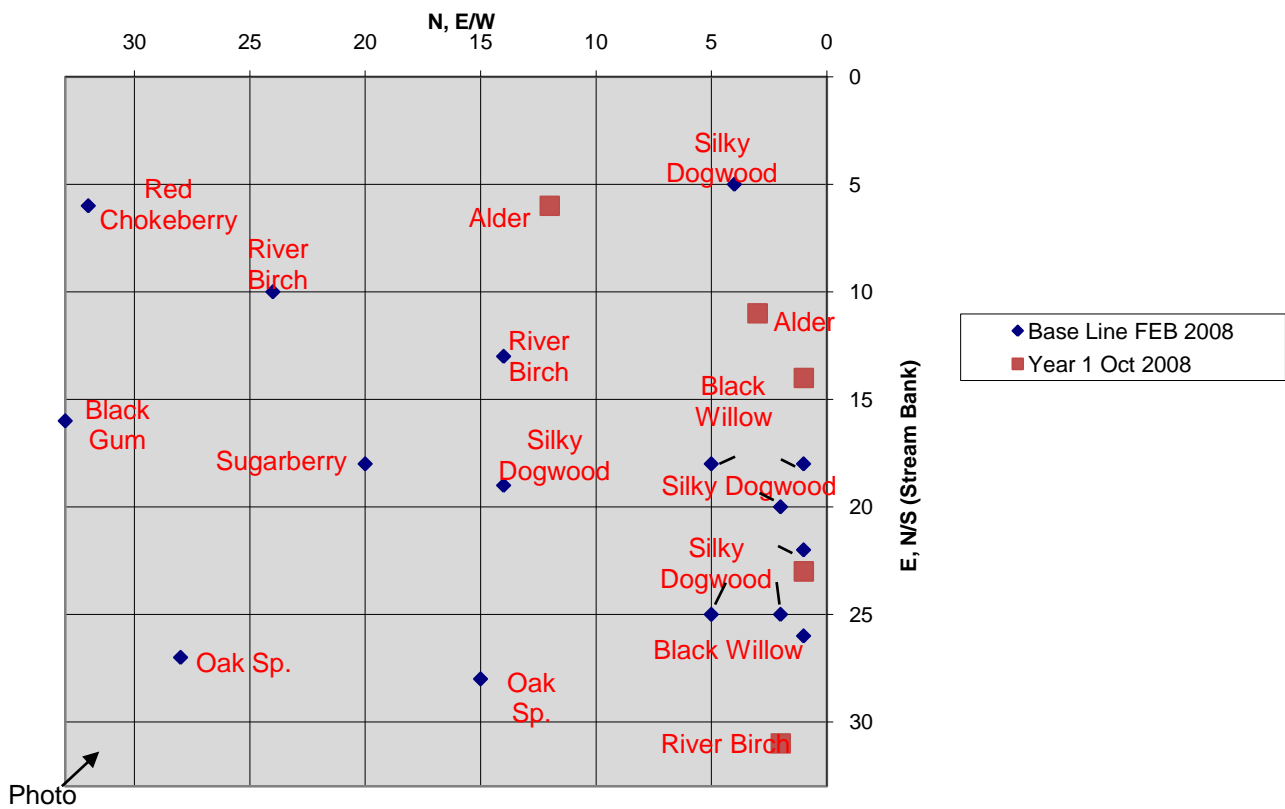
VP 6

Plot is over grown with extremely hearty polygonum

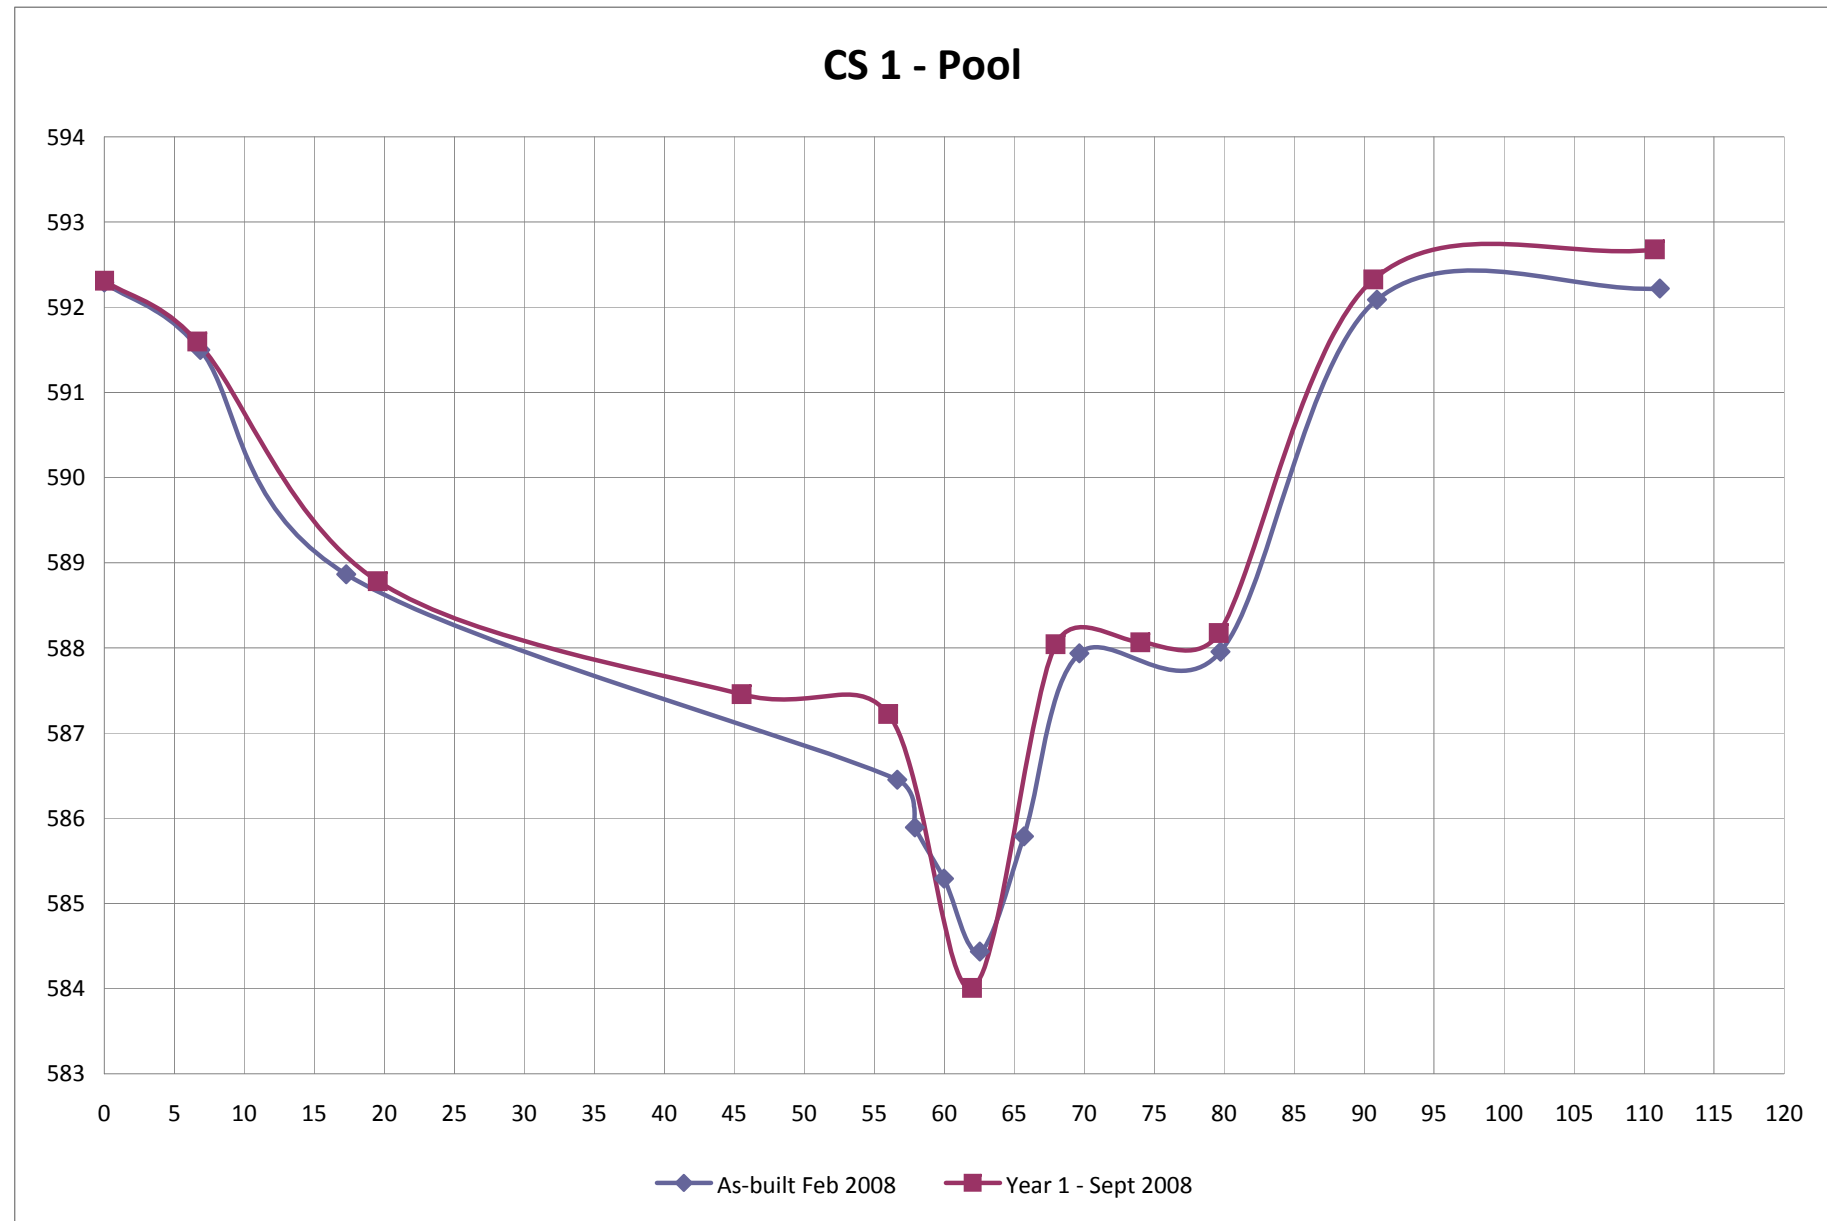
Since as-built documents were submitted, the site has been subject to several bankfull events, including hurricane remnant rainfall on August 27<sup>th</sup>, 2008. CS 1 and 2 on the lower section show no significant change since submittal of the as-built plans. The middle section of the project is the most susceptible to erosion and deposition problems. CS 3 shows some scouring on the left bank, while CS 4 shows deposition on the left bank. This is the same sand deposit present in veg plot 4. CS 5 and 6 are located at the end of the upper section (former pond area) where the concrete weir was removed. CS 5 shows some scouring on the right bank. CS 6 shows the most adjustment since the as built survey, with slight scouring on both banks. The Cross Section plots are located in Appendix B.

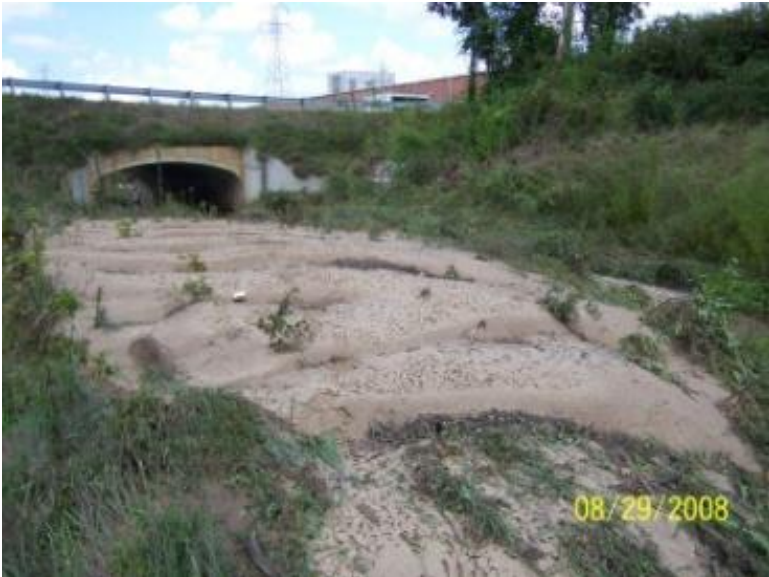
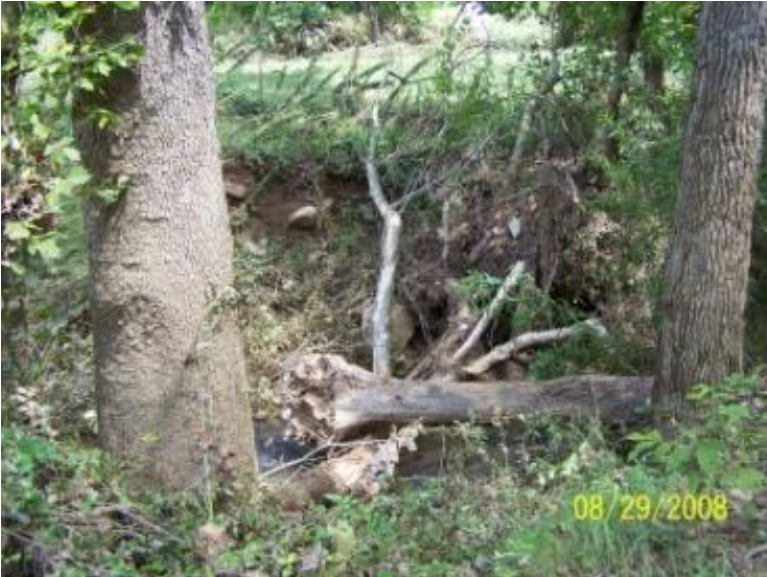
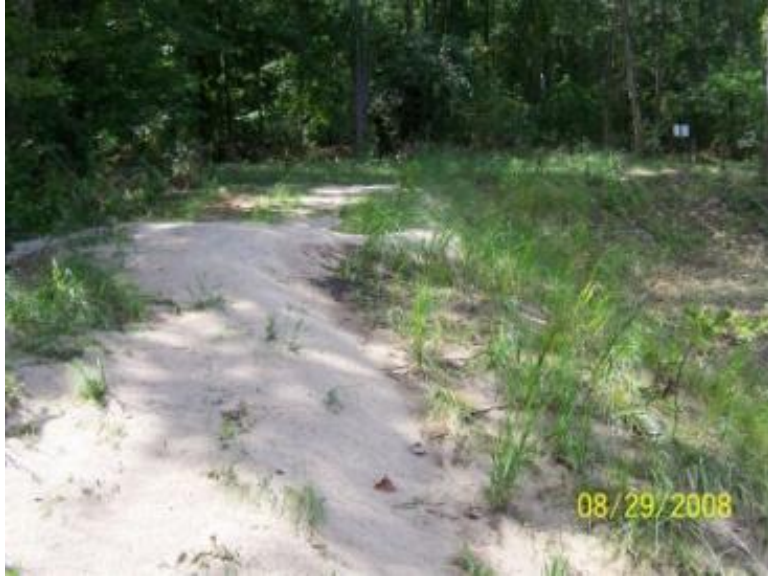
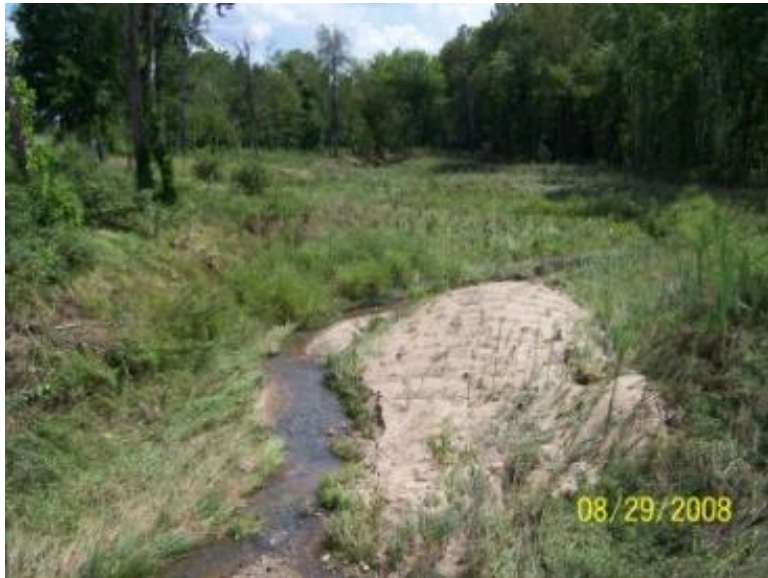
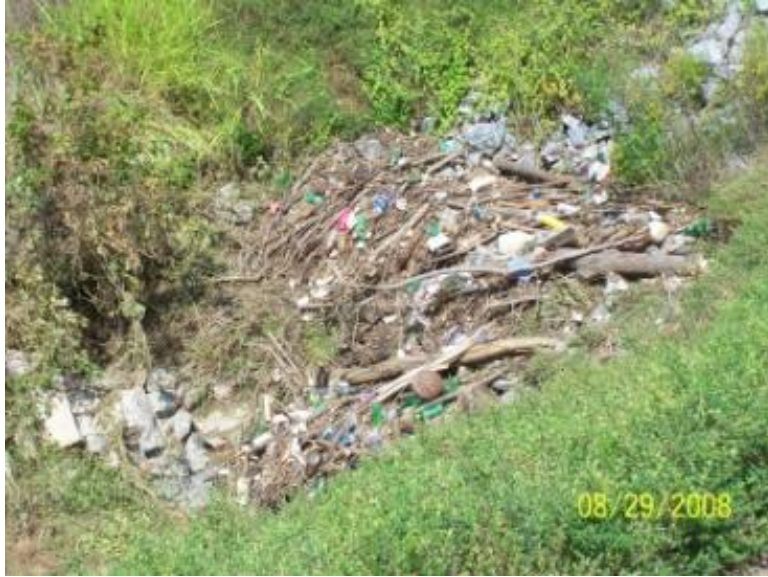
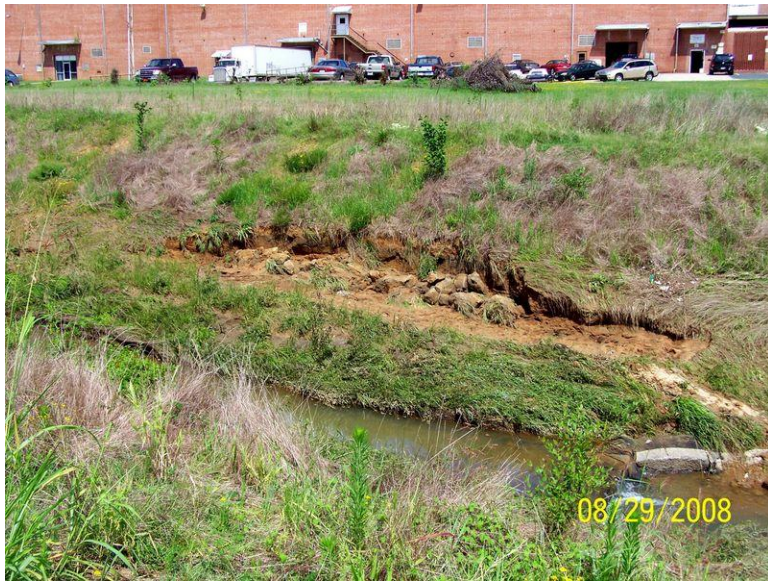
Aftermath of hurricane remnant rain event August 25<sup>th</sup> through 28<sup>th</sup> totaling approximately 23 inches over 4 days.
