Stricker Branch Stream Restoration Project Contract # D06054-G

County: Cabarrus
Cataloging Unit: Yadkin 03040105; Targeted Watershed 020040
Monitoring Firm POC: Mid-Atlantic Mitigation, LLC
Rich Mogensen (704) 782-4133
Prepared For: Ecosystem Enhancement Program

Year 2 (2009) Monitoring Report

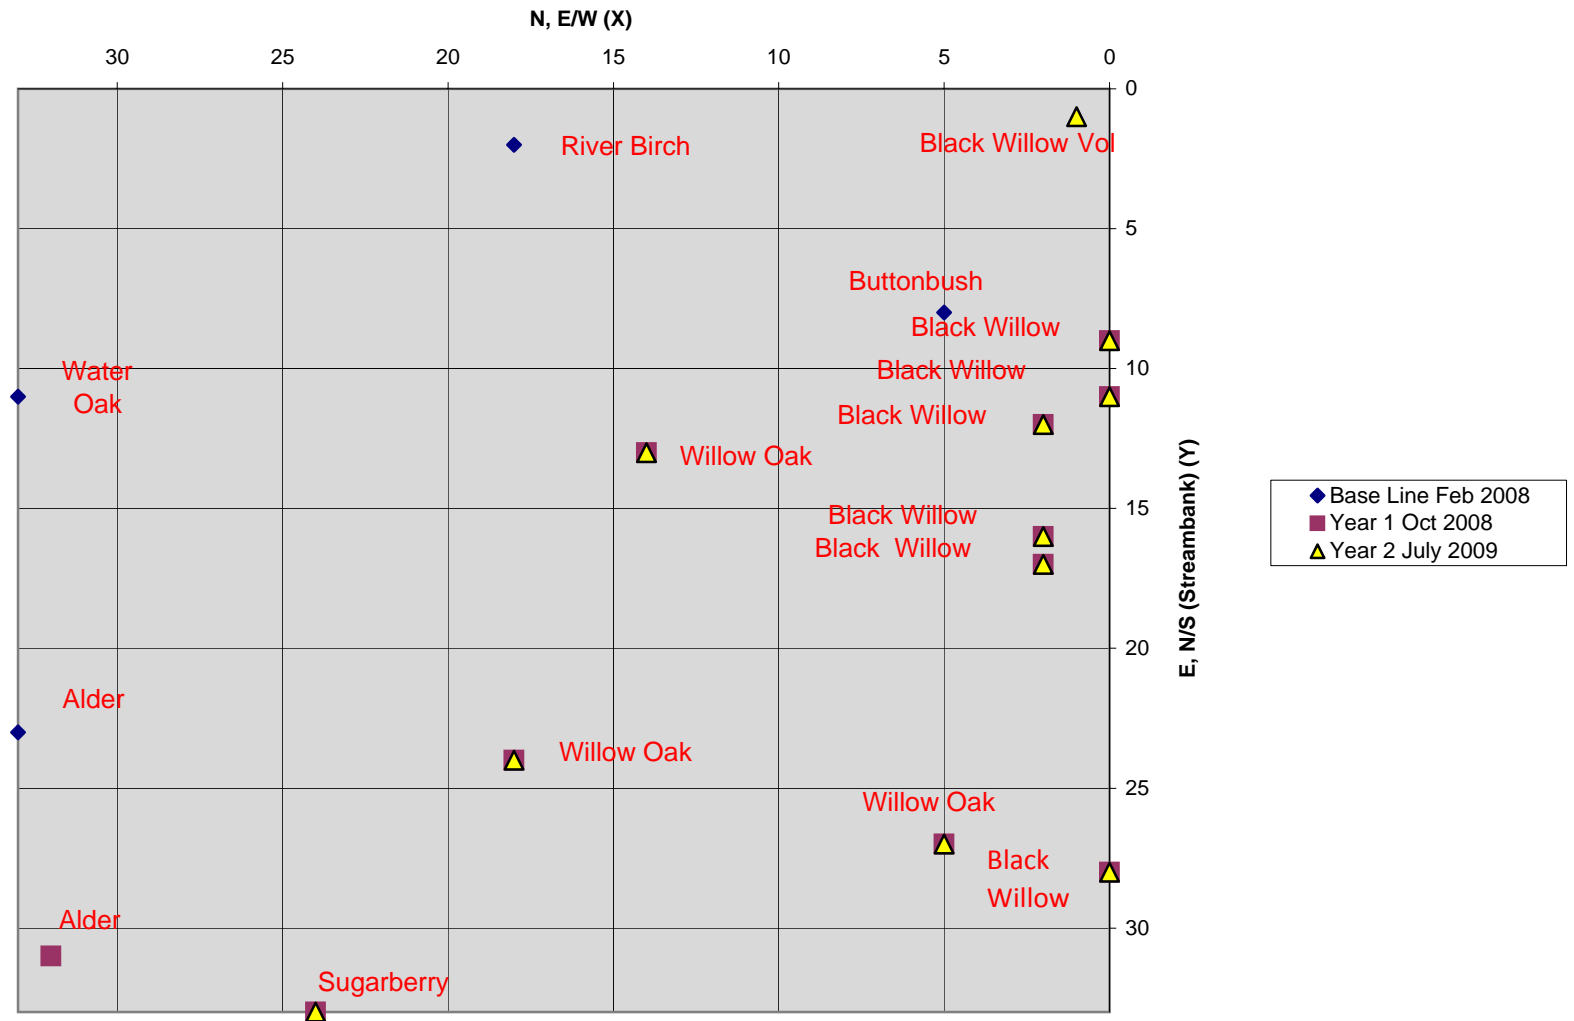
Plot 4 continues to sustain damage from sand deposition from bankfull events. The sand deposition has killed most of the livestakes in the north east quadrant of the plot. Because the problem in this area is deposition, not erosion, replacement livestakes are not necessary and given the hostile conditions in this plot any replanting would potentially be self defeating. Two cottonwood volunteers and two black willow volunteers are present in the plot and have been added to the grid. Currently, not counting volunteers, the plot has 320 stems per acre, which is low for year 2. Including the volunteers in this count brings the stems per acre to 480. Rather than suggesting a replant for this plot, it may be more effective to move the plot five feet south along the stream bank out of the range of the sand deposition area. Outside of the sand deposition area the plot demonstrates greater than 75% cover with a composition similar to Plot 3, above.

The north east quadrant of this plot has been subject to several wash outs and continues to be inundated with sand and debris, which are hostile to vegetation. Propose moving this plot slightly south west

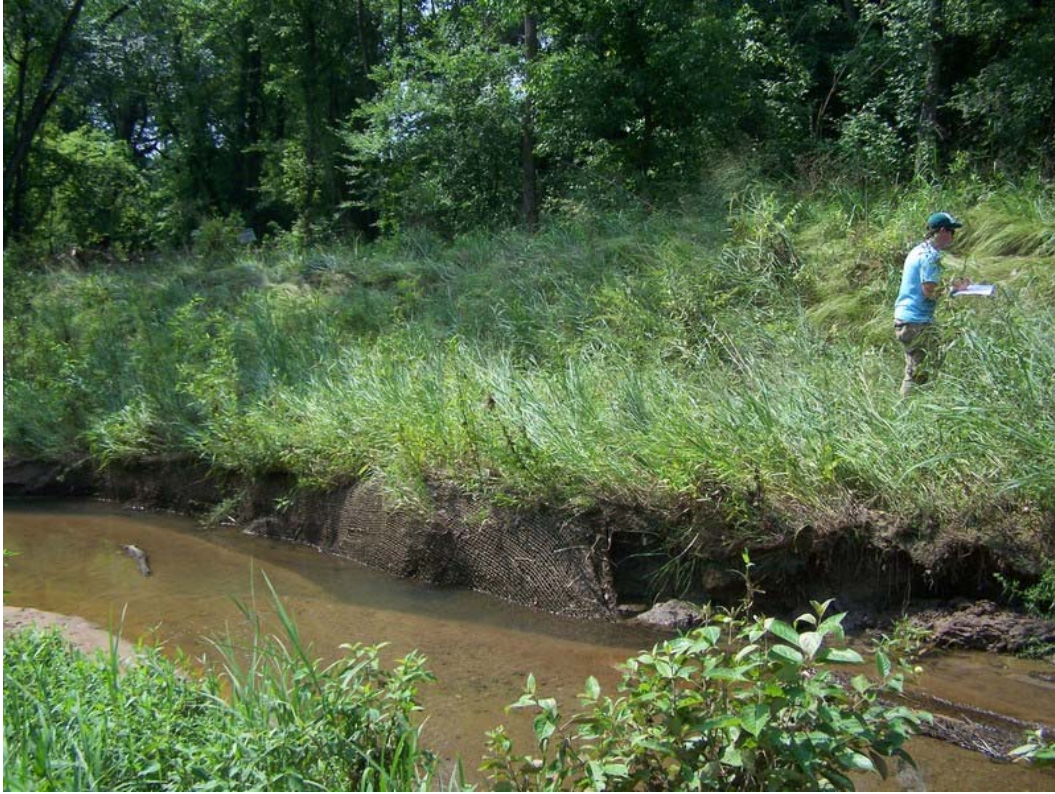
Problem Area at Station 229, right bank will be live staked this winter and watched.

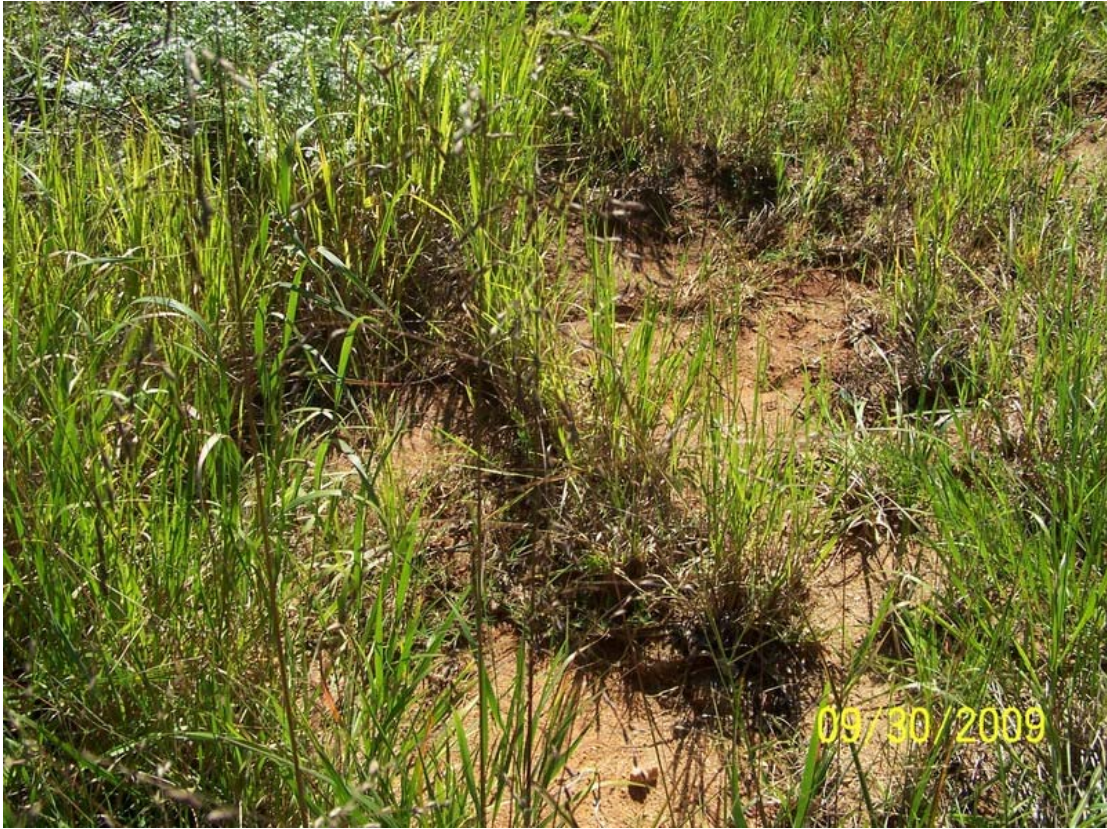
Small scour hole on XS 5, right bank

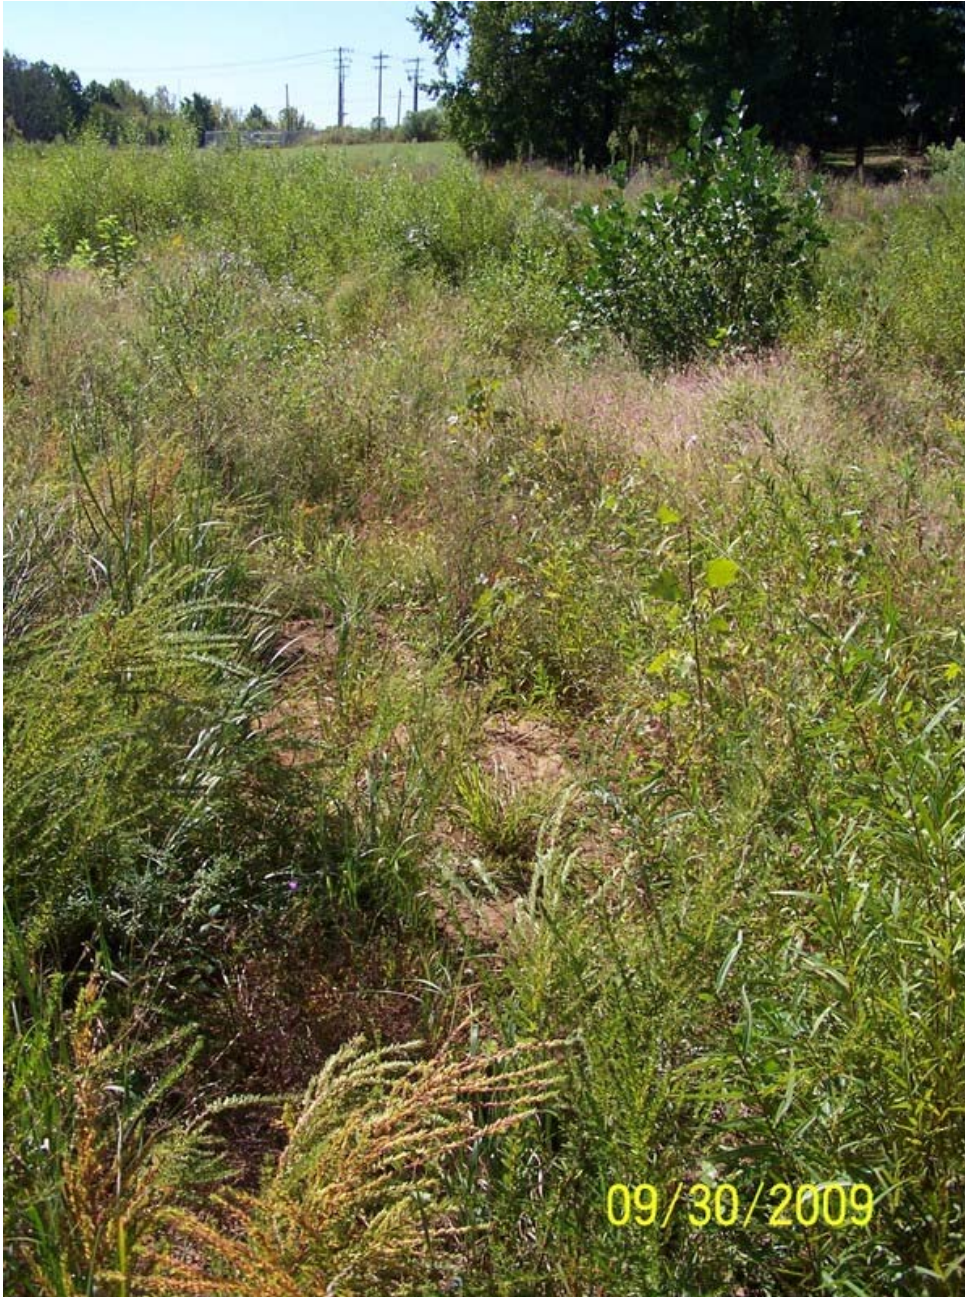
Swale parallel with Stream channel runs through XS 3, is vegetated and appears stable.

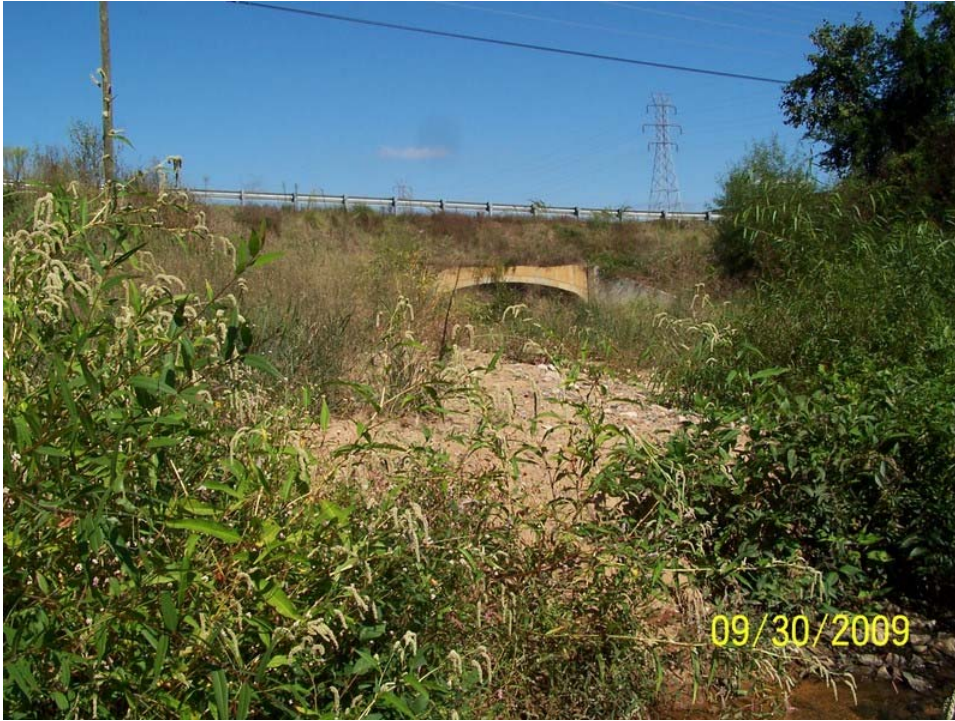
Sand deposition below bridge at Sign Drive

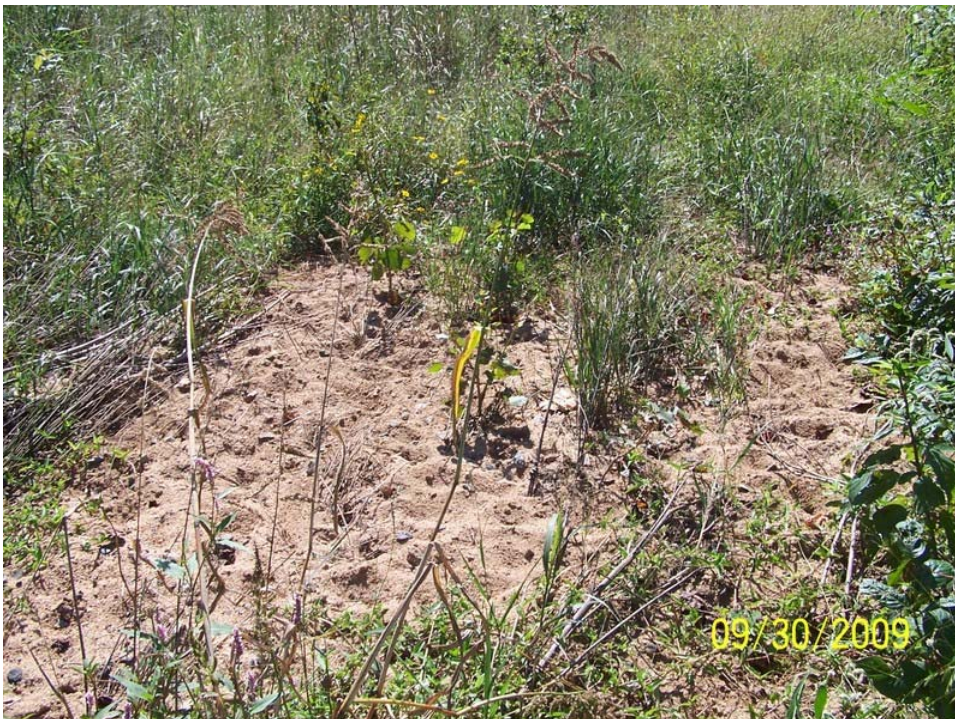
Sand deposition in XS 2

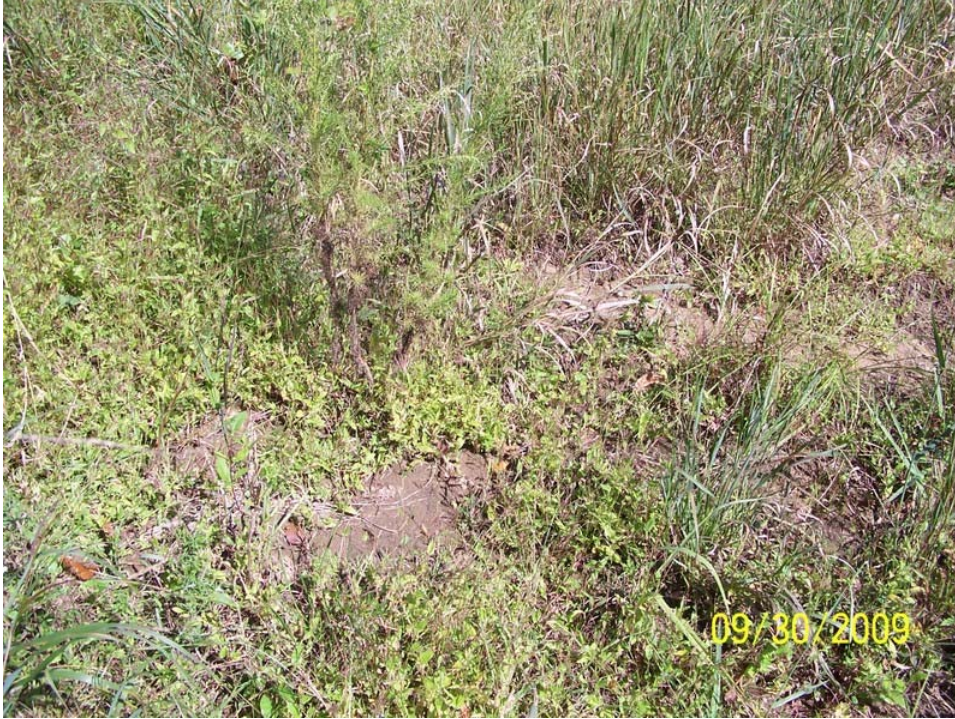
Scour and silt in XS 1, mostly re-vegetated

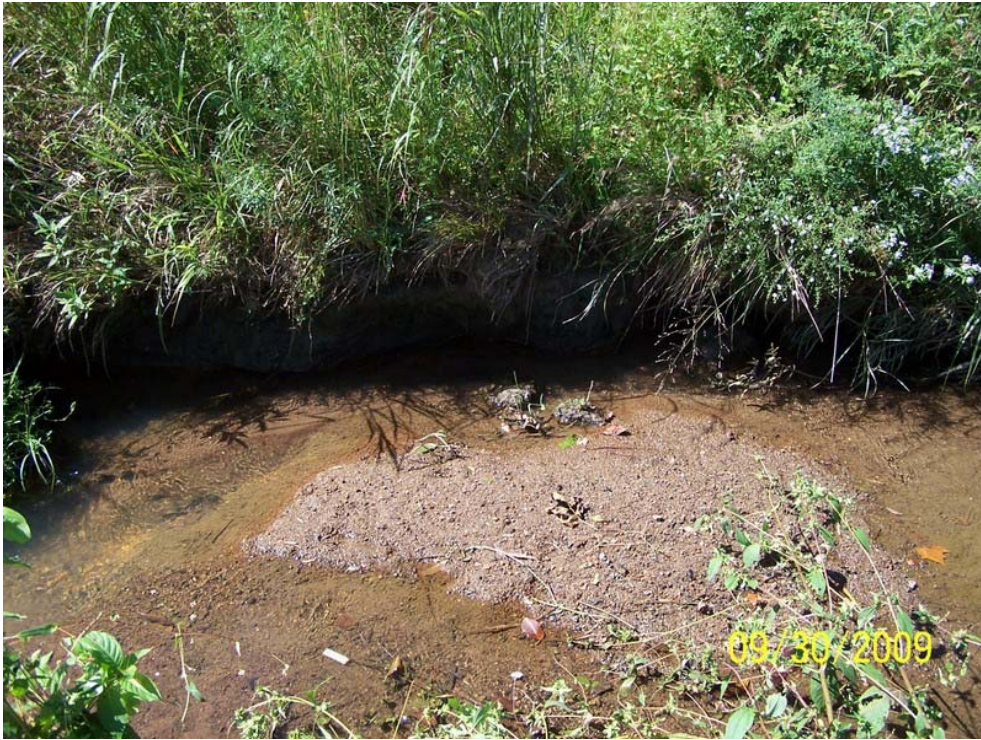
Small problem area just downstream of XS 1, will be live staked and watched

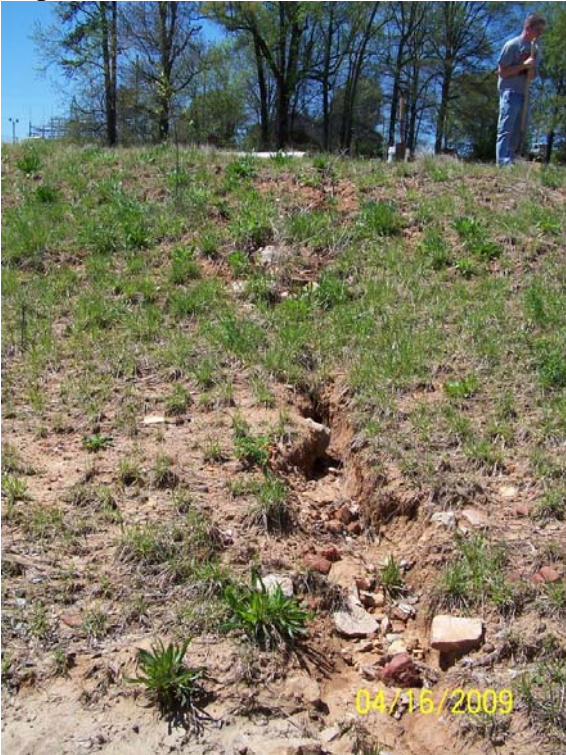
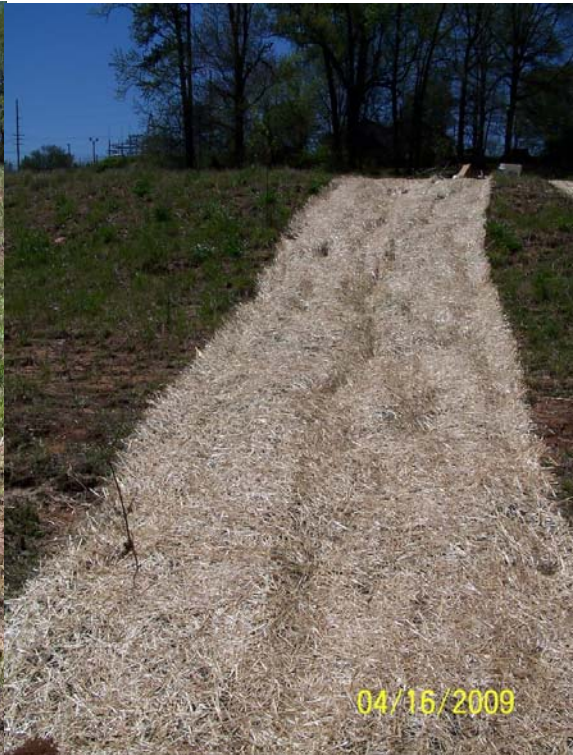
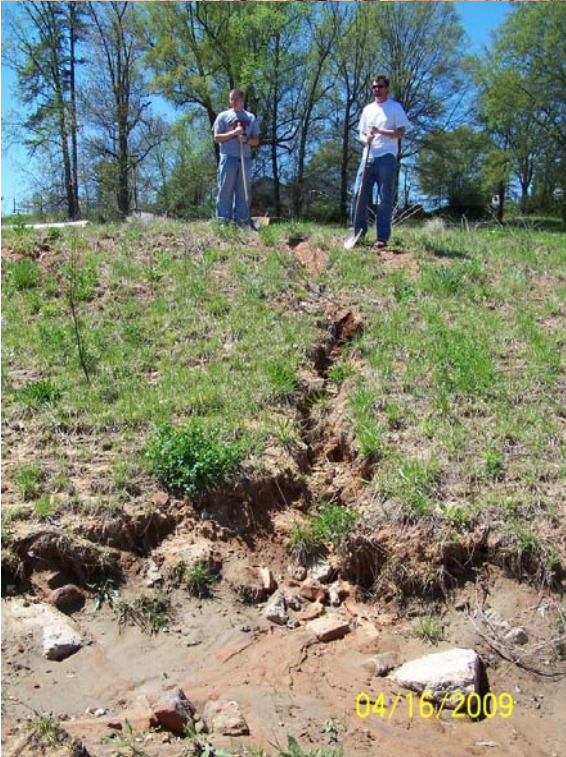
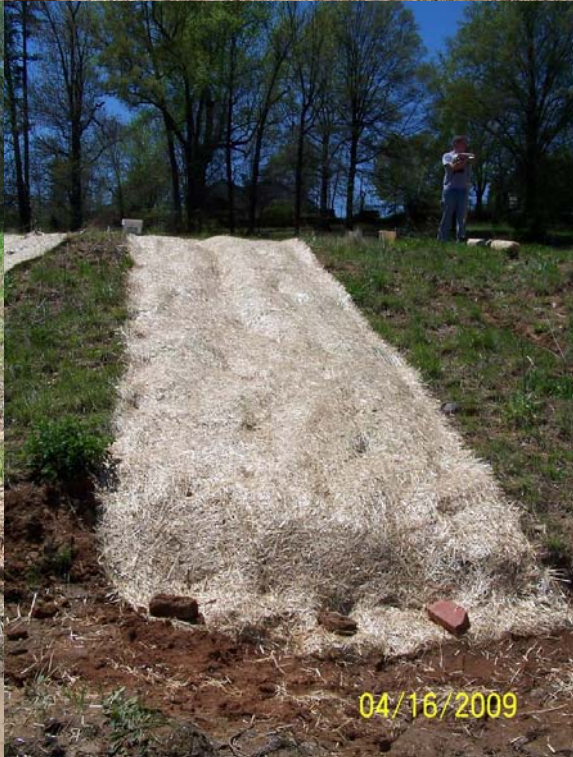
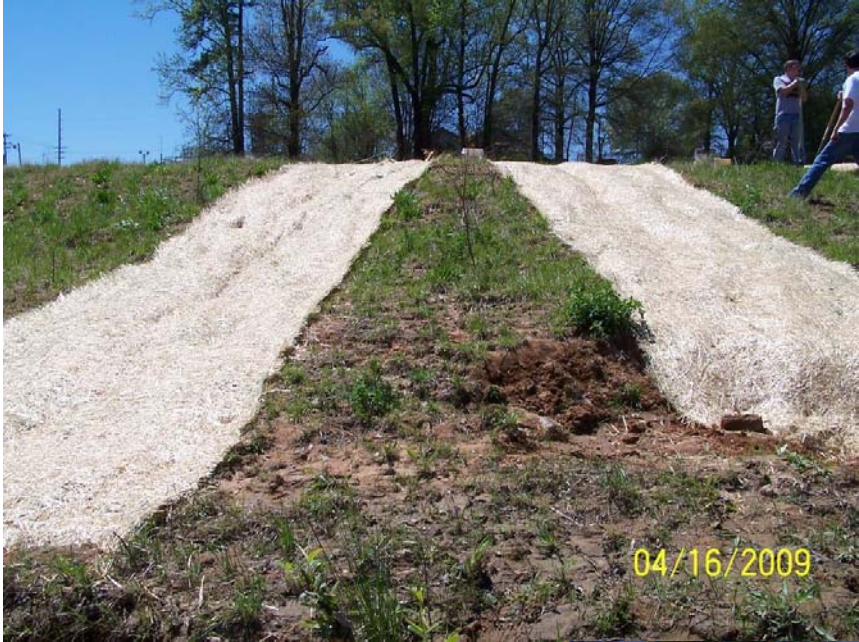
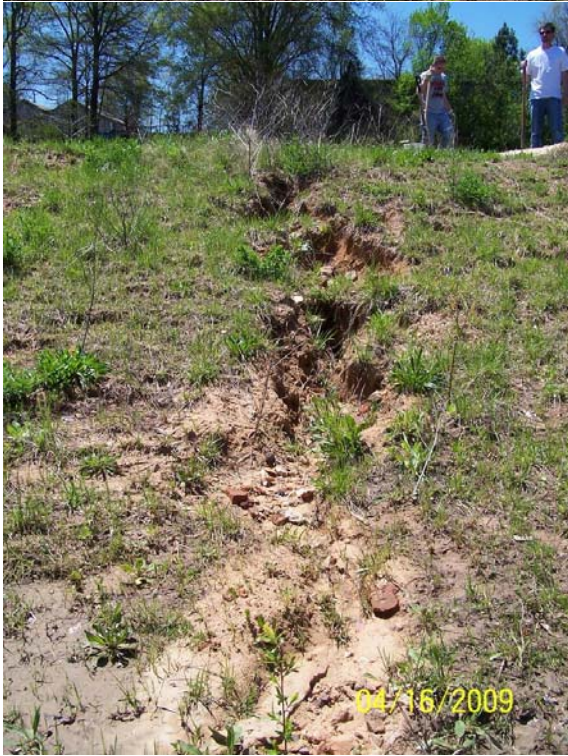
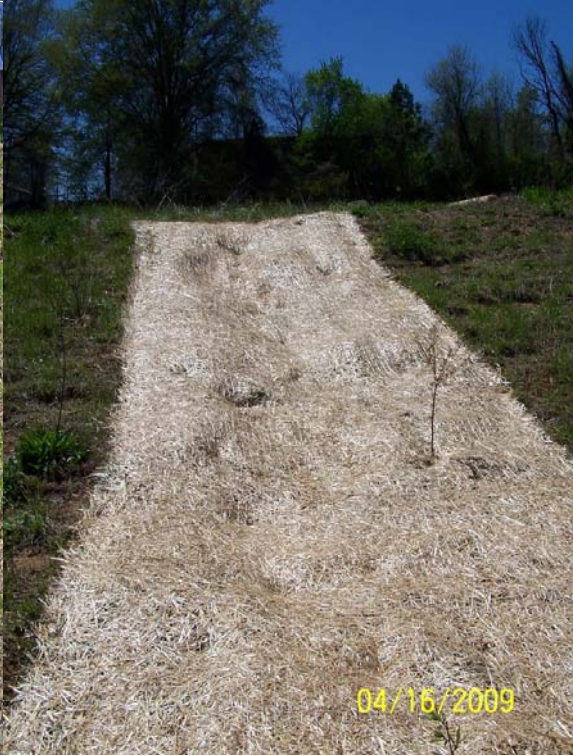
Repairs on Rills in Middle Section

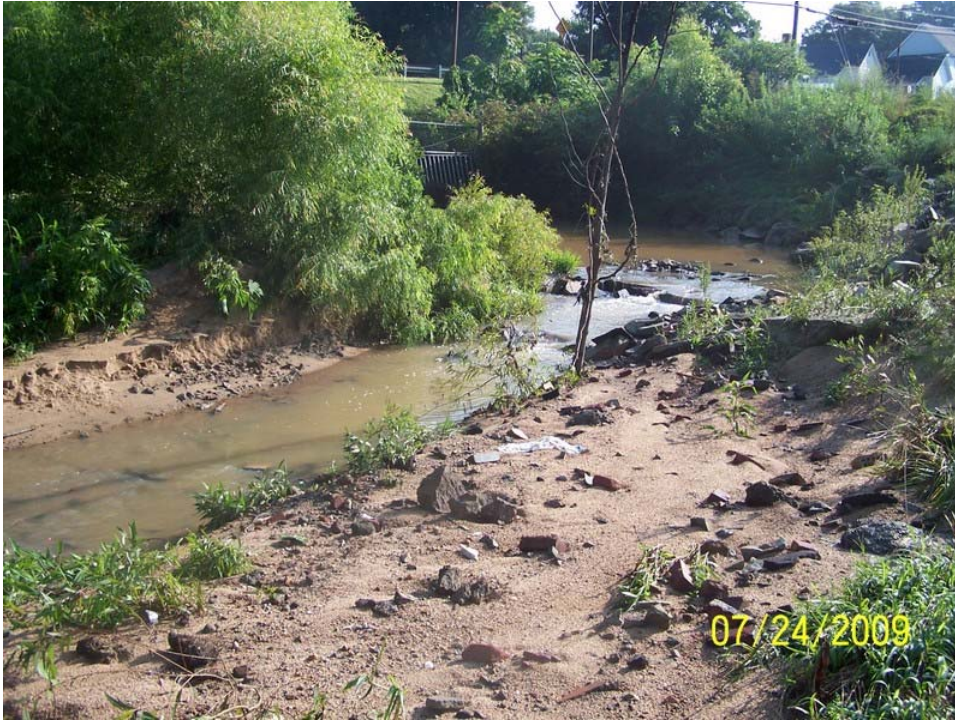
Area at start of easement below McGill Ave has repaired itself to a reasonable degree without intervention

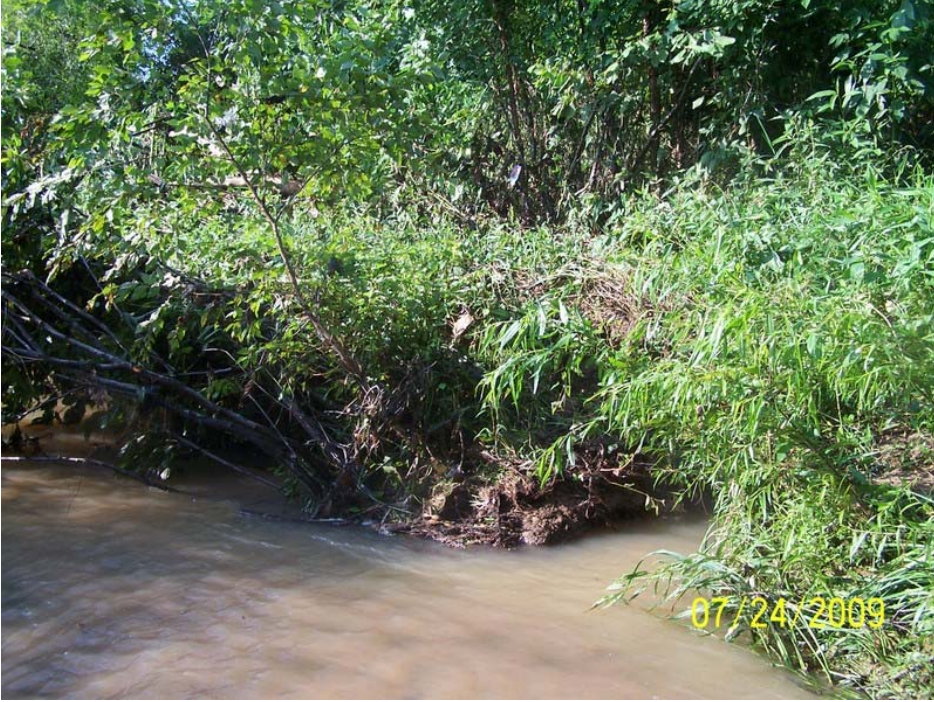
Other “rough” areas just below McGill Ave. will be live staked again and watched

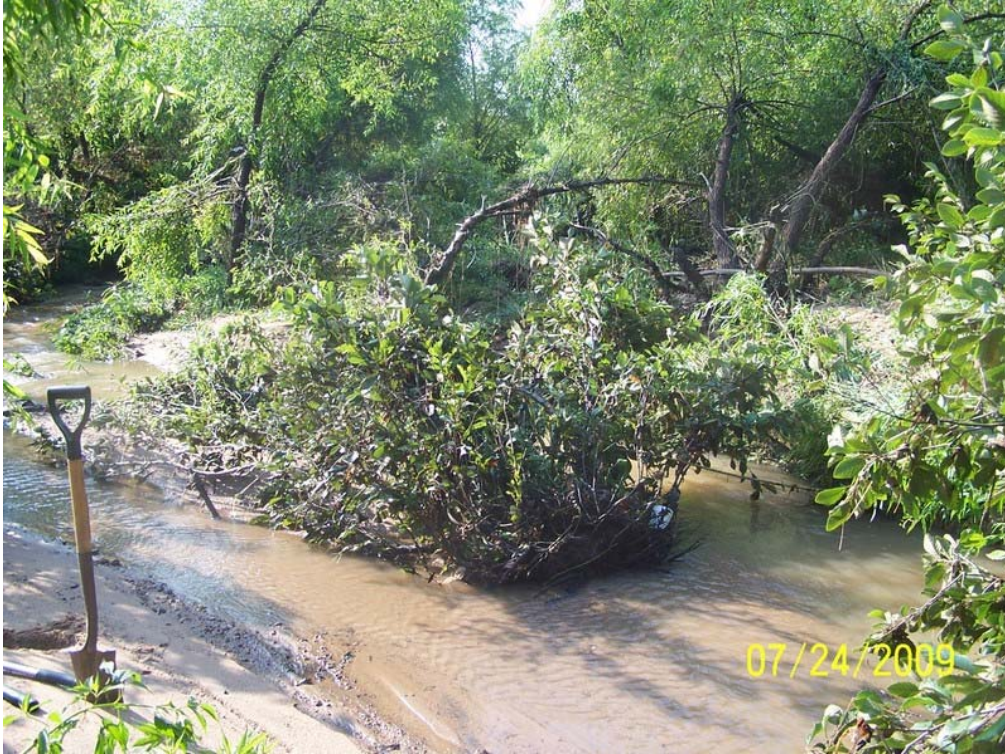
Overall, the stream channel has stabilized well and weathered multiple bankfull events. Sudden, severe, flash flood type events are typical of urbanized streams. Areas that sustained damage due to bankfull conditions were repaired by hand along several rills in the middle section. Other repairs, which are documented in the photo log include removal of two island bars formed around washed out alder transplants below McGill Road. These

Alder tree had dislodged from the bank and developed into a center bar island, which has now been removed.

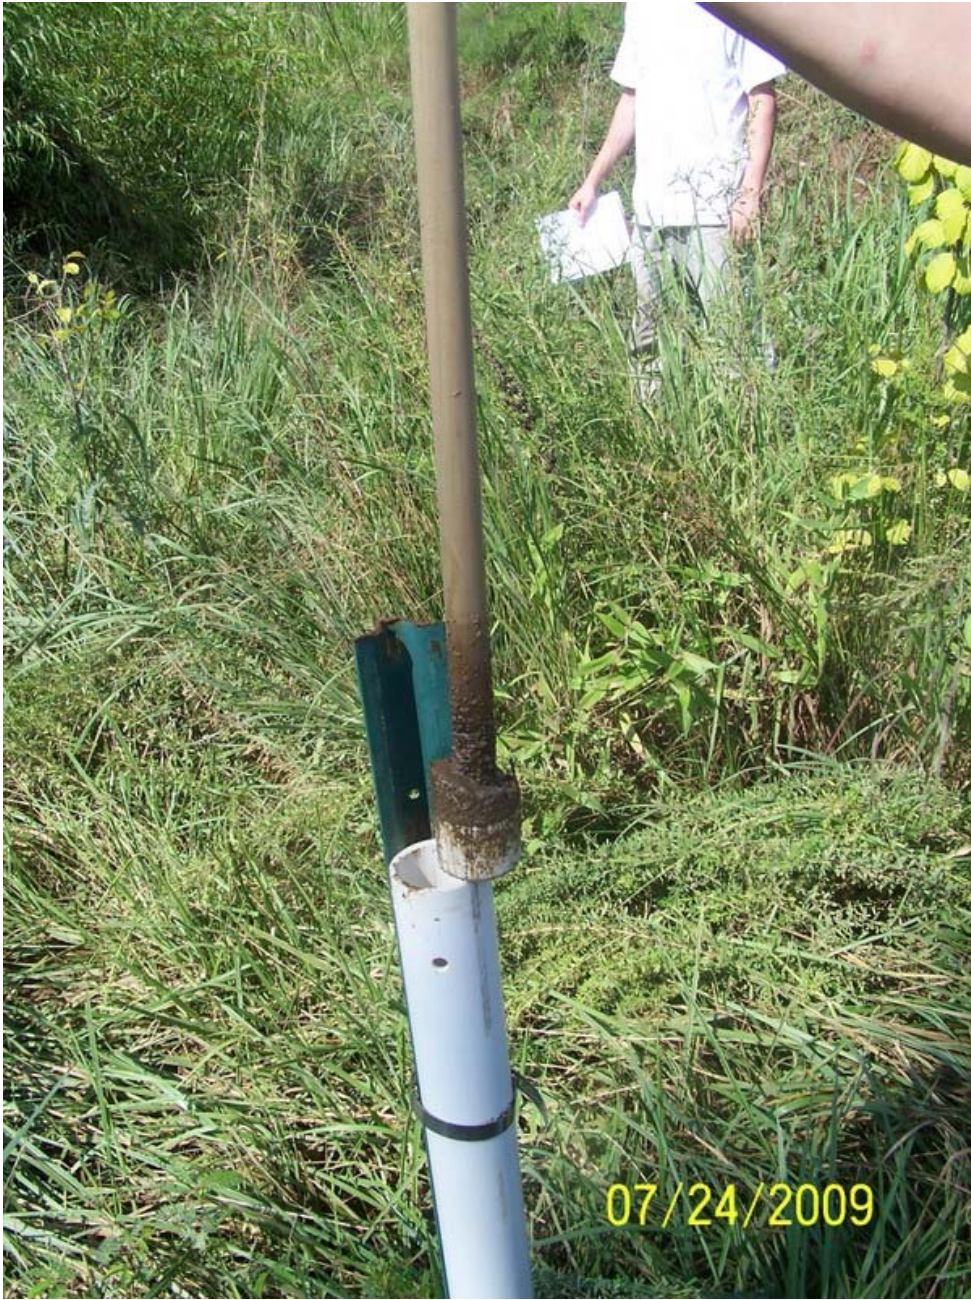
Rack Lines and Debris
