As-Built Report

Suck Creek Stream Restoration Project Moore County, North Carolina

Prepared for:
North Carolina Ecosystem Enhancement Program
Raleigh, North Carolina

July 2004

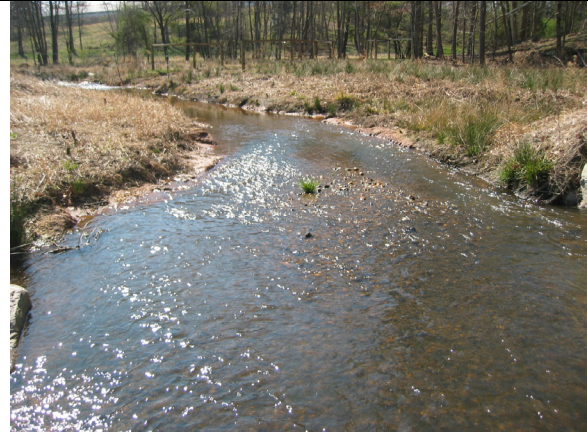
Photo 4: Issue 1 - Possible Aggradation

Overall the channel profile and banks appeared stable. The investigator did not observe head cuts or similar indicators of channel degradation. Possible evidence of aggradation as indicated by mid channel bars lie within upper reach in the region between station 4+00 and 5+00.

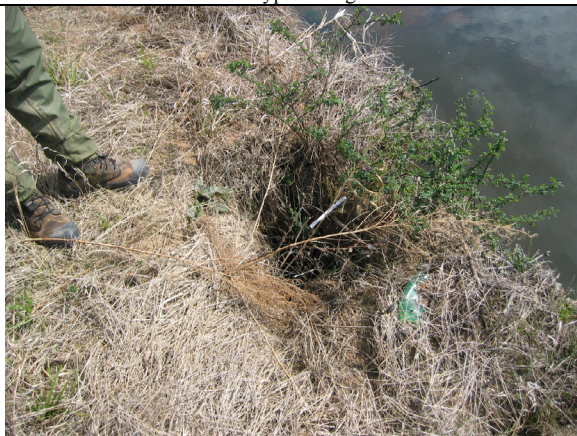
Photo 5: Issue 2 - Bank Erosion

The investigator observed isolated incidents of bank scour throughout the reach with more numerous occurrences within the lower reach. KHA observed bank erosion near the following stations:

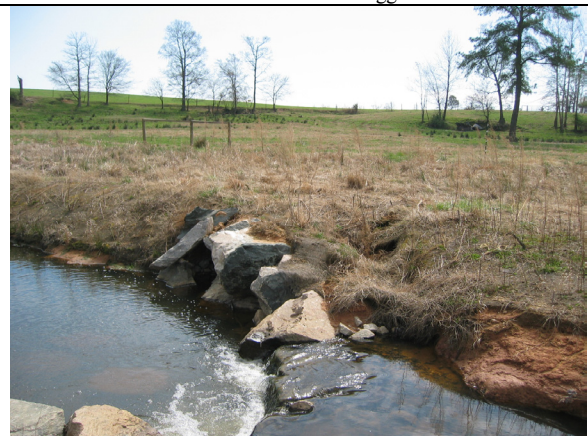
Photo 6: Issue 3 - Structure Arm Scour

All structures appeared to be functioning properly though the investigator observed erosion adjacent to the arms of several j-hooks and cross-vanes. KHA observed evidence of arm scour for the following structures:

The As-Built record drawing plan sheets (Section 2 of the As-Built Report) drawing identifies the structures experiencing arm scour. These structures should be monitored for changes

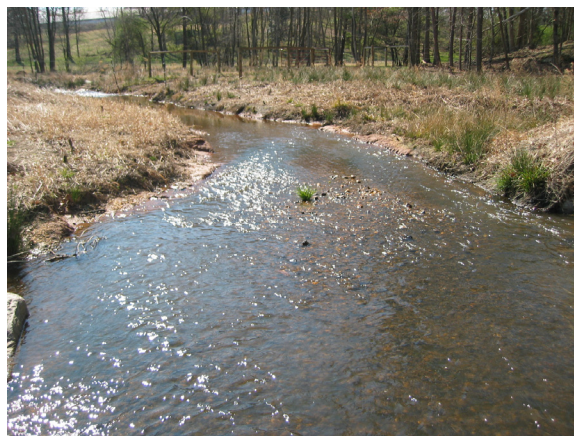
Photo 1: Potential Aggradation - Station 4+00

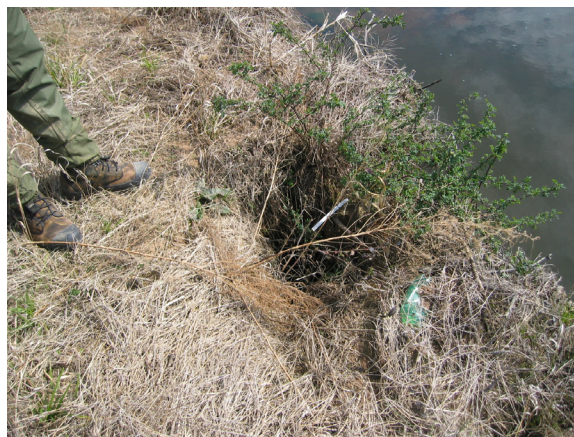
Photo 2: Evidence of Bank Erosion - Station 13+50

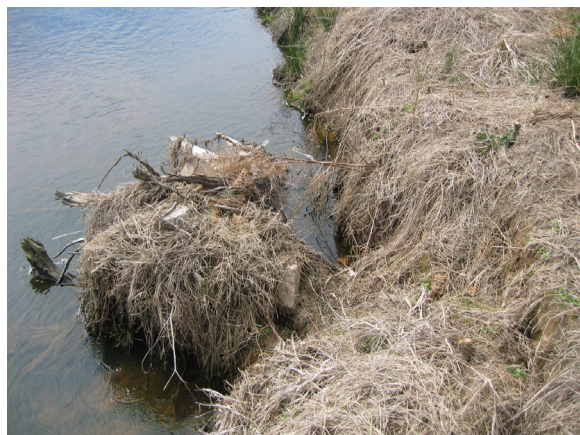
Photo 3: Evidence of Bank Erosion - Station 18+25

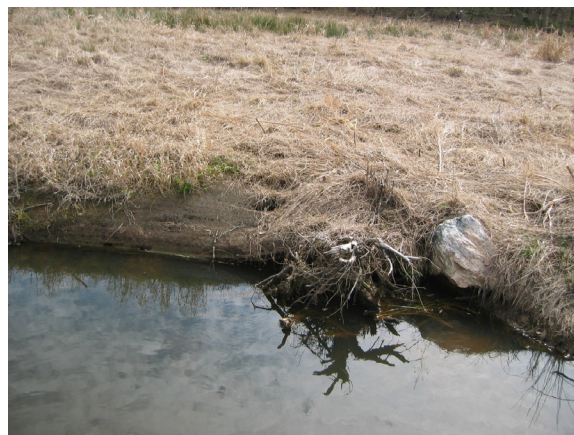
Photo 4: Evidence of Bank Erosion - Station 21+00

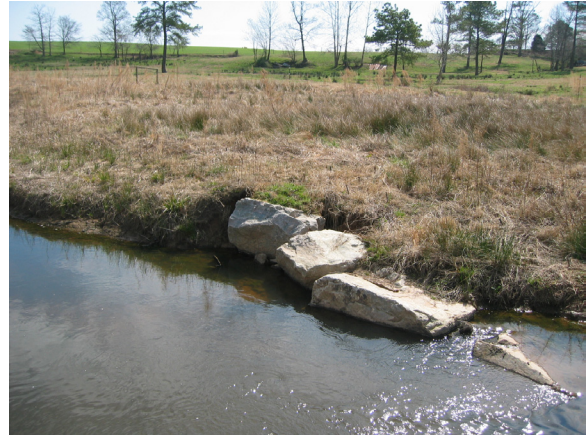
Photo 5: Structure Arm Scour - Station 16+00

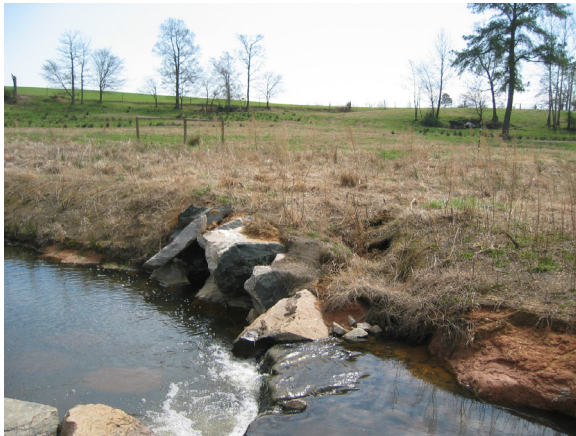
Photo 6: Structure Arm Scour - Station 17+50

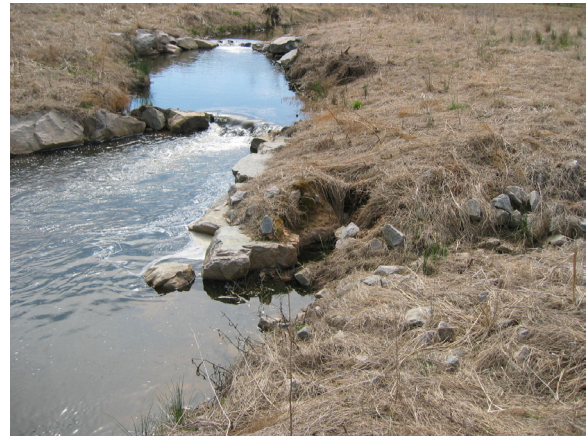
- 12+25
- 13+75
- 16+25
- 17+50
- 18+00 – Appears to have the most severe erosion
- 21+50
- 25+75
- 26+50

Photo 7: Structure Arm Scour - Station 18+00
