**SUCK CREEK STREAM RESTORATION
(Project No. .00012)**

MONITORING YEAR 2 (2005)

Submitted to:
North Carolina Department of Environment and Natural Resources
Ecosystem Enhancement Program
Raleigh, North Carolina

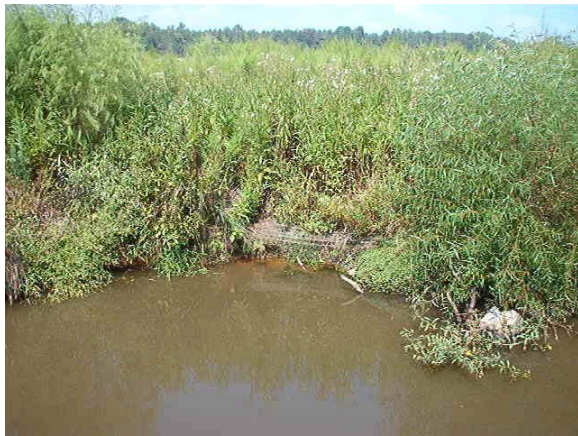
Feature/Issue	Station #/Range	Probable Cause	Photo #
Bare Bank	11+50	Backwater eddy scour	1
	19+10	Scour behind failed root wad	2
	22+80	Bank scour from upland sheet flow	3
Bare Flood Plain	22+80	Upland sheet flow	3
	Vegetation Plot 2	unknown	VP-2
	Vegetation Plot 3	unknown	VP-3
	Vegetation Plot 4	unknown	VP-4

Photo 14, bank scour at station 11+50

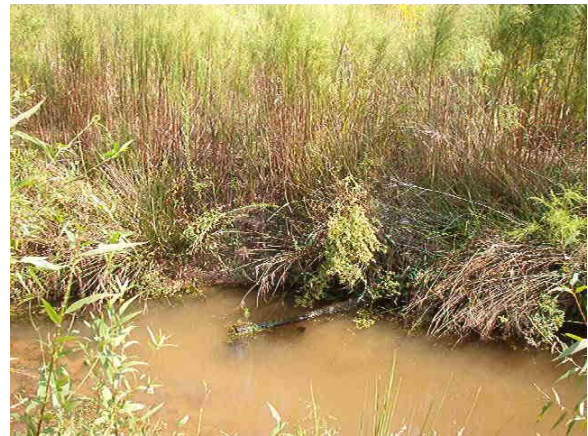
Photo 12, bank scour at station
19+10

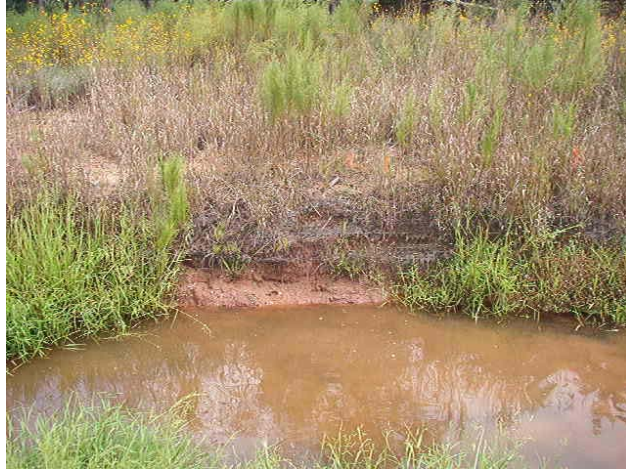
Photo 7, bank scour and un-vegetated floodplain bench at station 22+80.

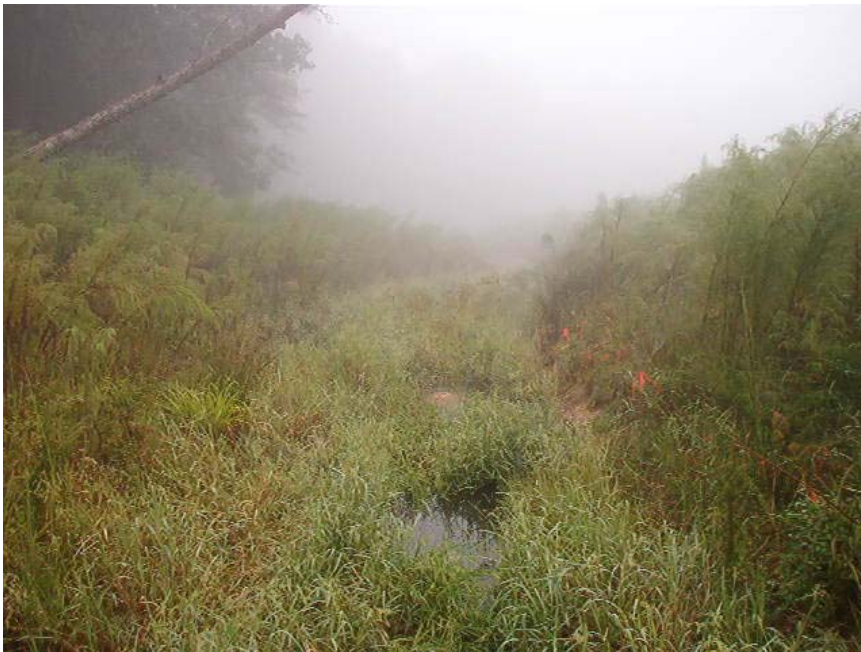
4+00-4+60

Feature Issue	Station numbers	Suspected Cause	Photo number
Mid channel bar	4+00 to 4+60	Slope not sufficient to move sediment	1
Cross Vane, arm scour	18+00	Large voids between rocks in vane	2
Root wad failure	19+10	Improper installation	3
Cross Vane, arm scour	21+60	Large voids between rocks in vane	4
Cross Vane, arm scour	25+70	Large voids between rocks in vane	5
Cross Vane, arm scour	26+60	Large voids between rocks in vane	6

The mid-channel bar downstream of the boulder field (Sta. 4+00 to 4+60) has become vegetated with rice cutgrass (*Leersia oryzoides*). This feature likely occurs because of unfocused velocity, post-boulder field, and too gentle a water surface slope. Low water levels due to the late summer drought may have also created shallow water conditions conducive for the germination and establishment of rice-cut grass.

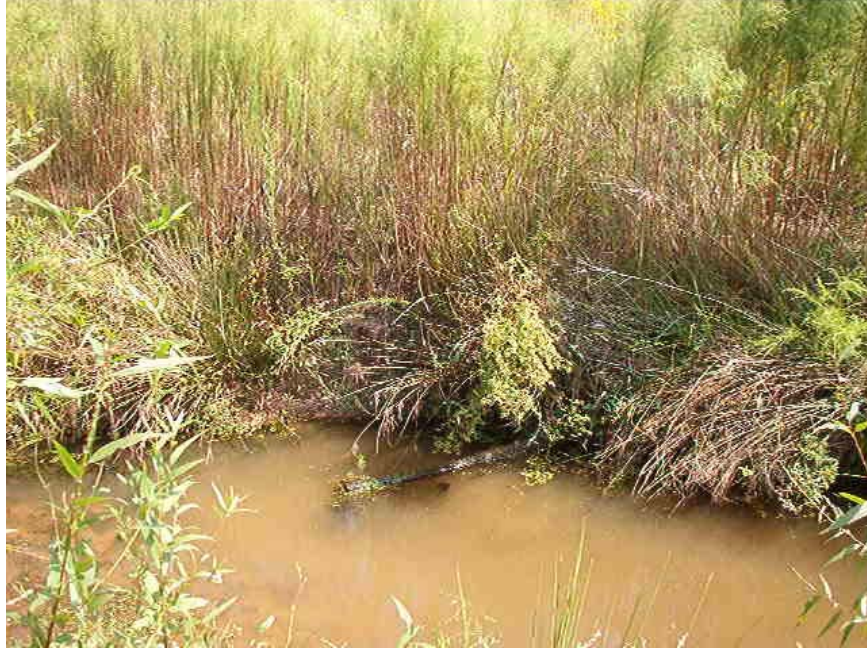
The root wad failure at Sta. 19+10 has caused bed scour beneath the structure and bank scour under the fabric matting. This structure acts in creating an eddy within the pool during high flows, causing the channel to widen slightly. The banks and fabric matting are forming a vegetated slumping bank. This area is expected to stabilize over time.
