**SUCK CREEK STREAM RESTORATION
(Project No. 0117950008)**

MONITORING YEAR 3 of 5 (2006)

January 2007

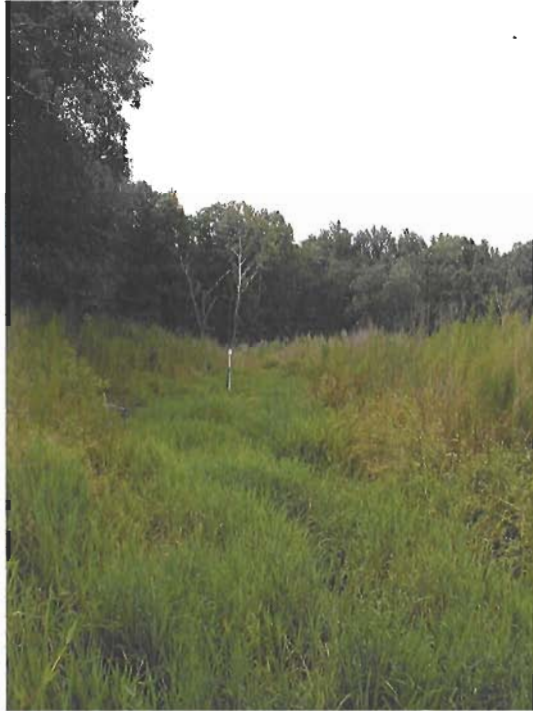
The mid-channel bar downstream of the boulder field (Stations 4+00 to 4+60) has become vegetated with rice cutgrass (*Leersia oryzoides*). This feature likely occurs because of unfocused velocity, down stream of the boulder field, and too slight a water surface slope. Low water levels due to the late summer drought may have also created shallow water conditions conducive for the germination and establishment of rice-cut grass. No maintenance actions are recommended at this time.

Feature Issue	Station Numbers	Suspected Cause	Photo Number / ID
Mid channel bar	4+00 to 4+60	Slope too slight to move sediment. More sediment has deposited and vegetation has established.	Station 4+00
Cross Vane, arm scour	18+00	Large voids between rocks in vane. No change from prior year.	Station 18+00
Root wad failure	19+10	Improper installation. Vegetation has established.	Station 19+10
Cross Vane, arm scour	21+60	Large voids between rocks in vane. No change from prior year.	Station 21+60
Cross Vane, arm scour	25+70	Large voids between rocks in vane. No change from prior year.	Station 25+70
Cross Vane, arm scour	26+60	Large voids between rocks in vane. No change from prior year.

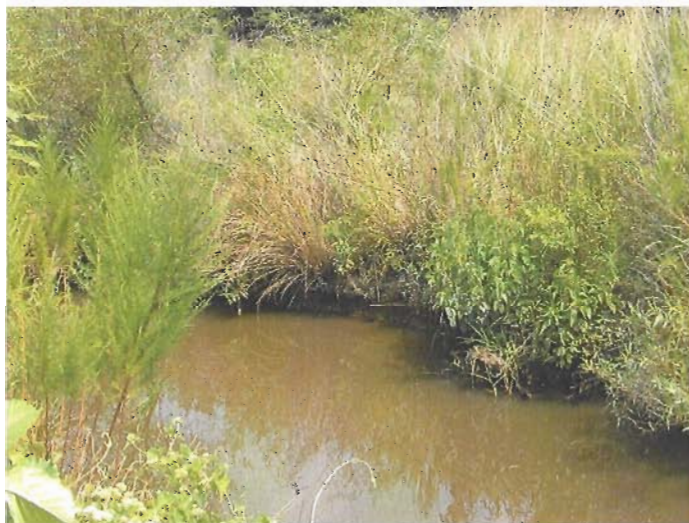
The root wad failure at Station 19+10 that caused bank erosion last year has stabilized. The banks and fabric matting have formed a vegetated slumping bank.

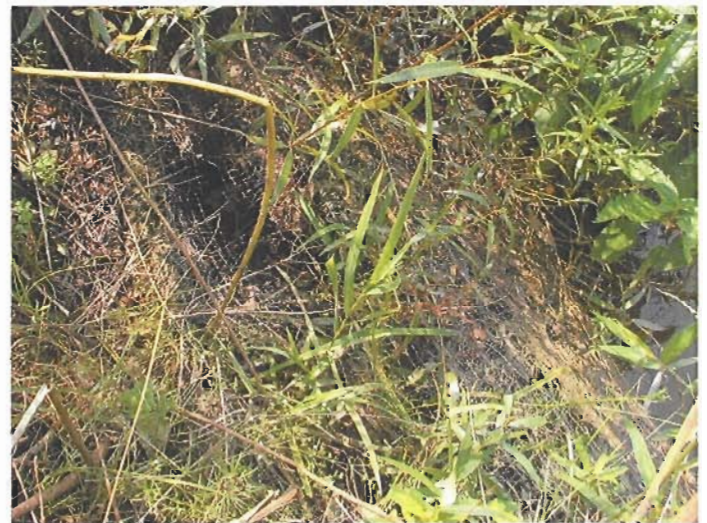
Station 21+60

Maintenance is recommended on the cross vanes at Stations 21+60 and 26+60 since scour between and around individual rocks in the arm is extensive and the arm of the structure is not creating a bar behind the structure of any kind. Sediment has deposited atop the vane arms and has become vegetated. Piping between vane rocks still continues.
