SUCK CREEK STREAM RESTORATION
(Project No. 368)
FINAL

MONITORING YEAR 4 of 5 (2007)

Submitted
October 2007

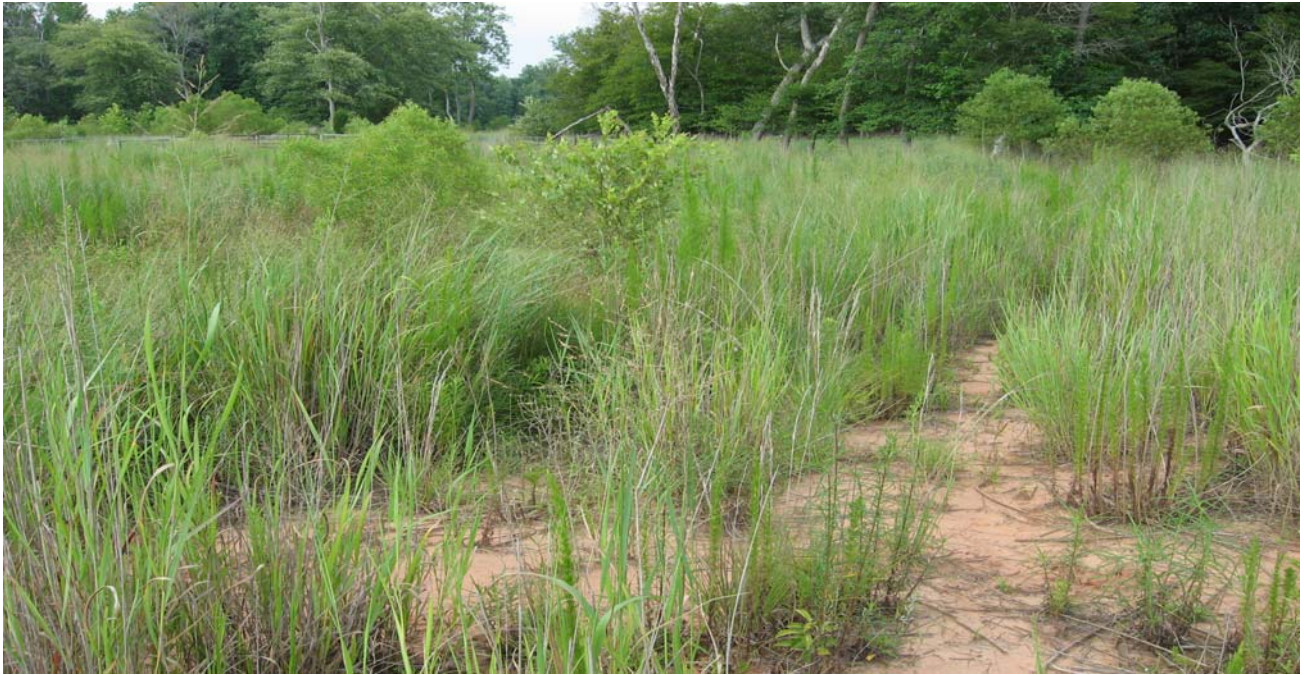
View of bare floodplain looking east near vegetation plot 3 – 7/18/2007

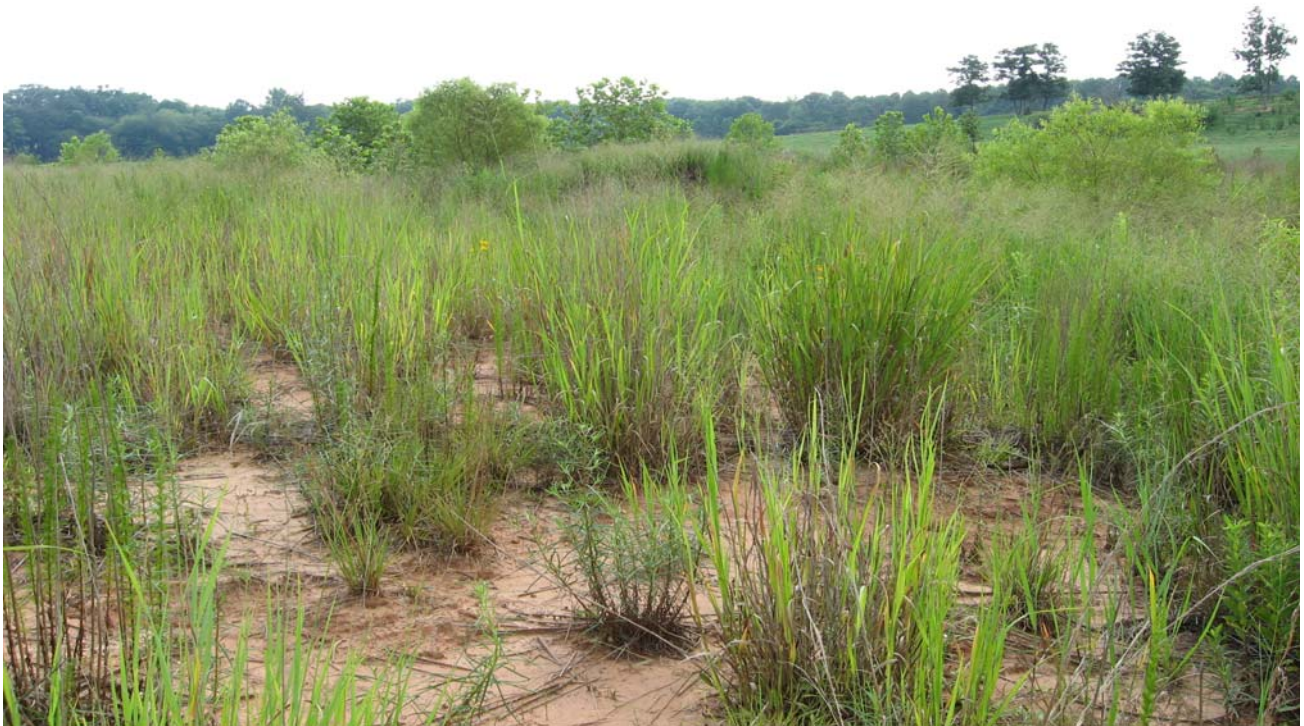
View of bare floodplain looking west, Stations 23+40 thru 23+70 – 7/18/2007

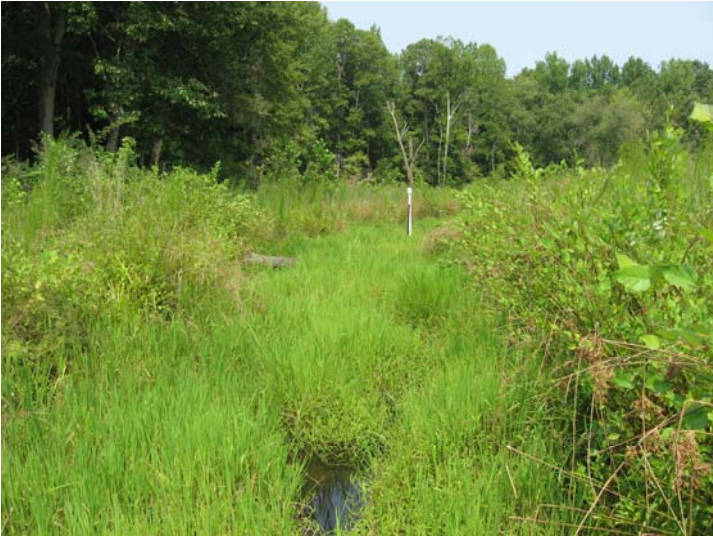
The mid-channel bars noted as problem areas (Stations 4+00 to 4+60 and Station 19+10) have become vegetated with rice cutgrass (*Leersia oryzoides*). This feature likely occurs because of unfocused velocity and too slight a water surface slope. Low water levels due to the late summer drought may have also created shallow water conditions conducive for the germination and establishment of rice-cut grass.

Feature Issue	Station Numbers	Suspected Cause	Photo Number /ID
Mid channel bar	4+00 to 4+60	Slope too slight to move sediment. More sediment has deposited and vegetation has established.	Station 4+00
Damaged bank	6+40	Cows trampled when entering stream.	Station 6+40
Flow backup	8+75 – 11+30	Beaver dam/debris dam at cross vane structure at 11+30	Station 8+75, 9+00-11+30
Cross Vane blockage	11+30	Beaver dam/debris dam	Station 11+30
Cross Vane, LB arm scour	18+00	Cross Vane failure, flow undermined left bank and now water flows around the vane instead of through it.	Station 18+00
Mid channel bar	19+00	Sediment has deposited and vegetation has established.	Station 19+10
Cross Vane, arm scour	21+60	Large voids between rocks in vane. No change from prior year.	Station 21+60
Log vane failure	25+50	Log vane has separated from bank, altering channel flow.	Station 25+50
Cross Vane	25+70	Large voids between rocks in vane. No change from prior year.	Station 25+70

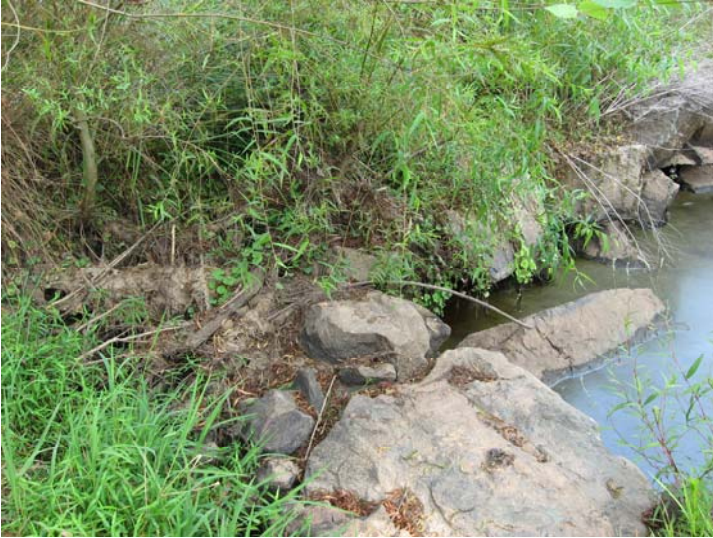
Station 26+60, left bank arm scour
