**Suck Creek Stream Restoration
Project No. 368
2008 Monitoring Report (Final): Year 5 of 5**

March 2009

Prepared for: NCDENR-EEP
1652 Mail Service Center
Raleigh, NC 27699-1652

Prepared by: Jordan, Jones, & Goulding
9101 Southern Pine Blvd., Suite 160
Charlotte, NC 28273

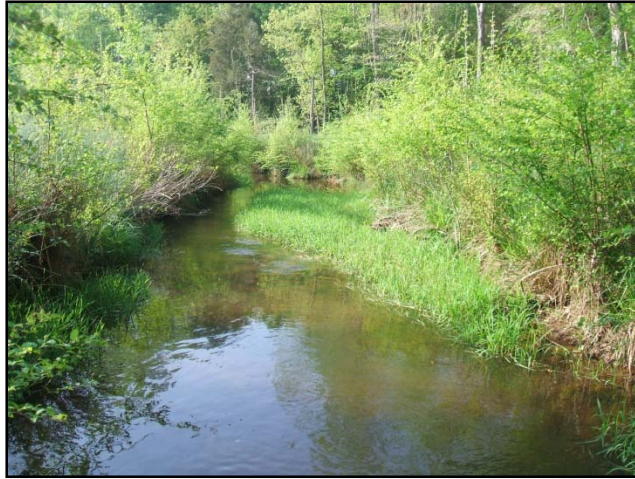
Feature Issue	Station Numbers	Suspected Cause	Photo ID #
In-Stream Vegetation	0+47.98-1+00	Herbaceous species in main channel	1
	1+25-1+91		
	2+78-3+86		
	4+69-5+00		
	5+06-5+36		
	9+82-11+00		
	14+27-14+68		
	16+48-16+66		
	17+94-18+23		
	19+75-20+14		
21+08-21+64

1. In-Stream Vegetation (5/2008)

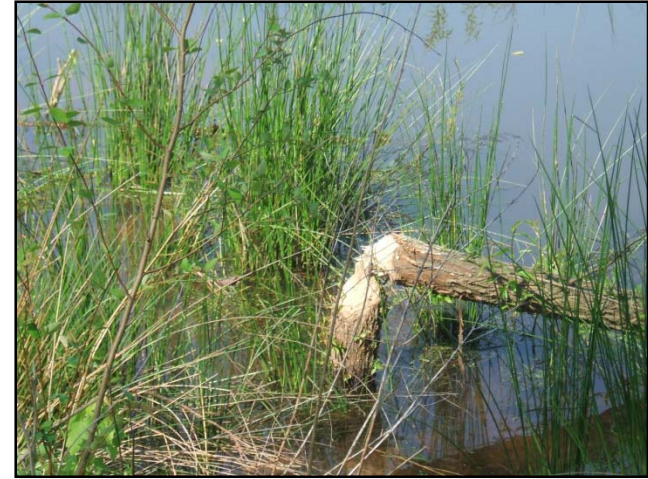
2. Beaver Chews (5/2008)

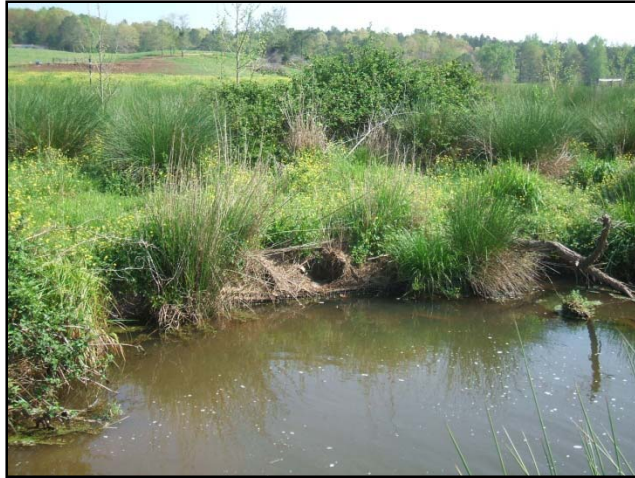
- In a few outer bends, there are areas of moderate to severe bank erosion. Most of these areas of bank instability appear to be new conditions, not previously addressed in the 2007 monitoring report. Station 17+62 and 20+70 are the only erosional areas noted in previous monitoring reports. JJG was not able to determine in the 2008 monitoring year whether or not the bank conditions noted in earlier reports have advanced from the previous monitoring year (2007).

Feature Issue	Station Numbers	Suspected Cause	Photo ID #
Bank Erosion - Moderate	9+80	Scour along streambank-BB	1
	17+62	Scour along streambank-RB	
	18+59-18+74		
	20+51-20+57		
	20+70-20+87		
Structure - Stressed	17+12	Bank Scour on upstream side of left arm	2
Aggradation	4+08	Mid-Channel Bar	3
	7+25		
	10+65		
	11+79		
	19+08		
Beaver Dam	28+13	Beaver Activity	5
Beaver Chews	N/A	N/A	6
Channel Inundation	23+65-28+13	Water at bankfull, but not over TOB	7

1. Bank Erosion: Moderate (5/2008)

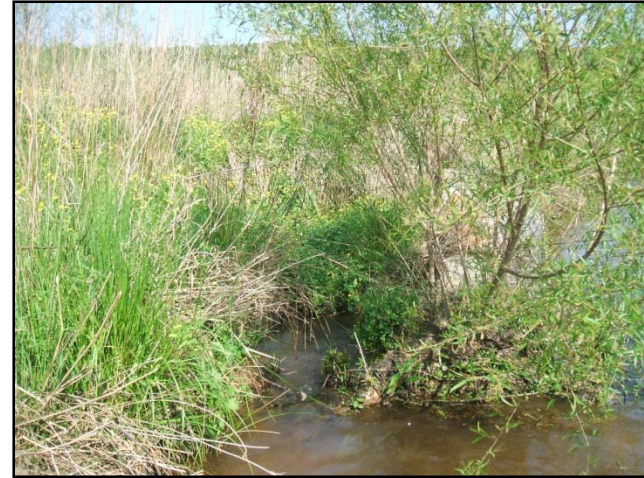
- The majority of structures appear to be in good condition; however, moderate to severe scouring is occurring along the outer arm of one structure. At stationing 17+12, the cross vane was determined to be stressed, due to severe bank scour around the boulder arms.

2. Structure-Stressed (5/2008)

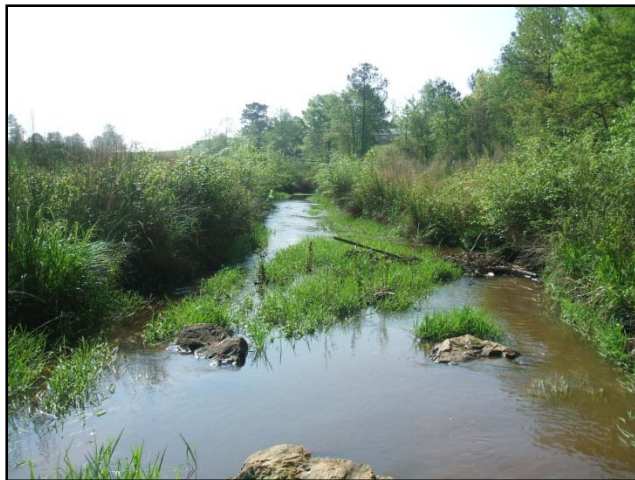
- Several mid-channel bars have formed throughout the Site (Approximate stationing 4+08, 7+25, 10+65, 11+79, and 19+08). Typically this is due to in-stream vegetation growth occurring sporadically throughout the entire stream restoration project creating abnormal flow conditions.

3. Aggradation-Mid-channel Bar (5/2008)

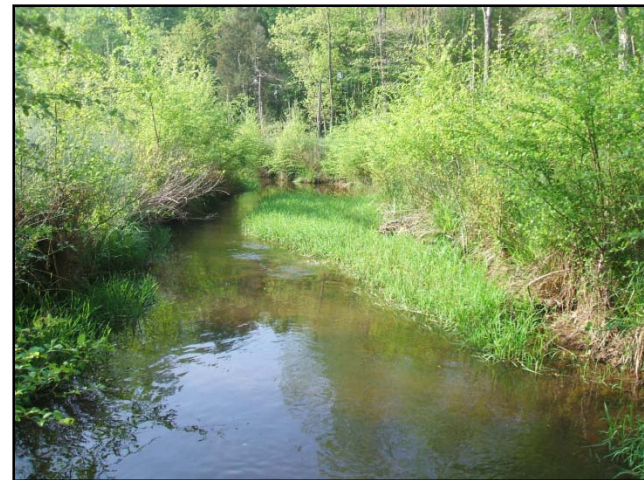
4. In-Stream Vegetation (5/2008)

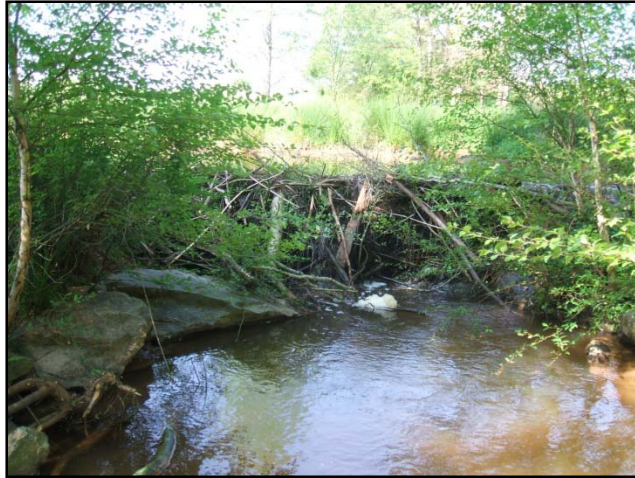
- Beaver activity is evident at the lower end of the Site. Approximately at station 28+13 there is a well established beaver dam which has created inundated conditions upstream (approximate station from 23+65 through 28+13). Flow is contained within the top of bank (bankfull) elevation and had not yet backed up onto the floodplain at the time of the stream survey was conducted.

5. Beaver Dam (5/2008)

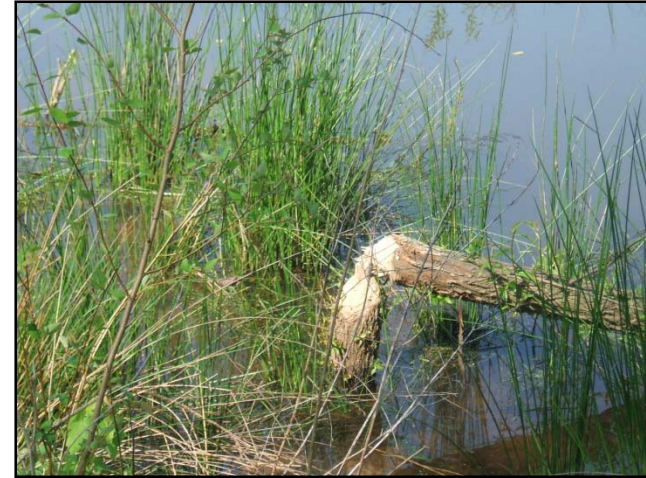
6. Beaver Chews (5/2008)

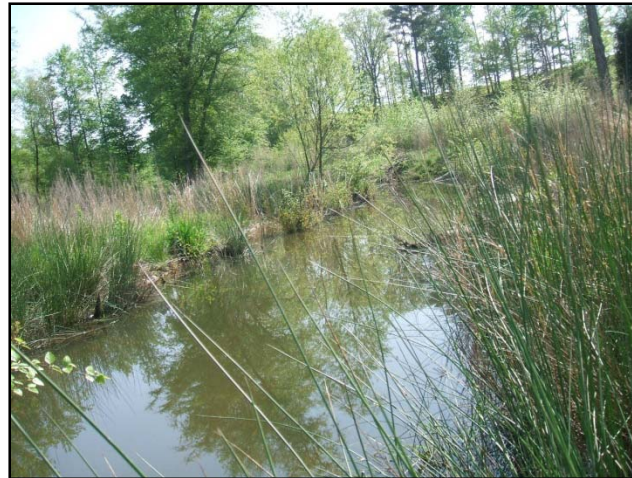
7. Inundation (5/2008)
