Suther (Dutch Buffalo Creek) Stream and Wetland Restoration Project

**EEP Project No. 370
2010 Final Monitoring Report: Year 1 of 5**

**Construction Completed: November 2009
Submission Date: June 2011**

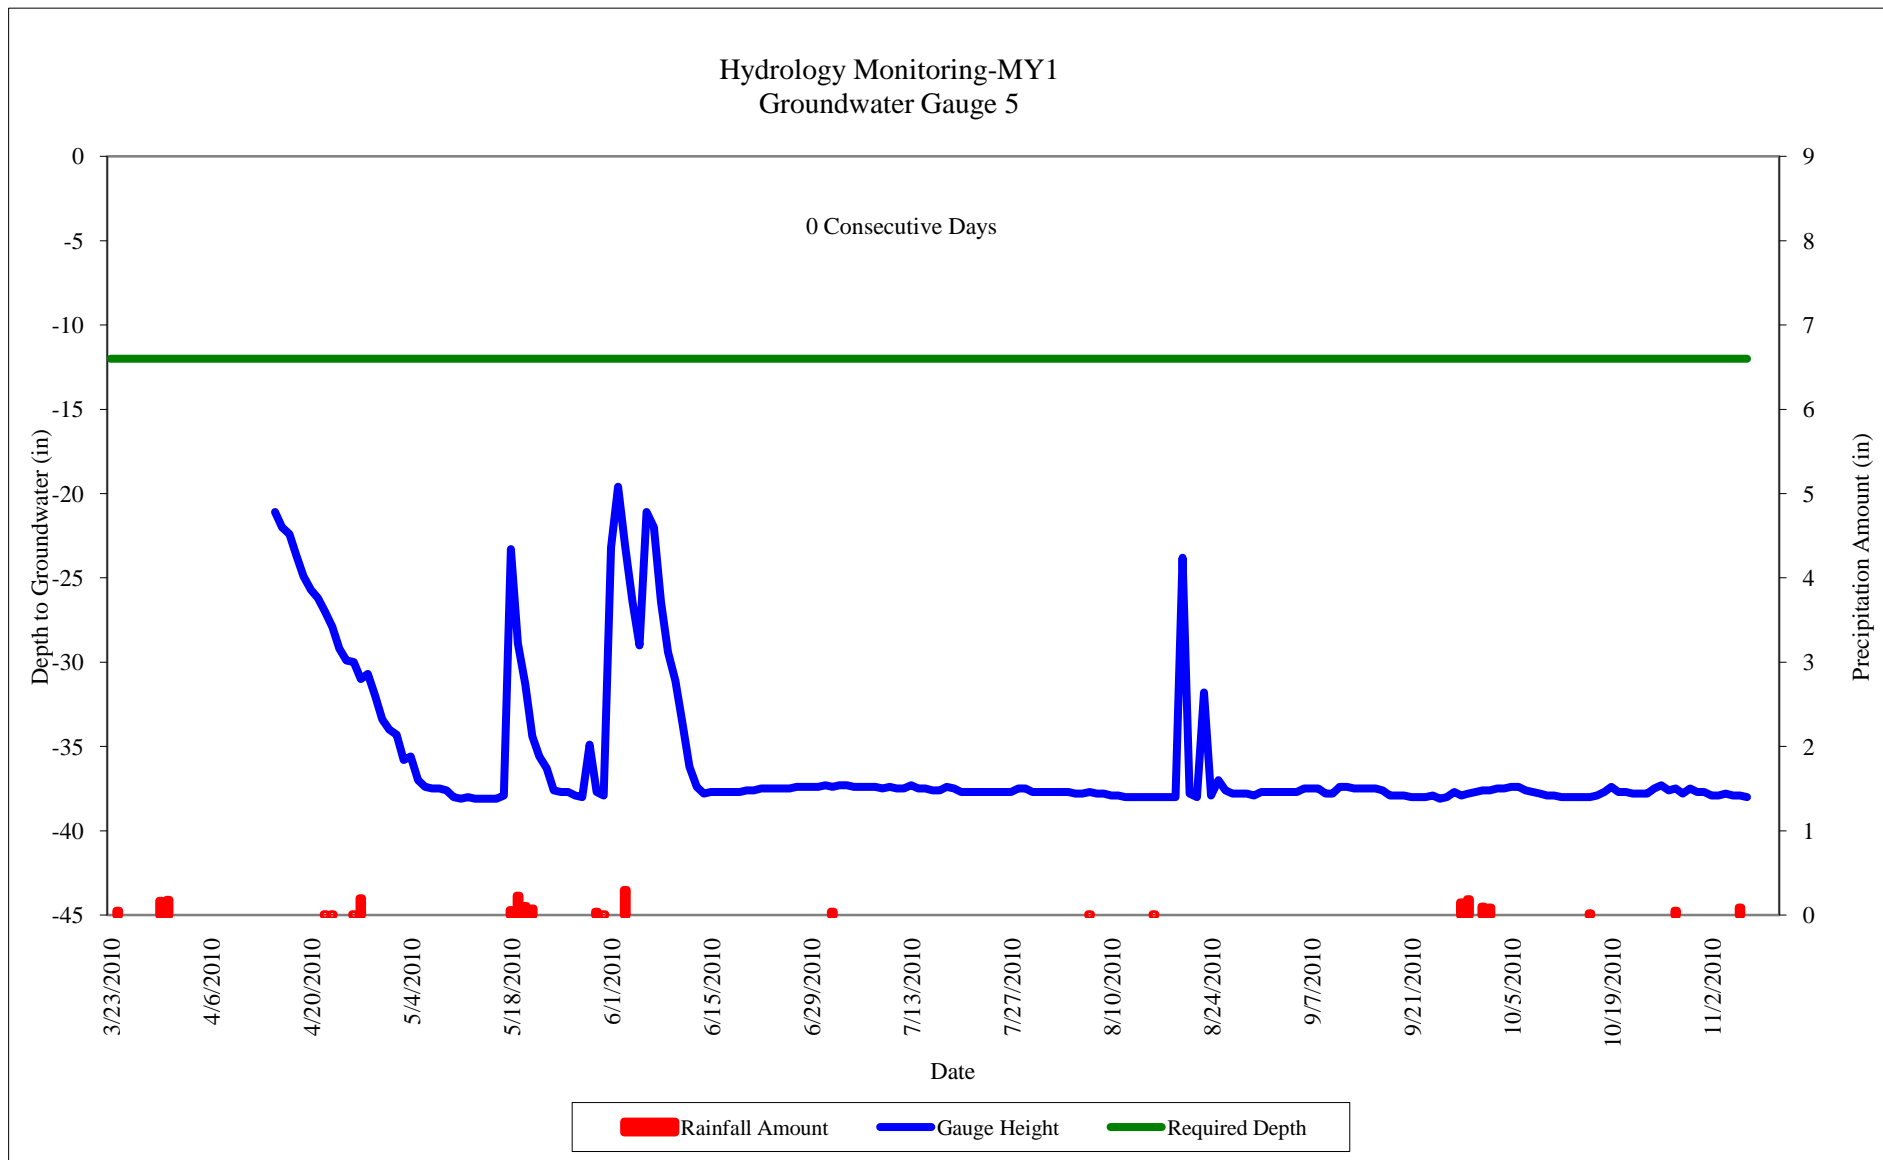
**Figure 7e: Precipitation and Water Level Plots for Gauges
 DBC (Suther) Stream and Wetland Restoration/EEP Project No. 370
 Monitoring Year 1 of 5**

(Groundwater gauge replaced April 2010 due to gauge malfunction prior to baseline monitoring.)

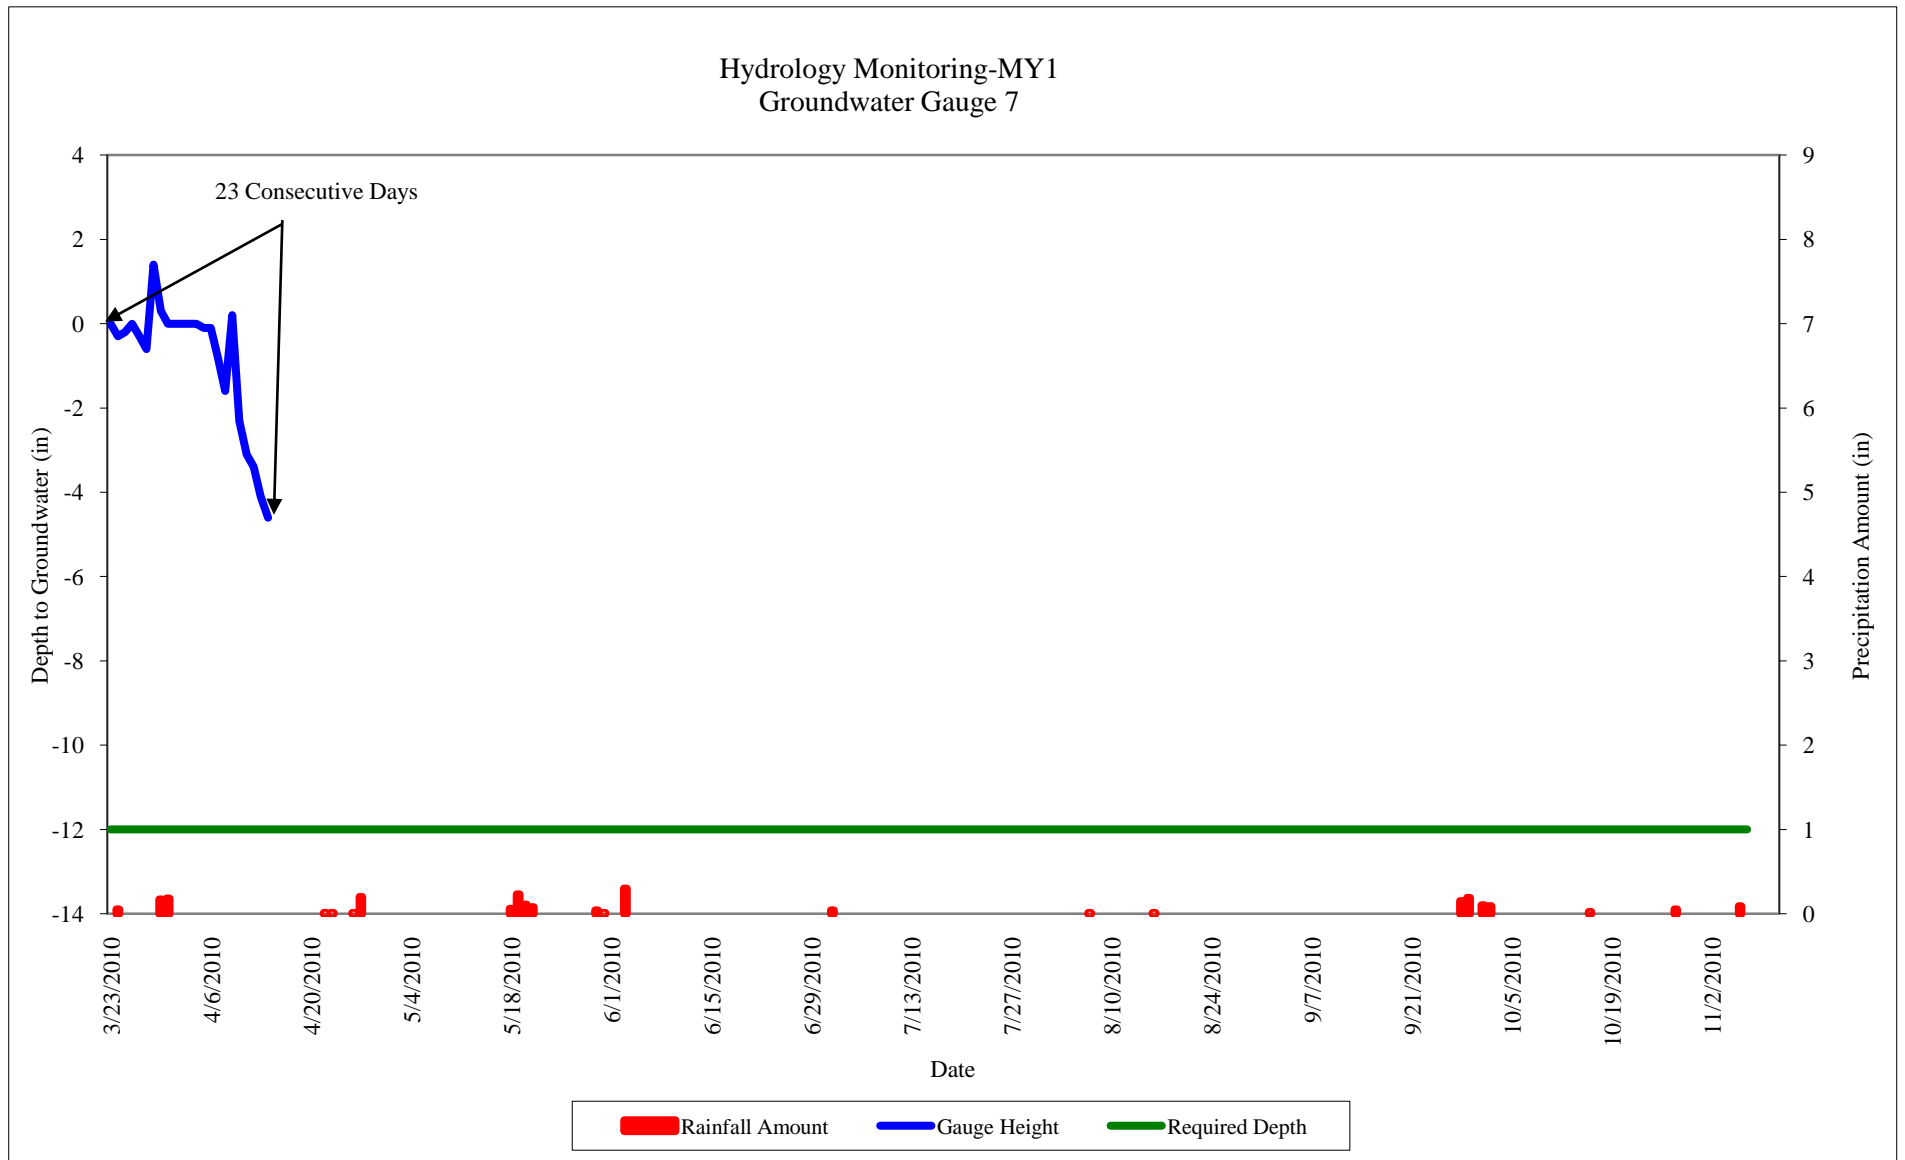
**Figure 7g: Precipitation and Water Level Plots for Gauges
 DBC (Suther) Stream and Wetland Restoration/EEP Project No. 370
 Monitoring Year 1 of 5**

(Gauge malfunctioned at the beginning of the growing season prior to starting the 2010 monitoring)

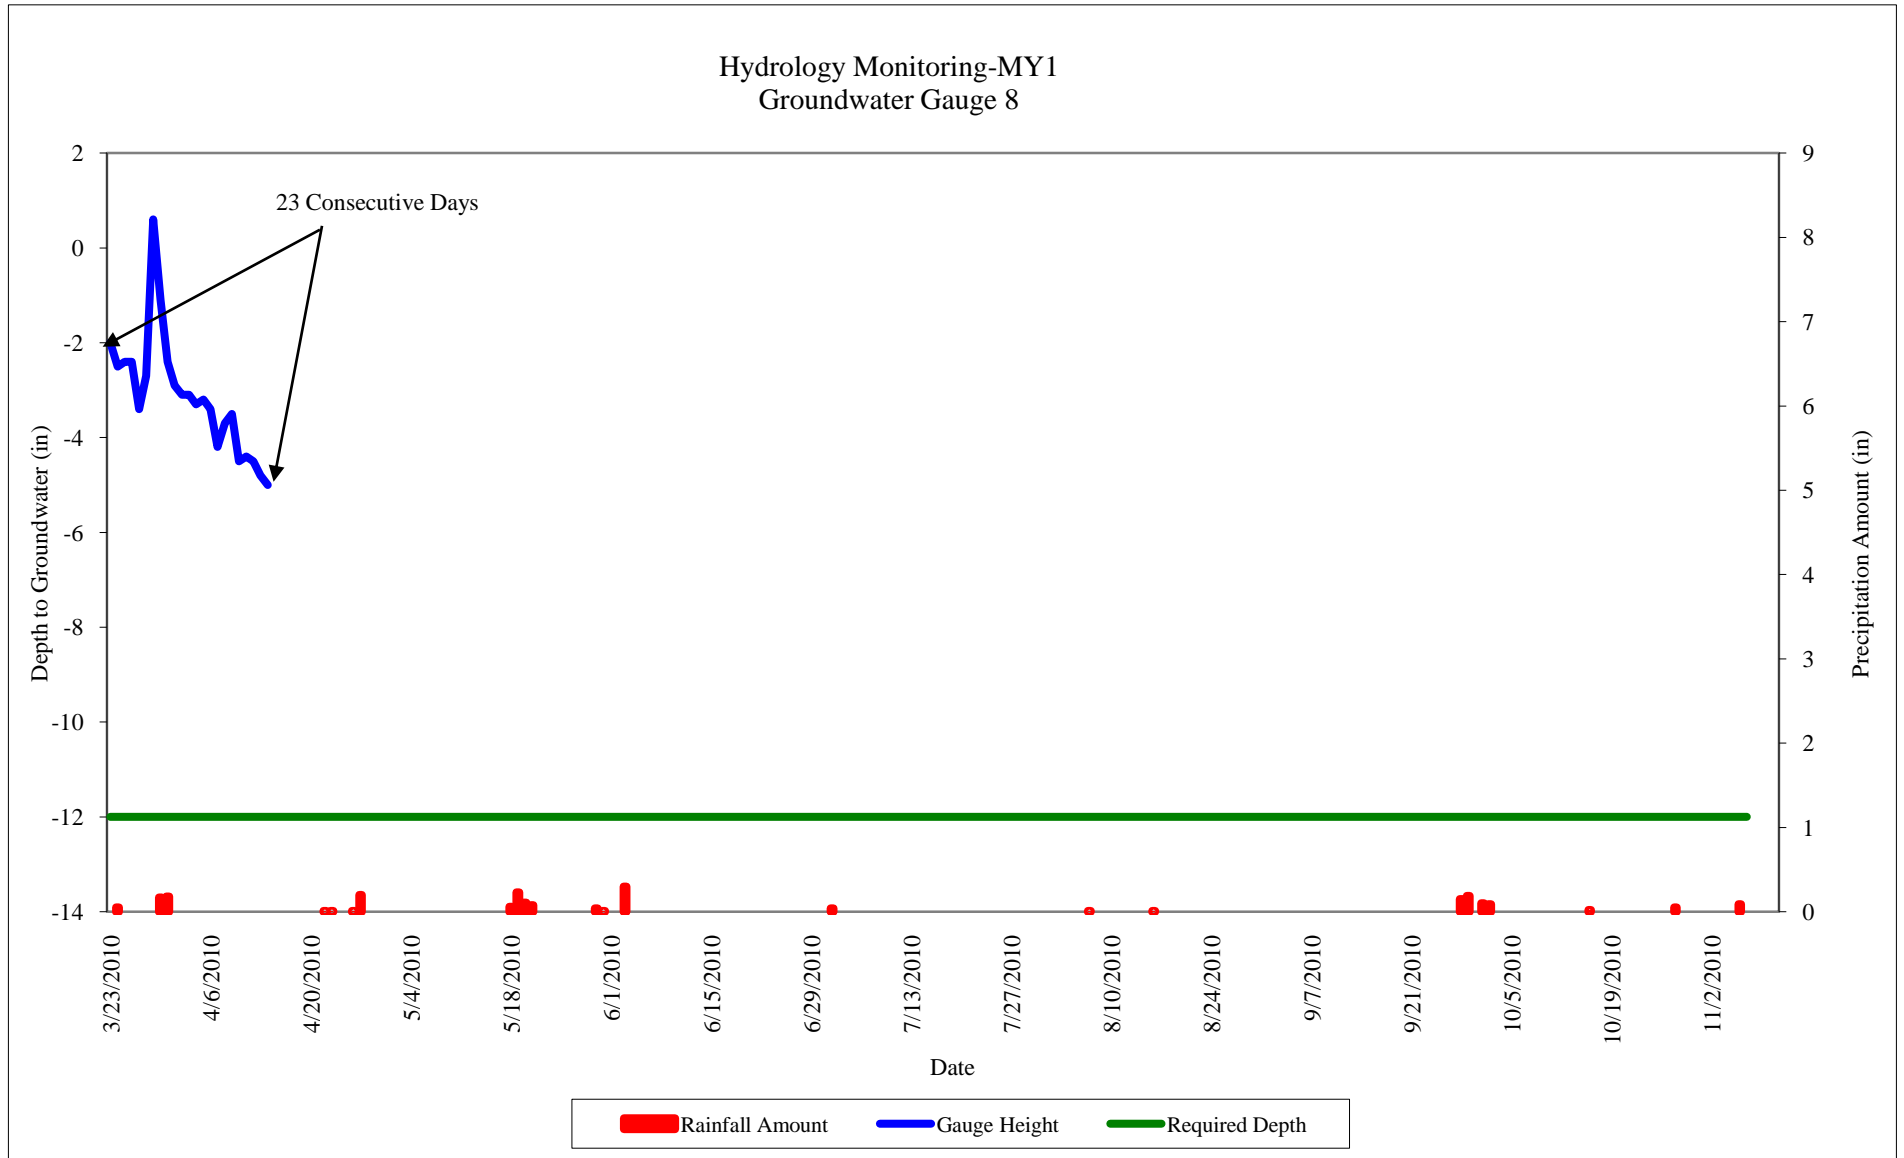
**Figure 7h: Precipitation and Water Level Plots for Gauges
 DBC (Suther) Stream and Wetland Restoration/EEP Project No. 370
 Monitoring Year 1 of 5**

(Gauge malfunctioned at the beginning of the growing season prior to starting the 2010 monitoring)
