**SUTHER STREAM & WETLAND RESTORATION SITE -- EEP #370
Cabarrus County NC -- PeeDee River HUC# 03040105-020060**

MY-3 (2014) ANNUAL MONITORING REPORT (Final)

**North Carolina Department of Environment & Natural Resources
Ecosystem Enhancement Program (DENR-EEP) -- Contract # 5764**

Data Collected: Aug-Sep 2014 Final Report Submitted: Mar 2015

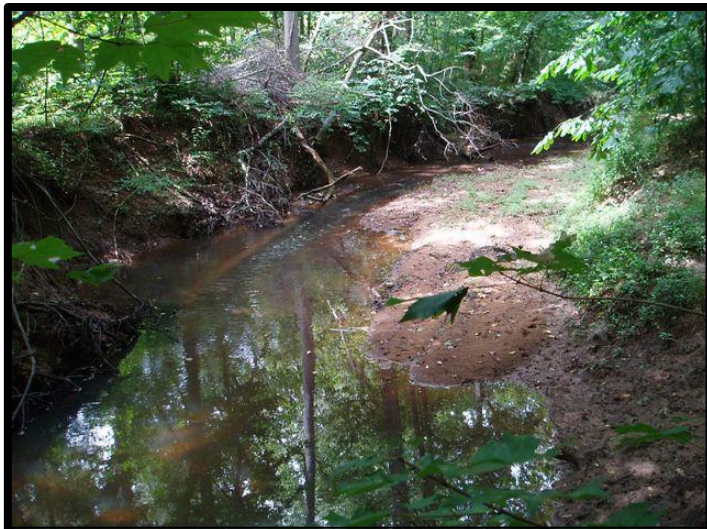
Photo Point # 18. DBC.Downstream.
10Apr2014. Cattle Crossing.

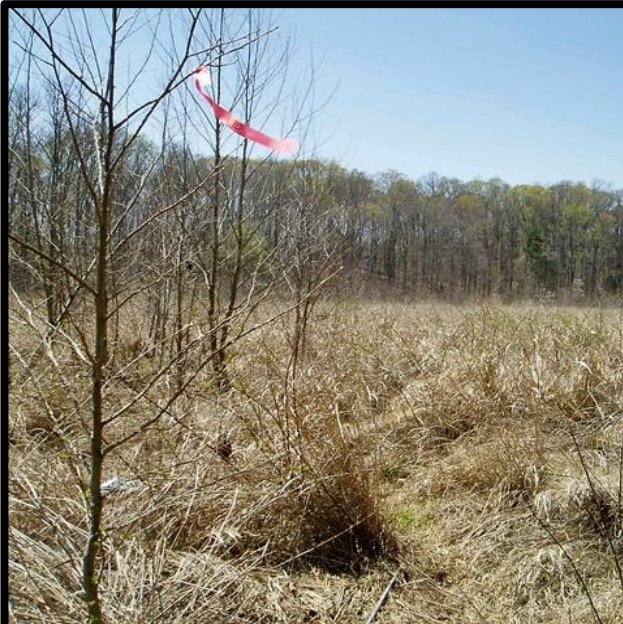
Vegetation Problem Area 1: Low woody density area in field west of well #16. The low stem density area mapped for replanting this winter extends ~ 650 feet west from this photo and is approximately 120 to 200 feet wide, or about 2.3 acres. 10Apr2014.

The preservation areas are in good condition and do not need supplemental planting. The northwestern corner of the site which is dominated by grasses and blackberries will receive supplemental planting in early 2015 to ensure vegetative success criteria. Feral hogs and deer are present and tend to uproot newly planted vegetation so this should be considered when the supplemental planting is done. MY 4 & 5 will include vegetation data from newly established 100 m² CVS vegetation plots which will be added to the CCPV. Much of the streamside zone within 30 feet of the restored UT also has low planted woody stem density, but the stream channel is surrounded by mature forest.

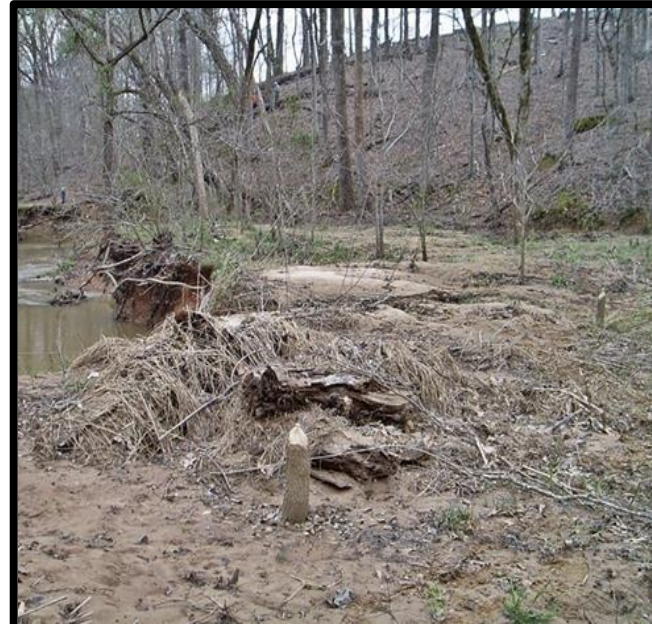
Vegetation Problem Area 2: Beaver-cut trees and low stem density along DBC right bank, station 16+50. 10Apr2014.

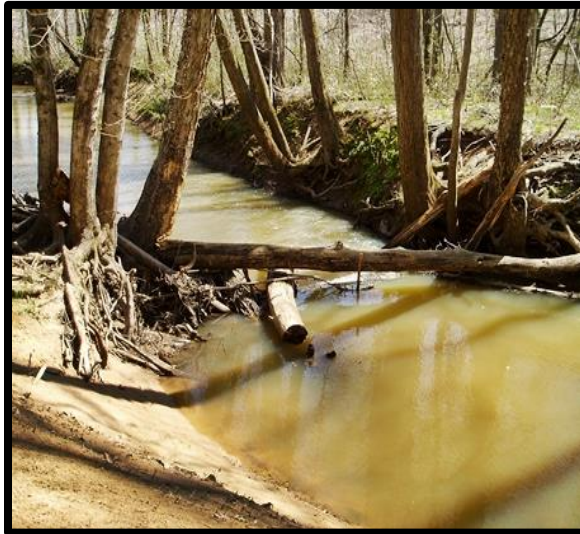
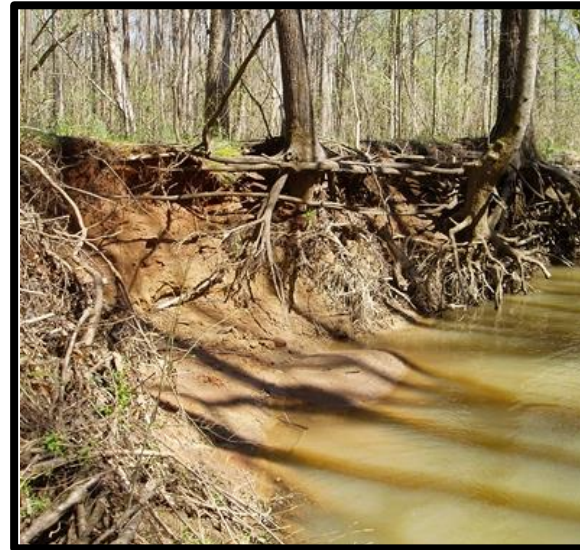
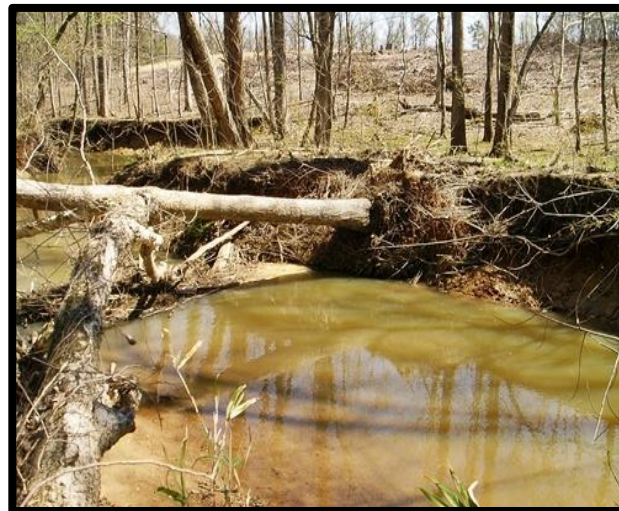
Stream Problem Area 2: DBC bank erosion at sta 24+00, possibly from log jam at sta 23+50. Also fallen oak & slumped bank at sta 26+40 (where missing bank pins A4 should have been). 10Apr2014.

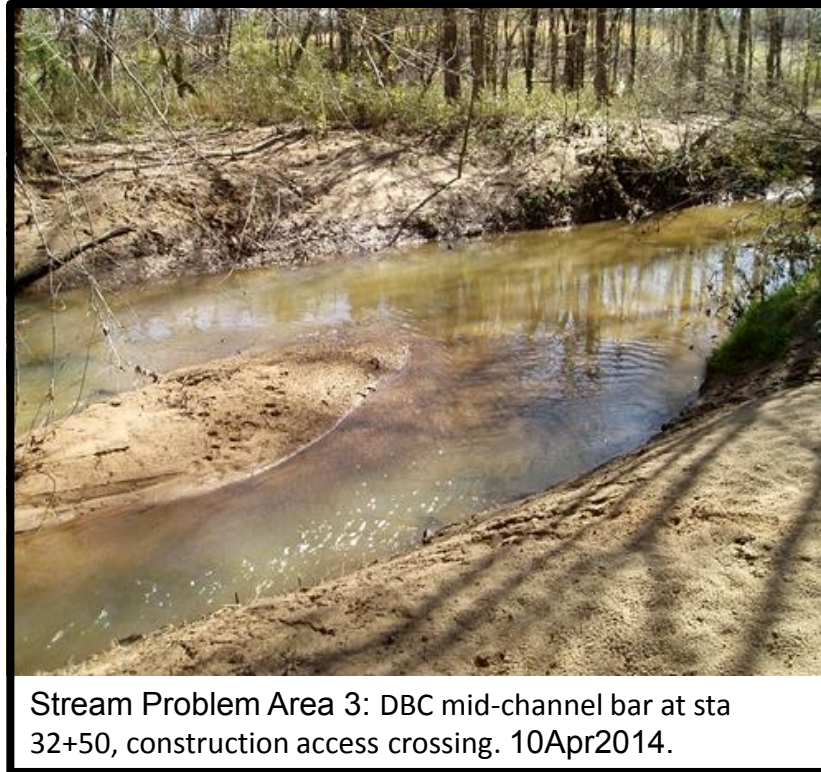
Stream: Dutch Buffalo Creek Enhancement Reach (Station 17+61 to 53+72 = 3,611 lin.ft)			
Feature Issue	Station & Bank	Length (ft)	Suspected Cause
Bank Erosion	17+60 - 18+20 LB	60	Poor tree survival at former construction crossing
Bank Erosion	23+80 - 24+30 LB	50	Log jam at stream bend
Bank Erosion	26+10 - 26+70 RB	60	Fallen tree, bank slump
Bank Eros + Mid-Bar	31+80 - 32+30 LB	50	Poor tree survival at former construction crossing
Bank Eros + Mid-Bar	31+80 - 32+30 LB	50	Poor tree survival at former construction crossing

Stream Problem Area 3: DBC mid-channel bar at sta 32+50, construction access crossing. 10Apr2014.

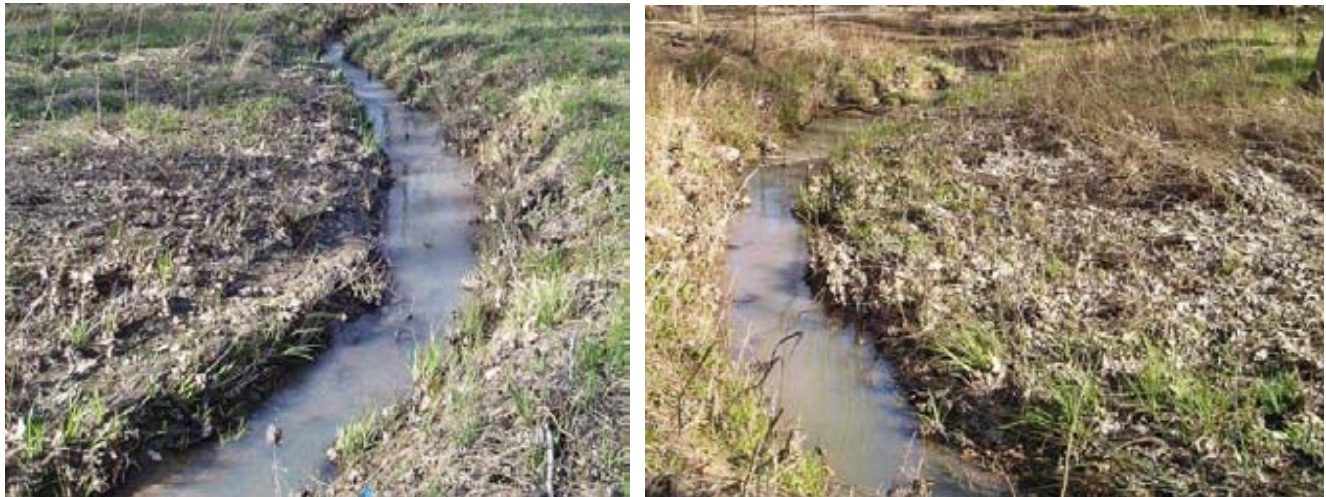
bankfull along 60% or more of the tributary, even without accounting for flow coming from the tributary's own watershed. Matted vegetation and wrack lines were observed in multiple locations along the tributary floodplain during the April site visit.

Matted vegetation and wrack lines, between Trib stations 3+00 to 5+00, Apr 9-10, 2014.
