**SUTHER STREAM & WETLAND RESTORATION SITE -- DMS #370  
Cabarrus County NC -- PeeDee River HUC# 03040105-020060**

**MY-4 (2015) ANNUAL MONITORING REPORT (Draft)**

**North Carolina Department of Environmental Quality  
Division of Mitigation Services (DENR-DMS) -- Contract # 5764**

**Data Collected: Sep-Oct 2015**

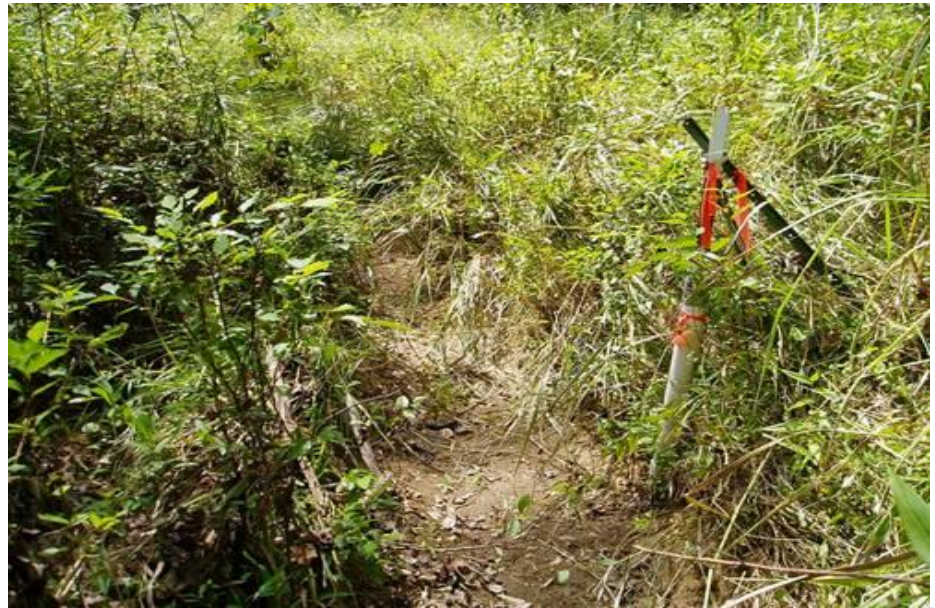
Photo Point 29, Upstream (Hobo Gauge): 2015

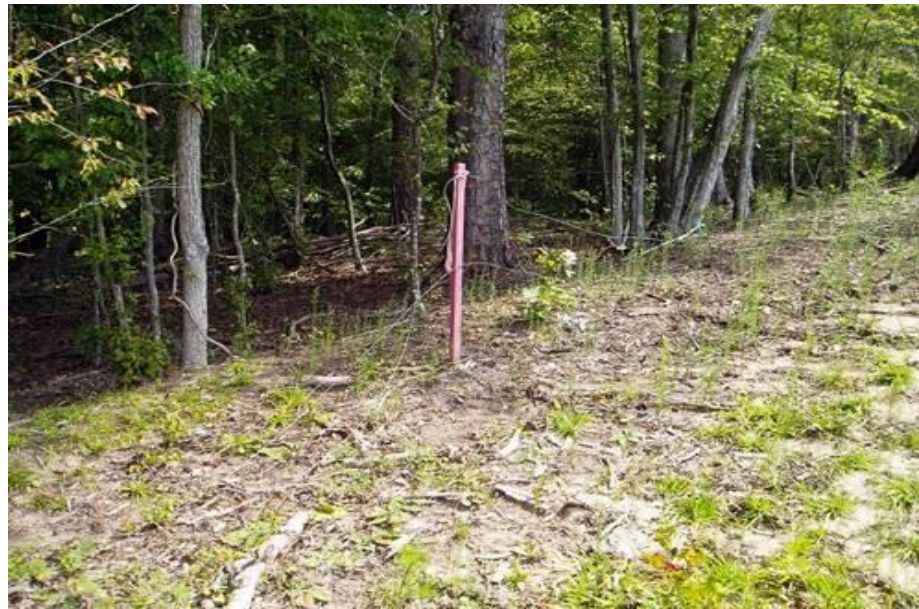
**Easement fence broken, SE of PhoPt-2, DBC sta 15+00, Sep 2015**

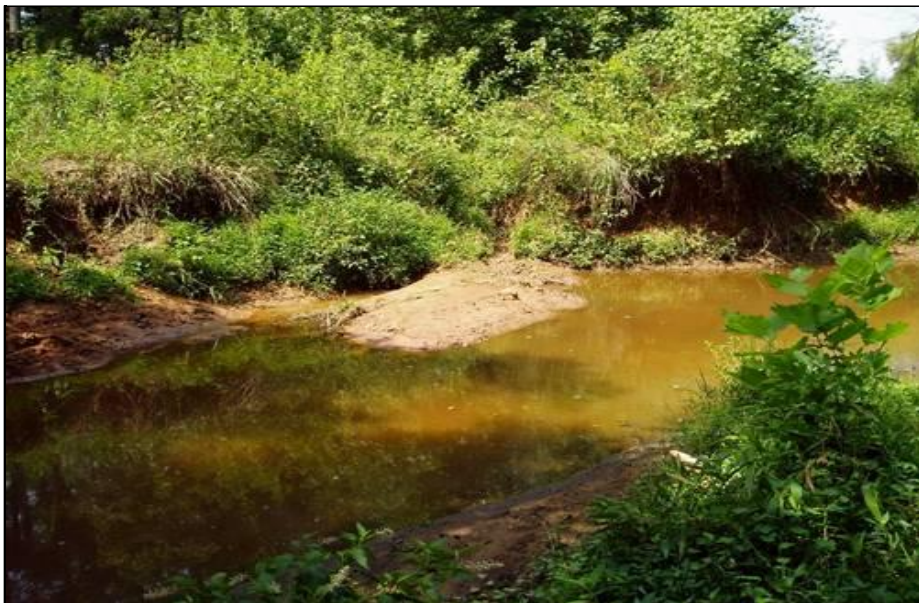
**DBC RBK sta 16+80 erosion, face upst, Sep 2015**
