**SUTHER STREAM & WETLAND RESTORATION SITE -- DMS #370
Cabarrus County NC -- PeeDee River HUC# 03040105-020060**

MY-5 (2016) ANNUAL MONITORING REPORT

**North Carolina Department of Environmental Quality
Division of Mitigation Services (DENR-DMS) -- Contract # 5764**

Data Collected: Sept 2016

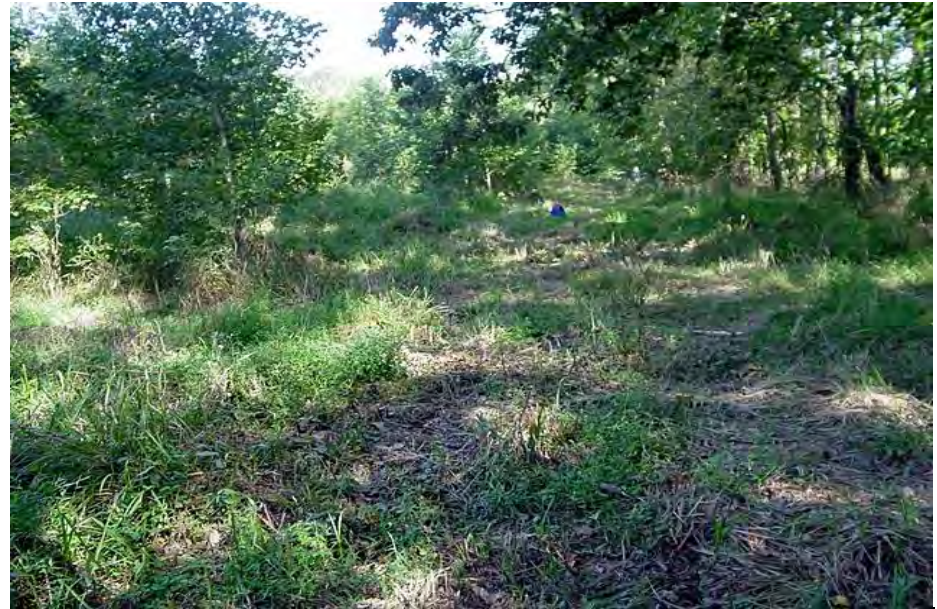
Mowed area: SW of Groundwater Gauge 2 (Facing East), Sept 2016

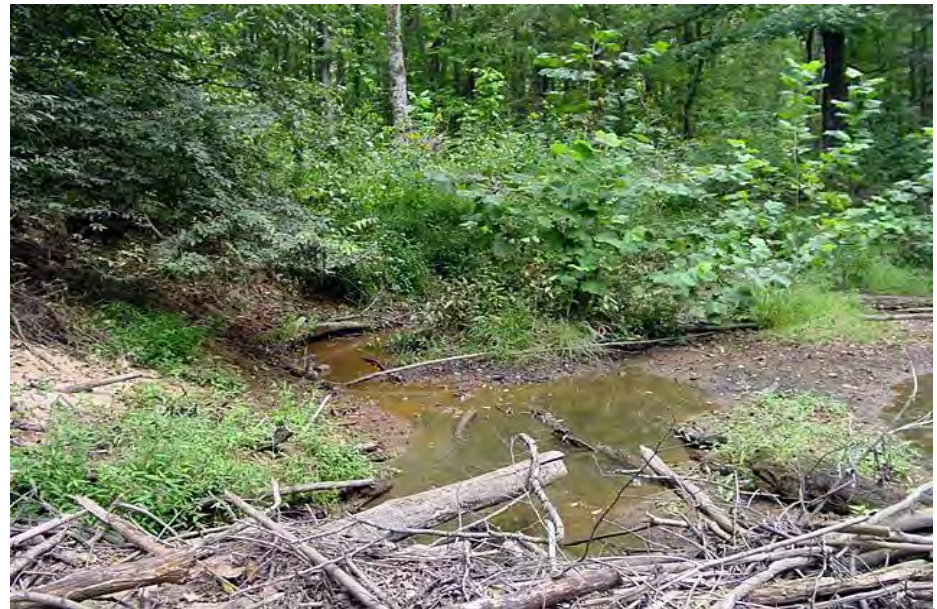
Beaver Dam: Trbutary Station 17+40, Sept 2016

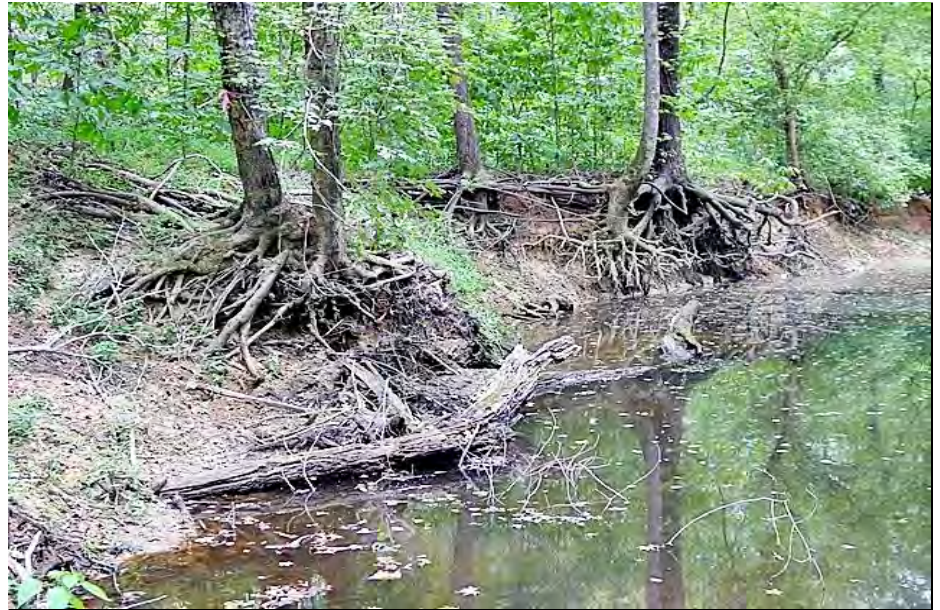
Bank Erosion: Tributary Station 23+50, Sept 2016

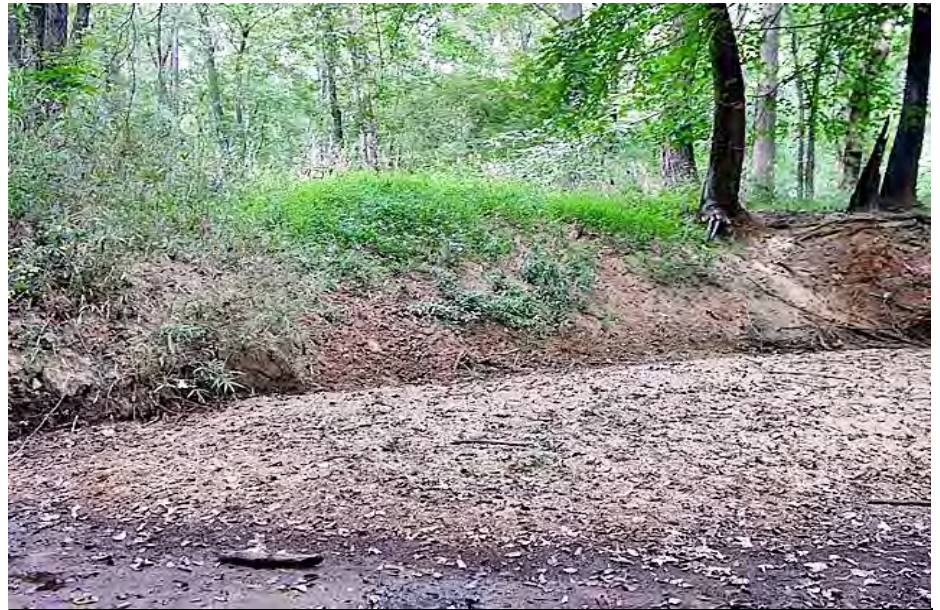
DBC construction crossing, Station 32+50, Sept 2016

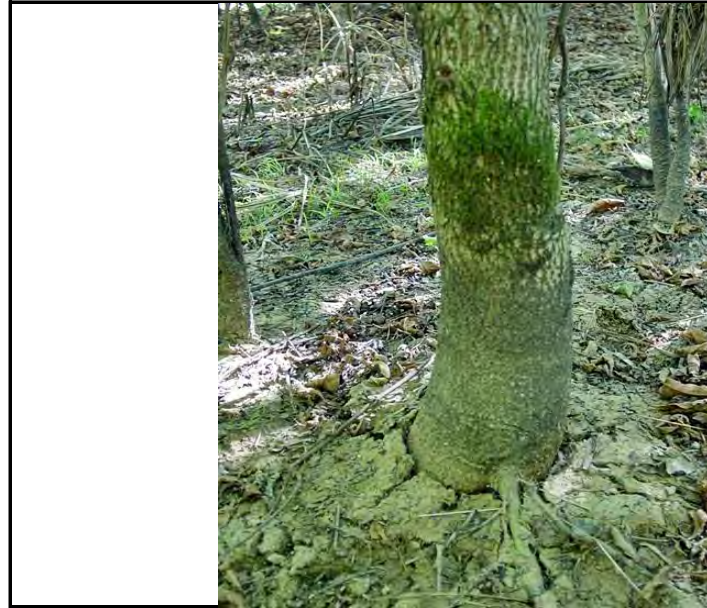
Moss Trim Lines & Soil Surface Cracks: W of Veg Plot 9, Sept 2016

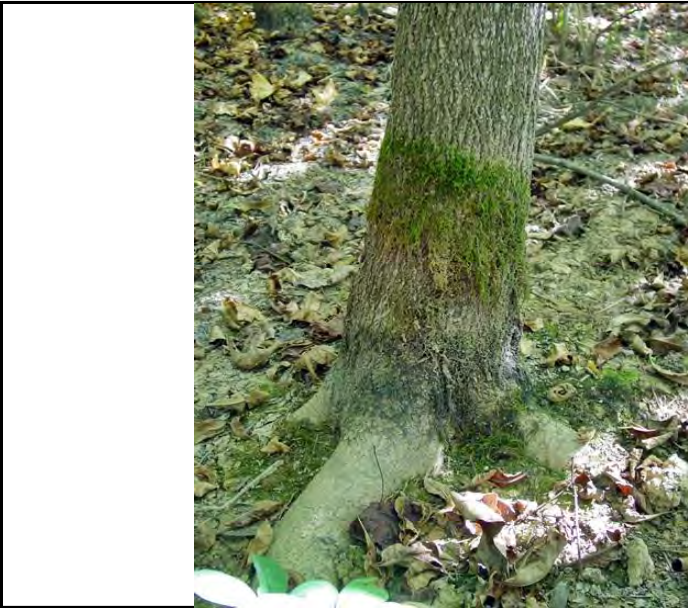
Moss Trim Lines: W of Veg Plot 9, Sept 2016
