**SUTHER STREAM & WETLAND RESTORATION SITE -- DMS #370  
Cabarrus County NC -- Yadkin-PeeDee River HUC# 03040105-020060**

**MY-6 (2017) ANNUAL MONITORING REPORT**

**North Carolina Department of Environmental Quality  
Division of Mitigation Services (DENR-DMS) -- Contract # 5764  
USACE Action ID # SAW-2008-0218                      NCDWR Project # 20080134**

**Final Report: January 2018**

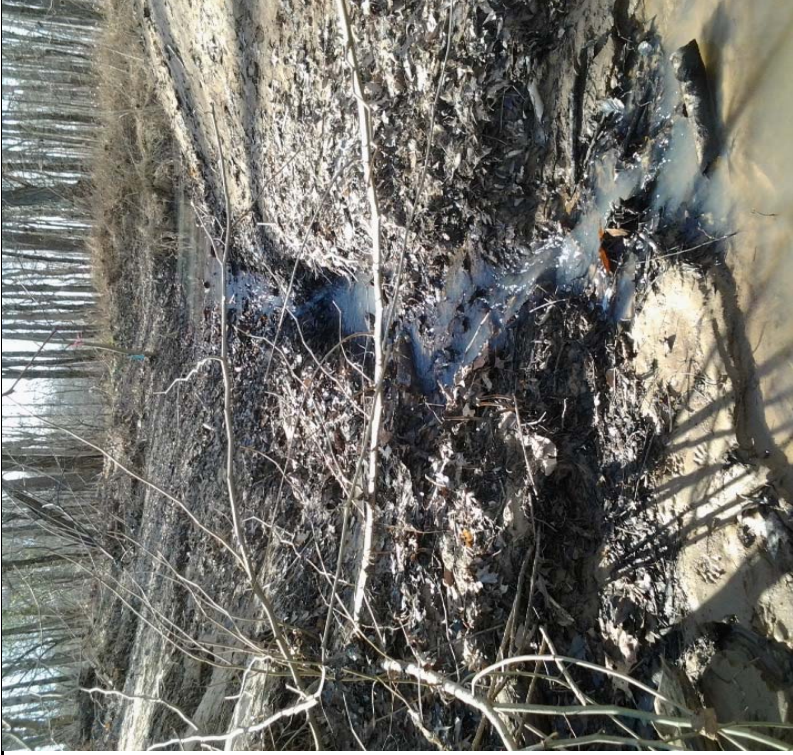
The restored tributary (UT-1) appears similar in 2017 to the previous years' reported condition. The stream pattern, profile, and dimension are maintaining vertical and lateral stability over most of the restored reach, and the cross-vanes and constructed riffles are performing as designed. Stream-bank vegetation density appears adequate in most areas. The lowermost 15 feet of UT-1 adjacent to DBC still has low woody stem density along the banks and remains prone to alternating cycles of erosion and deposition, depending on flow conditions in both streams. This year the lowermost segment of UT-1 appeared aggraded with sand and silt, whereas in 2016 a deep scour pool had formed at the confluence. The deeply incised condition and steep banks along DBC combined with a heavy sediment load during high flow events and shade from floodplain trees makes establishment of woody stems on the banks difficult in this confluence area.

UT1 (Upstream) at Confluence with DBC: Oct 2017

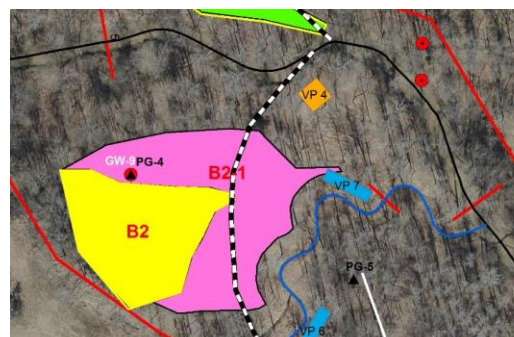
Current status of Wetland B-2 Area

***Both areas in Wetland B2 (B2 and B2-1) are being removed from crediting due to inadequate attainment of hydrology criteria.***
