Tarlton Stream and Wetland Restoration Project

Contract #: D05013-1
County: Cumberland
Cataloging Unit: Cape Fear 03030004
Monitoring Firm POC: Mid-Atlantic Mitigation, LLC
Rich Mogensen (704) 782-4133
Kimley-Horn Associates, Inc.
Will Wilhelm (704) 333-5131
Prepared For: EEP Project Manager, Guy Pearce

Year 1(2006) Monitoring Report

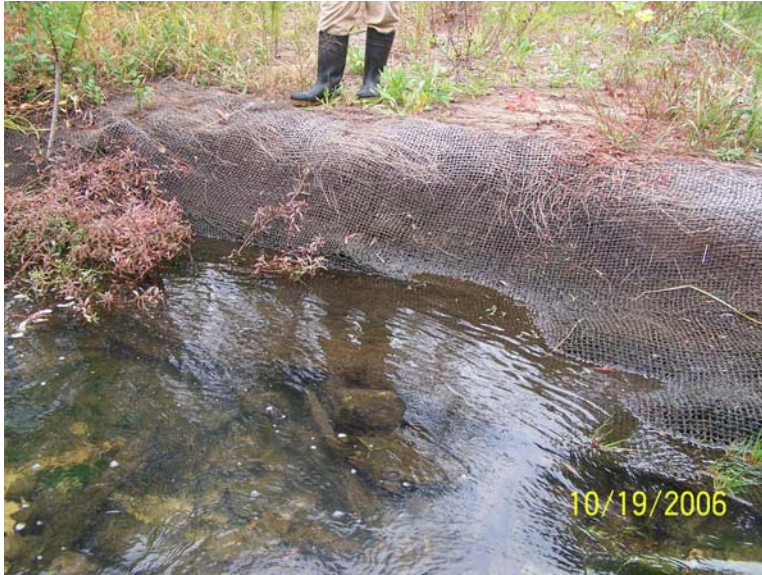
Problem Area 1 – Rocks and bank under matting have settled. Vegetation hasn't taken root due to rock under matting, area will be live staked this winter.

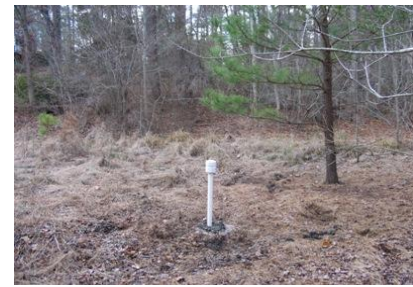
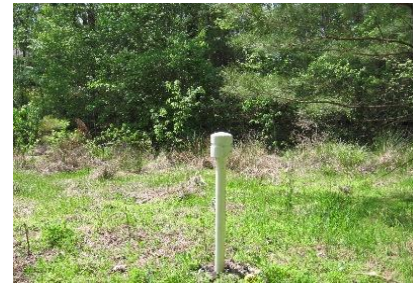
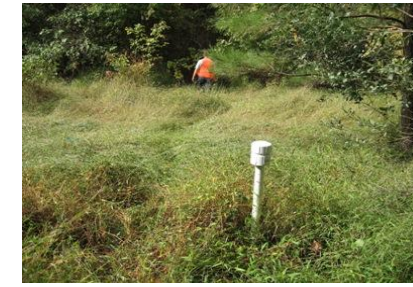
COMMENTS: 1/17/06 - soil is saturated with pockets of ponded water in depressions. 4/21/06 - area is dewatering slightly with new herbaceous growth. 10/19/06 - Herbaceous veg has done very well (see 4+ft tall *Polygonum sagittatum*). Stream downslope from gage has gone from multiple streams to single channel and may have some headcutting.

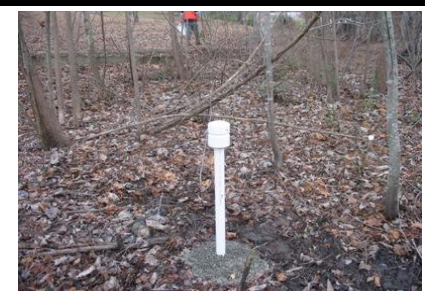
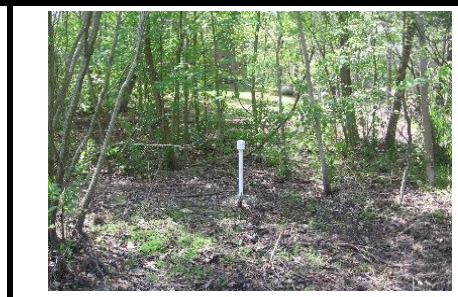
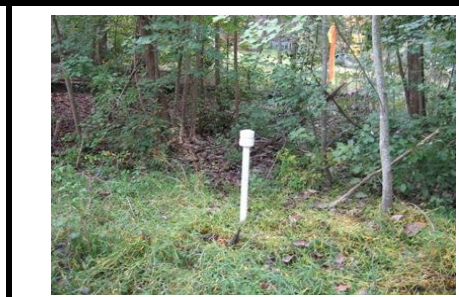
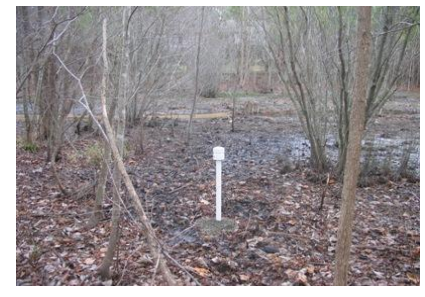
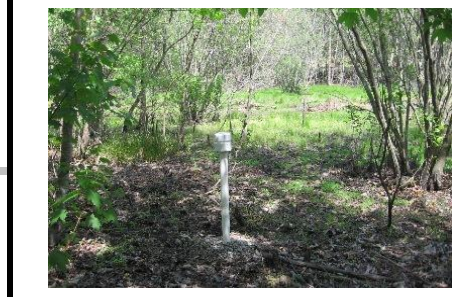
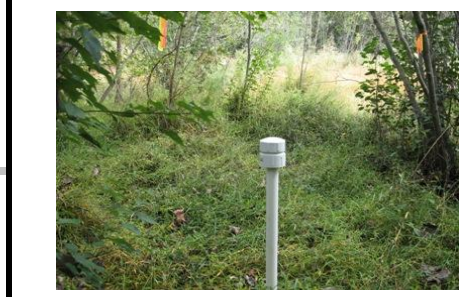
COMMENTS: 1/17/06 - soil is saturated with pockets of ponded water in depressions. 4/21/06 - soils are still saturated at the surface, however there is less evidence of ponding. Herbaceous veg and ferns (*Woodwardia areolata*) coming in. 10/19/06 - Herbaceous veg is well established. There is some stream adjustments in the area where the primary flow is no located further from the gage. There may be some headcutting.

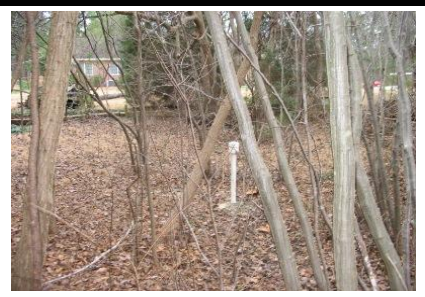
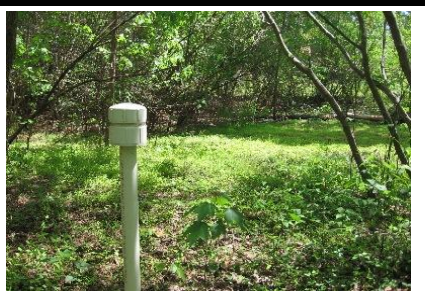
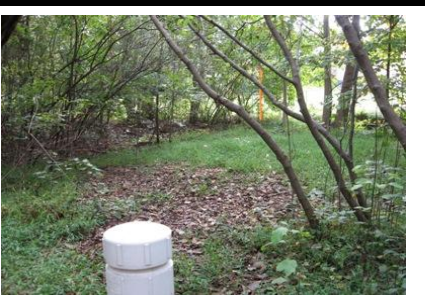
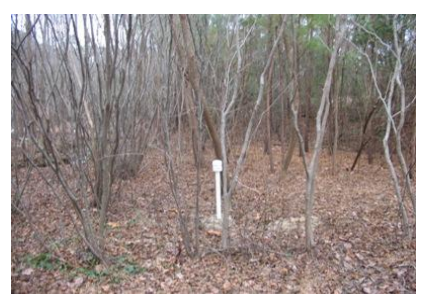
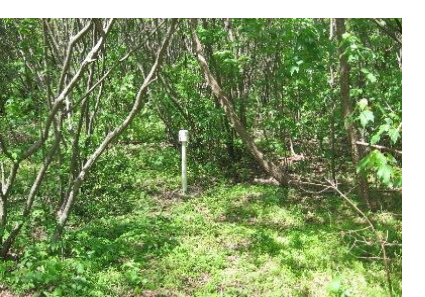
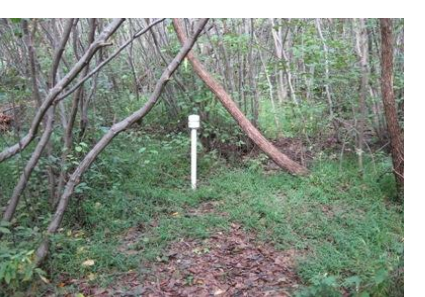
COMMENTS: 1/17/06 - evidence of recent flooding and inundation 10/19/06 - the stream downstream from the gage location has not formed into a single channel and continues to be braided.

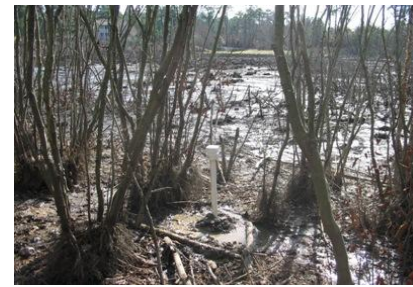
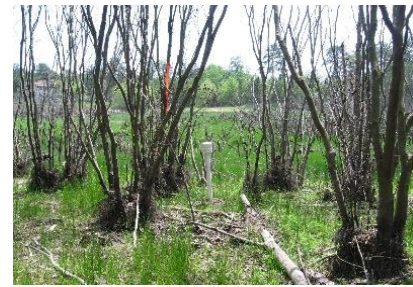
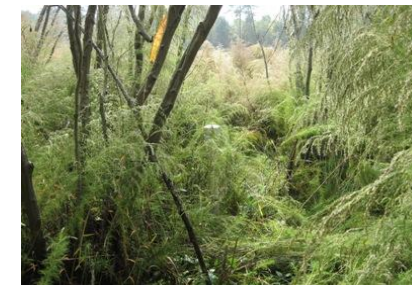
COMMENTS: 4/21/06 - area is dewatering slightly with new herbaceous growth. fennel is more dominant herbaceous veg. 10/19/06 - Fennel has taken over the location making locating the gage difficult. Many young alders are re-establishing.

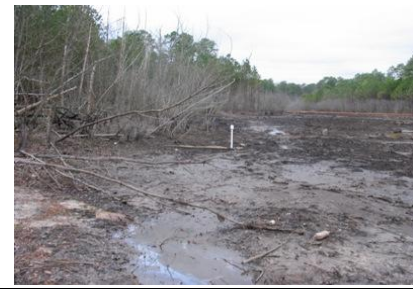
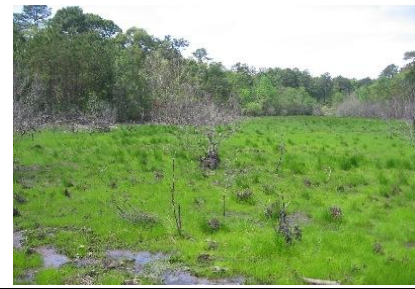
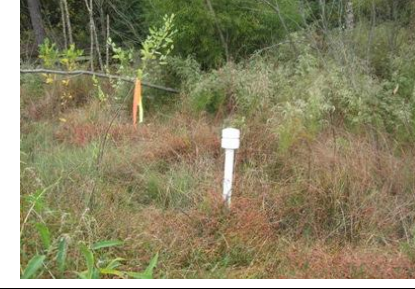
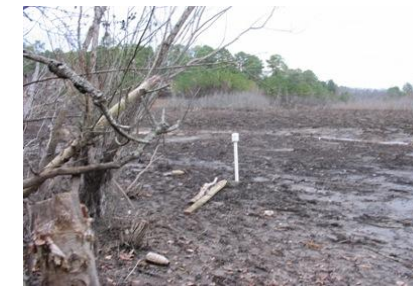
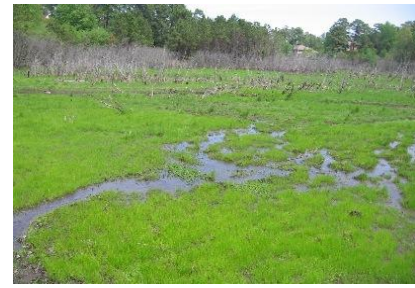
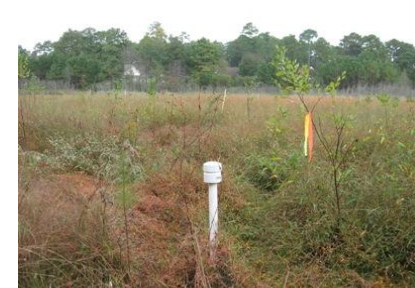
COMMENTS: 4/21/06 - area is dewatering slightly with new herbaceous growth. 10/19/06 - Herbaceous vegetation and planted shrubs are doing well. The surface has dewatered and become more solid (compared to soupy... see January photo where boards were needed to access the gage).
