Tarlton Stream and Wetland Restoration Project

Contract #: D05013-1
County: Cumberland
Cataloging Unit: Cape Fear 03030004
Monitoring Firm POC: Mid-Atlantic Mitigation, LLC
Rich Mogensen (704) 782-4133
Kimley-Horn Associates, Inc.
Will Wilhelm (704) 333-5131
Prepared For: EEP Project Manager, Guy Pearce

Year 2 (2007) Monitoring Report

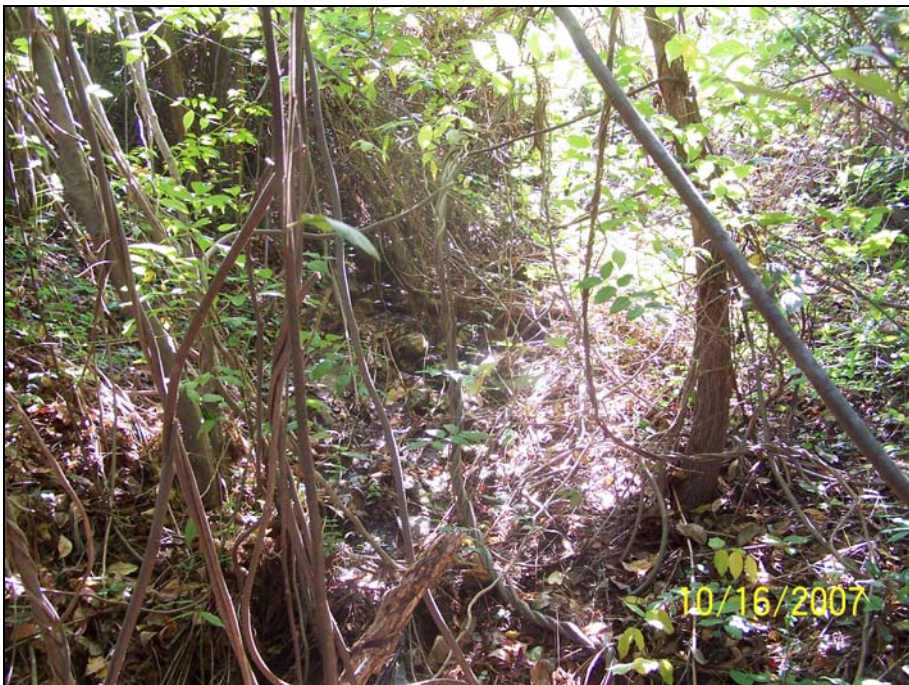
Storm water outfall 6, located in the eastern prong in the stream restoration section.

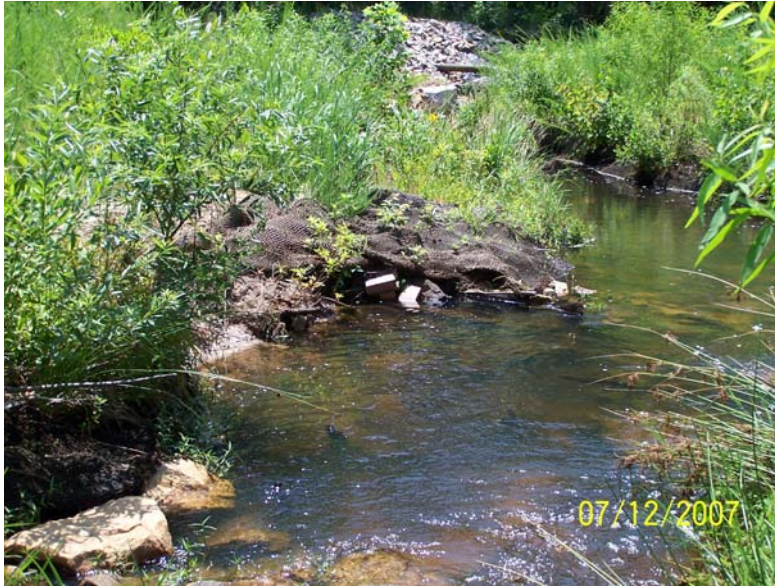
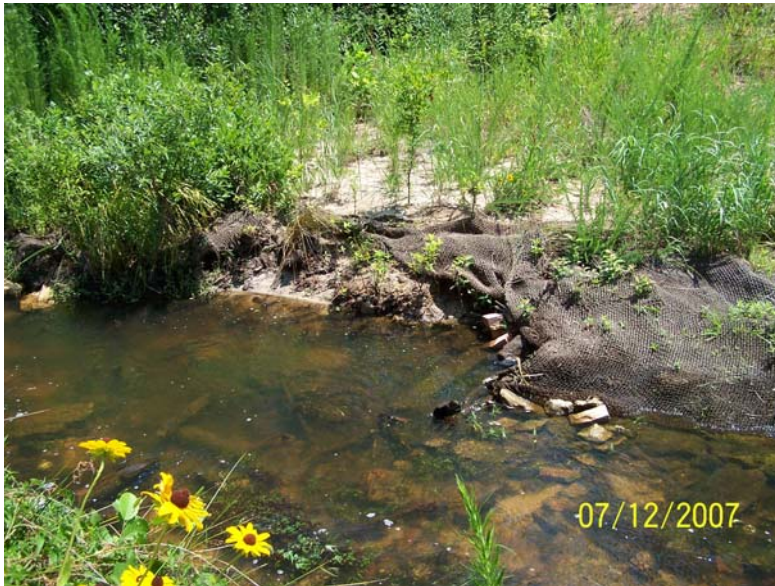
Problem area at end of project between Cross Sections 1 and 2.
This area was smoothed out and live staked.

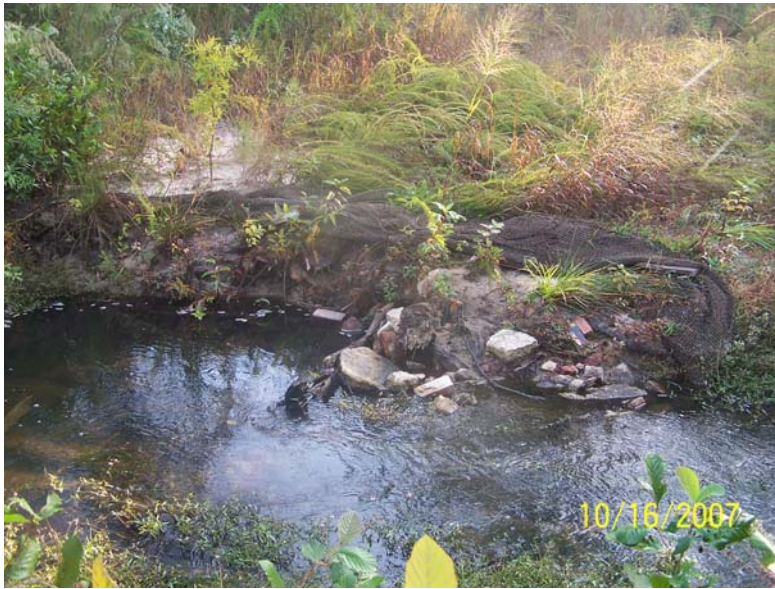
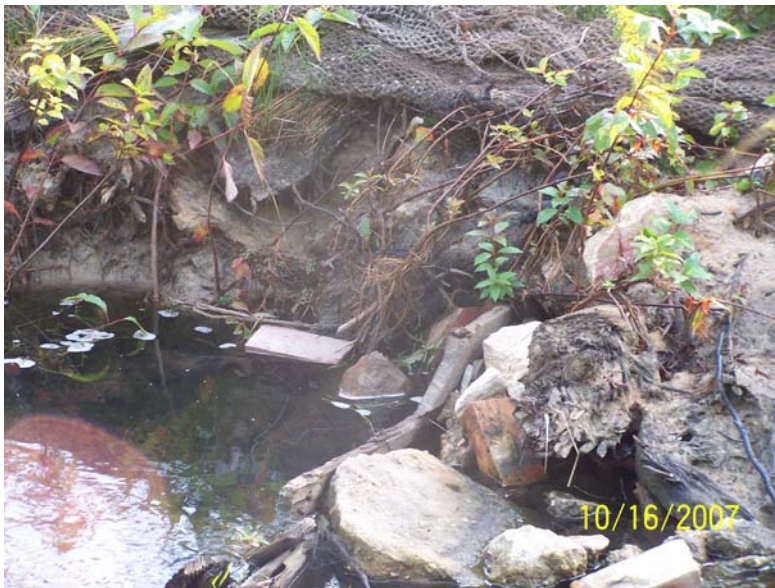
This area did not weather the September Bank full event very well and will be repaired and monitored.

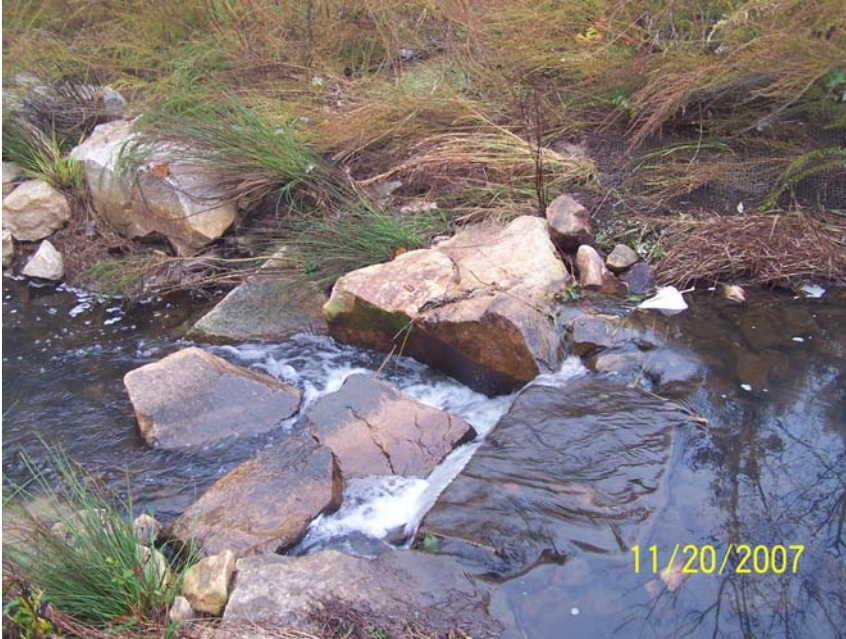
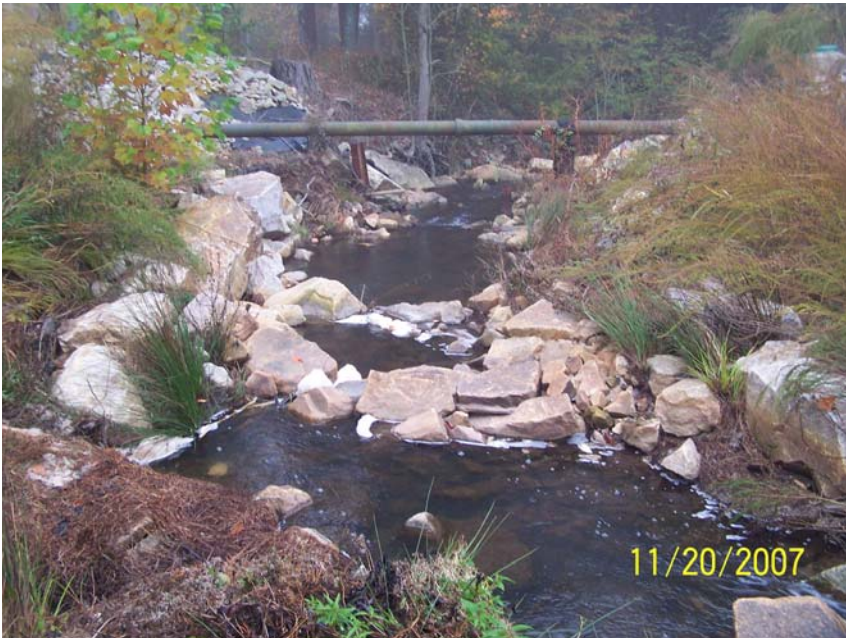
Structure at Station 36+00 has settled in a few areas but appears to be in good condition.

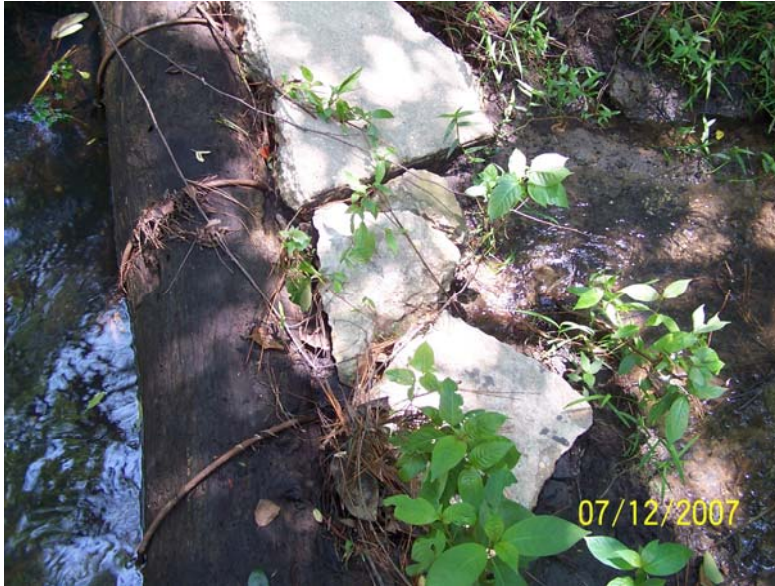
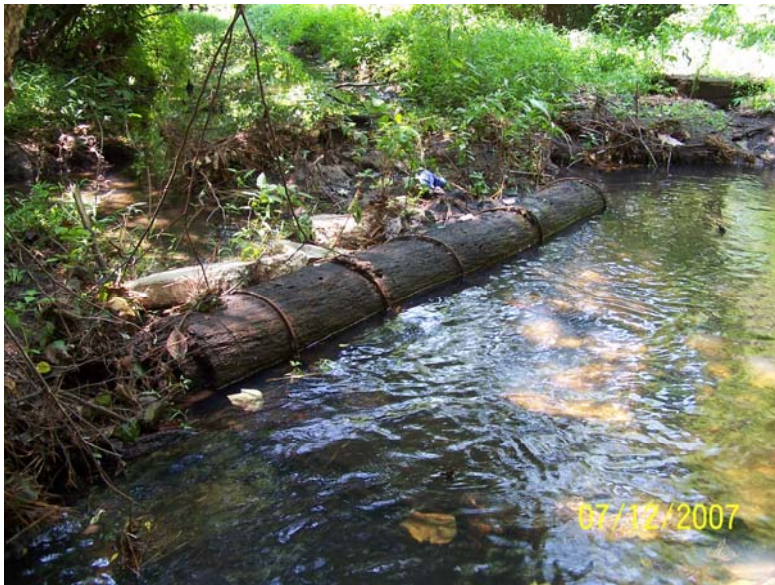
Log Diversion structure in enhancement area. In order to confine flow to the main channel and limit the braided nature of the channel the flowing log structure was installed.

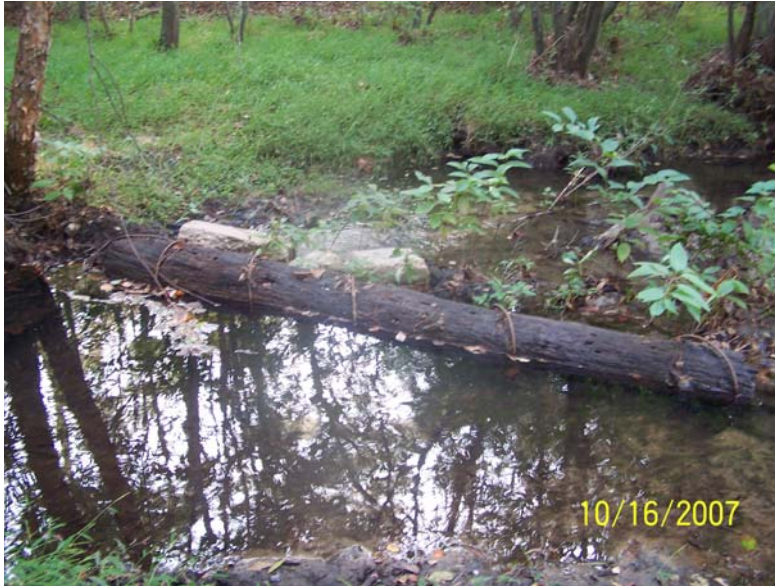
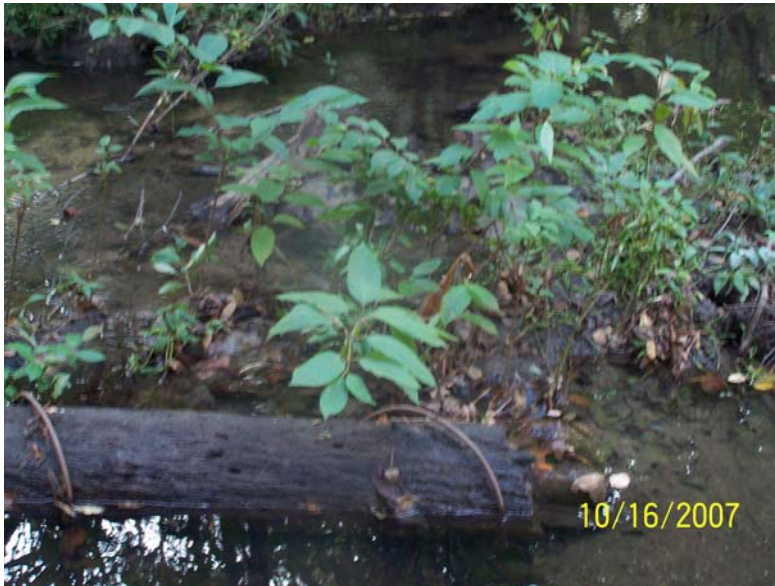
Structure weathered September storms moderately well and will be repaired and monitored as needed.

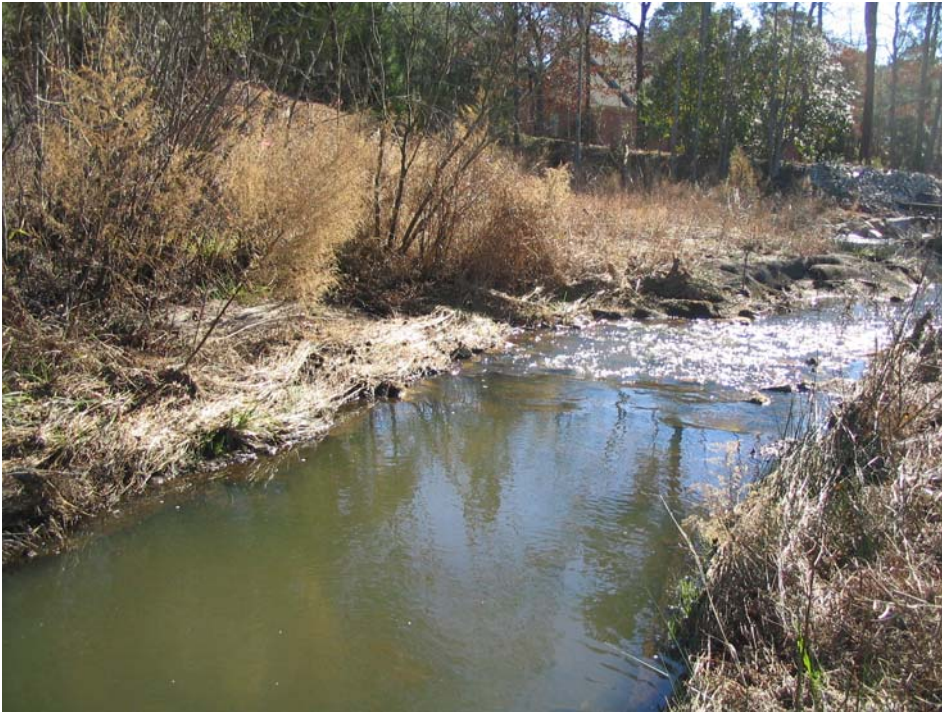
Vegetation flattened by bank full event, Photos taken January 9th, 2007. Several significant storms came through the Fayetteville area the week of Christmas 2006.

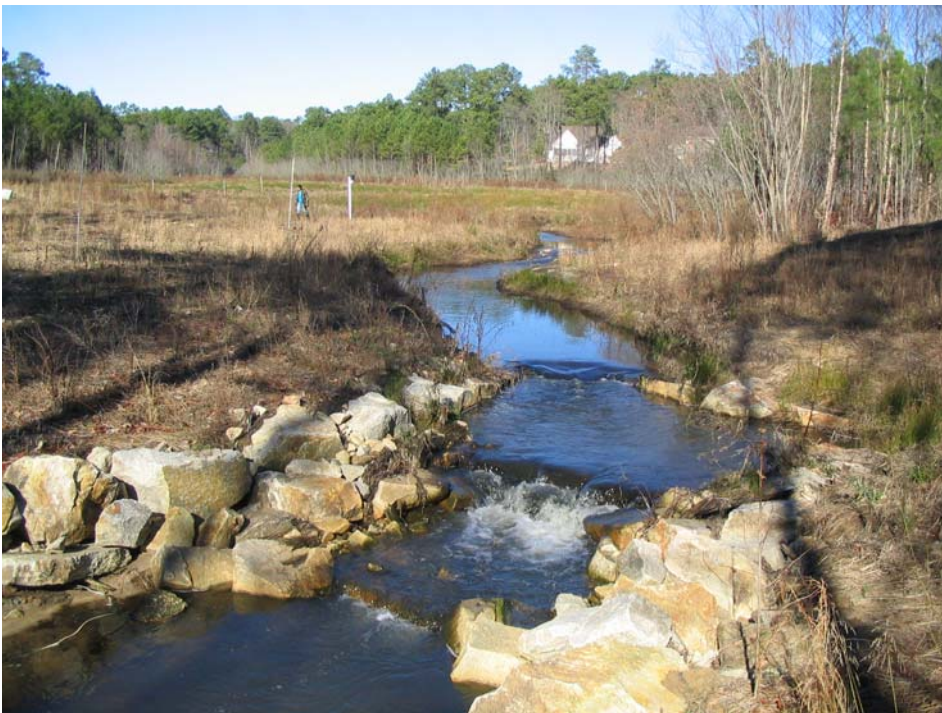
Main Structure after bank full event , January 2007

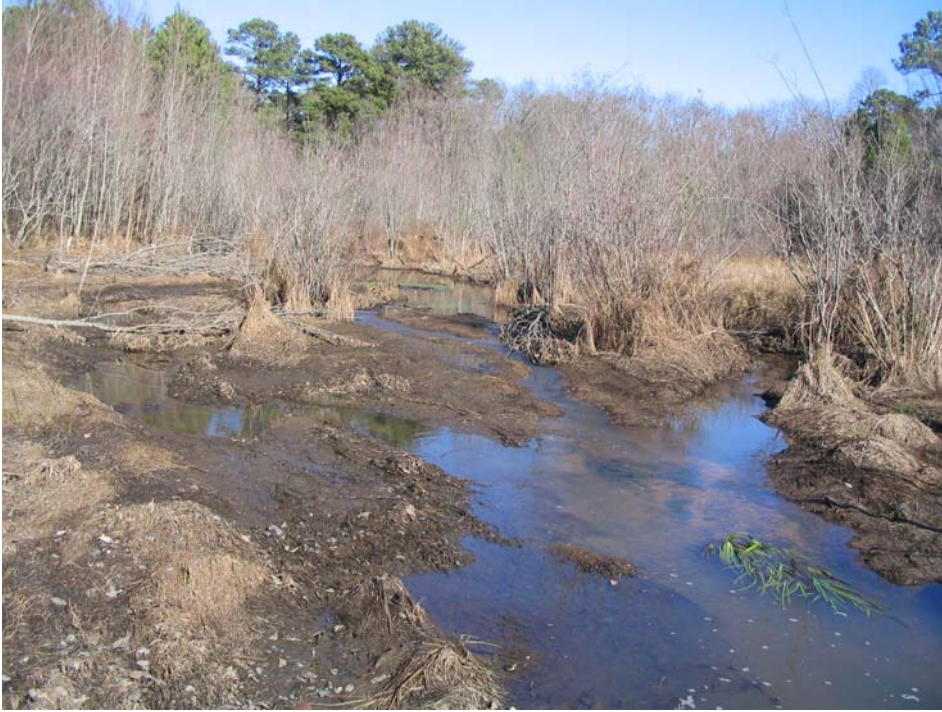
Areas of inundation during bank full event, January 2007

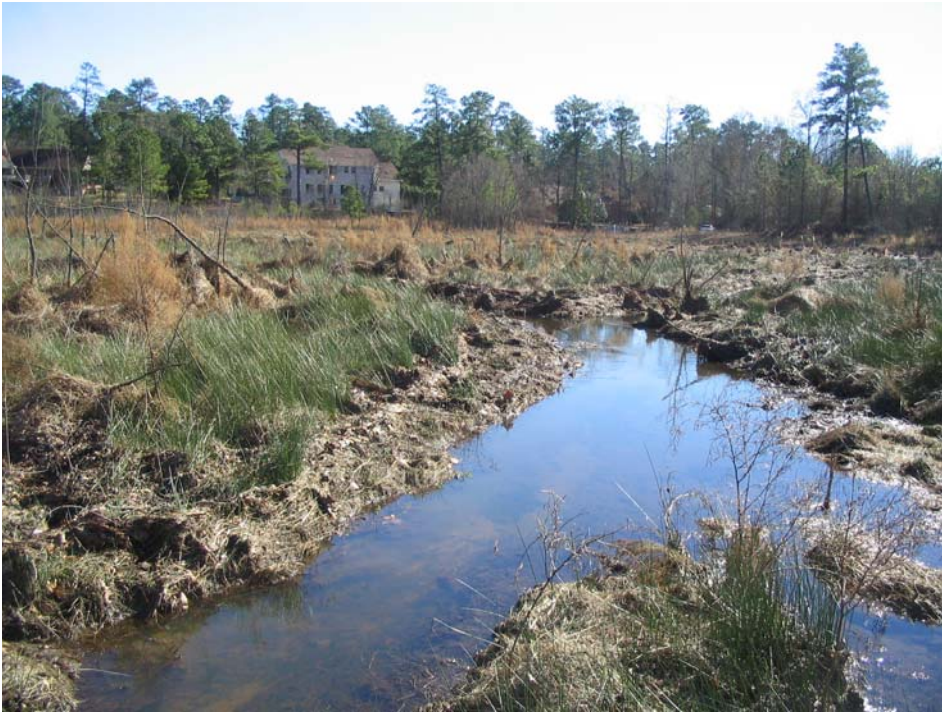
Vegetation flattened and rack lines along banks in center of project, January 2007

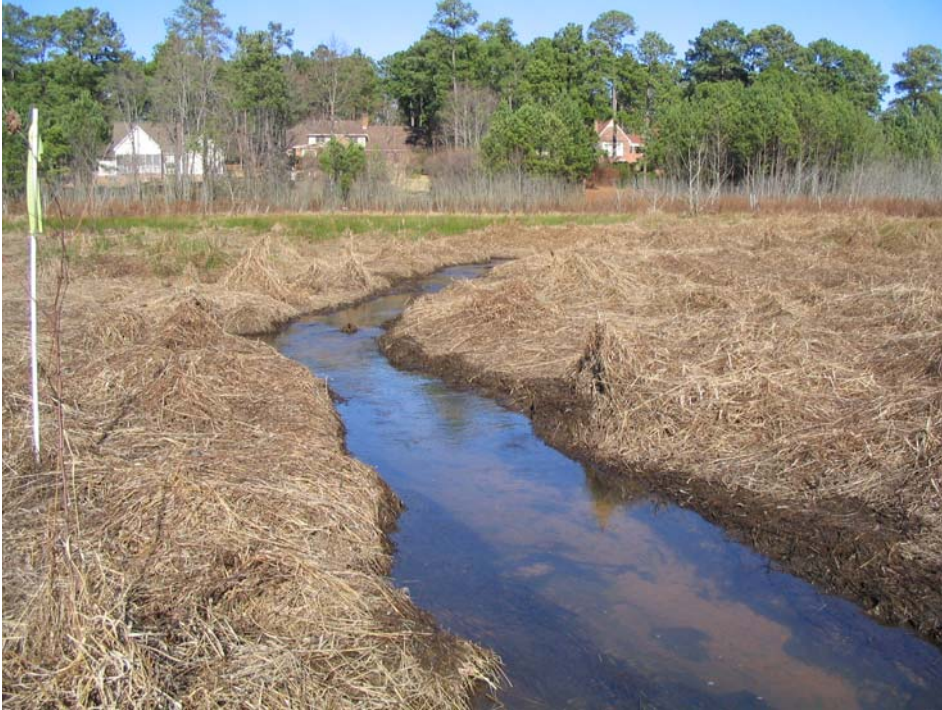
High water mark still visible in some areas, January 2007

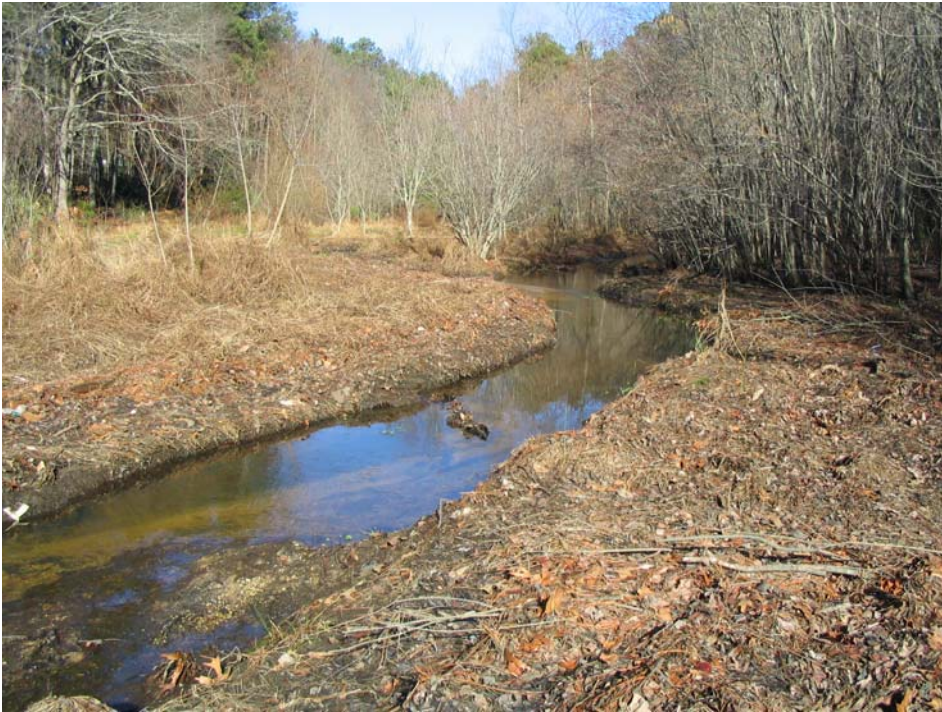
Leaf litter rack line along banks close to enhancement area, January 2007

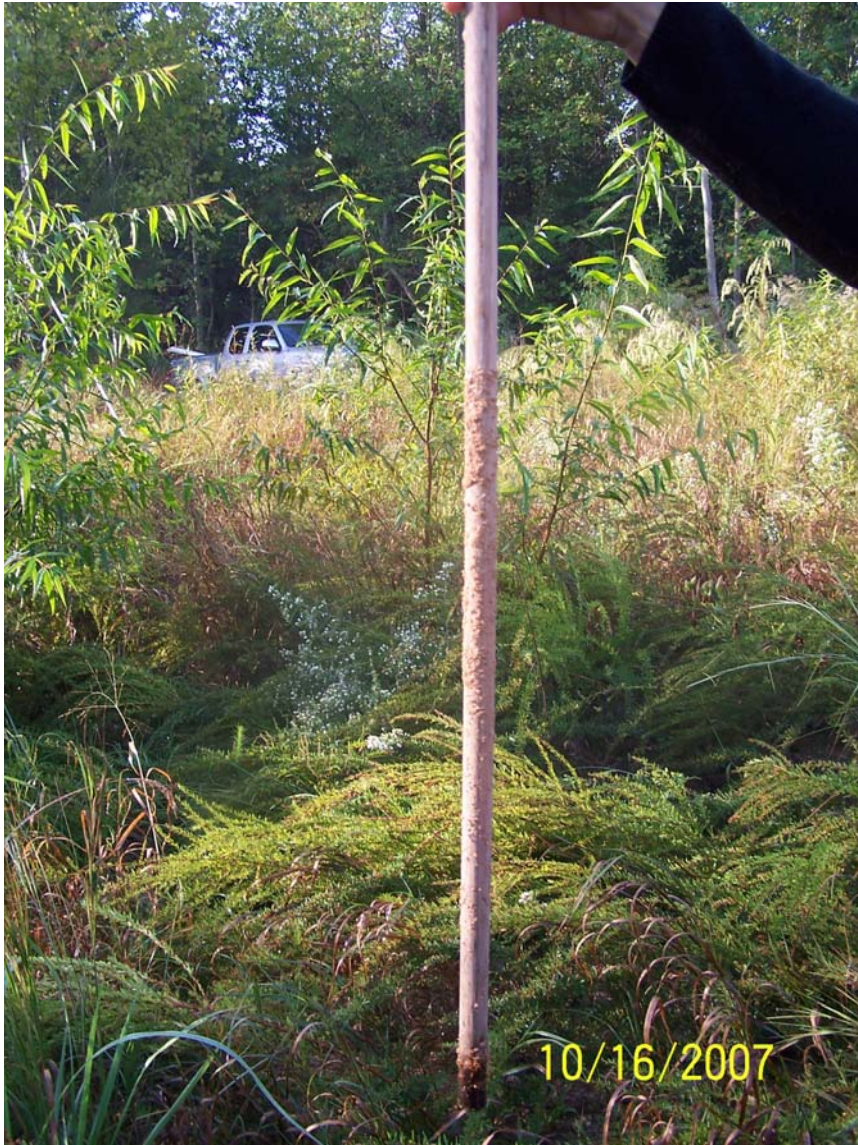
Crest Stage gage checked above 10/16/2007 showing bank full event from September 2007.
