Tarlton Stream and Wetland Restoration Project

Contract #: D05013-1
County: Cumberland
Cataloging Unit: Cape Fear 03030004
Monitoring Firm POC: Mid-Atlantic Mitigation, LLC
Rich Mogensen (704) 782-4133
Kimley-Horn Associates, Inc.
Will Wilhelm (704) 333-5131
Prepared For: EEP Project Manager, Guy Pearce

Year 3 (2008) Monitoring Report

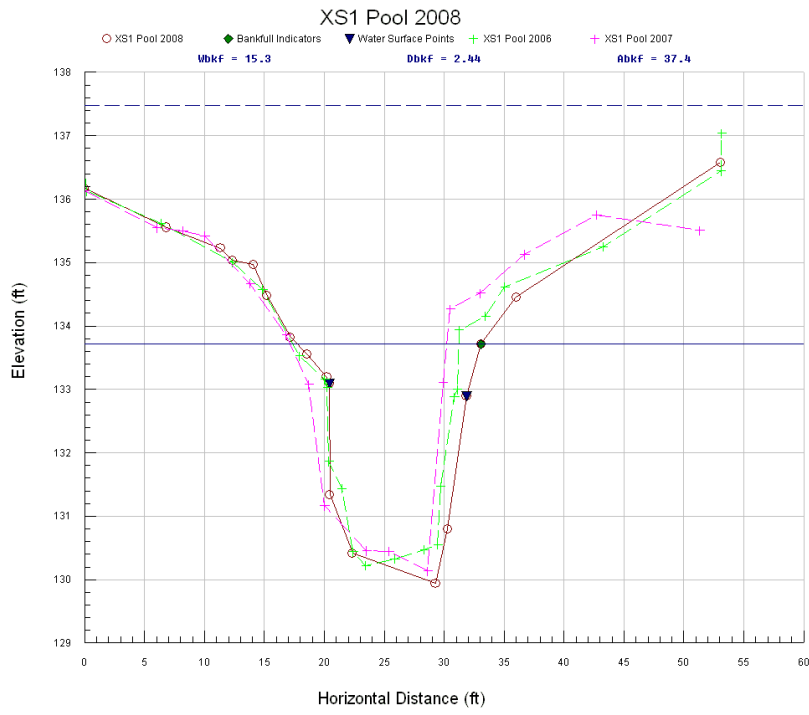
Graph 1: Cross Section 1 Pool

Cross Section 1 – No significant changes, Thalweg right of center.

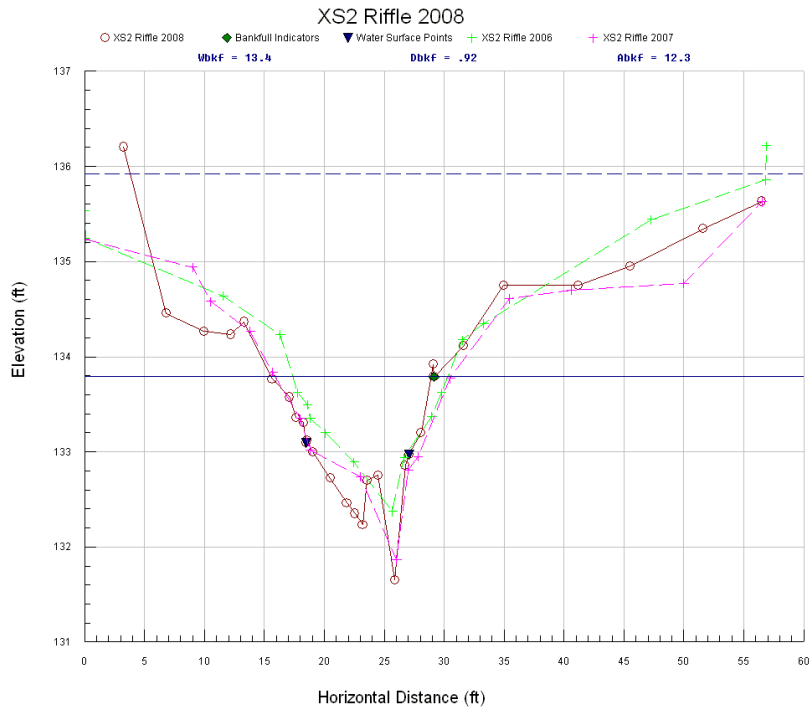
Graph 2: Cross Section 2 Riffle

Cross Section 2 – There may be some scouring present along the left bank and a small sand bar may be developing, thalweg right of center.

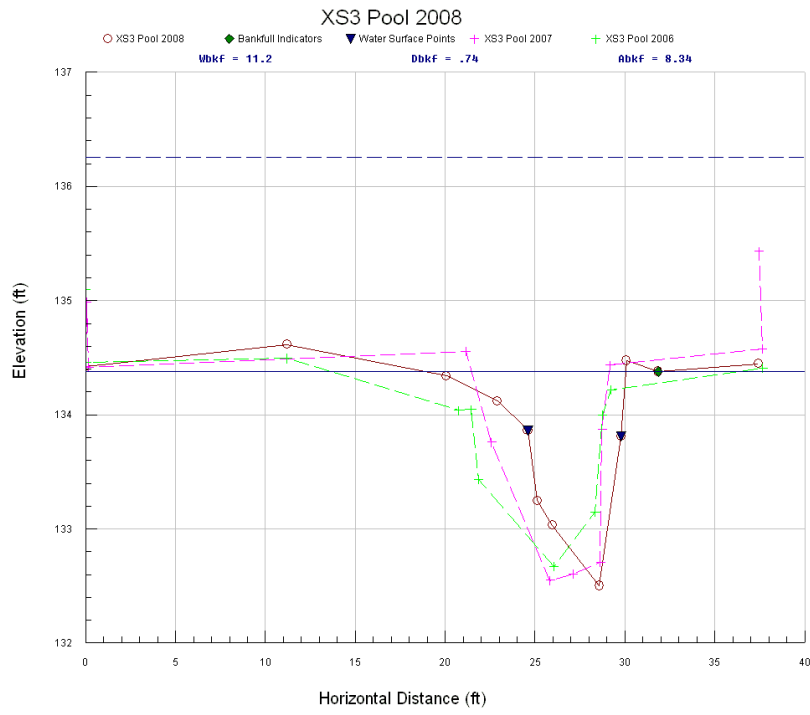
Graph 3: Cross Section 3 Pool

Cross Section 3 – Channel appears to be narrowing, thalweg right of center.

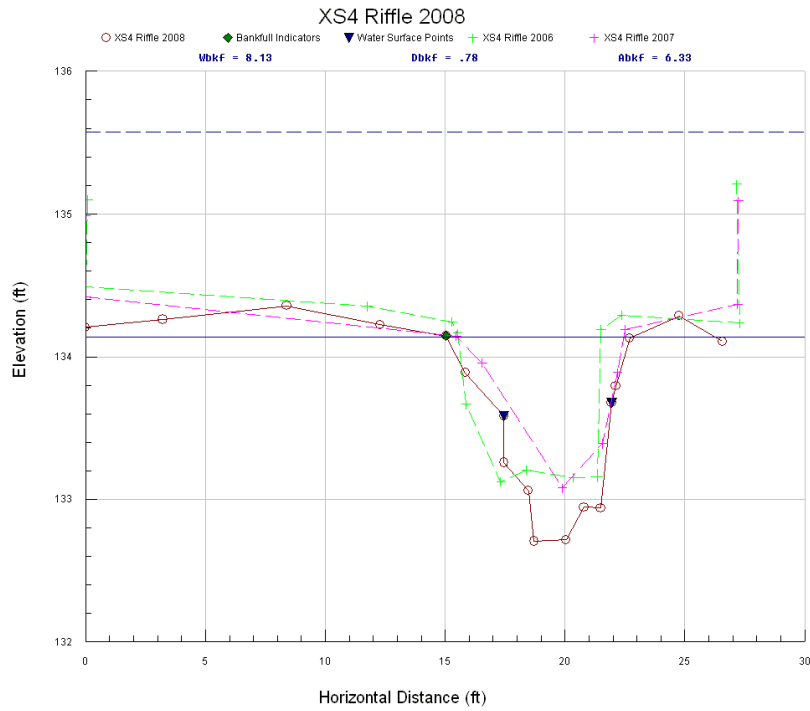
Graph 4: Cross Section 4 Riffle

Cross Section 4 – Channel has deepened slightly, thalweg left of center.

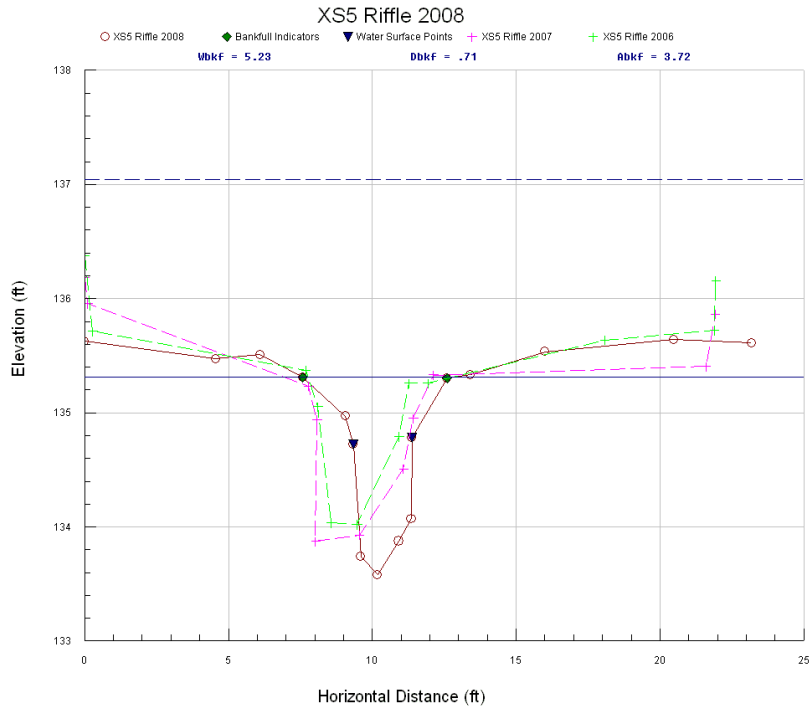
Graph 5: Cross Section 5 Riffle

Cross Section 5 – Channel shows narrowing and deepening trend, thalweg left of center.

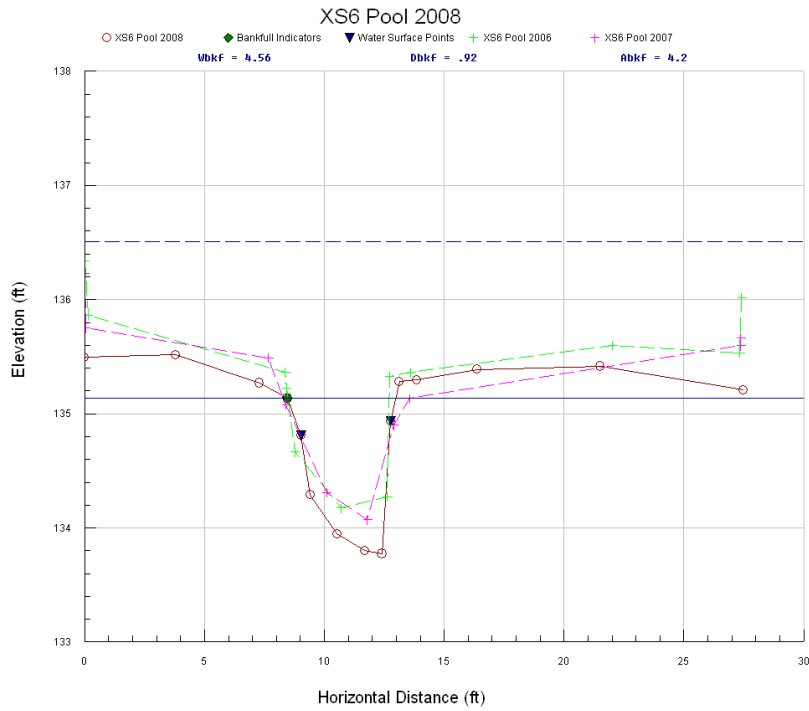
Graph 6: Cross Section 6 Pool

Cross Section 6 - Channel has deepened slightly, thalweg right of center.

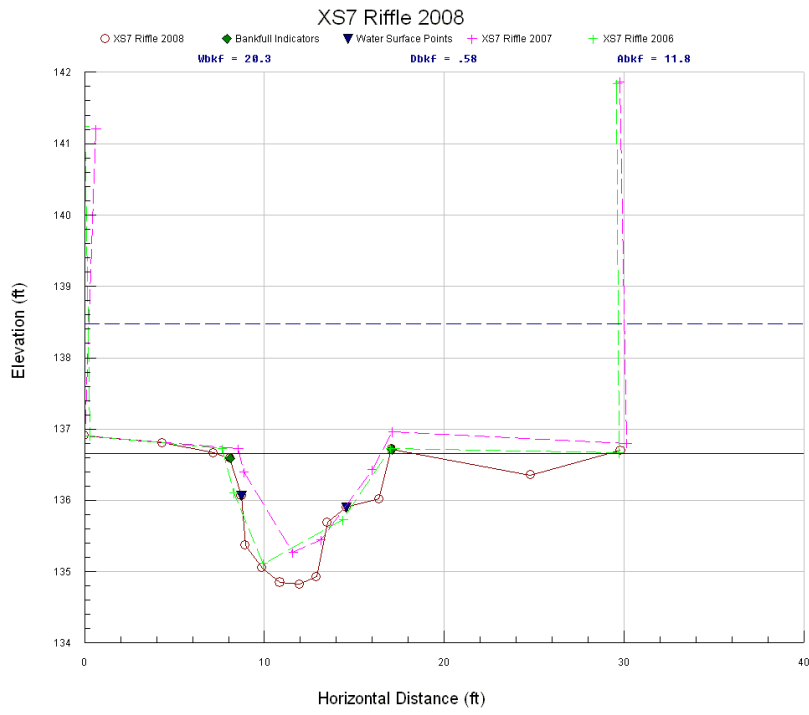
Graph 7: Cross Section 7 Riffle

Cross Section 7 - Channel has deepened slightly, thalweg left of center.

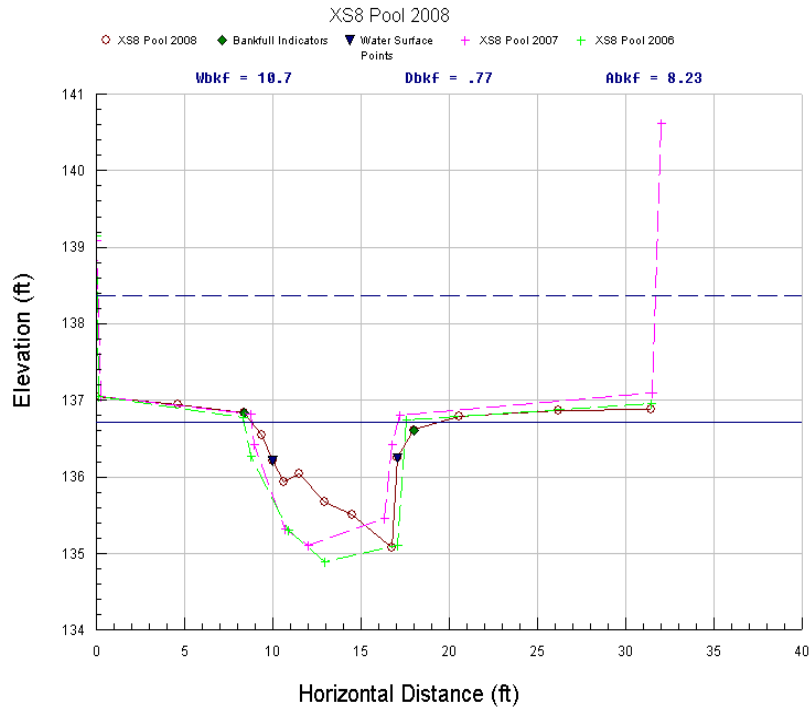
Graph 8: Cross Section 8 Pool

Cross Section 8 – Deposition appears to have occurred in this pool along left bank, thalweg right of center.

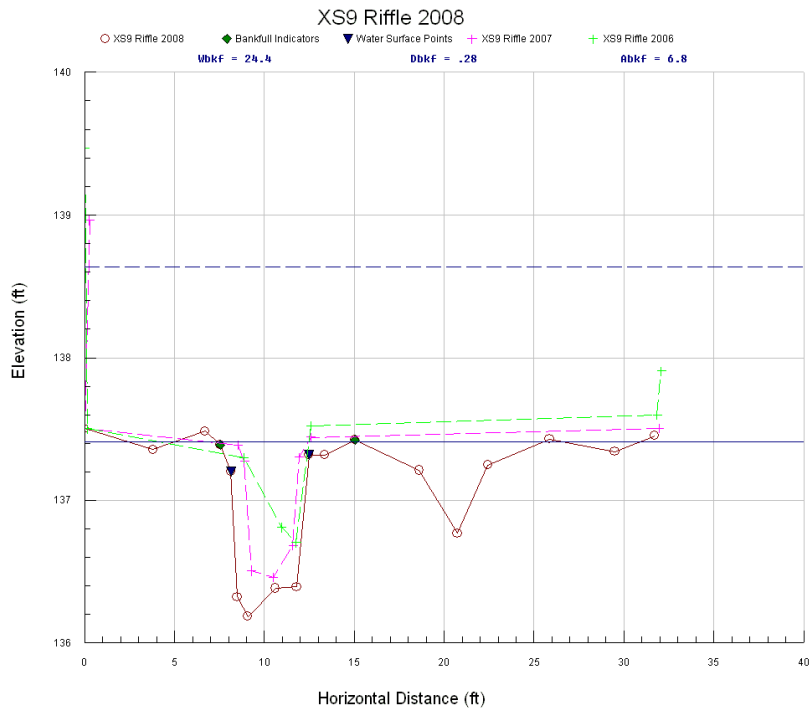
Graph 9: Cross Section 9 Riffle

Cross Section 9 – Channel shows deepening and widening trend, thalweg left of center, scouring may be present along right bank.

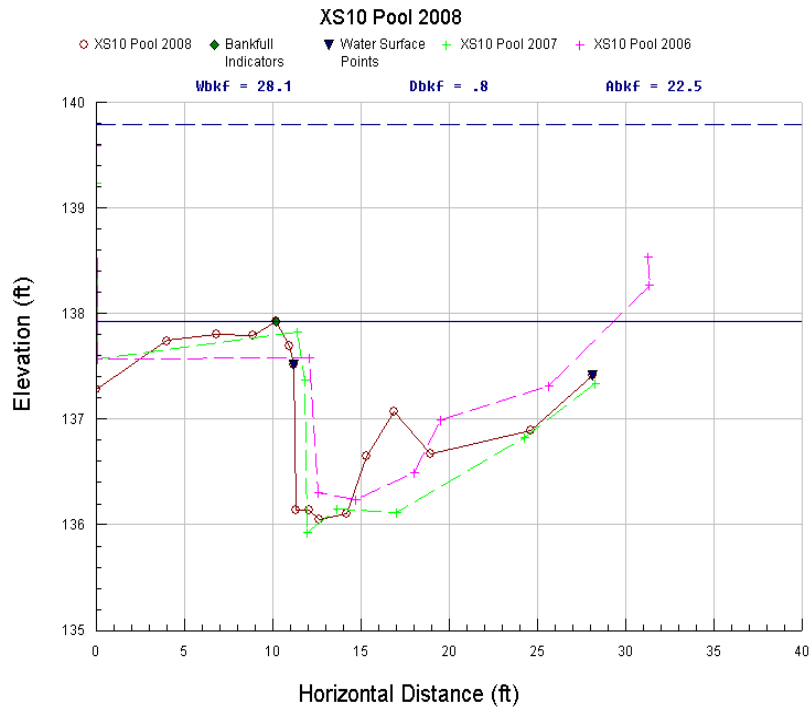
Graph 10: Cross Section 10 Pool

Cross Section 10 – Channel indicates a potential right bank failure may have sloughed into the channel, thalweg left of center.

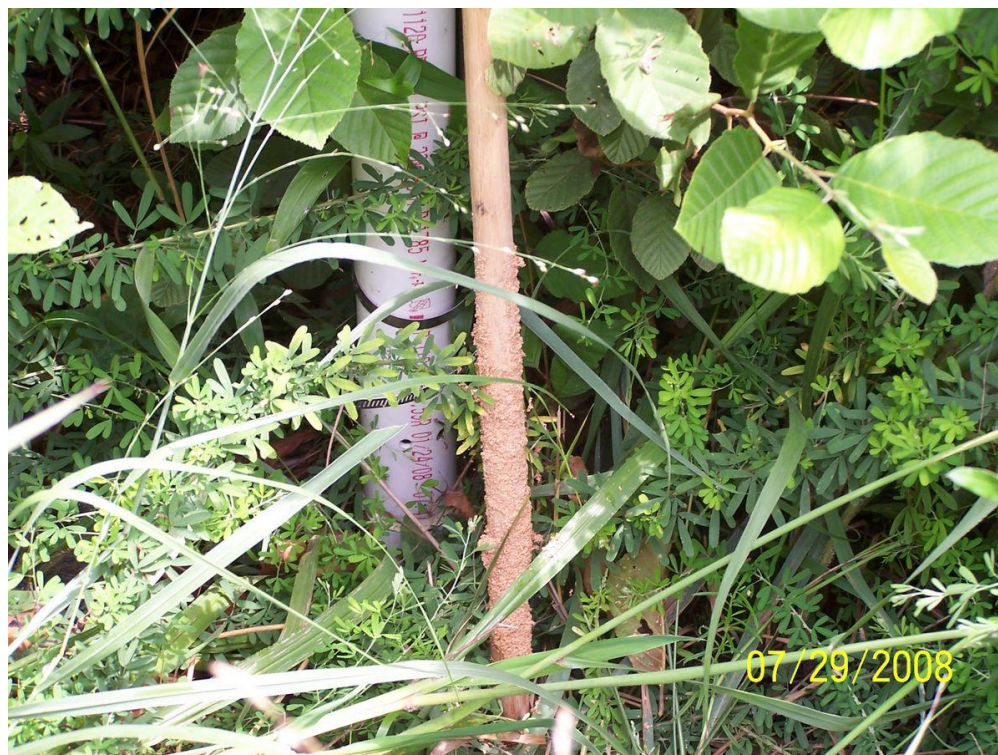
Bankfull Events Log

Crest Stage Gage was reset on 1/24/2008 and indicated a bankfull event
 Crest Stage Gage was reset on 7/29/2008 and indicated a bankfull event

Stream gage peaks of aprox. 24 inches may result in the CSG triggering if rainfall (onsite) is significant
